PREPARED FOR SAFETY RESEARCH & STRATEGIES, INC.

Toyota Electronic Throttle Control Investigation

Preliminary Report

2/21/2010

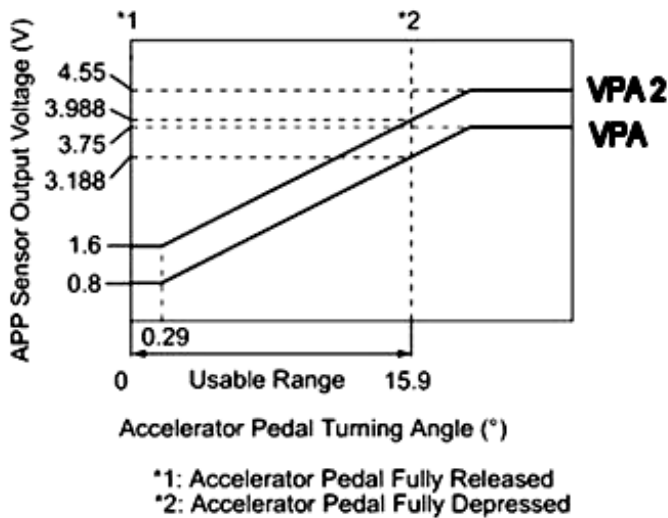
Normal Toyota APP

angle and is used for engine control” (Appendix: TIS Service Document, p. 1). Voltage limits for VPA, range from 0.4 to 4.8 Volts or more. The signal from VPA2 (sub) “conveys the status of the circuit and is used to check the APP sensor itself” (Appendix: TIS Service Document, p. 1). Voltage limits for VPA2, range from 1.2 to 4.8 Volts or more. Of important note, are the *overlapping* voltage values of the two APP signal inputs to the ECM.

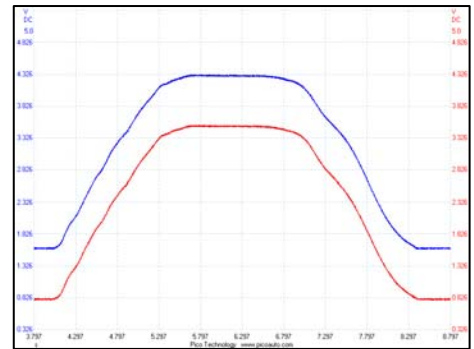
Potential Loss of APP Sensor Redundancy

Because their important role to accurately convey vehicle driver demands for throttle opening, APP sensor voltage inputs should always be confirmable by the ECM as absolutely correct. It was noted in the service literature that the threshold limits for a voltage difference of “0.02 Volts or less” between the two APP signal circuits should set a DTC P2138 (Appendix: TIS Document, p. 3). This voltage appeared to be an unusually close threshold value for a short between circuits. In other words, these two signal voltages could have been *almost* identical, and remain safely within the parameters of the P2138 DTC threshold limits. The VPA and VPA2 normally operate through a common range of parallel planes of voltage values. In addition, the two signal voltage values are normally supposed to rise and fall in unison with each other. If the two signal voltages

were in some fashion to become interconnected (shorted) through a certain amount of circuit resistance, the lower VPA voltage could be pulled up slightly in value. The higher VPA2 voltage could be affected in the opposite manner and pulled down slightly in value. At the same time, both sensors could conceivably stay within the upper voltage boundary of 4.8 Volts or more for the P2123 and P2128 DTC criteria. Similarly, the VPA2 1.2 Volt low threshold limit value for a P2127 DTC would not be reached, and the VPA 0.4 Volt low threshold limit value for a P2122 DTC would not be reached. Signal interconnection through resistance could then potentially tie the two circuits together without setting a DTC. At that point, APP signal circuit redundancy is lost and neither signal circuit is verifiable by the ECM as defective. The ECM will only react to defective voltages outside of the range of programmed limitations-so if the circuit is not defective; it must be good. Without a DTC set, the ECM will not logically enter into a fail-safe mode of operation.

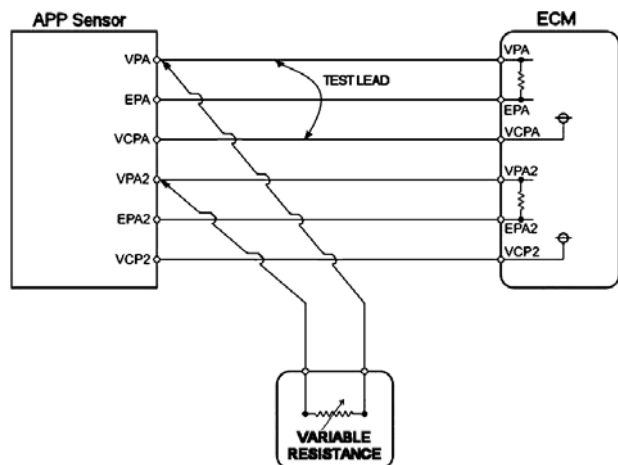
While running the engine in a VPA to VPA2 short circuit state, without MIL illumination or stored DTCs, accelerator pedal response rate and range was noted. Accelerator pedal observations were made with simultaneous brake pedal application, and without simultaneous brake pedal application. Recorded data, observations, and results were listed in detail for each specific test vehicle. To further test the absence of fault detection, experimentation was done to determine if the ECM would set a DTC with a combination of additional circuit abnormalities. Two combination tests were performed to include VPA and VPA2 shorted together (operating undetected), and circuit continuity to ground and power. The VPA and VPA2 signals operating in a short circuit state (undetected by the ECM)

were given a circuit path to EPA AND EPA2 (ground). Additionally, the shorted VPA and VPA2 signal circuits (undetected by the ECM) were tested with a circuit path to the VCPA and VCP2 (5 Volt supply). These tests were made during both: KOEO, and KOER conditions. Several different combinations of trials were made before discovering that when VPA and VPA2 were shorted together, with an undetectable resistance, and a connection was made from either VCPA or VCP2 to the VPA2 circuit *only* – both VPA voltages would rise together in unison. As a direct result of the connection to the VCP 5 volt supply circuit, the ECM responded by opening the engine’s throttle. Surprisingly, the ECM was repeatedly unable to detect this serious circuit fault abnormality. The vehicle showed no MIL illumination nor stored DTC in the ECM. Most alarming during KOER trials, the engine speed increased almost instantaneously to the full operating RPM limits of the engine. The resulting condition was also present with or without brake pedal application.

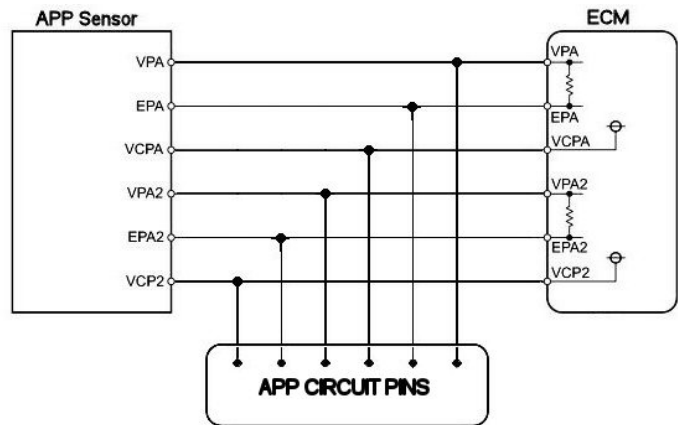
At this point, the back-probing of the APP circuits and ETC testing procedures were re-evaluated. All Toyota test vehicles were considered operationally unstable, with the known potential to reach Wide Open Throttle (WOT) anytime after the engine was started. For more extensive investigation on the research vehicles, wire test leads were tapped directly into the APP wiring harness. The decisive reasoning for installing wire

taps was to provide more secure and stable connections to the APP circuitry. By providing more accessible and manageable “pin-out” connections of the APP circuits, testing methods were enhanced with more reliable voltage and resistance measurements. Plus, secure and clearly labeled circuit connections

provided for a much safer laboratory testing environment. Evaluation tests were now more narrowly focused on the capabilities of the ECM to detect fault conditions to set a DTC P2138. DTC P2138 is the code used to detect the presence of a short between VPA and VPA2 signal circuits. Resistance values for shorted VPA and VPA2 signal circuits,

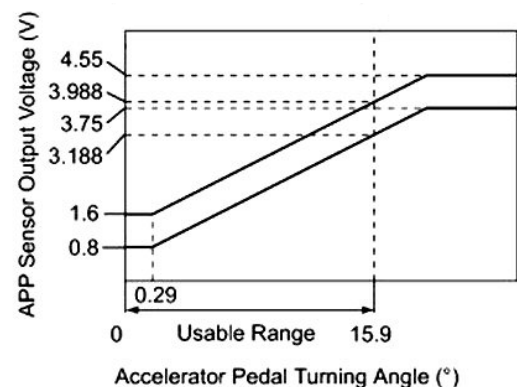
In review of the TIS service information, collected vehicle data, and performance observations; some general assumptions can be drawn from the research completed to date. The inability of the Toyota ECM to detect certain types of short circuit malfunctions could fall back to the basic design of the normal APP signal voltage limitations. The parameters for APP signal short circuit fault detection are apparently too lenient. In the Toyota ETC system, the APP sensor signal voltages rise simultaneously in direct response to accelerator pedal depression. With this design, interconnected signal circuits could be more difficult to identify with a circuit fault detection strategy that uses only threshold voltage limitations.

A more conclusive circuit fault detection strategy could use APP signal voltages (see A & B) that have rising slope, but with offset voltages that increase at slightly different rates. Several vehicle manufacturers currently use this fault detection strategy for APP sensor signal circuits.
