QUICK REACTION REPORT ON THE
BAGHDAD POLICE COLLEGE
BAGHDAD, IRAQ

SIGIR PA-06-078.1

SEPTEMBER 27, 2006

Quick Reaction Report on the Baghdad Police College, Baghdad, Iraq

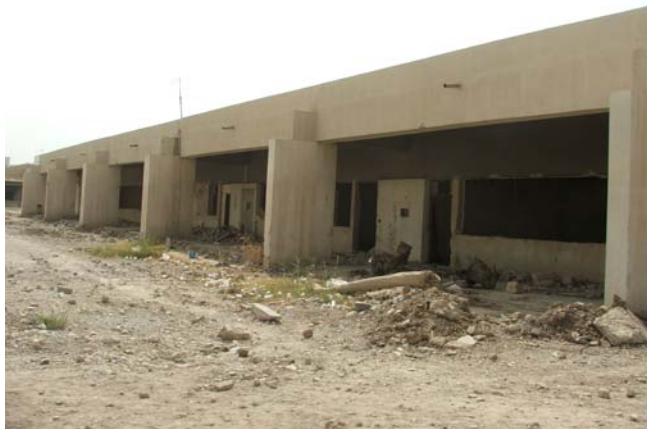
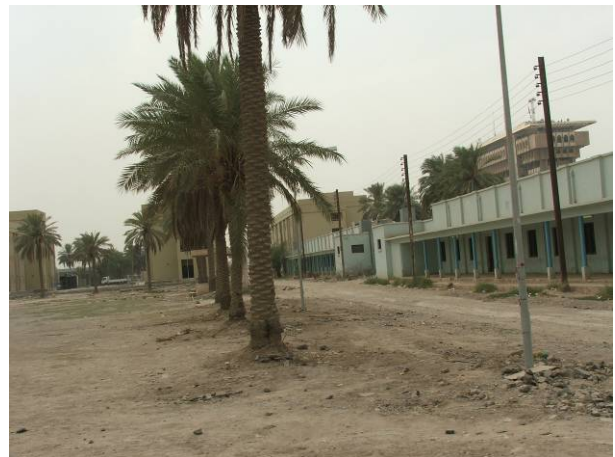
The description of the facility (pre-construction) was based on information obtained from the contract, the U.S. Army Corps of Engineers (USACE) project file, and Baghdad Police College personnel. The project site is located at the existing Baghdad Police College, in Baghdad, Iraq. The Baghdad Police College previously was a three year officer training facility. However, with an emphasis of providing a large number of cadets thorough Basic Police Training, this facility was determined to be insufficient. The existing facility consisted of a number of buildings, constructed approximately between 1935 to 1940. The existing buildings were in various stages of decay (Site Photos 1 and 2).

Site Photos 1 and 2. Existing buildings at the Baghdad Police College

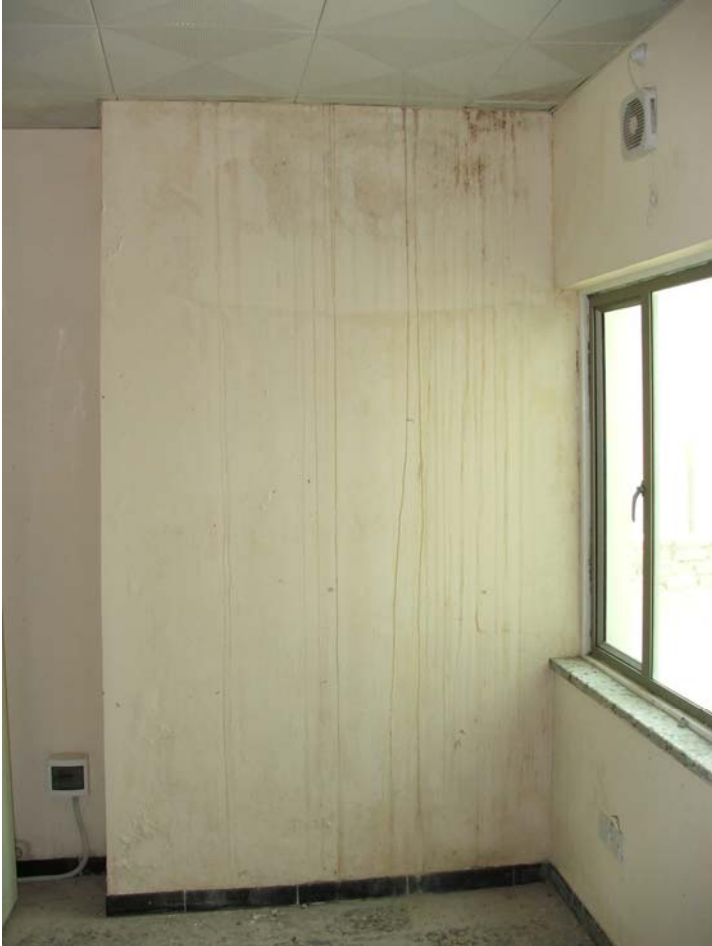
During our site visit, we immediately identified water damage and staining on the ceiling and walls of the ground floor (Site Photos 4 and 5). We toured the second floor bathroom and saw evidence of similar water damage and staining on the ceiling (Site Photo 6).

Site Photo 4. Water damage to wall

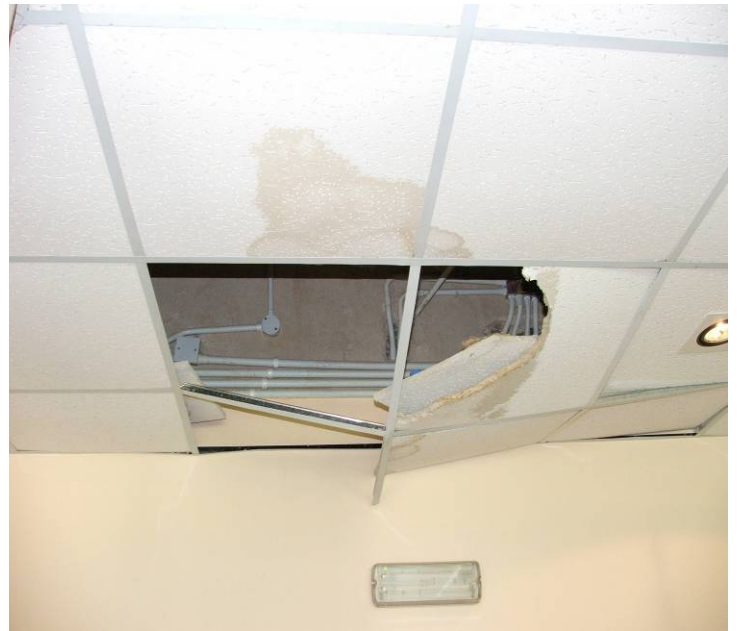
Site Photo 5. Water damage to ceiling

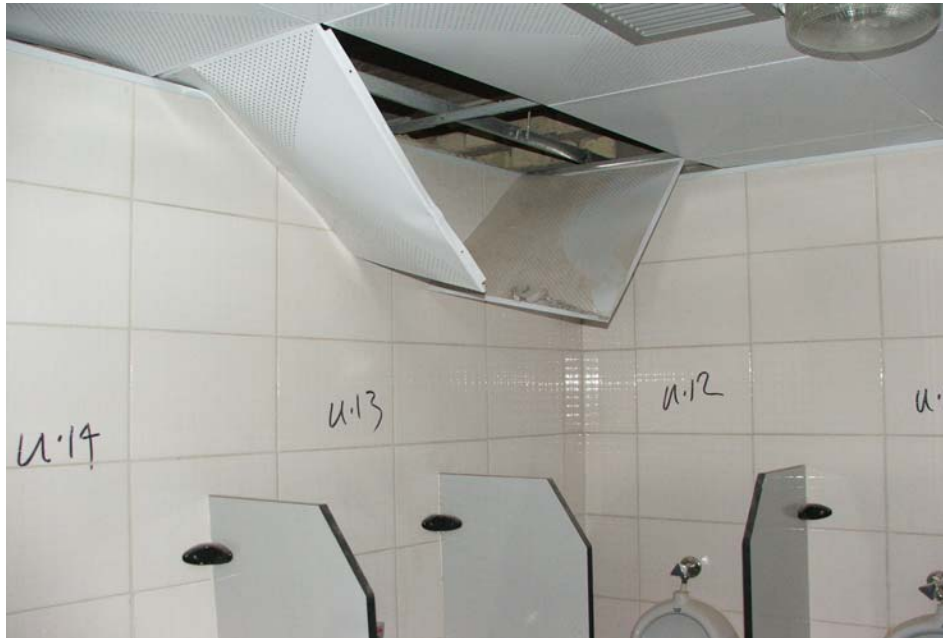
Site Photo 6. Water damage to second floor bathroom ceiling

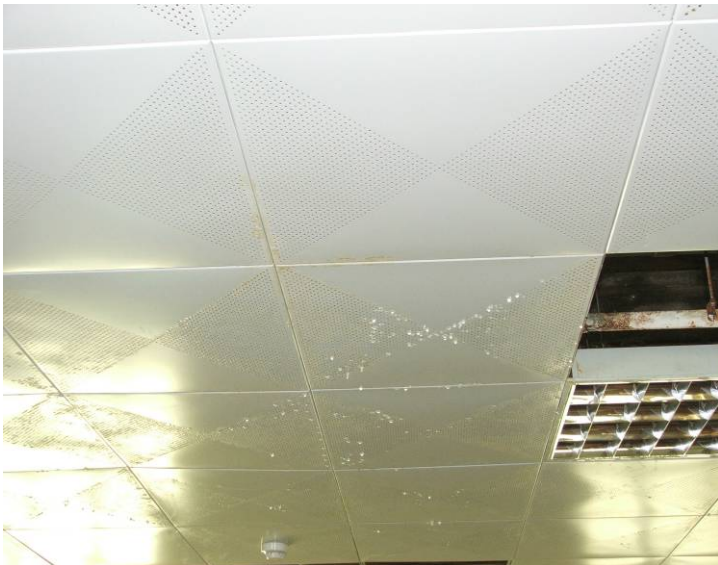
We visited another cadet building and, while on the ground floor, we witnessed firsthand the leaking of water and the residue of dissolved minerals and materials that had been transported by the water from the second floor (Site Photos 7-11). The water has been dripping at such a rapid rate that the Baghdad Police College Director refers to this room as the “Rain Forest.”

Site Photo 7. Water leaking from ceiling

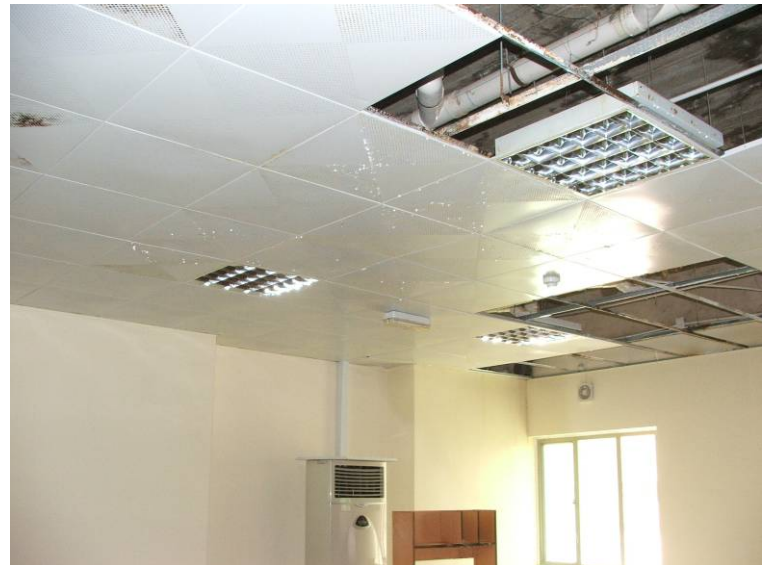
Site Photo 8. Water leaking from ceiling

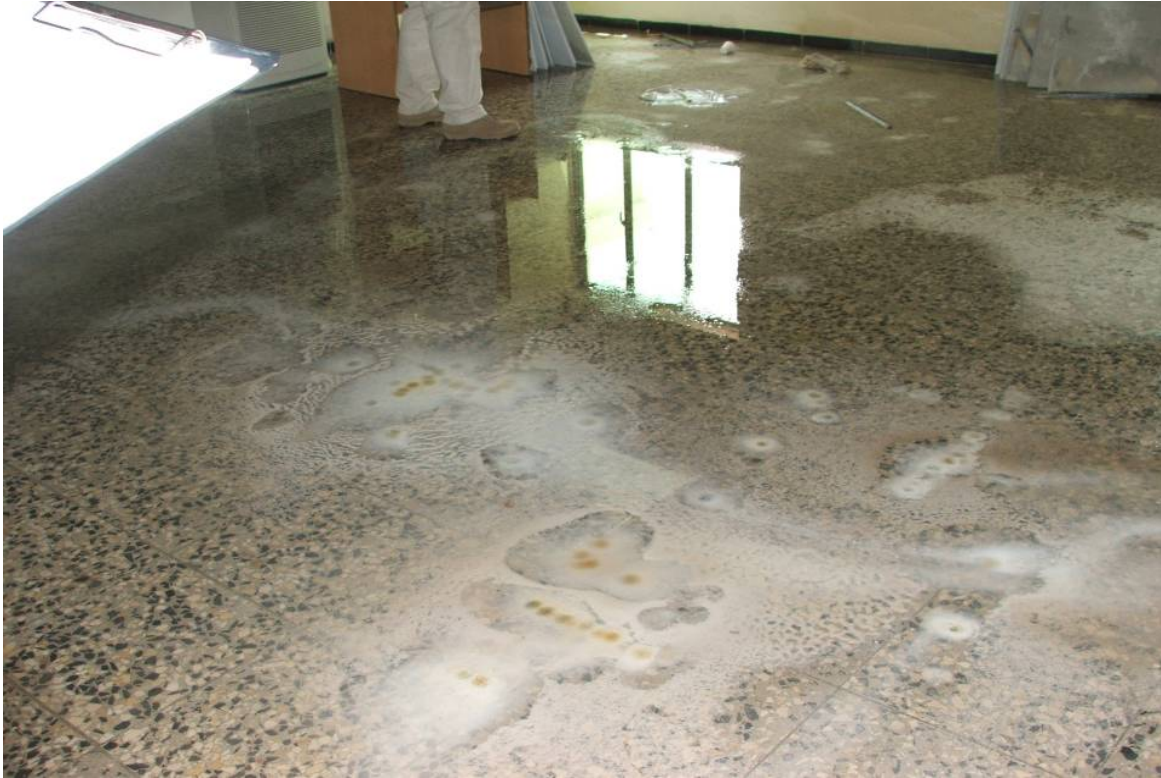
Site Photo 11. Additional view of water damage and residue from dissolved minerals and materials in the water from leaking ceiling

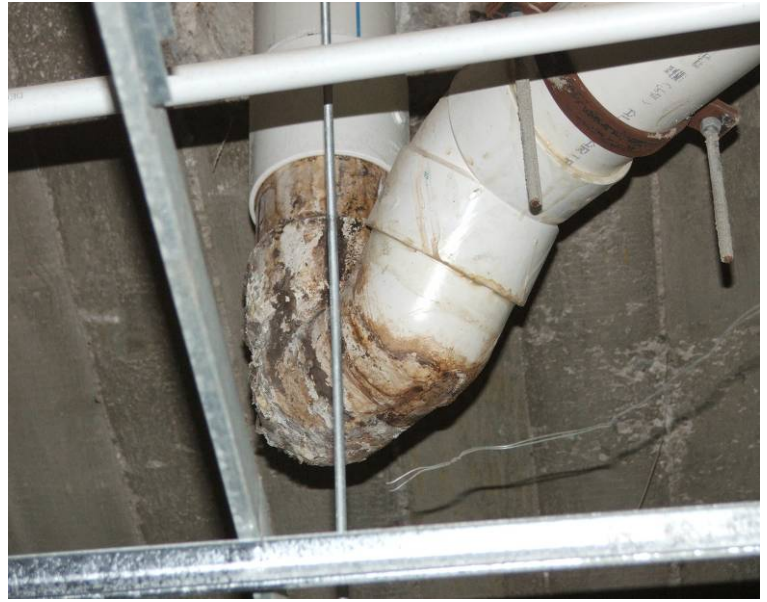
- Floor drains are not adequately sealed to the floor surface and/or properly affixed to adjacent fittings with the proper adhesive or sealant, which causes water to drain outside rather than inside the drain collectors (Site Photo 12 and 13)
- Drains were assembled without the specified molded plastic fittings, which resulted in water and waste materials flowing from the collection trees through the improperly fabricated joints directly into the concrete floors. The contractor used pipes with holes that were hand cut with secondary pipes inserted (Site Photo 14) rather than the appropriate type of pipe (Site Photo 15).

Site Photo 13. View of another pipe leaking wastewater

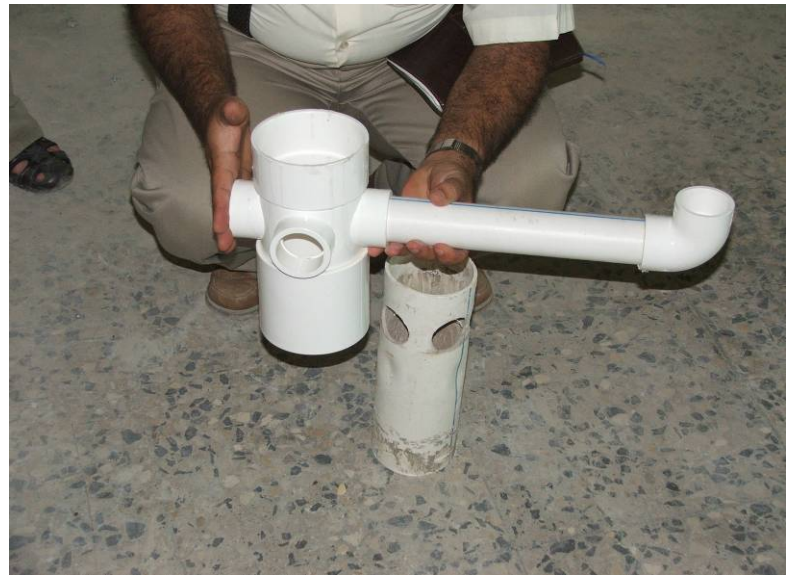
Site Photo 15. Contract specified wastewater pipe connection method

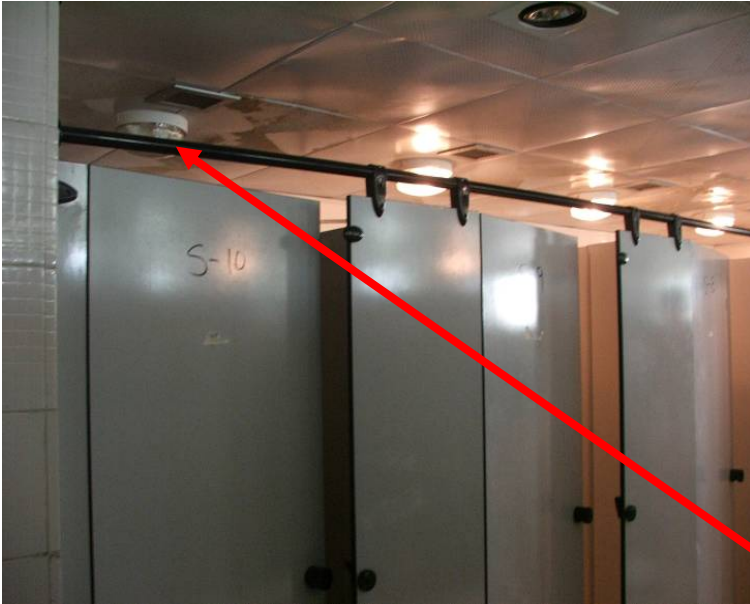
As a result of the inferior plumbing techniques, methods, and bonding materials used by the contractor to join the wastewater pipes, water and other waste materials from showers, wash basins, and toilets are continually draining through the reinforced concrete floors, from the top floor to the second floor to the ground floor, permeating and filling light fixtures, showers, and toilet areas, with liquids, including diluted urine and fecal matter. For example, we witnessed a light fixture so full of diluted urine and feces that it would not operate (Site Photos 16 and 17). As we continued

Site Photo 16. Bathroom lights on second floor

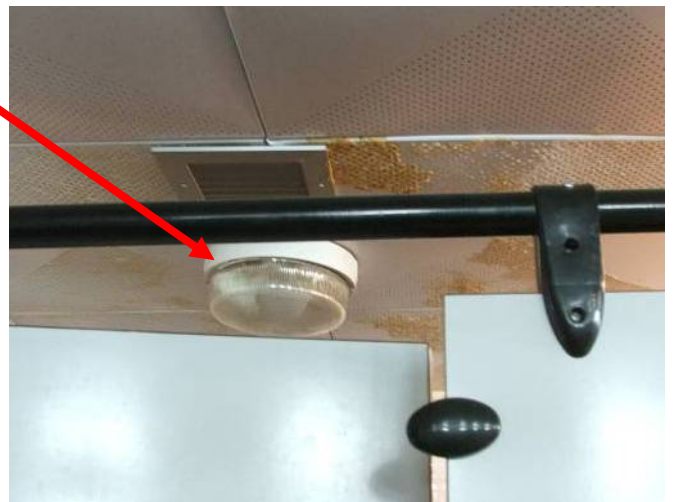
Site Photo 17. Close-up view of far left bathroom light not operating because it is full of diluted urine and fecal matter

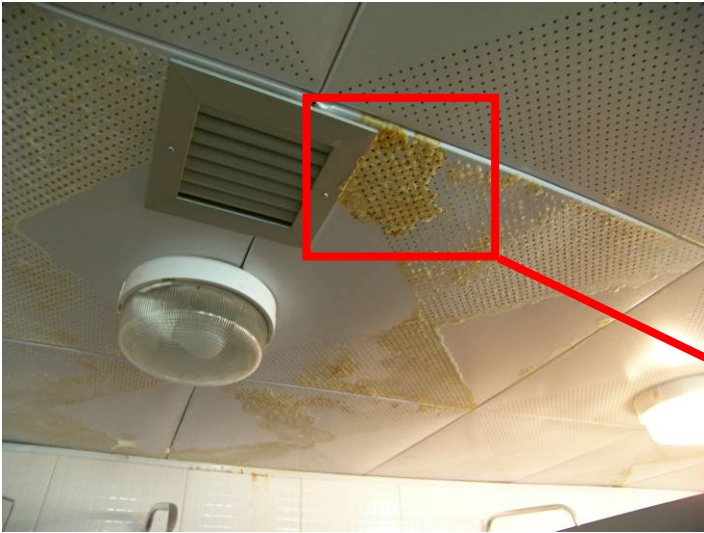
our assessment throughout the second floor bathroom, we identified evidence of large quantities of diluted urine dripping from the top floor down through the ceiling. The urine was so pervasive that it had permanently stained the ceiling tiles (Site Photos 18 and 19). During our visit, a substance dripped from the ceiling onto an assessment team member's shirt (see Site Photos 20 and 21).

Site Photo 18. Urine stain on the second floor ceiling

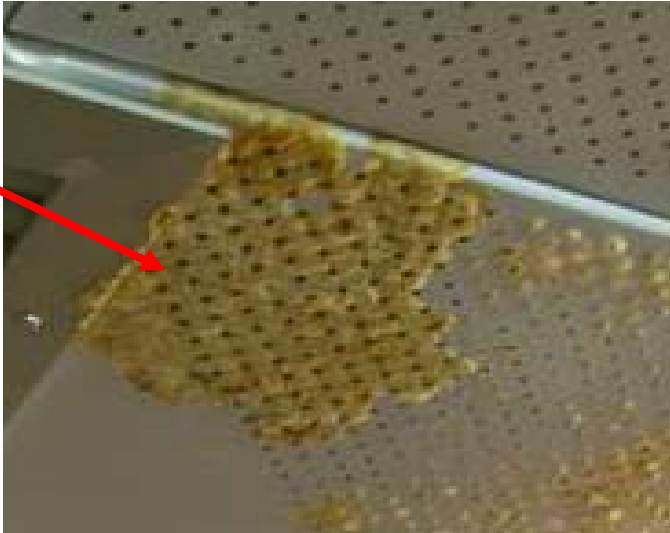
Site Photo 19. Enlarged picture of urine stain

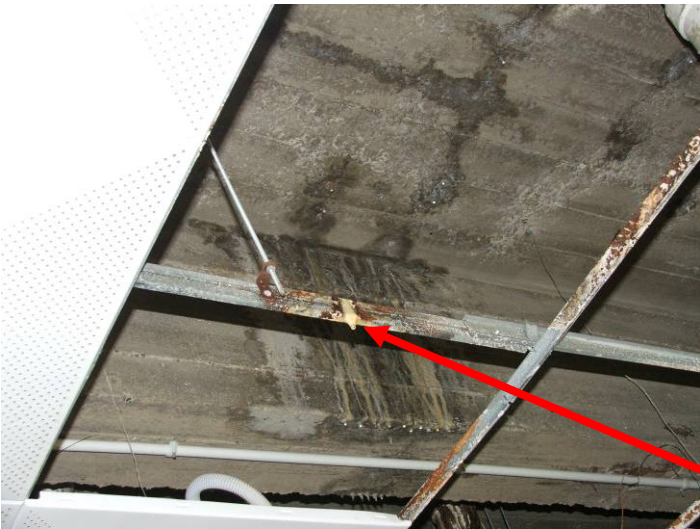
Site Photo 20. Ceiling Dripping

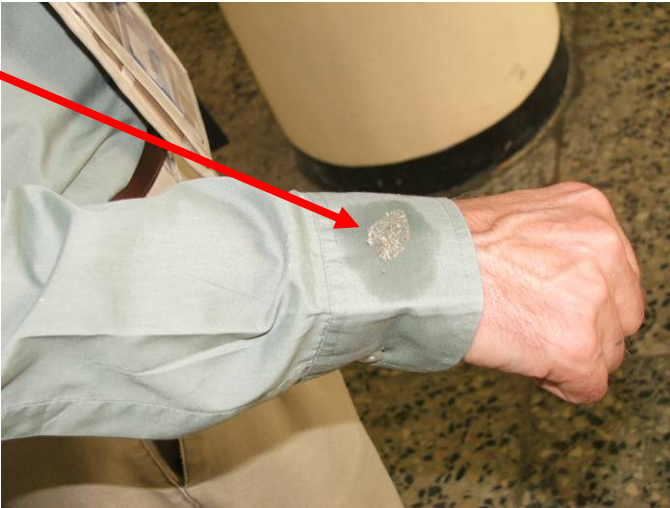
Site Photo 21. Substance on engineer's shirt

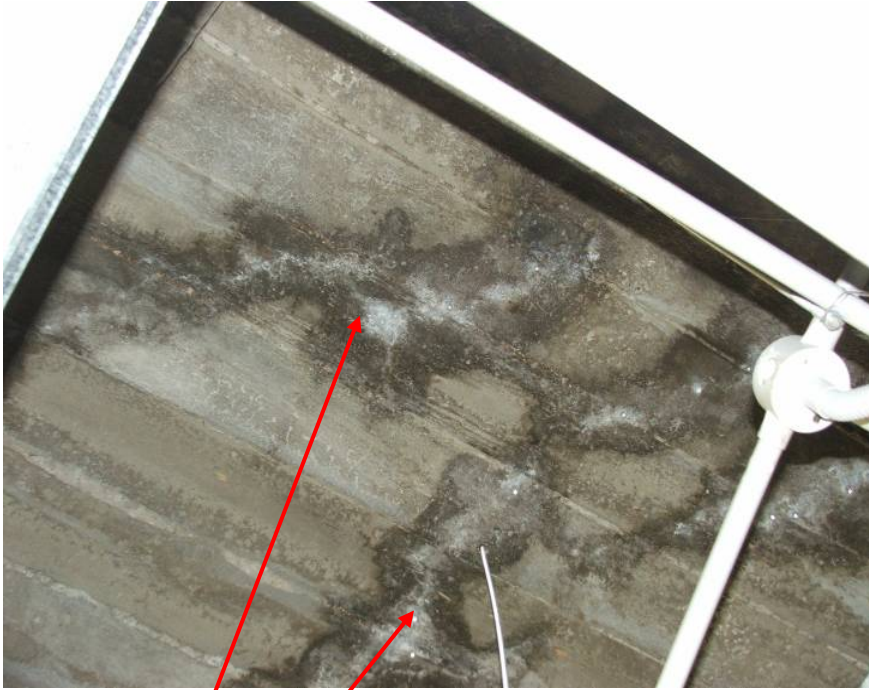
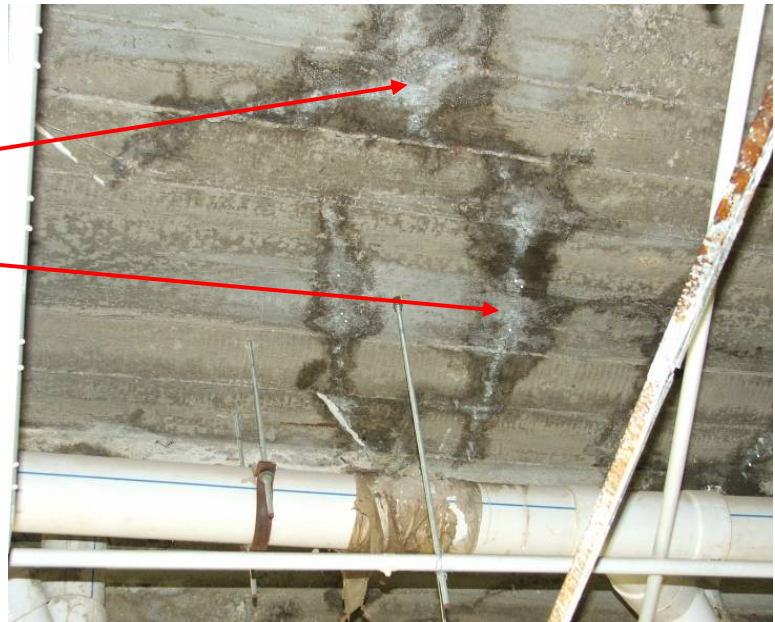
Even though the subcontractor is taking steps to correct the problem, the Baghdad Police College staff and students still have to deal with the damage caused by the poor subcontractor workmanship. In addition to water and waste materials soaking and filling light fixtures, showers, and toilets on the ground and second floors, the amount of material was so pervasive that it has soaked through the reinforced concrete floors causing deterioration of the reinforcing steel, and leaching of the chemical salts that are necessary for the proper strengthening of the concrete. The visible salt deposits, known as efflorescence, are readily apparent on the underside of the slabs (Site Photos 23-26). The subcontractor is making the corrections needed to fix the original problem; however, the subcontractor did not make any assessment of the damage already done including the structural integrity of the reinforced concrete slabs for each floor of the building. The Director of the Baghdad Police College is also concerned that the rust, mold, and presence of urine and fecal matter caught within the concrete floors presents a serious threat to the health of all Baghdad Police College students and staff. Further, if an environmental and/or health hazard is present at the Baghdad Police College, the number of basic recruits graduating through the facility will be impacted.

**Underside of 2nd floor
Concrete slab cracks with
soaked through with urine,
fecal matter and efflorescence.**

1. Perform an assessment of all wastewater plumbing installations in all newly constructed buildings, both single and multiple storied, sponsored under this contract. This assessment will be to determine if similar methods of inadequate plumbing techniques were utilized in other project locations as were discovered in the cadet barracks buildings.
2. Perform a critical technical study of the structural integrity and load carrying capacity, as well as the potential environmental and health hazards posed by the rust, mold, and presence of urine and fecal matter within the concrete floor slabs of the cadet buildings to the Baghdad Police College students and staff.

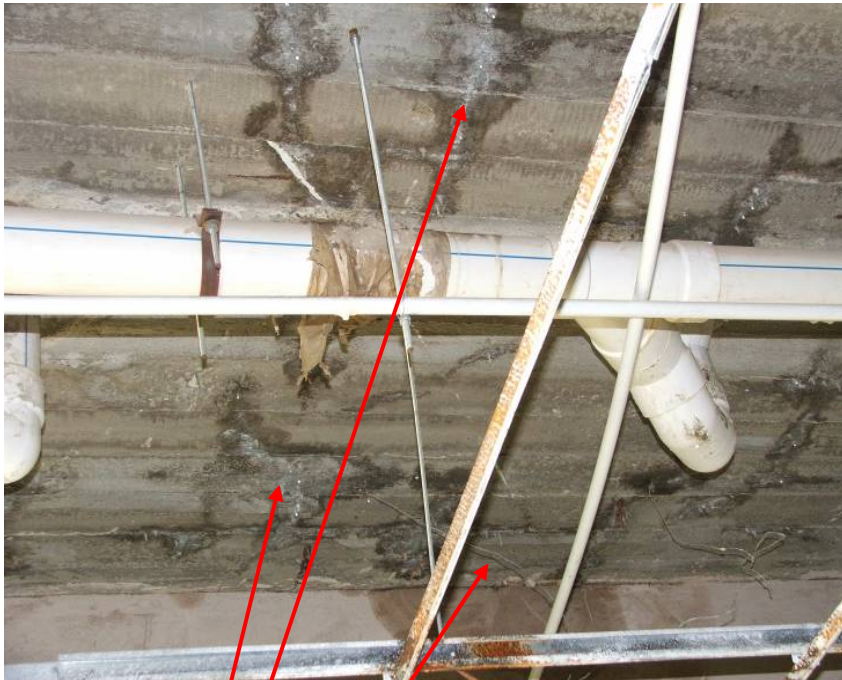
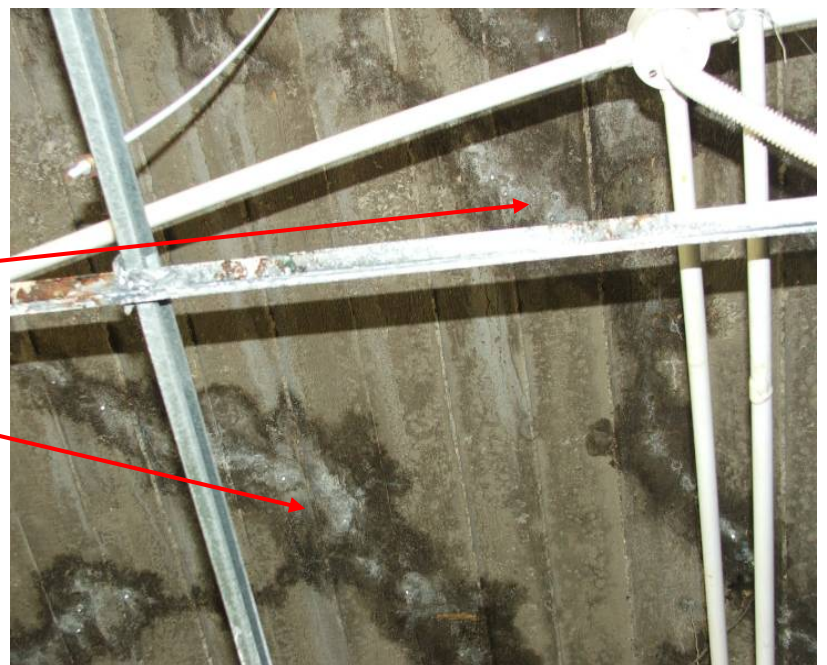
Underside of 3rd story Concrete floor slab cracks soaked through with extensive urine, fecal matter and efflorescence.
