Deepwater Horizon Incident – Internal Investigation
INVESTIGATION UPDATE – INTERIM REPORT

June 08, 2010

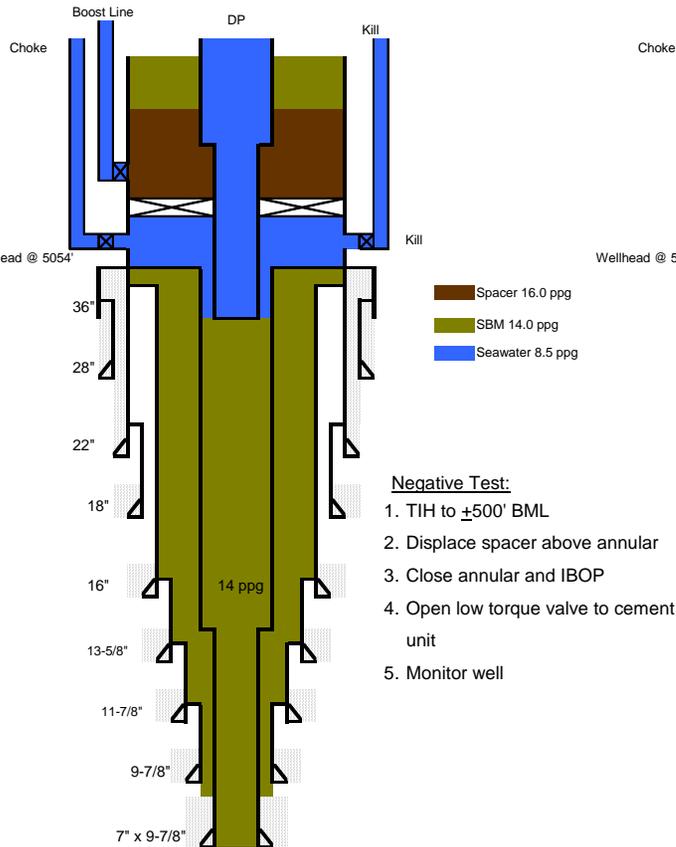
Negative Test Standard Procedure

- Typically negative test to ~500 ft below well head with sea water
 - ✓ ~3300 ft below – stated on MMS permit in order to prevent well head seal area contamination
 - ✓ Imposed additional 1000 psi differential on float equipment/casing/cement
- Where did ~60 bbls from riser go below annular
 - ✓ U-tube up kill line or up drill pipe?
 - ✓ Impacts final negative test pressure applied to well

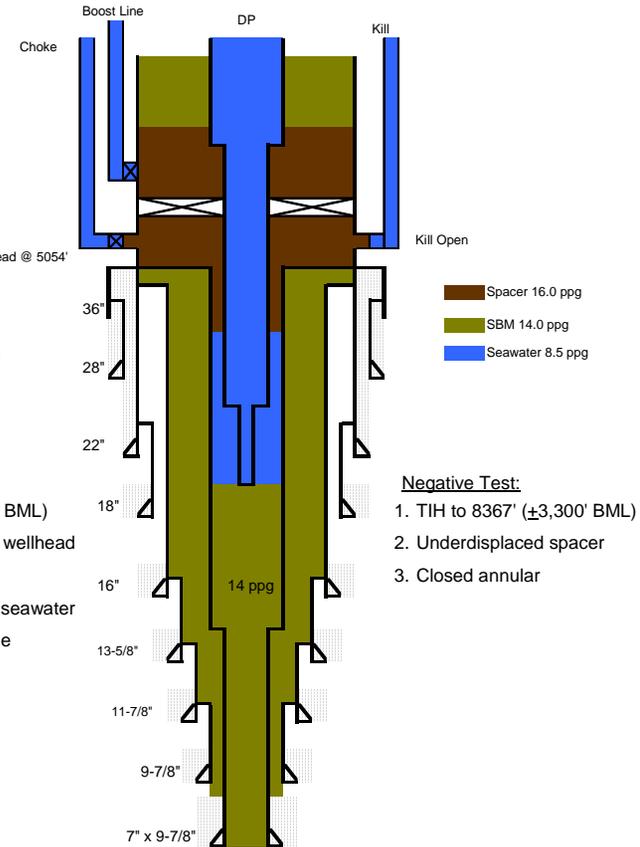
Negative Test Setup at 4/20 17:45

- Set up for negative pressure test began approximately 17:00
 - ✓ ~17:15, 60 barrels of spacer moved below annular
 - ✓ Increased annular activating pressure from 1200 to 1900 psi
 - ✓ Set up fluids through crew handover at 18:00
- Under-displaced 16 ppg spacer
 - ✓ Spacer was not in MMS permit
 - ✓ Position under annular led to confusing pressure readings
 - ✓ Float equipment under tested by 285 psi
- Discussion 18:00-19:00
 - ✓ About fluid volumes due to movement below annular and line up for monitoring – either from drill pipe (normal procedure used by rig) or kill line (MMS permit)
 - ✓ Either line up is appropriate and will correctly monitor well

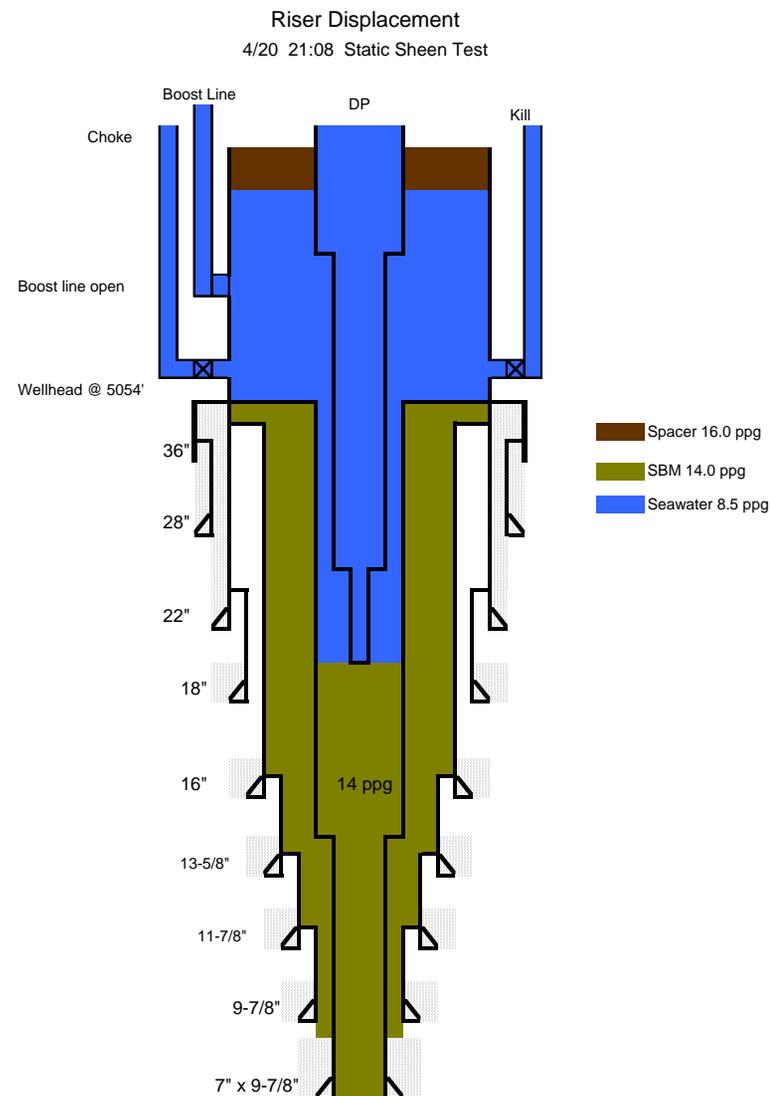
- **Circulate out riser 20:00 to 21:08**
 - Mud circulation out prior to second plug – well reaches highest underbalanced pressure to this point
 - Shut down for static sheen test to begin going over board with water-based spacer
- **Areas of Investigation**
 - Flow changes and volumes
 - Mud transfers
 - Flow sensors accuracy
 - ✓ *Require Sperry Sun system set up details and calibration records*

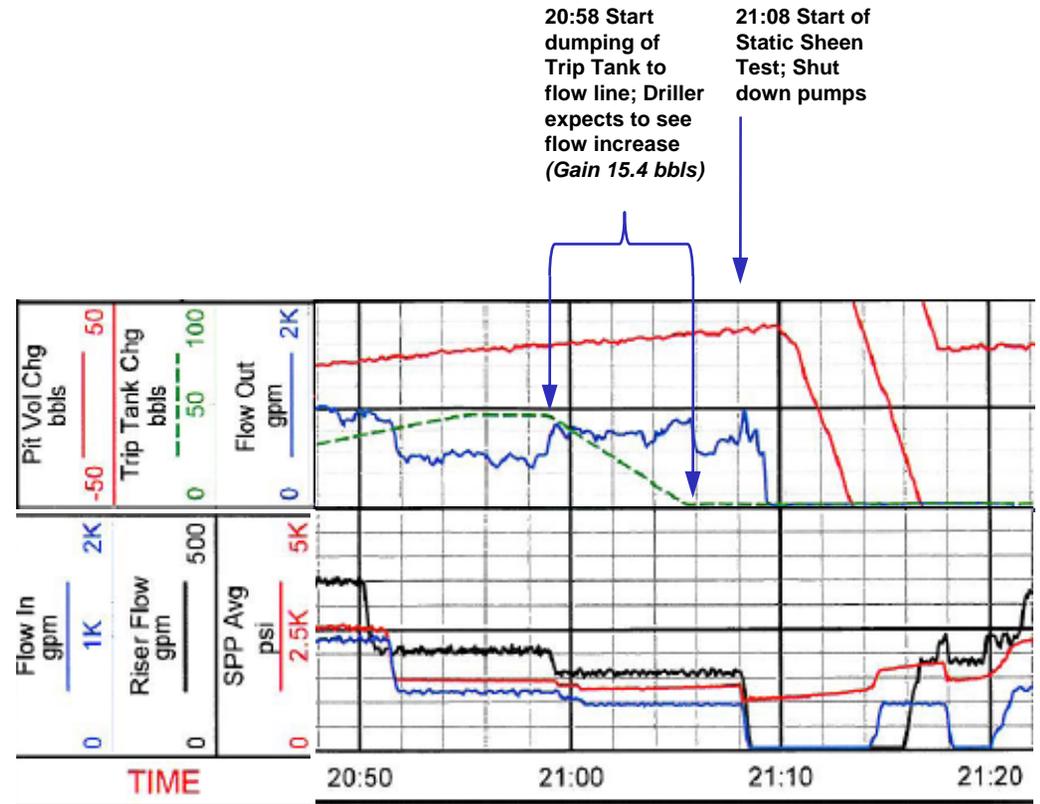
Source: BP OCS-G 32306 001 ST00BP01 Mississippi Canyon 252 Macondo, Last 2 hours before end of transmission

- Trip tank being discharged to pits through flow line (normal procedures ahead of change from oil to water mud in active system)
 - ✓ At same point pumps ramp down for stop at static sheen test
- Increased flow out due to discharge of trip tank
 - ✓ Driller expected to see flow increase
 - ✓ Flow returned near pre-tank discharge level when trip tank pump stopped, THEN increased
 - ✓ Potentially masked the gain

- Complete review of all volumes and real time data (received 5/24)
- Use of trip tank in operation
- Sperry Sun sensors failure to record a flow out after 21:10

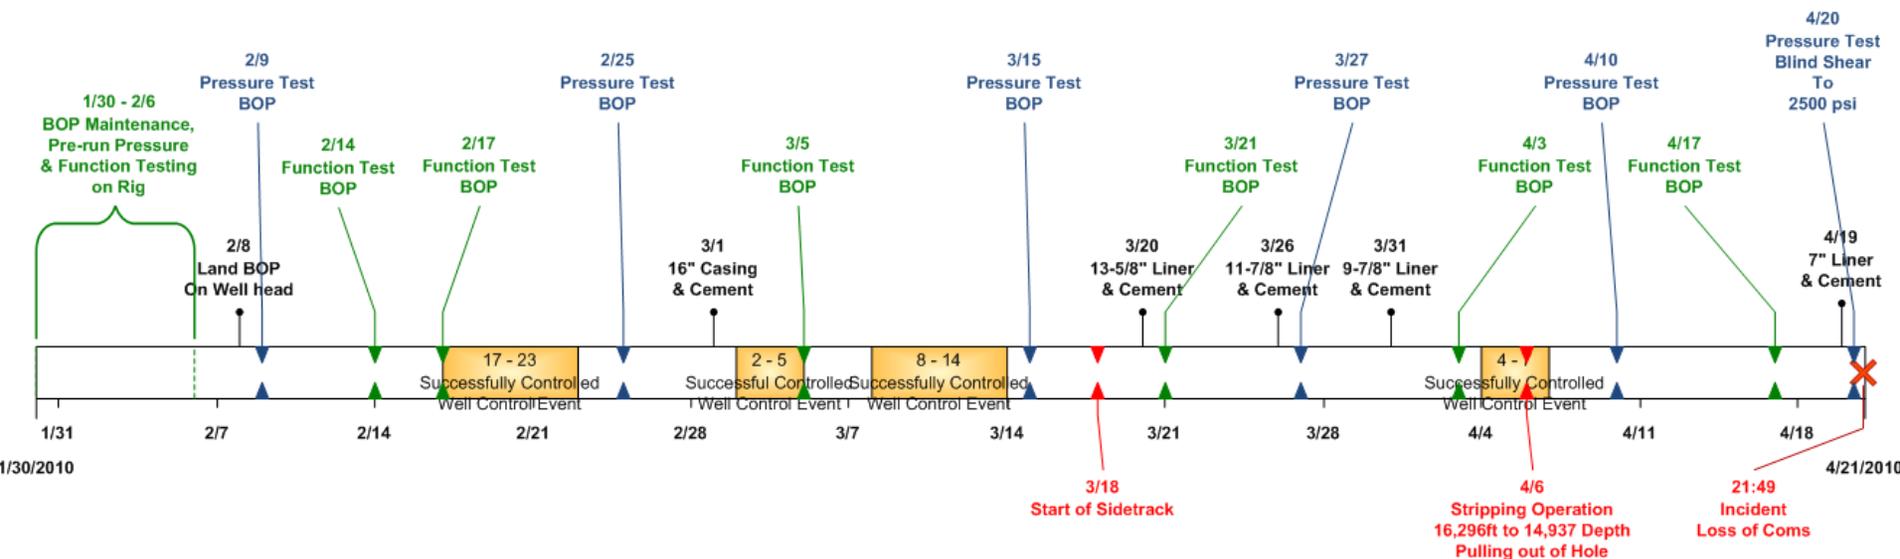
- **Timeline of tests from start of drilling – all tests passed** (*source: IADC reports*)

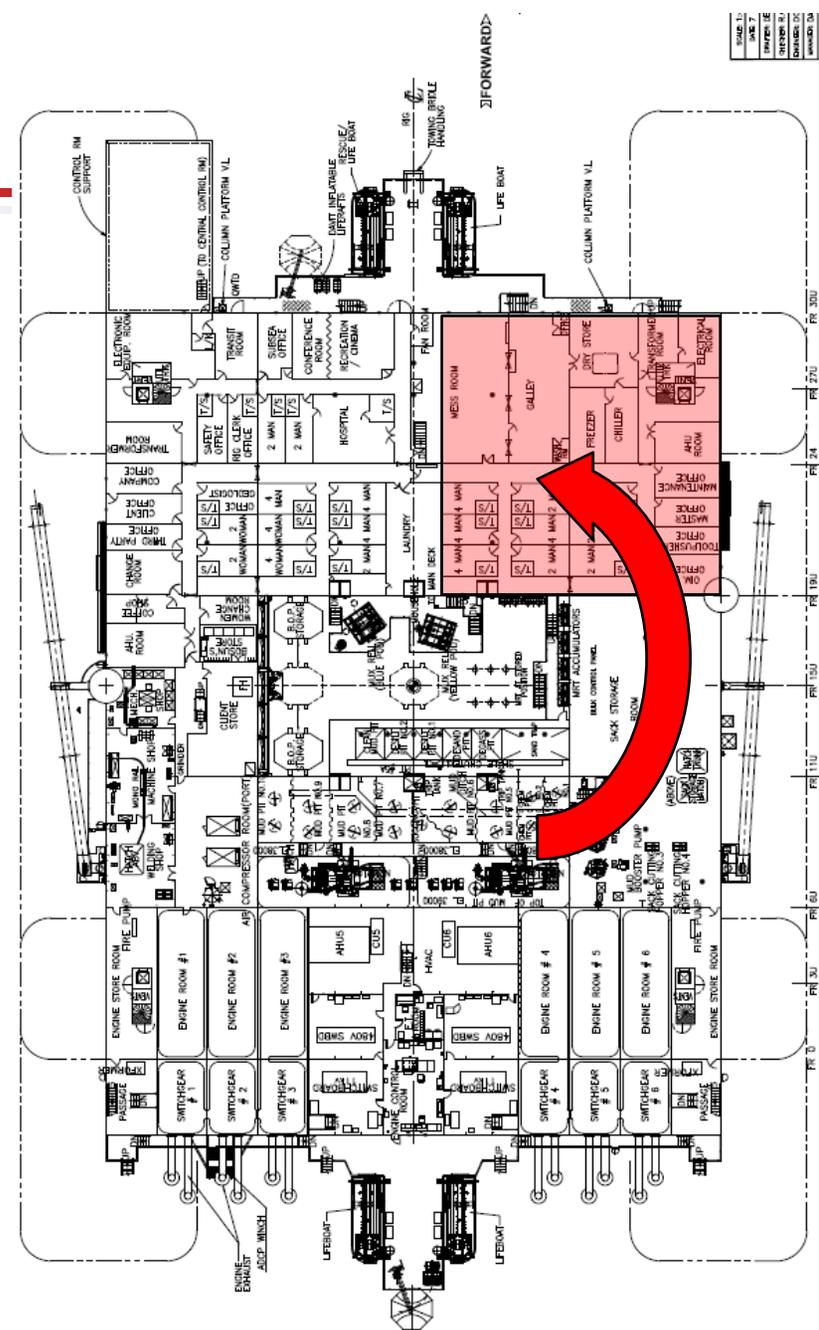
- Most damage on 2nd deck, starboard side (*light red area*)
- Believed blast moved forward from pit/pump rooms through sack room and then into accommodations
- Main deck significantly damaged on starboard side, fire aft of derrick
