STUDY OF DETERIORATION OF SEPARABLE ELECTRICAL CONTACTS IN SMOKE DETECTORS

Contract No. CPSC-C-93-1139

IITRI Project No. A06393

Final Report

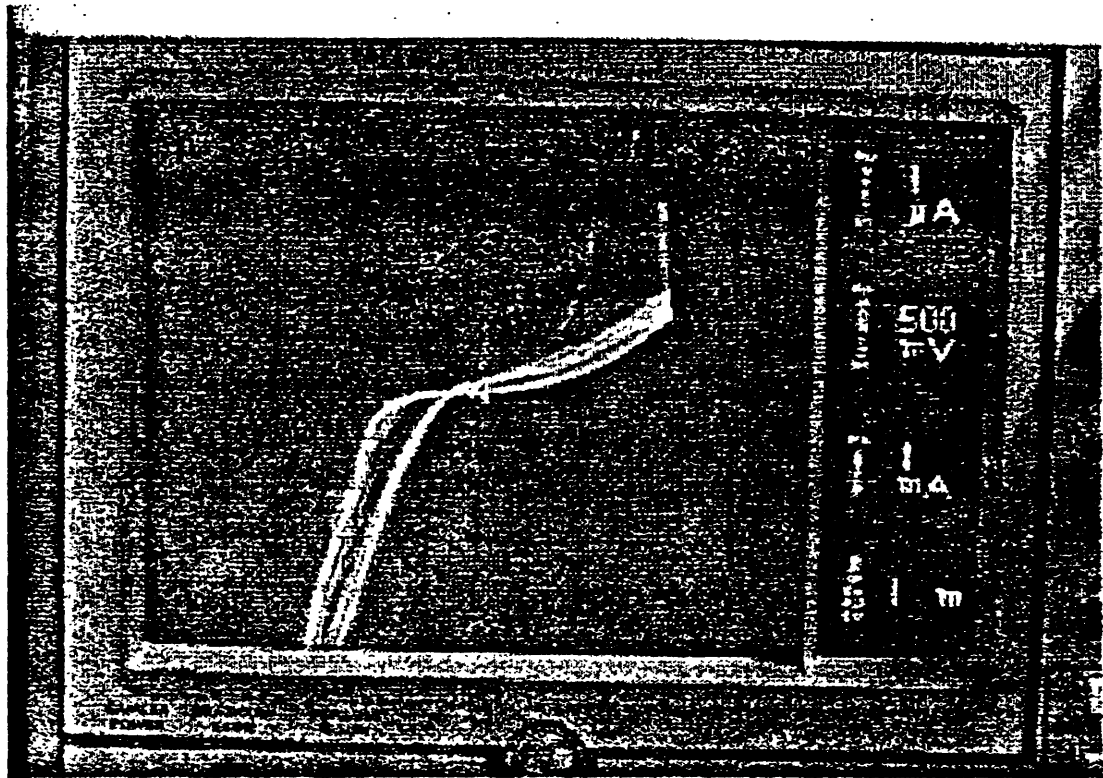
FIGURE 3: HORN V/I CHARACTERISTICS

Horns were then selected for additional curve tracer testing to further document photographically the non-linear contact characteristics of these horns that indicate the tunneling mechanism is predominant. A typical result appears in Figure 3.

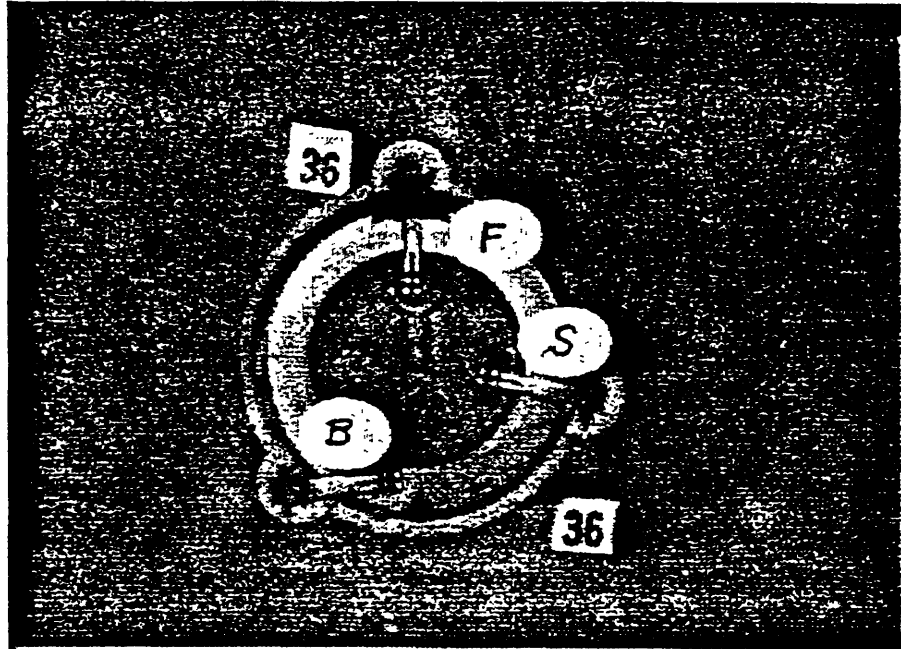
FIGURE 5: SEPARABLE CONTACTS ON A SMOKE DETECTOR HORN (1.25X)

Figure 5 shows the separable contacts on a typical smoke detector horn. The three contacts B, S and F are indicated on the photograph. The six smoke detectors

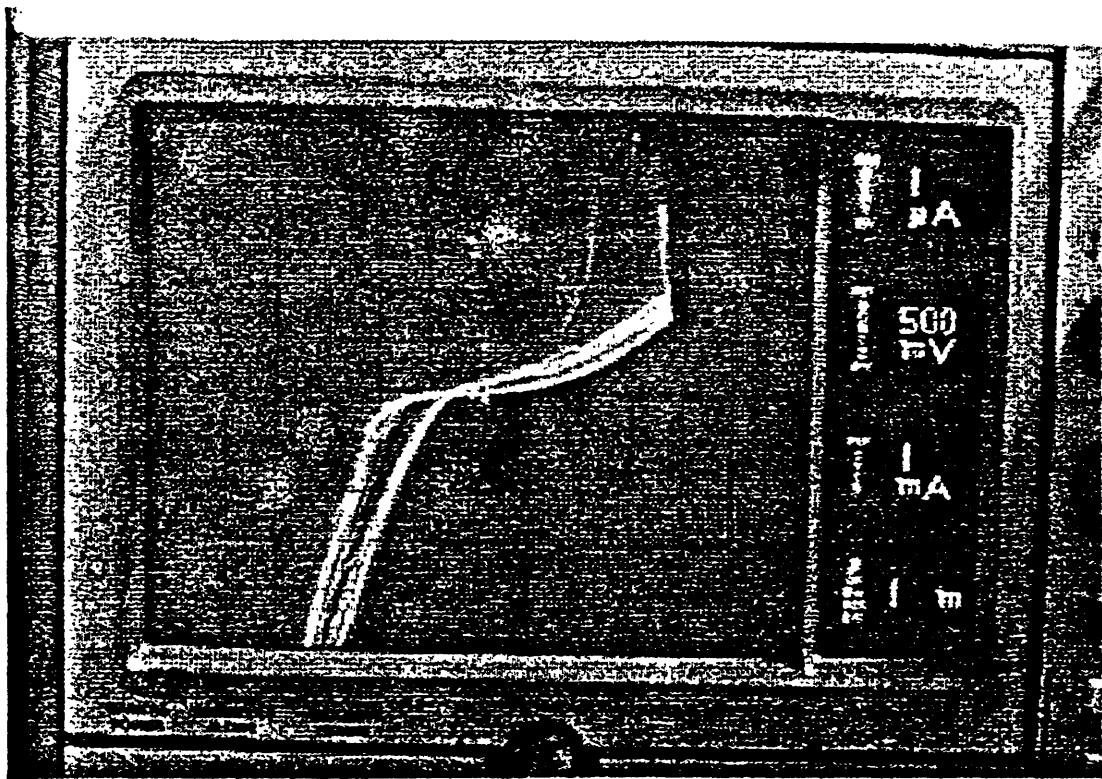
FIGURE 10: NON-LINEAR V/I CHARACTERISTICS OF A SMOKE DETECTOR HORN CONTACT

non-conductive layer has formed in the contact interface. Figure 10 is a photograph of a non-linear V/I characteristic exhibited by a horn contact. In this case the forward diode breaks down at about 1.75 volts and the reverse breakdown is at about 1 volt. As the voltage is increased by ± 5 volts, very little current (less than $.1\mu\text{A}$) flows through the contact in either polarity. Through tunneling [4, 5] and film rupture, the current increases rapidly. Figure 10 also shows the instability in the contact interface. If the current is increased, the film will rupture and the V/I characteristic will return to a linear characteristic. As a result, when the voltage across a non-linear contact in a horn circuit is not large enough to cause rupture of the film, the horn will malfunction. Units 16, 17, 36 and 39 had one or more non-linear contacts. Units 32, 35 and 39 had one or more open contacts. The remaining units 6, 14, 18, 21, 26, 29, 34, 37, 45, 49 and 50 had normal contacts.

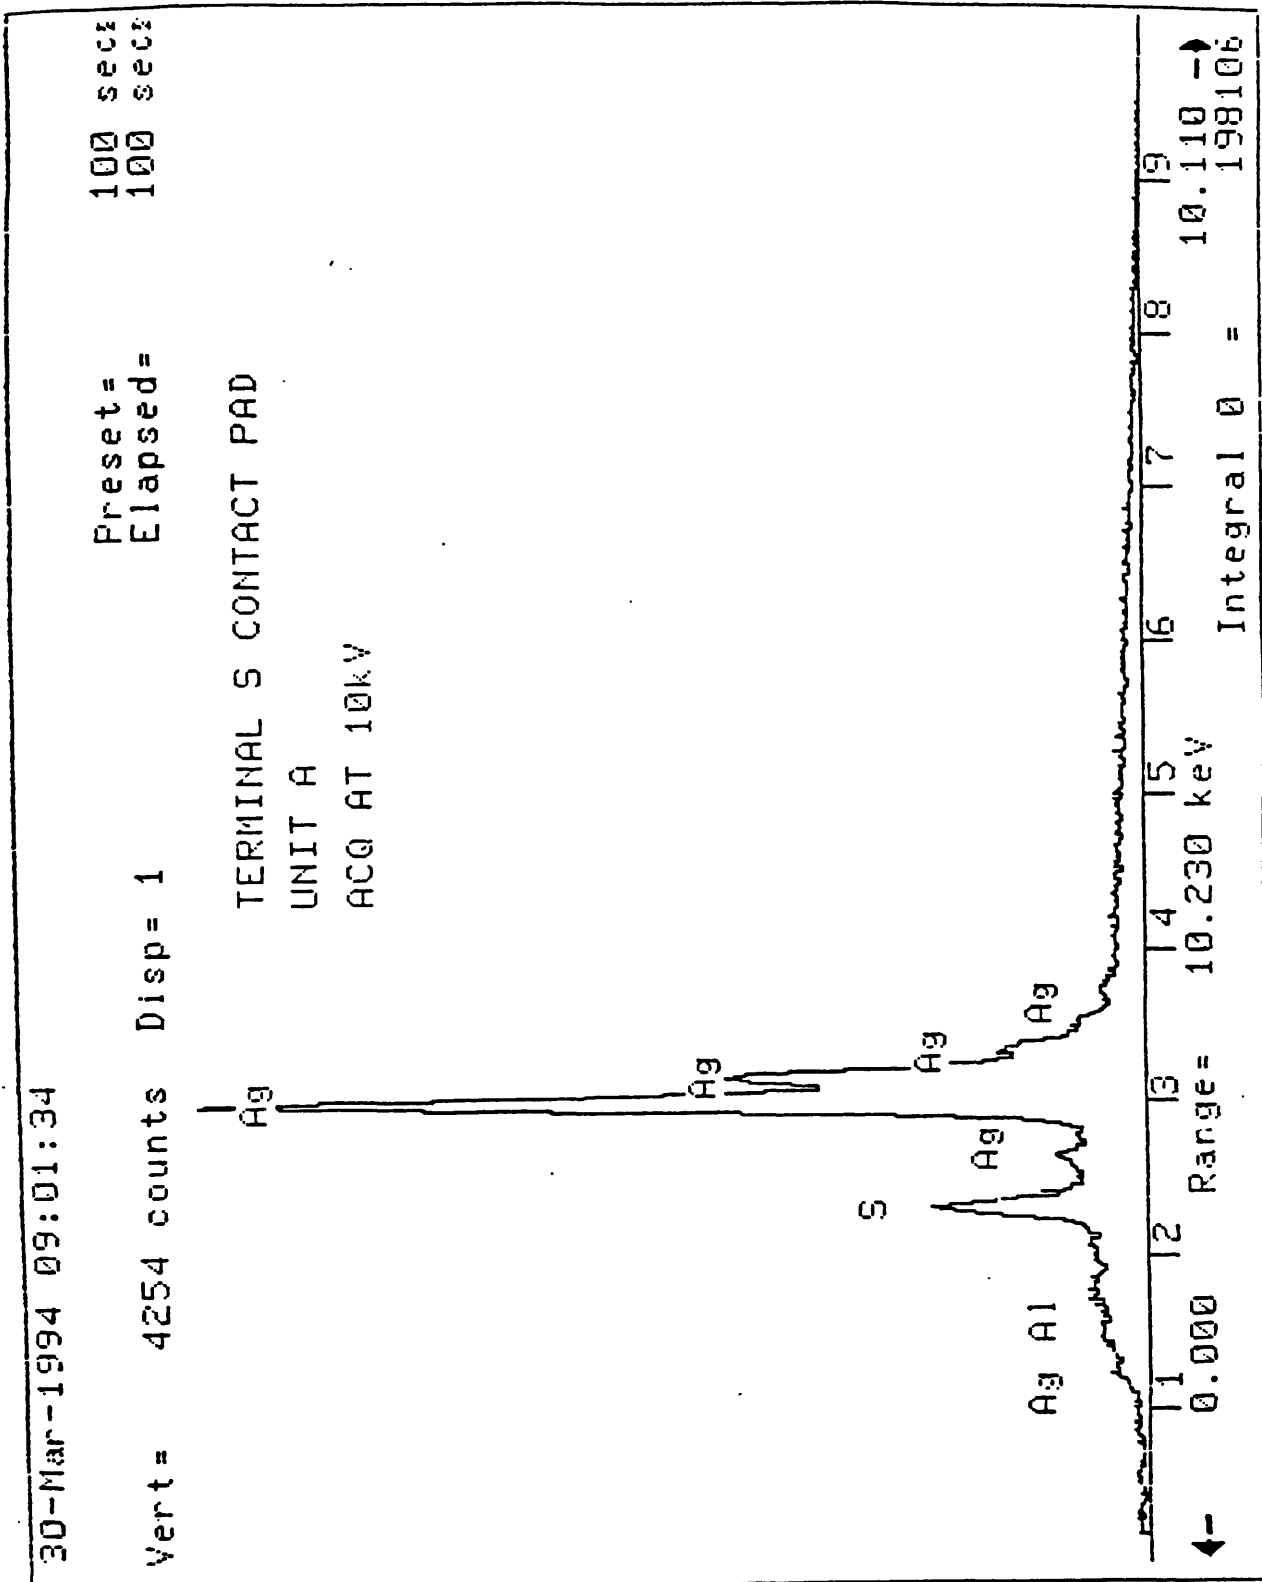
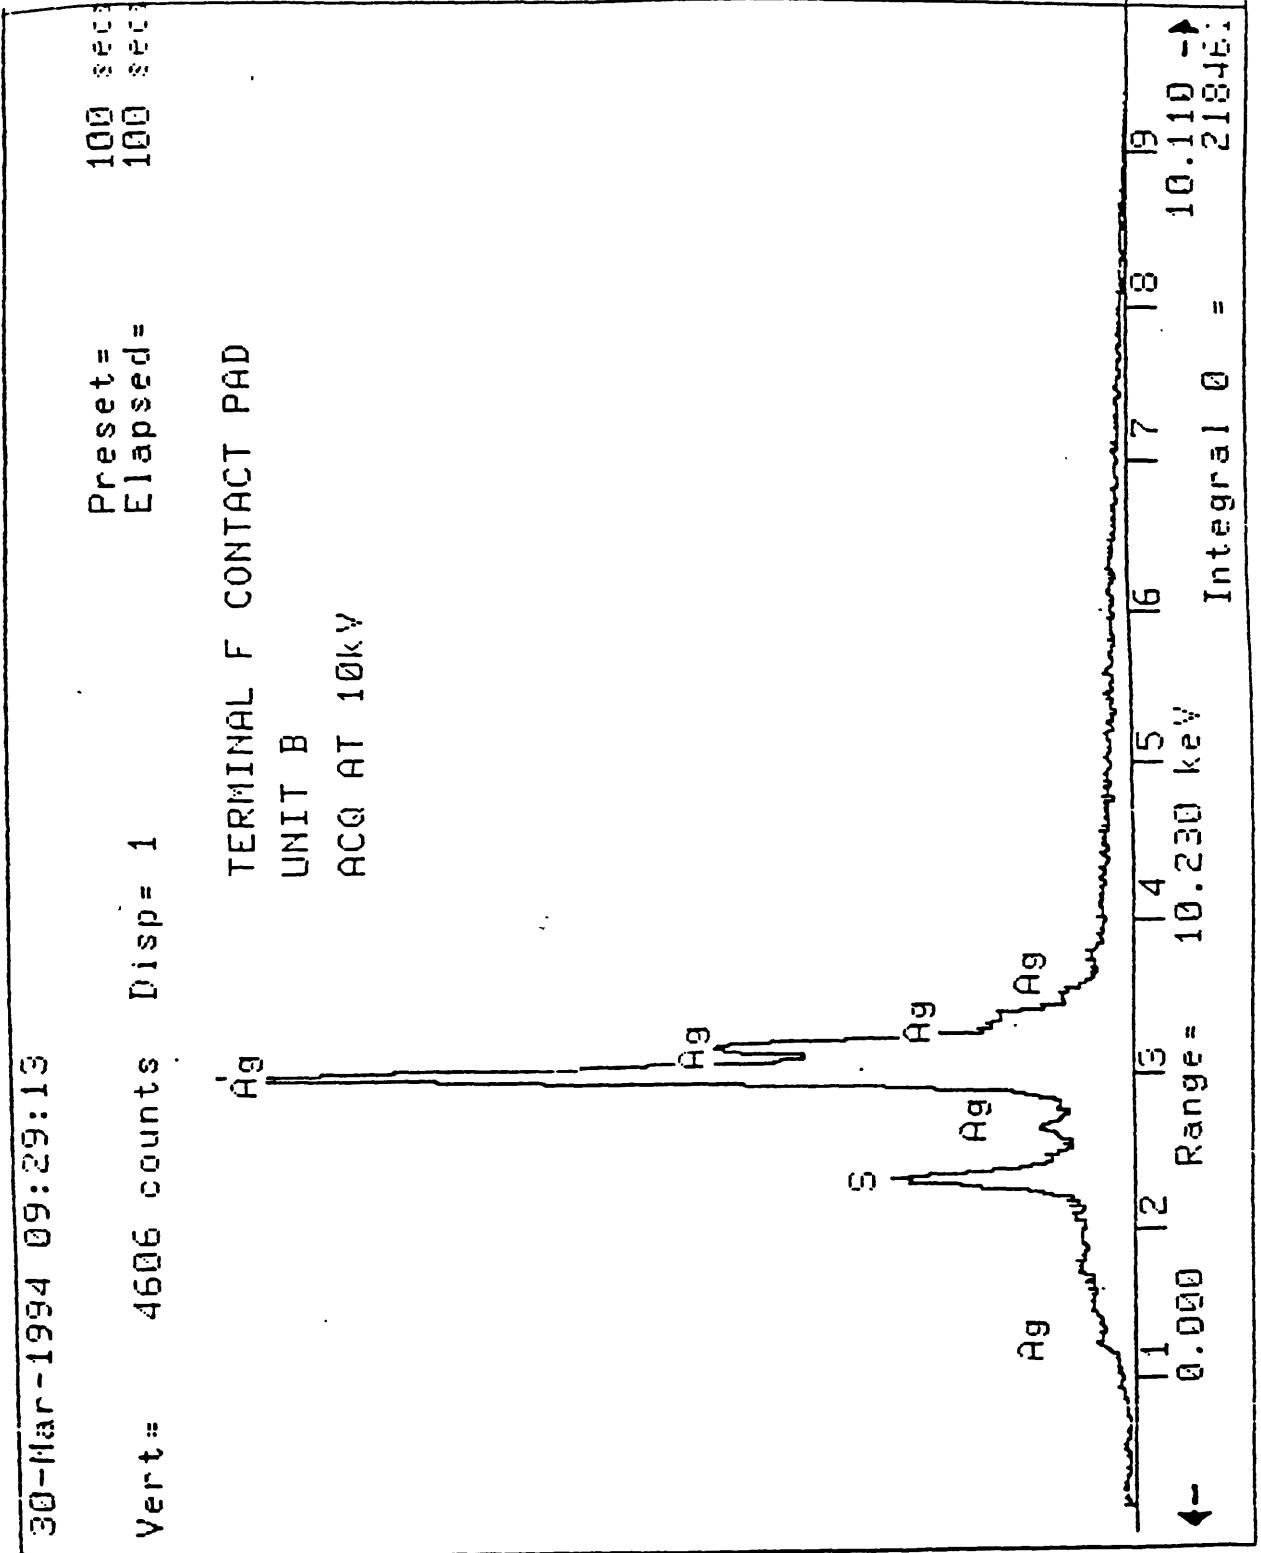
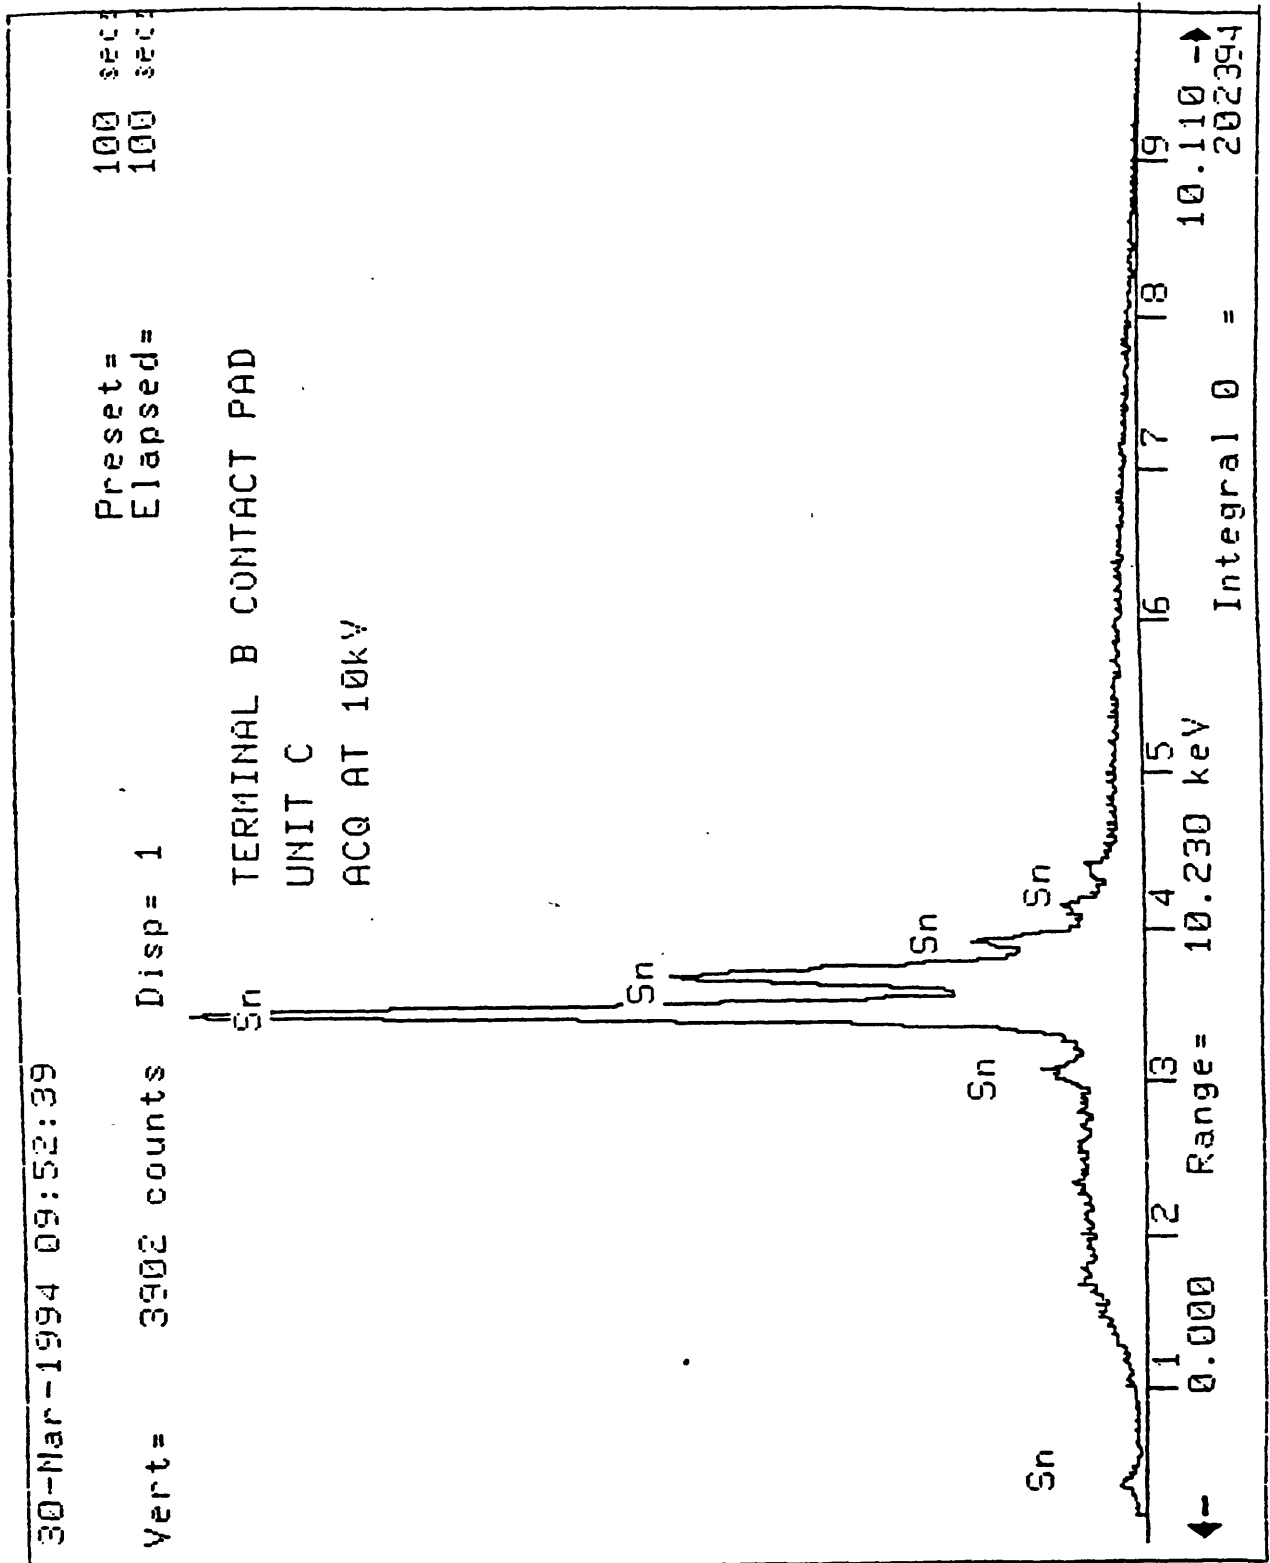
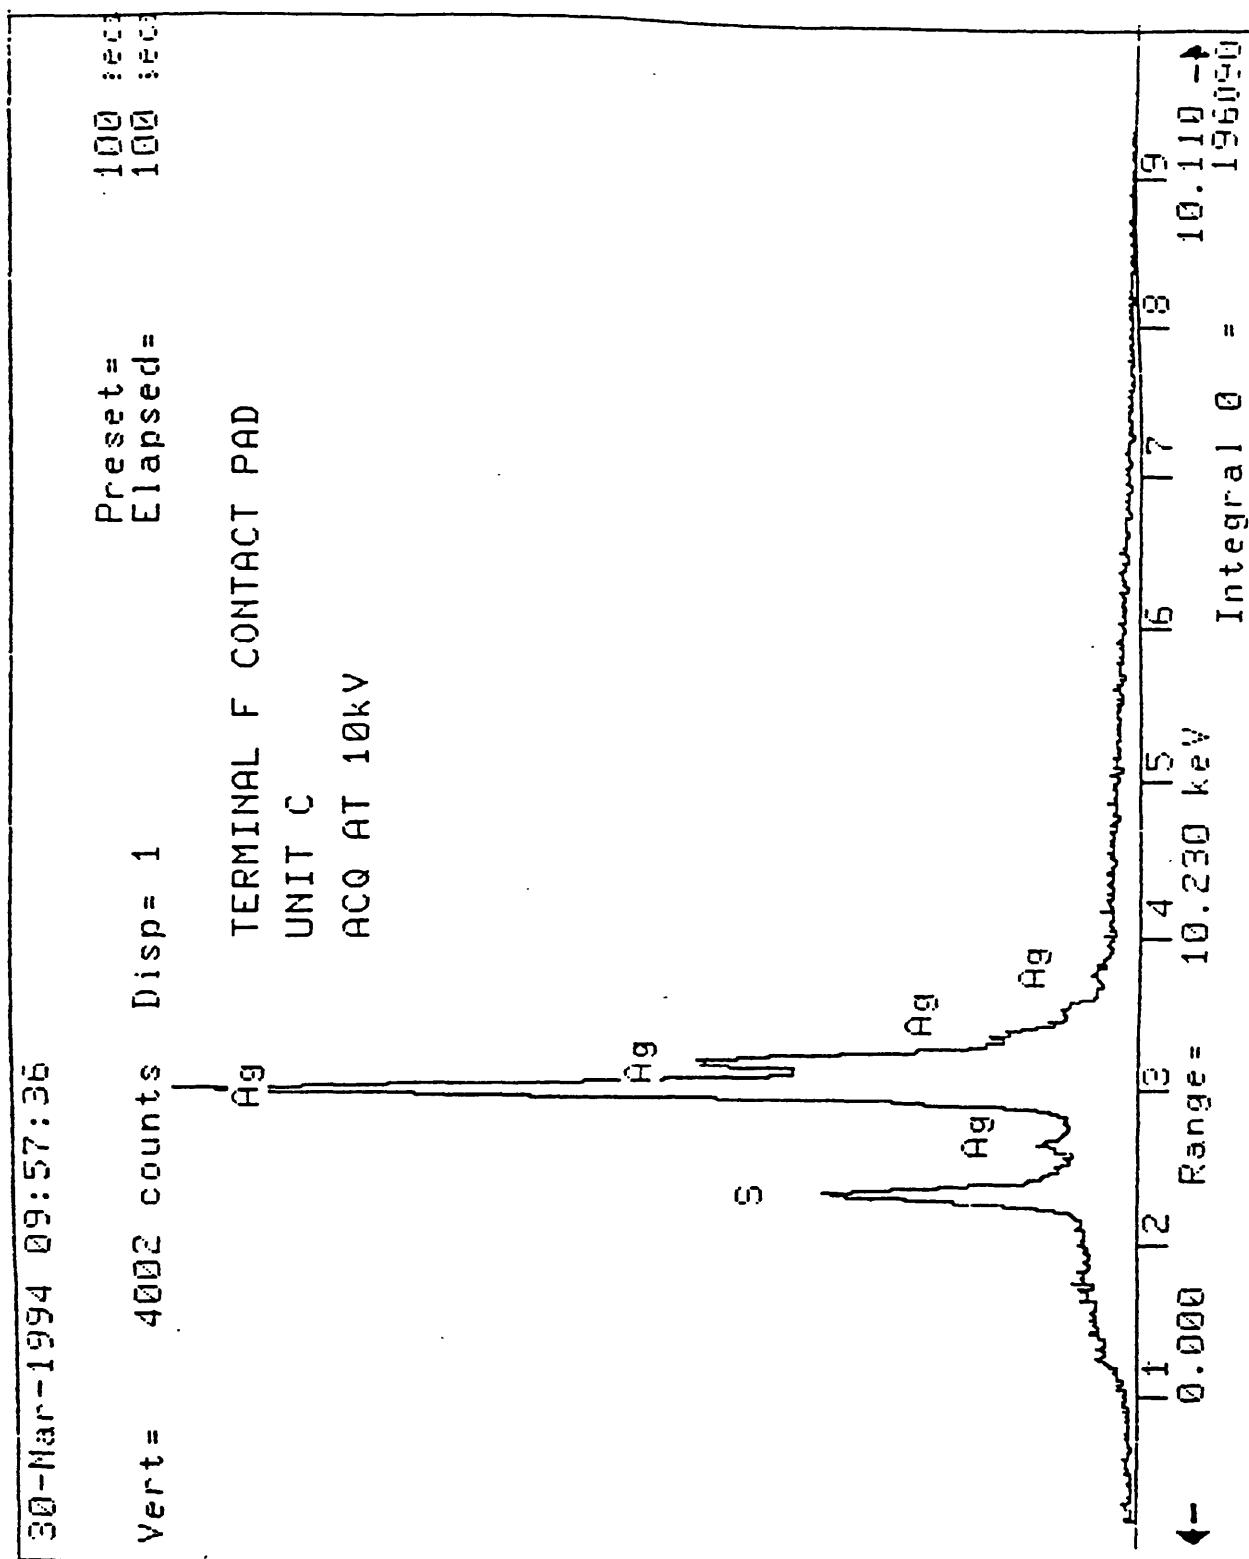
Each horn was then documented photographically and delivered to ORS for surface analyses. The horns subjected to SO₂ had less film deposits than the H₂S testing, while those exposed to the combination of H₂S and SO₂ had the most deposits.

Units A, B and C were investigated with SEM and EDAX before and after the corrosion testing. No noticeable visual difference could be found for any unit. However, the EDAX testing showed some differences. Figures 16 and 19 show the before and after tests of Unit A, Terminal S. The only difference is the increase in sulphur. Figures 17 and 20 show the before and after tests of Unit B, Terminal F. Again, the only difference was an increase in the sulphur. Figures 18 and 21 show the before and after tests of Unit C, Terminal B. In this case there was no difference between the before and after plots. This testing again shows how benign the corrosion tests are concerning the horn contacts. The silver, which has an affinity for sulphur, did show an increase in sulphur, but the tin plated area did not show any significant amount of sulphur either before or after testing. A post corrosion EDAX test was run on the silver pad at contact F for Unit C. This plot (Figure 22) showed that the sulphur level was similar to the post corrosion EDAX tests on Units A and B.

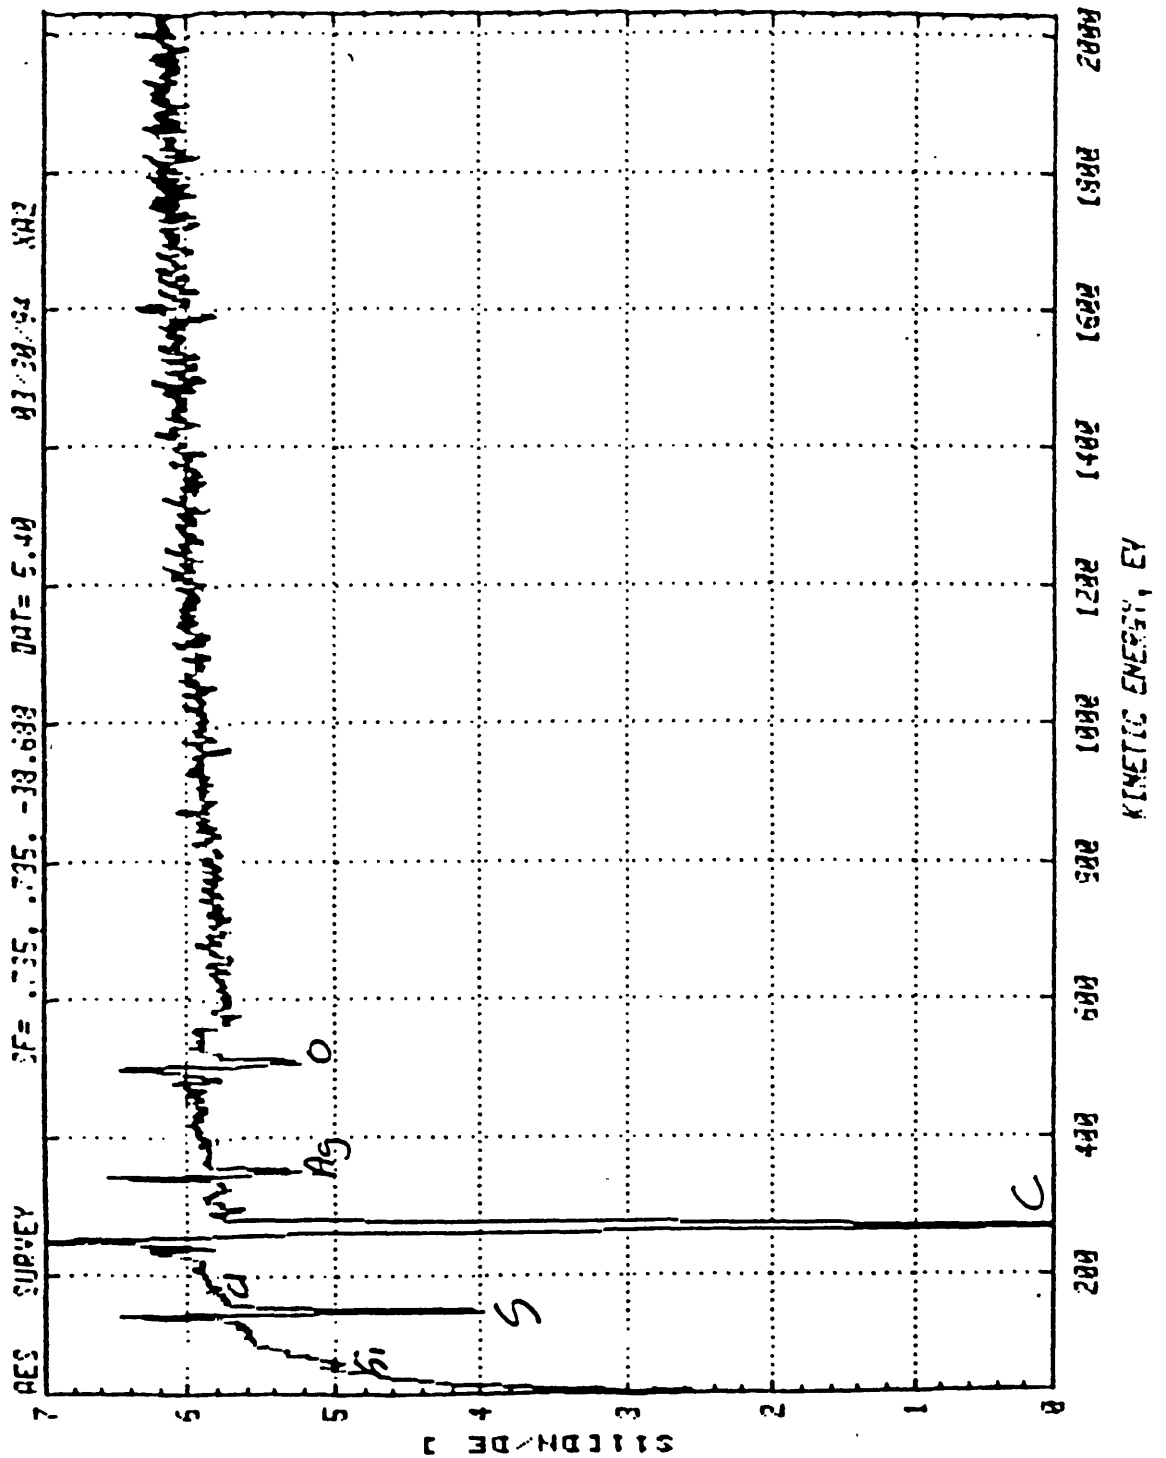
FIGURE 23: AUGER ELEMENTAL SURVEY OF SAMPLE X, TERMINAL S

As shown in Figure 23, the pre-sputtering surface analysis on terminal S of horn X shows only a slight trace of sulphur. Both silicon and chlorine have higher levels than the sulphur. Horn X which was exposed to both gases was selected for this testing because it should have had the thickest layer of contamination and to confirm the EDAX surface analysis on horn C (Figure 21). Comparison of this data with the Table 5 EDAX test results of field units, which identified significant levels of sulphur, shows that the UL 217 test environment does not represent field conditions.
