TO : The Commission
 THROUGH : Sadye E. Dunn, Office of the Secretary
 THROUGH : James V. Lacy, Office of General Counsel
 THROUGH : Leonard DeFiore, Executive Director
 THROUGH : Douglas L. Noble, Director, Office of Program Management
 and Budget
 THROUGH : Carl W. Blechschmidt, Program Manager, Office of Program
 Management and Budget
 FROM : Linda L. Glatz, Project Manager, Electrical Hazards
 Program, OPMB
 SUBJECT : Residential Electrical Distribution System Fires

SUBJECT: Residential Electrical Distribution System Fires

This memorandum transmits a joint Epidemiology and Engineering Sciences report evaluating causes of fires in the residential electrical distribution system. It indicates that many fires are caused by lack of adherence to the National Electrical Code and suggests some actions that CPSC might take to reduce these fires.

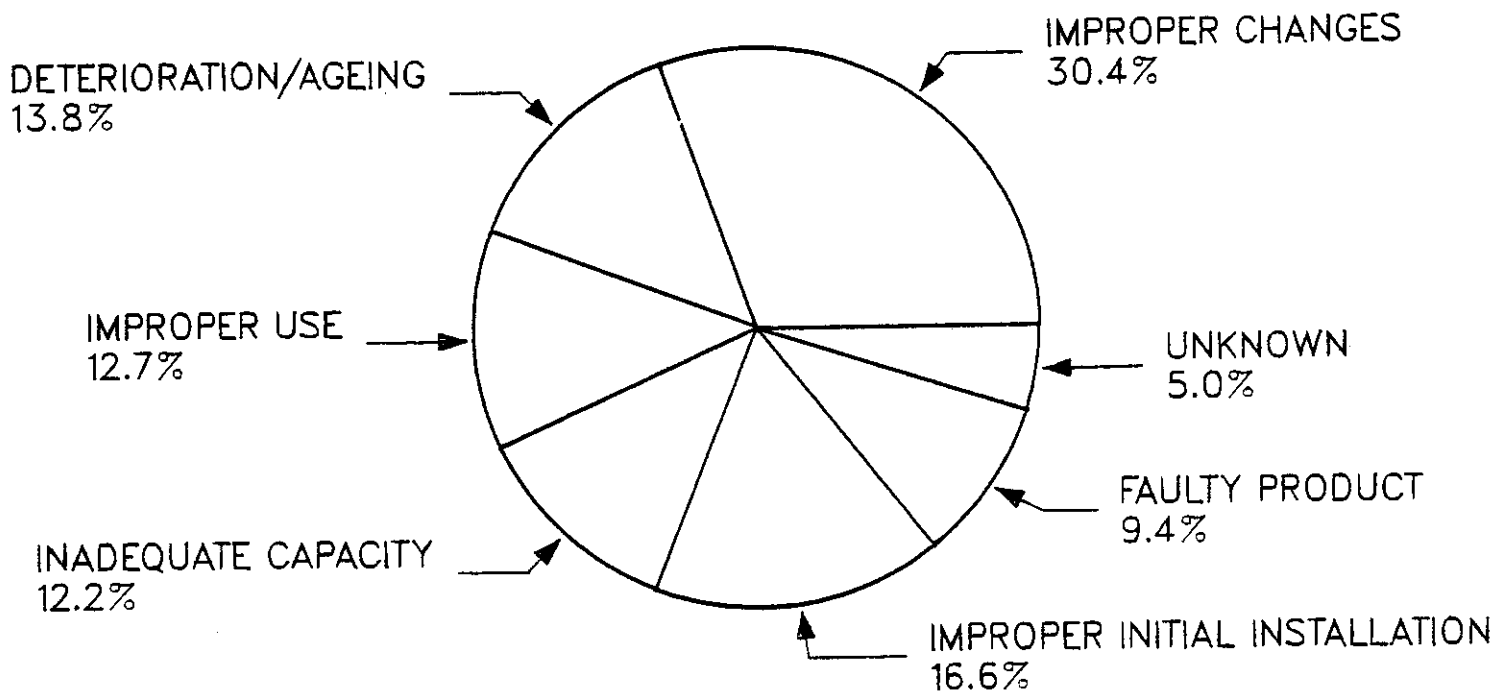
FIGURE 1
**
CONTRIBUTING FACTORS INVOLVED IN RESIDENTIAL
ELECTRICAL DISTRIBUTION SYSTEM FIRES

The presence of an older, inadequate electrical system was a factor in several of these groups, which to a large extent reflected the ways consumers reacted to meet their electrical needs (Table 14). In simplified terms, some consumers attempted to modify the system in a manner that resulted in fires (improper changes - 55 fires). Others chose to use extension cords to extend the system without changing its capacity (improper use - 23 fires). Some overloaded the system by placing increased demands upon it (inadequate capacity - 22 fires). Still others merely continued to use a system that had deteriorated to the point that it would not safely handle its usual load (deterioration due to ageing--25 fires). As a combined group, these incidents accounted for 125 of the 181 factors cited (103 of the 149 fires).

Of the remaining factors, 30 fires exhibited evidence of improper installation. Sixteen of these involved branch circuit wiring but service equipment and receptacles were involved in 6 fires each (Table 15).

Faulty products were believed to be the cause of 17 fires. Most often these involved cords to various appliances, though several faulty receptacles were identified.
