**Analysis of Fatal Incidents Associated
With Window Covering Cords (1996-2002)**

November 2004

Caroleene Paul
U.S. Consumer Product Safety Commission
Directorate for Engineering Sciences
Division of Mechanical Engineering
4330 East West Highway
Bethesda, MD 20814

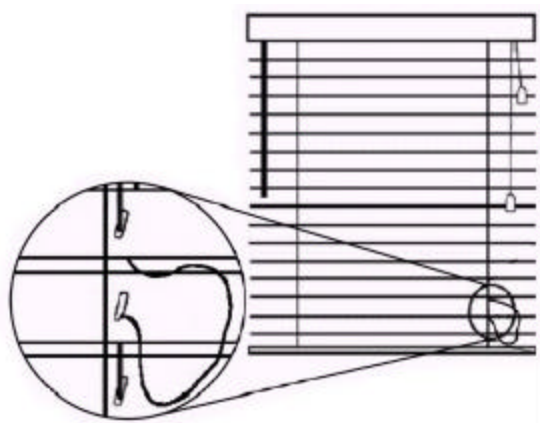
Figure 1. Inner Cord Loop

The inner cord of a horizontal blind refers to the portion of the lift cord that threads through the horizontal slats and is attached to the bottom rail. When the blind is fully lowered the inner cord can be pulled out from between the slats to form a loop, which poses a strangulation hazard (see Figure 1).

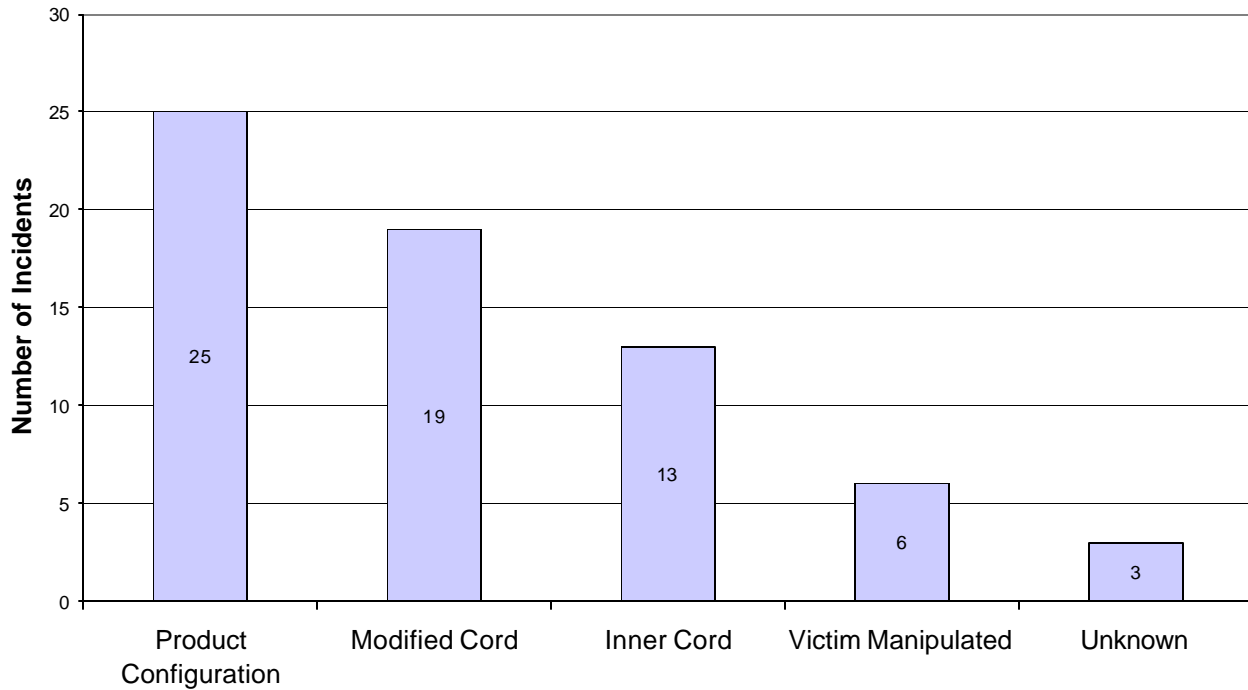
Figure 4. Source of Loop Formation in Fatal Window Covering Incidents (1996-2002)

As shown in Figure 4, the hazard scenarios were: 1) Product Configuration -- strangulation in a loop that is an existing part of the product's configuration such as single tassel cords and free hanging cord loops; 2) Modified Cord -- strangulation in a loop that was formed by a cord that was knotted or tied up in some way; 3) Inner Cord -- strangulation in a loop formed in the inner cord of a horizontal blind; 4) Victim Manipulated-- strangulation due to the child wrapping a cord or loop around his/her neck, and 5) Unknown -- undetermined hazard patterns due to lack of information.

The majority of the incidents that involved the product's configuration occurred in the continuous loop of vertical blinds or draperies. The majority of the incidents that involved strangulation in a loop formed by modification of the blind cord occurred in the lift cords of horizontal blinds. All the inner cord incidents involved a horizontal blind.

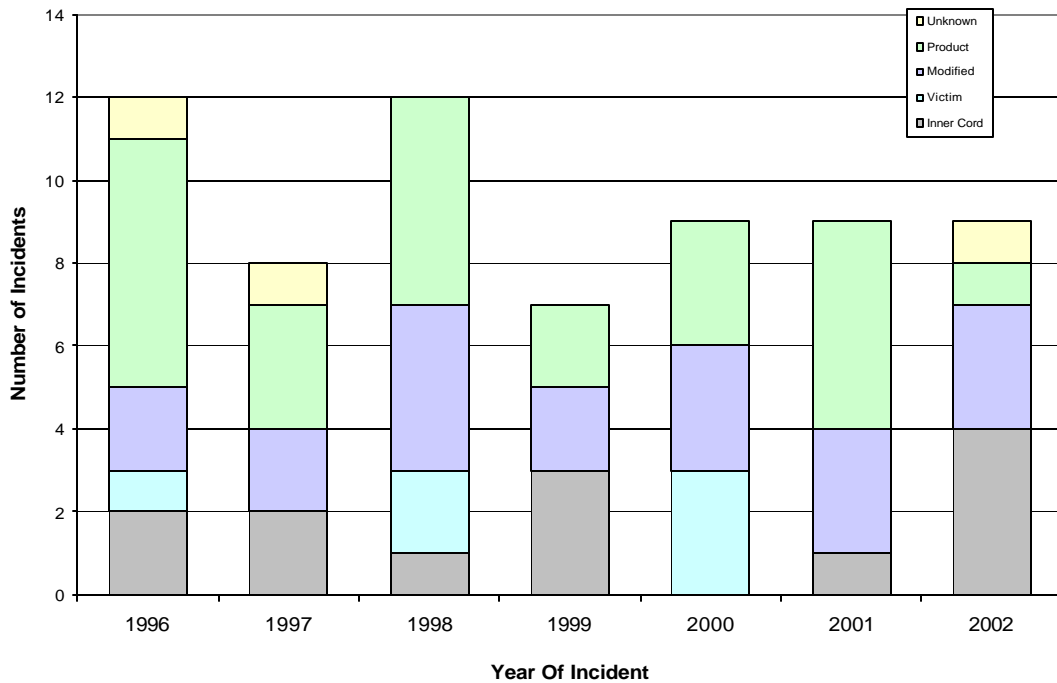
Figure 5. Source of Loop Formation in Fatal Incidents by Year

A distribution of the hazard scenarios by year is shown in Figure 5. There does not seem to be a discernible trend in any of the hazard scenarios.

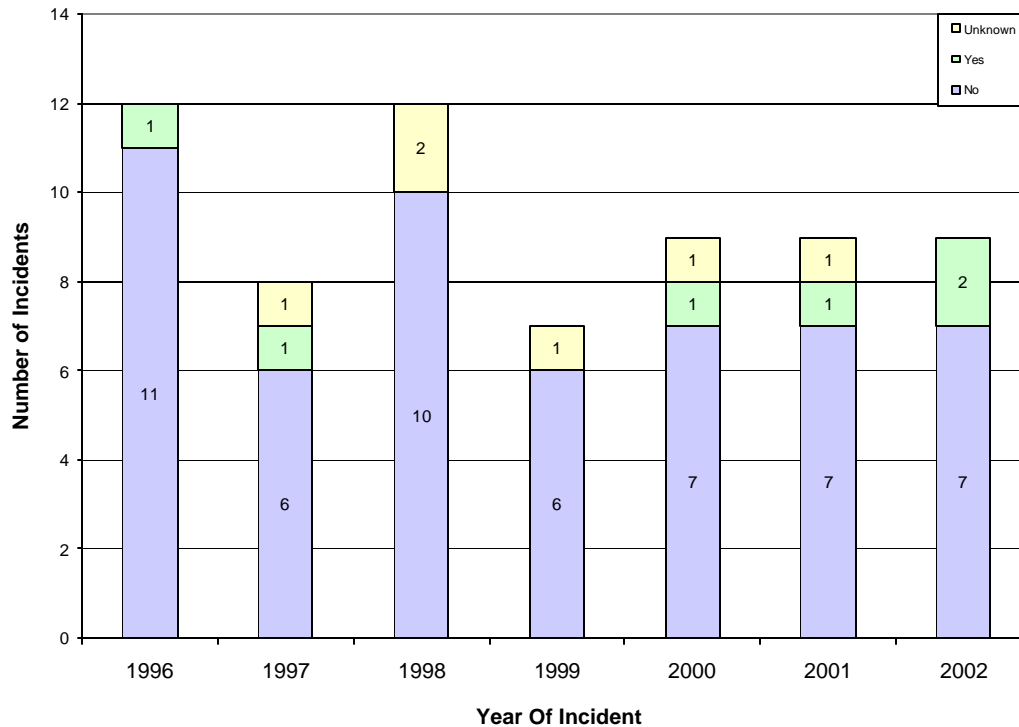
Figure 6. Product Conformance to 2002 Voluntary Standard

Of the 66 incidents reviewed for this analysis, 54 products did not meet the current voluntary standard, 6 products did meet the standard requirements, and 6 products could not be categorized. Products that did not meet the voluntary standard included 13 horizontal blinds that did not have inner cord stops, 16 horizontal blinds with cords that terminated in a single tassel, 23 continuous

loop control products whose cord or chain was not tied down with a tension device, and 2 roll-up blinds with pull cords that terminated in a single point. Products that met the voluntary standard included 5 horizontal blinds with operating cords that terminated in separate tassels and one continuous loop control product where a tension device was present (but not used). The distribution of product conformance by year is shown in Figure 6, which indicates that the majority of incidents continue to occur in products that do not meet the current voluntary standard. The configuration of the products that do not meet the voluntary standard suggests that they were older products that were manufactured before the standard took effect.

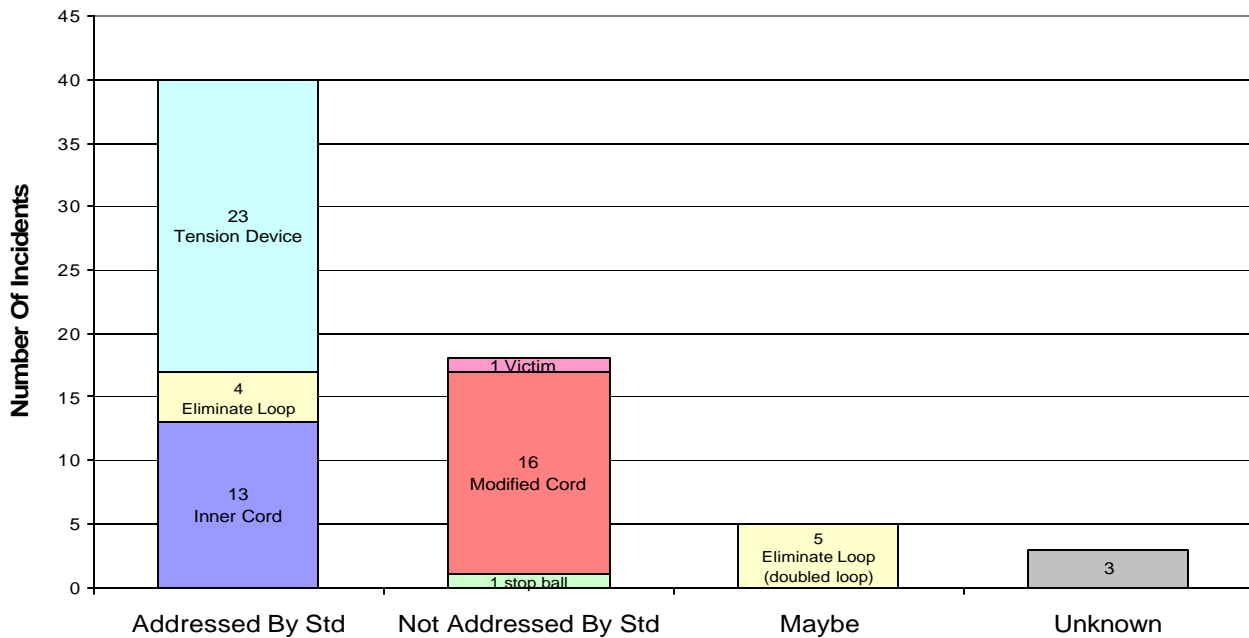
Figure 7. Incidents Addressed by 2002 Standard Requirements

Details of how the standard requirements would have addressed the incidents are shown in Figure 7. Of the 40 incidents that would have been addressed by product conformance to the voluntary standard, 23 would have been addressed by the use of a tension device, 4 would have been addressed by elimination of a loop in the operating cord, and 13 would have been addressed by the use of inner cord stops. Of the 18 incidents that would not have been addressed by product conformance to the voluntary standard, 1 involved strangulation due to the victim wrapping the cord around her neck, 16 involved strangulation in a cord that was modified (usually tied into a knot), and 1 involved strangulation in the exposed loop above a stop ball.

The current voluntary standard does not address approximately 27% (18 out of 66) of the fatal incidents associated with window covering cords in this analysis. As seen in Figure 7, the voluntary

standard does not address incidents where the cord was modified, where the victim wrapped the cord around her neck, and in one instance, where the victim strangled in the loop above a stop ball. CPSC staff believes that modification of the cord by the consumer (such as tying a knot) and manipulation of the cord by the child (such as wrapping the cord around the neck) are foreseeable events that should be addressed by a safety standard with performance requirements rather than warning labels. In addition, the current standard allows an exposed loop for products that use a stop ball. The loop is accessible when the blind is raised, and CPSC staff is aware of one fatal incident associated with this type of window covering.

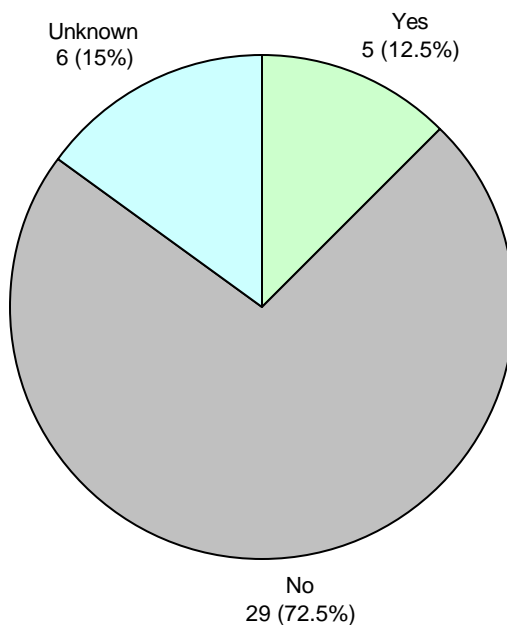
Figure 8. Product Conformance to Voluntary Standard
(Cord Lift Control Systems)

Of the 40 incidents associated with products that use a cord lift control system, 29 incidents (72.5%) involved products whose cord configuration did not meet the current voluntary standard, 5 incidents (12.5%) involved products whose cord configuration did meet the current voluntary standard, and 6 incidents (15%) involved products whose conformance to the voluntary standard was unknown. As shown in Figure 8, the majority of the cord lift products did not meet the current voluntary standard.

Of the 29 incidents that involved window covering products that did not conform to the voluntary standard, 13 products did not have inner cord stops and 16 products had lift cords that terminated in a single tassel. However, of the 16 products whose lift cords terminated in a single tassel, 7 victims strangled in a loop that was formed by a knot that was tied in the pull cord.

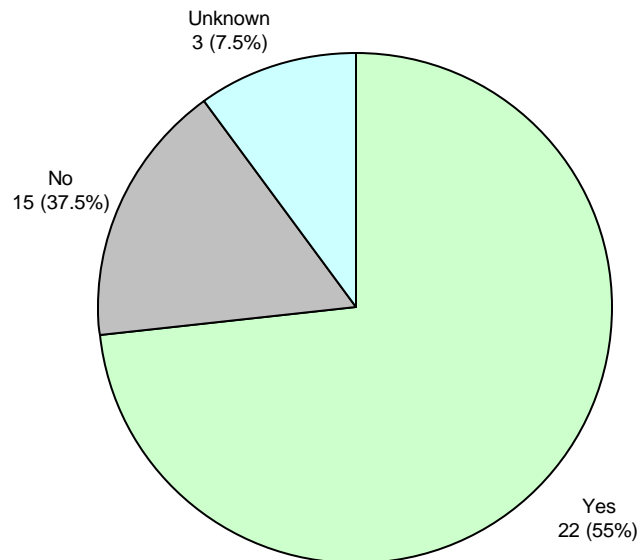
Figure 9. Incidents Addressed by Voluntary Standard (Cord Lift Control Systems)

Of the 40 incidents associated with products that used a cord lift control system, 22 incidents (55%) would have been addressed if the product had met the requirements in the voluntary standard, 15 incidents (37.5%) occurred in a manner not addressed by the voluntary standard, and 3 incidents (7.5%) were unknown (see Figure 9). Product compliance with the current voluntary standard would have addressed 13 incidents that involved the inner cord and 9 incidents that involved a loop formed by a single tassel in the pull cord (assuming that a single tassel was the primary cause of the loop in 5 incidents where the victim wrapped the loop around his/her neck a second time). Product compliance with the standard would not have addressed 14 incidents that involved a loop that was formed by a knot tied in the pull cord and 1 incident that involved the loop above a stop ball. The voluntary standard does require a temporary hang tag that warns the consumer not to tie the cords together, but CPSC staff concluded that a warning label that is intended to be discarded upon product use does not adequately prevent a user from tying a knot in blind cords.

Assuming that elimination of loops in the operating cord (separate cords) would eliminate the primary cause in the incidents where the victim wrapped the loop a second time around his/her neck, the current voluntary standard would address approximately 55% of the incidents associated with cord lift products. More than half of those incidents are addressed with inner cord stop requirements that depend on active user participation to properly install the safety devices. If the safety devices are not installed properly, the product is operable with the inner cord hazard still present.

The current voluntary standard did not address 37.5% of the incidents associated with cord lift products. Specifically, the standard does not prevent users from tying a knot in the cord to form a hazardous loop, does not prevent the victim from wrapping the cord around his/her neck, and does not prevent strangulation in the exposed loop above a stop ball.
