## USGS Monitoring Data Confirm Submerged Vanes Help Stabilize Eroding Bluffs, Fish Creek, Wisconsin

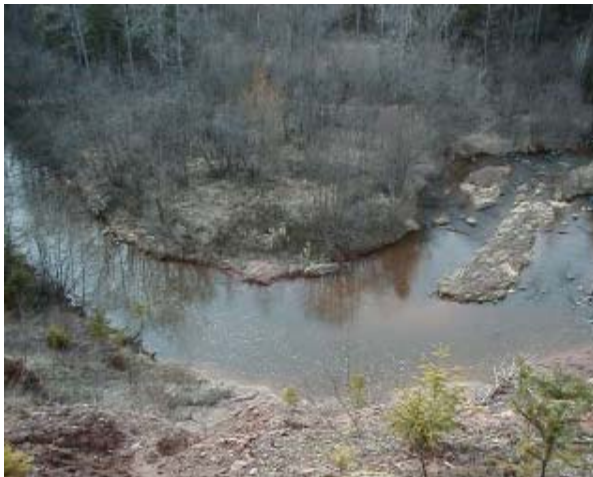
North Fish Creek, site 1, before vanes, April 7, 2000. Flow is from left to right in photo, base of bluff is in foreground.

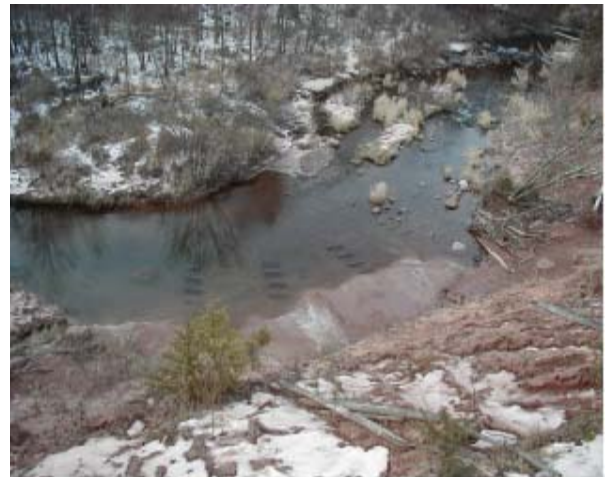
North Fish Creek, site 1, after vanes, January 7, 2003. Note dark rectangles (vanes) and sedimentation at the base of the bluff.

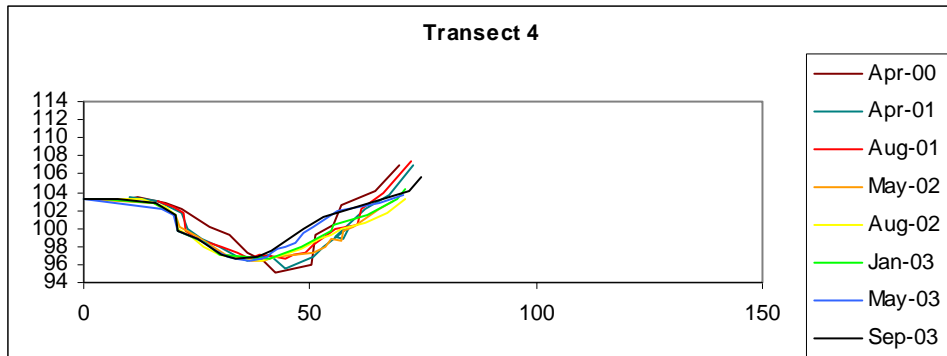
Channel cross-section data from 2000-2003 for one transect at site 1 on North Fish Creek. Base of bluff is on right side of cross section.
