## **Carpenter School Bus Advisory** **June 2003**

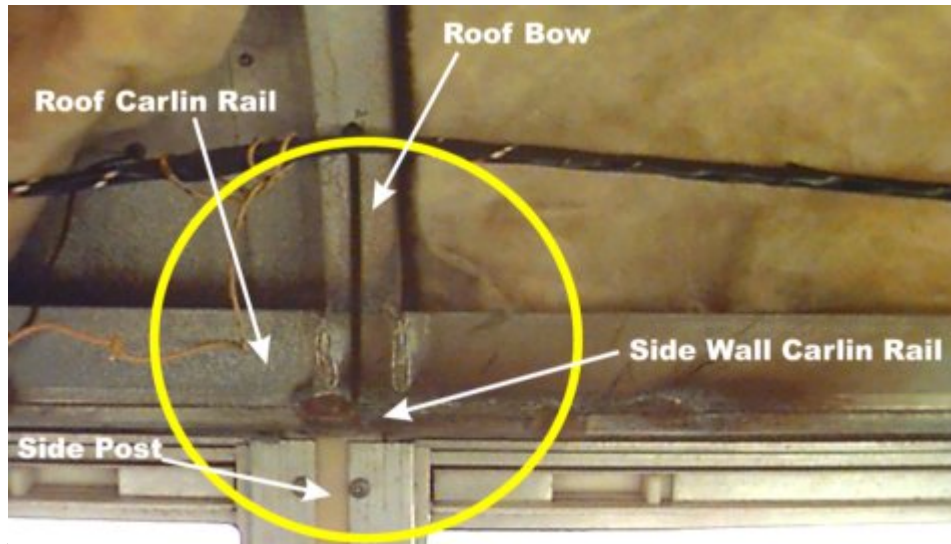
**Figure 5: Photo depicting weld locations**

3. All Carpenter school buses built in Mitchell, Indiana, no matter what the body number, should be inspected for cracked or broken welds in the roof structure. The photograph below shows the locations of the components that are welded together.

**NHTSA recommends that the following actions be taken with respect to any Carpenter school bus built in the Mitchell plant that has been found to have cracked or broken welds in the roof structure:**

**The bus should be taken out of service and replaced as soon as practicable.**

**If the bus must continue in use, the cracked or broken welds should be repaired as soon as possible by qualified service personnel.**

**In order to minimize the risk of a rollover, the bus should be used on routes that operate in low speed environments.**

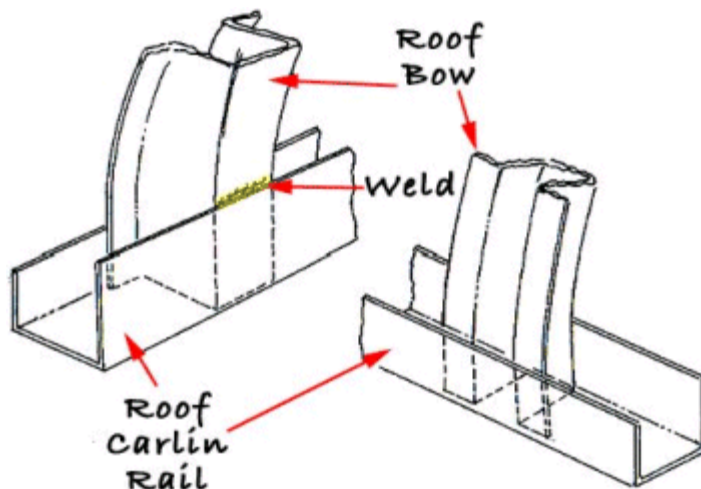
**Figure 6: Roof bow weld locations**

At this time, we strongly encourage owners and operators of the Carpenter school buses described below to inspect them to determine if there are structural weld failures in the roof structure. The welds in question are located at the junction of the vertical side posts (between the windows) and the horizontal structural member (the “Carlin” rail) above the windows. The inspection will require the removal of interior panels as well as the removal of some of the windows. The following information is provided for your consideration and use:

4. Two diagrams showing the components and weld locations are shown below:
