**Investigation of Hydrocarbon Spill,
West Cameron Block 198,
Gulf of Mexico,
Off the Louisiana Coast**

Frank Pausina
Milford Cole
Cliff Delouche

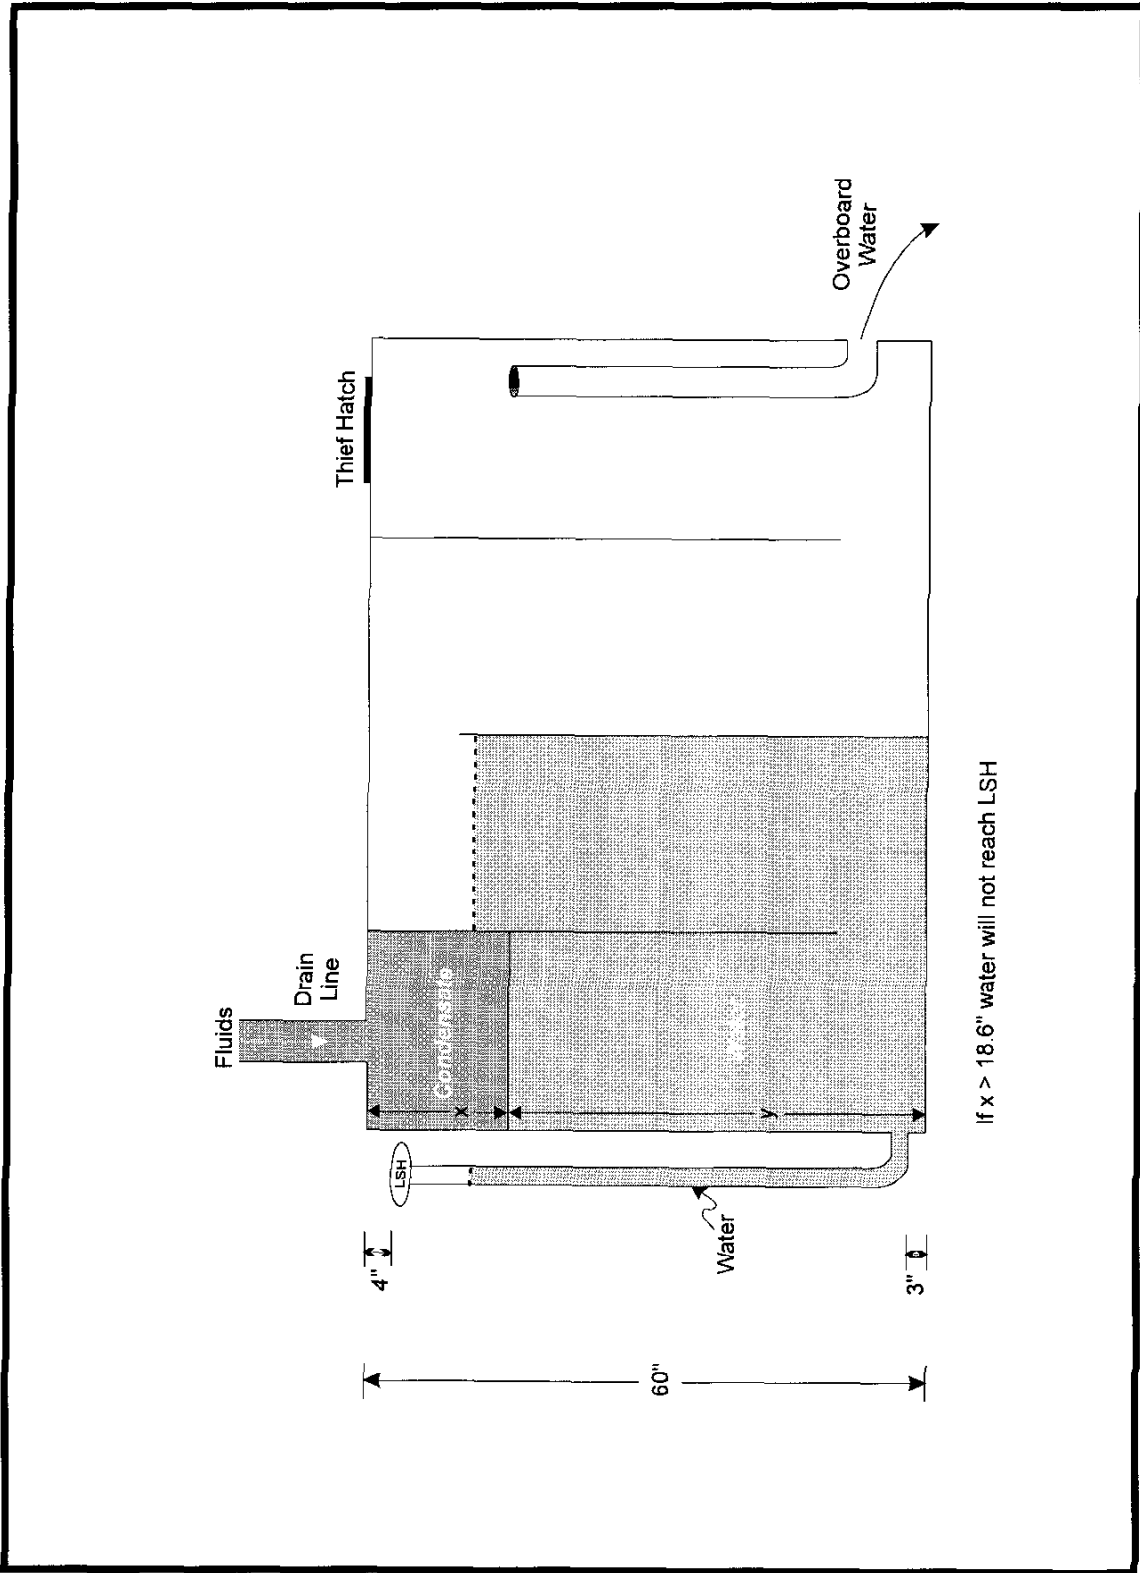
Sump tank schematic

The LSH at the time of the accident was configured in such a manner that a fluid level that would normally be expected to actuate the LSH would fail to do so if a critical volume of condensate in the tank were exceeded. (For a simplified schematic of the sump tank, see Attachment 3.) The external tubing leading to the LSH, if initially containing water, will not reflect the true contents of the tank as condensate begins to enter the tank. The tubing will contain water while the tank will contain condensate and water. The difference in the composite specific gravity of the water and condensate in the tank and the specific gravity of the water in the tubing will result in the column of fluid in the tank exerting less force on the tube inlet than the column of fluid in the tubing. Therefore, if there were enough condensate in the tank, the difference in the aforementioned specific gravities would be great enough such that the water level in the tubing would not reach and not actuate the LSH even if the level in the tank were to exceed the height of the LSH. On December 15, after the platform was shut-in, the LSH was tested with water and did actuate.

2. Ineffective LSH configuration — As production entered the sump tank, water already existing in the tank was forced up the tube leading to the LSH. The amount of condensate in the tank reduced the specific gravity of the contents of the tank, even when full, to such an extent that the pressure exerted on the LSH tube inlet, located at the bottom of the tank, could not force the water in the tube high enough to actuate the LSH, located at a level near the top of the tank. Therefore, after the tank filled, condensate production began to spill from both the water leg and thief hatch of the tank without the actuation of the LSH.

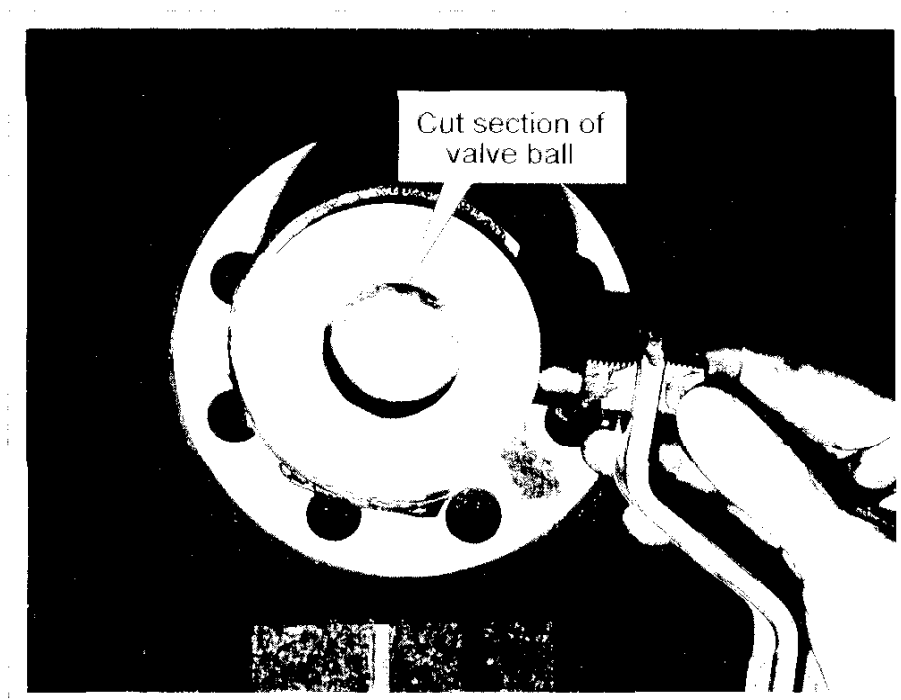
Attachment 6

Through an analysis of the drain line valve, it was determined that the ball and body of the valve were cut out and that the valve is not completely closed when the valve handle is perpendicular to the valve body. (For a picture of the position of the valve bore when the valve handle is perpendicular to the valve body, see Attachment 6.) The handle must be turned an additional 10 to 20 degrees past perpendicular to completely close the valve. (For a picture of the position of the valve stem and the valve handle when the valve is closed, see Attachment 7.) It was also discovered that the valve stem is twisted. (For a picture of the twisted valve stem, see Attachment 8.)

Valve handle perpendicular to valve body / ball bore visible through valve bore.

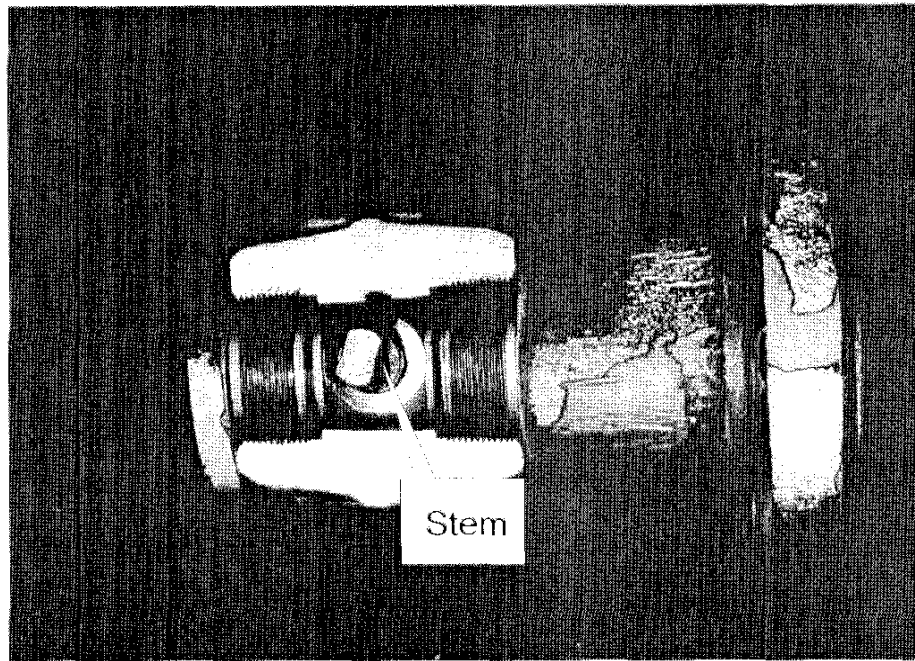
Stem position with valve closed.

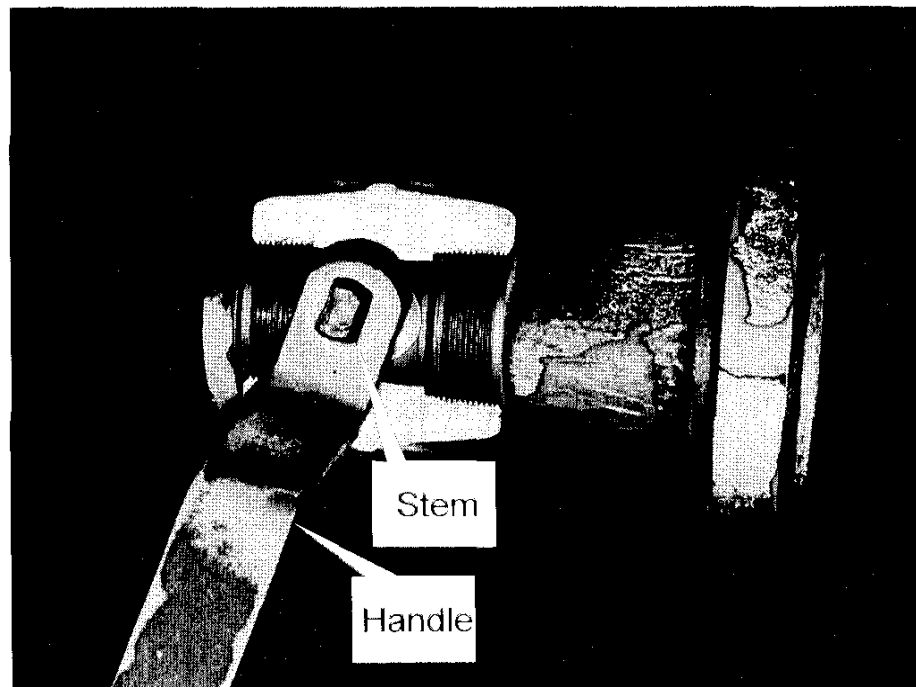
Stem and handle position with valve closed.

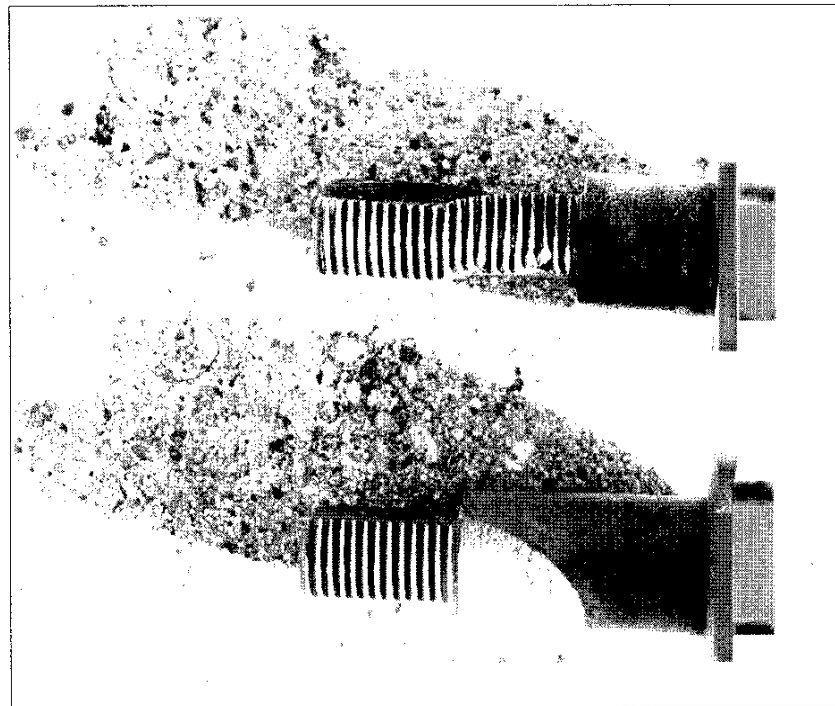
1. Deformed valve stem — The twisted valve stem allowed the high-pressure separator drain line valve to remain slightly open when the valve handle was perpendicular to the valve body, the position in which the valve is normally closed. The complete closing of the valve required the turning of the valve handle through an additional 10 to 15 degrees past perpendicular. Once production was restored, gas, water, and condensate from the high-pressure separator began to cut out the valve ball and body and allowed an increasing flow of production to the sump tank.

Twisted stem of subject valve compared to new stem.

2. The MMS should issue a Safety Alert to recommend to all lessees that all manual valves be checked periodically for holding capabilities.
