**Investigation of
Rig Collapse Accident, Fatalities, and Injuries
Main Pass Block 153
Gulf of Mexico
Off the Louisiana Coast
July 17, 1998**

U.S. Department of the Interior
Minerals Management Service
Gulf of Mexico OCS Regional Office

Frank Pausina
Tommy Laurendine
Tom Perry
Daniel Knowlson

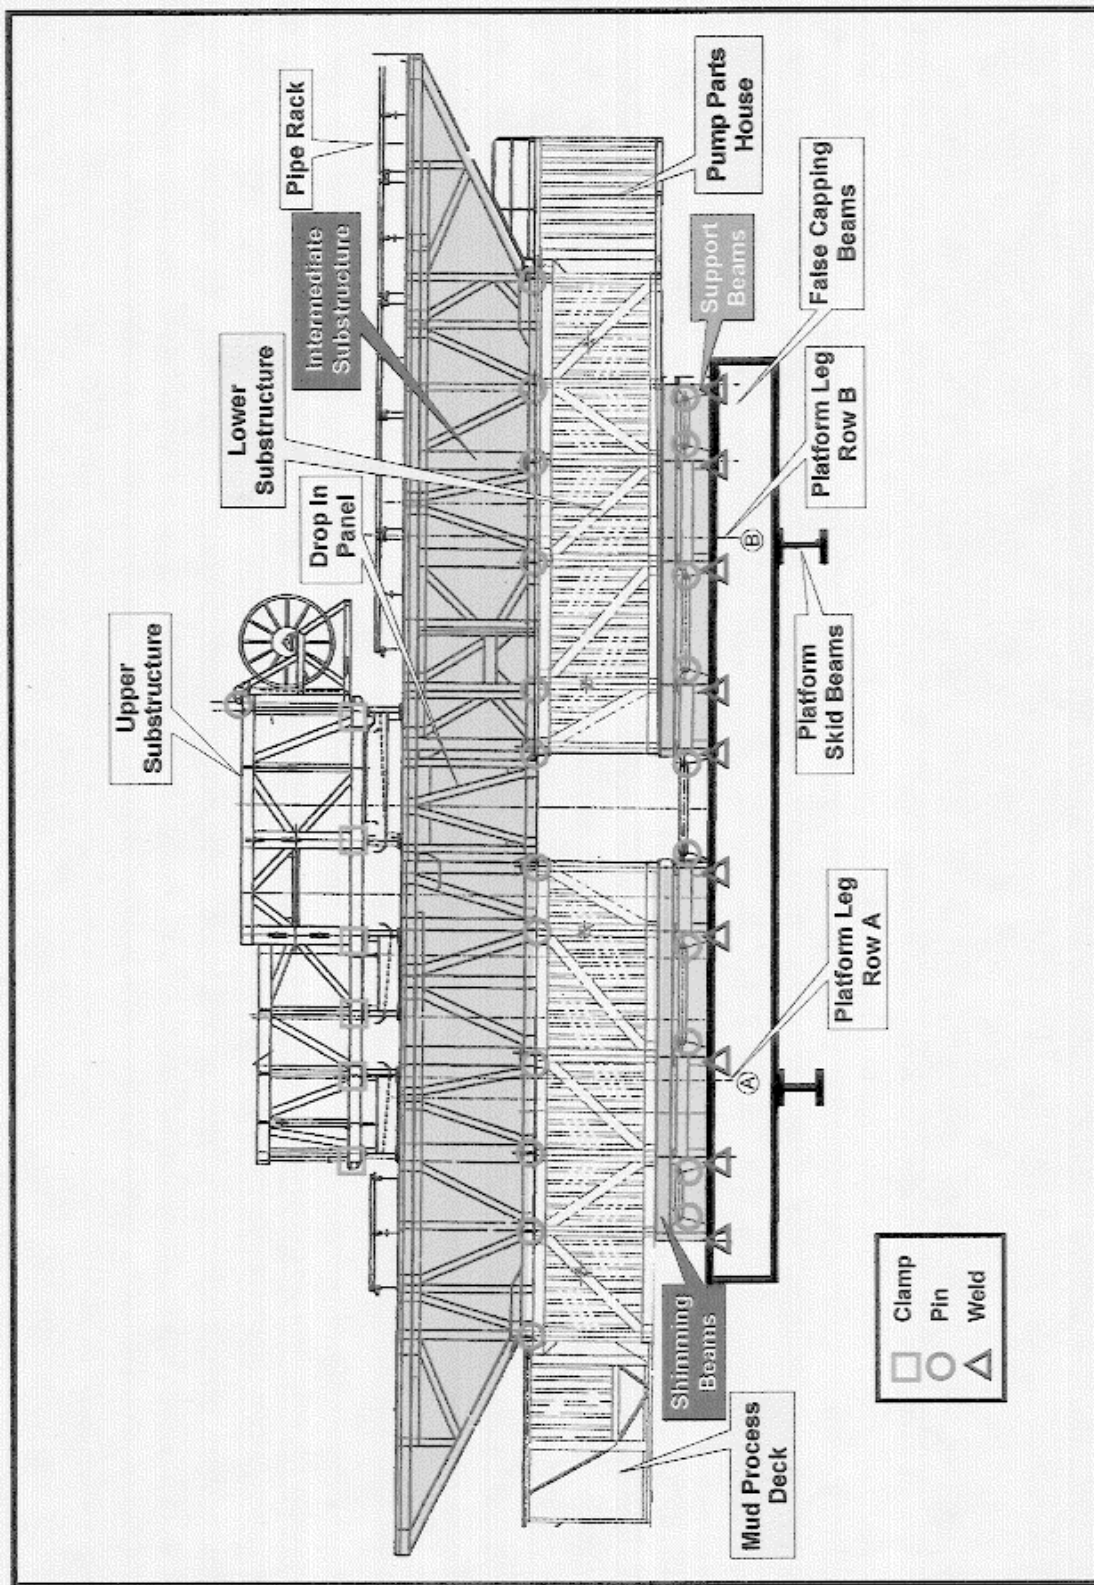
Schematic of Assembled Substructure of Rig 269 Prior to Skidding Operation

Nabors drilling Rig 269 was originally a land-based rig that was modified for offshore use. The rig was first used offshore on Chevron's Platform C in South Pass Block 77. The rig was then modified again for use on OEI's Platform B in Main Pass Block 153. OEI's plans called for the rig to drill two side-tracks and four to five developmental wells. *For a schematic of the assembled substructure of Rig 269 at the time of the accident and prior to the skidding operation, see Attachment 2.*

As can be seen from the schematic and drawing, the lower substructure extends beyond the supporting structures beneath it, namely the shimming beams, support beams, and false capping beams. Further, at the time of the accident, the only physical attachment between any of the substructures and underlying beams

existed between the false capping beams and support beams, which were welded together, and the intermediate and lower substructures, which were pinned.

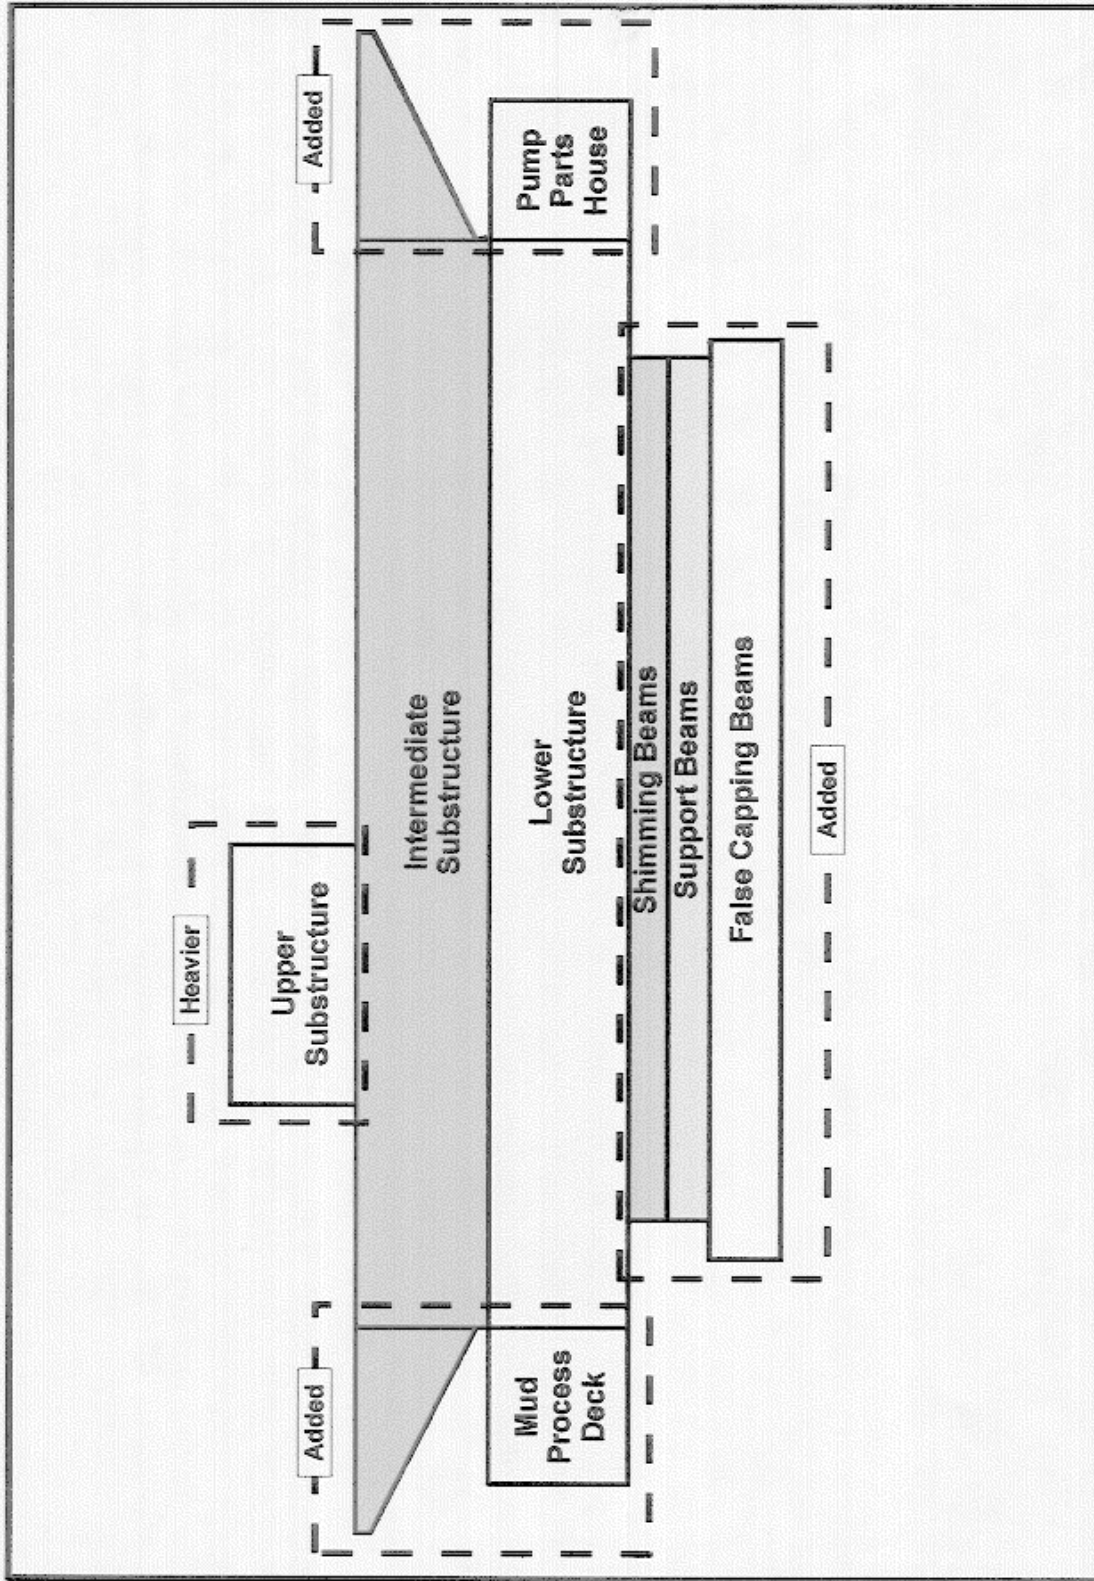
Drawing of Rig 269 Indicating Modifications.

The above-referenced modifications of the rig for use on Platform B consisted of the following:

1. The addition of the mud process deck and pump parts house to the lower substructure.
2. The lengthening of the intermediate substructure with associated strong back supports.
3. The addition of shimming beams, support beams, and false capping beams.
4. The use of a heavier upper substructure.

For a simplified drawing of the rig at the time of the accident and prior to the skidding operation indicating the modifications, see Attachment 3.

2. Given the aforementioned absences of connections and water in the mud tanks, the extension of the false capping beam, shimming beams, and support beams to the original end of the lower substructure, i.e., that part of the lower substructure to which the mud process deck was added, would have both (a) increased the countering moments by lengthening the moment arms of the intermediate and lower substructures and shimming beams to the last support beam and (b) decreased the moment of the upper substructure by decreasing its moment arm to the last support beam.

Therefore, the failure to provide such an extension is considered to be a contributing cause of the accident.

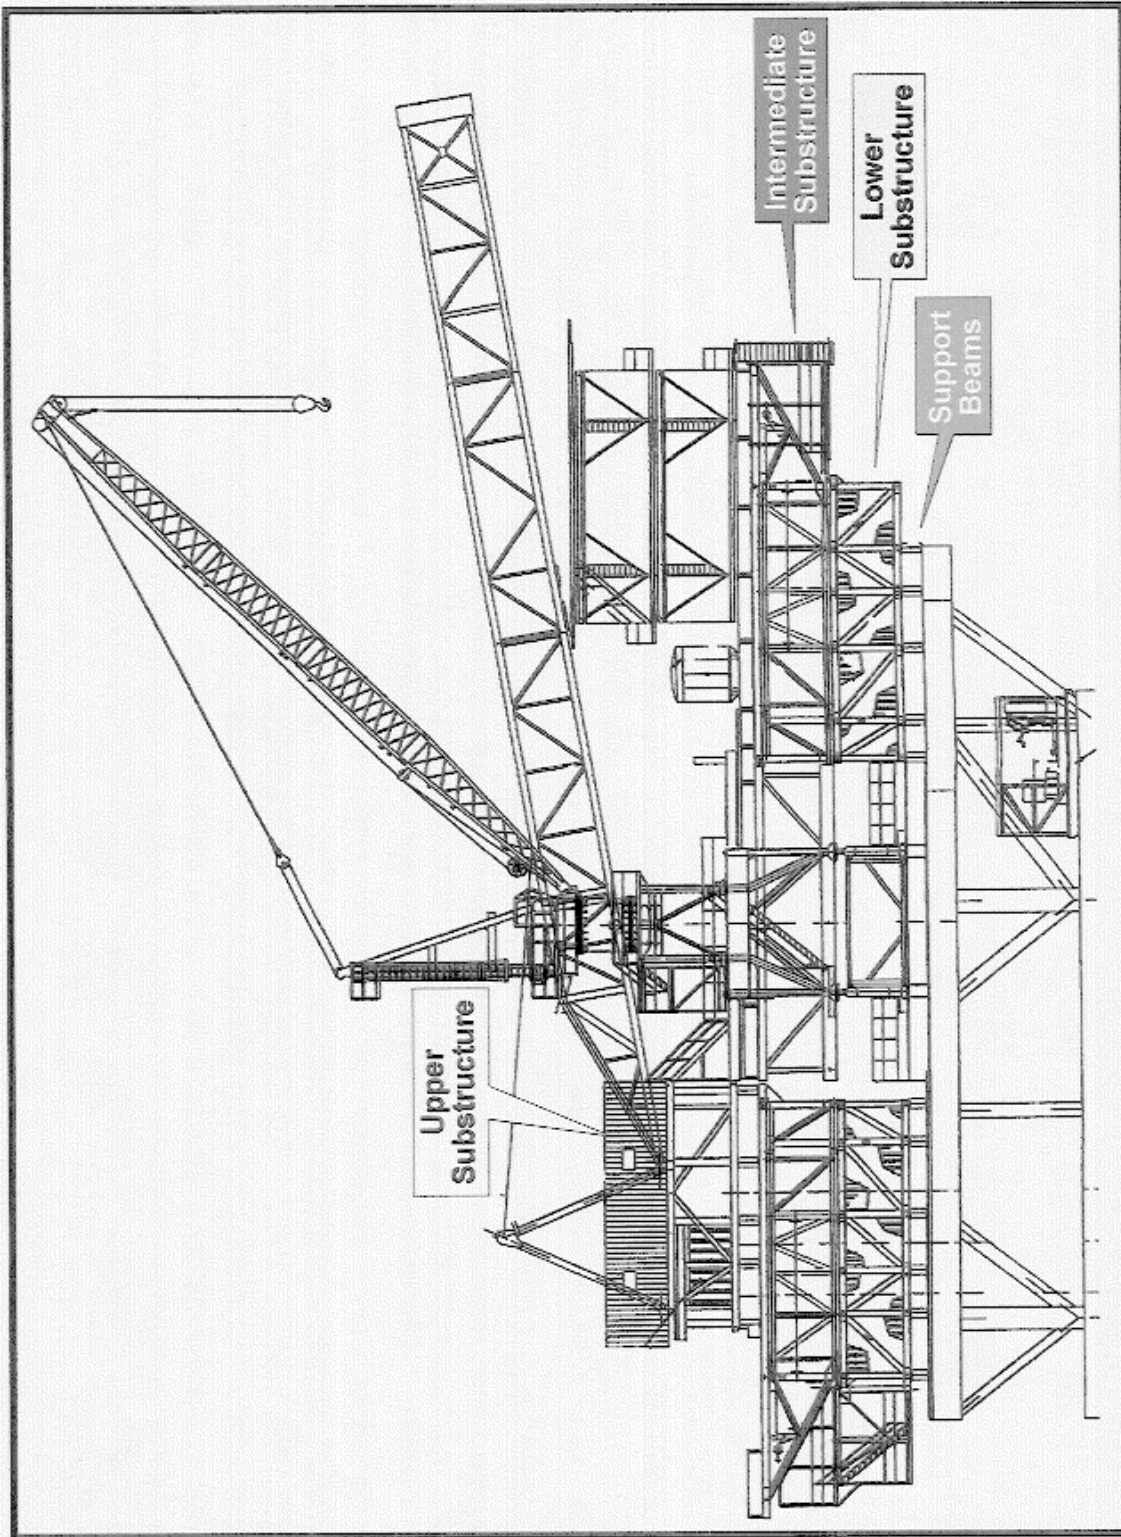
Schematic of Rig 270's Transverse Deployment

Prior to the accident, Rig 269's sister rig, Nabors Rig 270, had been similarly deployed transversely on Pogo Producing Company's Platform A in Ship Shoal Block 331. The significance of that transverse deployment of Rig 270 will be discussed later in the report. *For a schematic of Rig 270's transverse deployment, see Attachment 4.* As can be seen from Attachment 4, the lower substructure rests on support beams that extend on one side to the end of the main part of the lower substructure, and it is to that side that the upper structure was skidded.

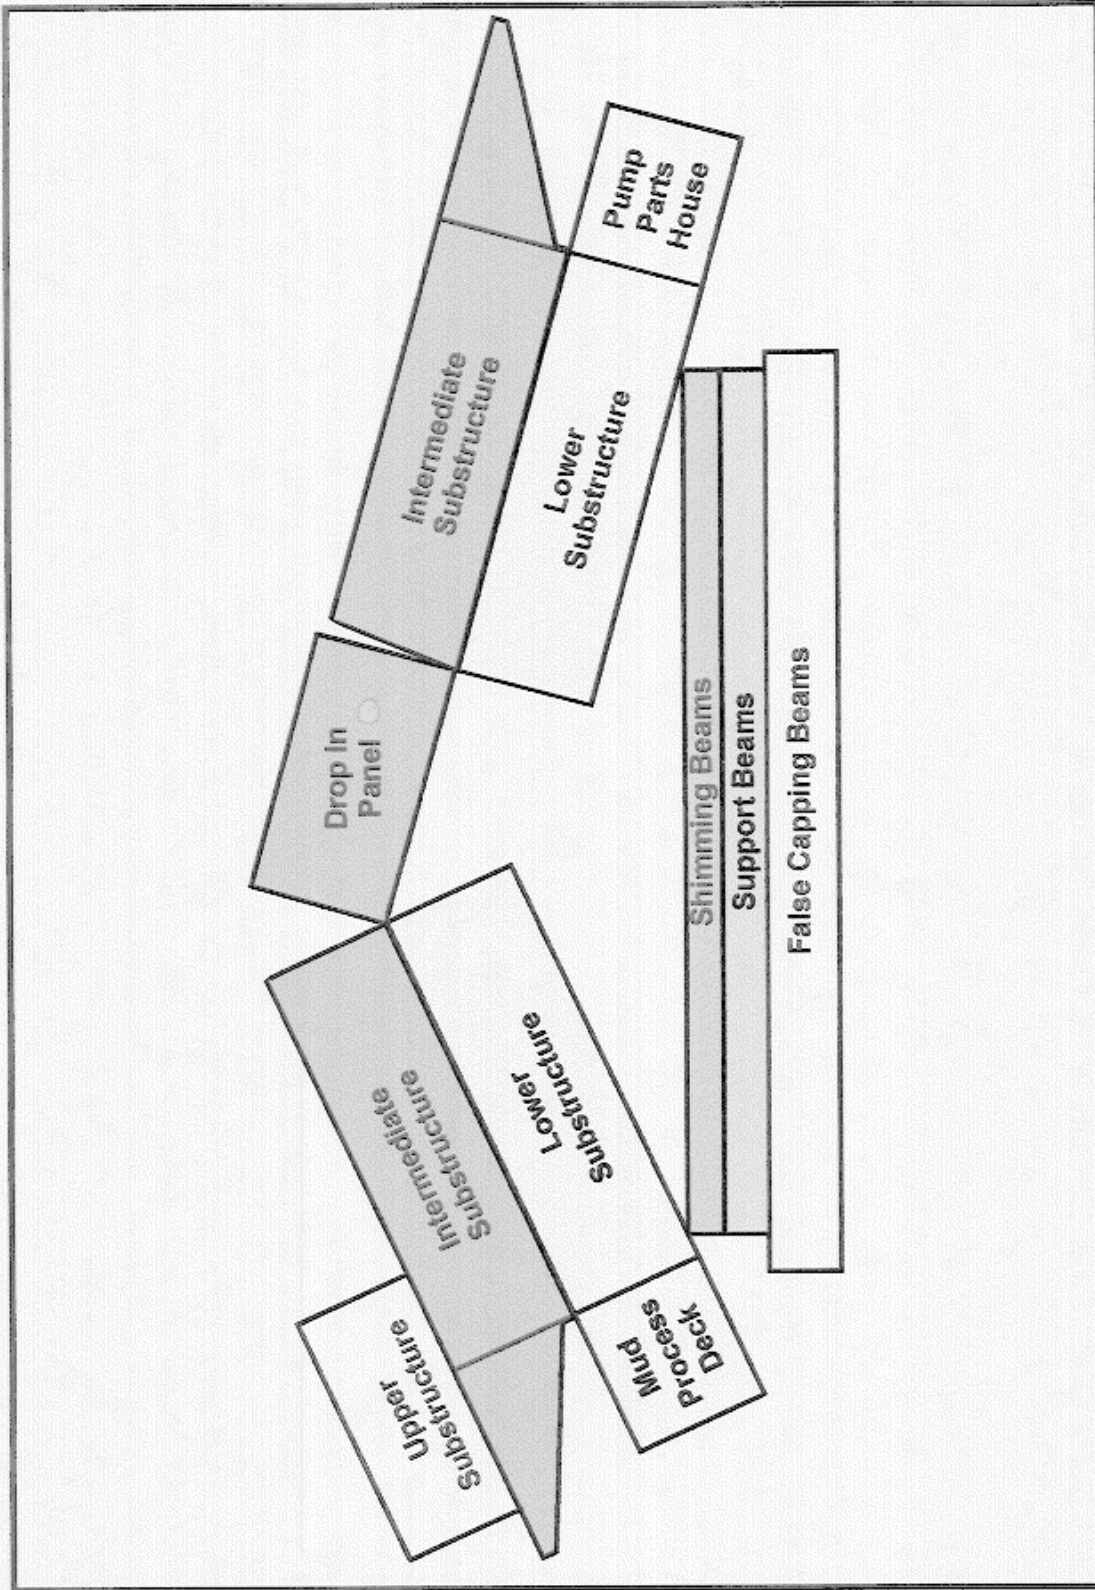
Drawing of Rig 269 in the Initial Stages of Accident

During or at the conclusion of a skid jacking stroke at approximately 1200 hours, and with the upper substructure approximately a foot from the targeted final position, the lower and intermediate substructure tilted downward to the side of the skidded upper substructure. This caused the intermediate substructure drop-in panel and the interior portion of the intermediate and lower substructures to rise. The entire substructure then began sliding to the side of the platform to which the upper substructure had been skidded. As a result of that movement, the upper substructure, other components of the rig, and two employees fell into the sea. One of these employees, the project drafting coordinator, was rescued; the other, the toolpusher, was never found. In addition, two contract hands were fatally injured when they fell from the pipe rack area to the materials barge. Twelve other employees were injured in the accident.

For drawings of the substructure positions in the initial stages of the accident and at the conclusion of the accident, see Attachments 5 and 6, respectively. For

During the skidding operation, the upper substructure reached the point where its center of gravity had moved sufficiently beyond the last support beam to the extent that the moment of the weight of the upper substructure acting through its center of gravity about the last support beam was greater than the summation of the countering moments of the weights of the intermediate and lower substructures and shimming beams about that same support beam. This imbalance caused the lower and intermediate substructures to rotate about the last support beam resulting in the lower and intermediate substructures sliding to the side of the platform to which the upper substructure was skidded. As a result of that movement, sufficient tilting occurred which caused the upper substructure, other rig components, and two employees to fall into the sea. Of those two employees, one was never found and is presumed a fatality, while the other was rescued. Two other employees fell from the other side of the platform to a materials barge and were fatally injured. Twelve other employees were injured, with varying degrees of severity, as a result of the rig's movement.

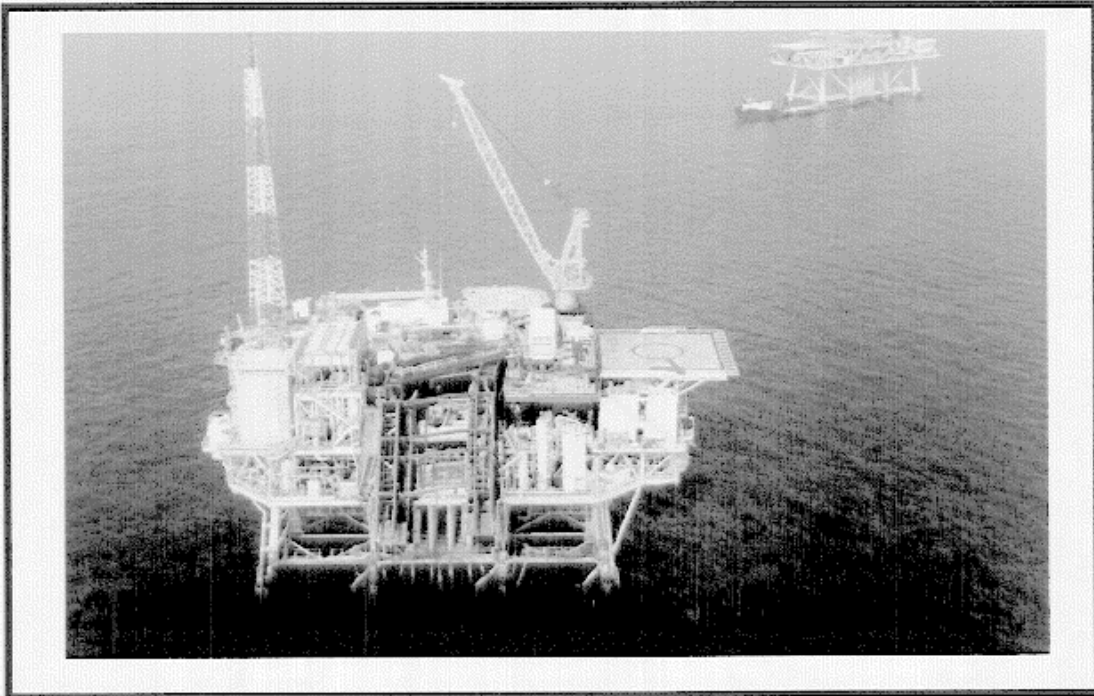
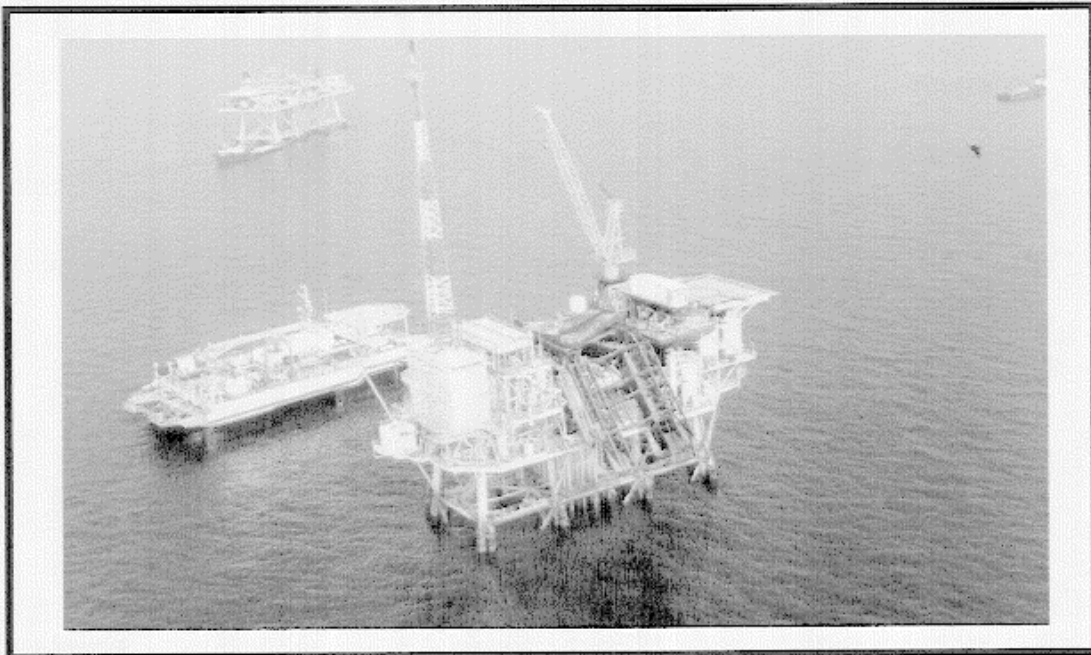
Photographs of Platform B After Accident

photographs of the platform at the conclusion of the accident, see Attachments 7, 8, and 9.
