**TYPE A**

**ACCIDENT INVESTIGATION**

**JULY 15, 2004**

**HANFORD 200 EAST AREA**

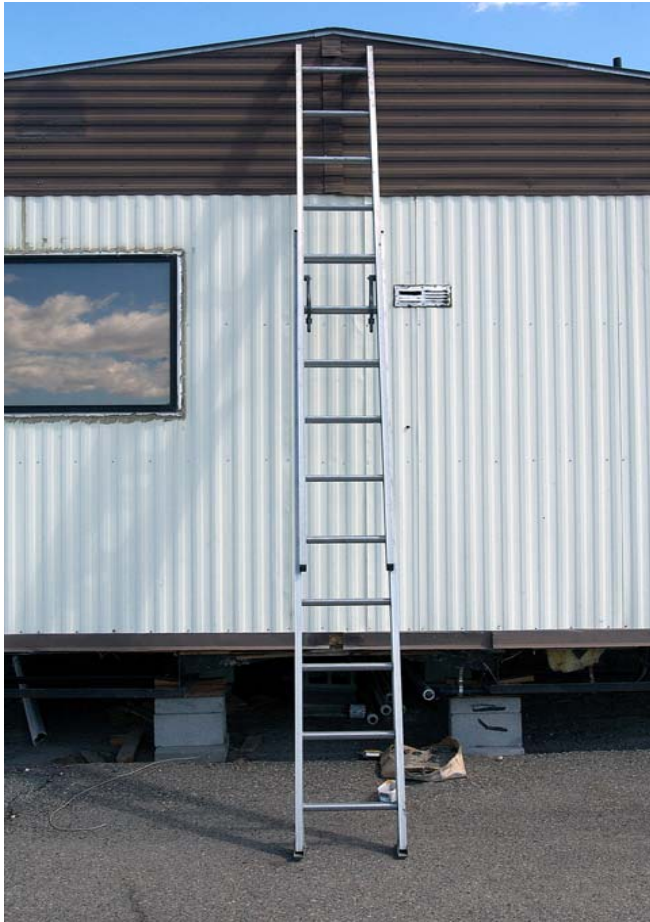
Testimony, review of photographs, and inspection of the accident scene provided the following detail. The ladder was located at the south end of MO-392, propped against the wall with both feet firmly placed and the top rails in contact with the wall directly below the peak. The top of the ladder was not secured. The area is a wide expanse of level asphalt with one speed bump half way between the center line and west side of the building. Loose gravel, dirt, or liquids were not present. The length of the ladder was 14 feet, 2 inches and the center peak of the gable end of MO-392 was 13 feet, 10 inches. With these measurements, the ladder (in its most vertical position) would reach four inches above the peak of the roof. Inspection by the Board and the Benton County Sheriff's Corporal indicated that no activity had occurred on the roof.

Exhibit 2-1, Ladder base at 3 ½ feet from MO-392, south wall.

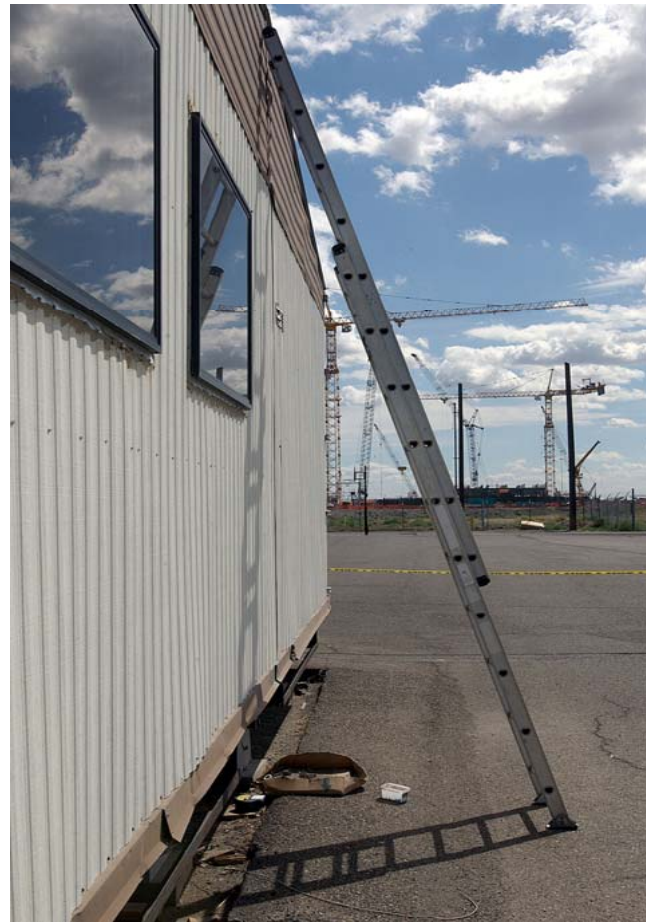
Exhibit 2-2, Ladder base at 3 ½ feet from MO-392, south wall

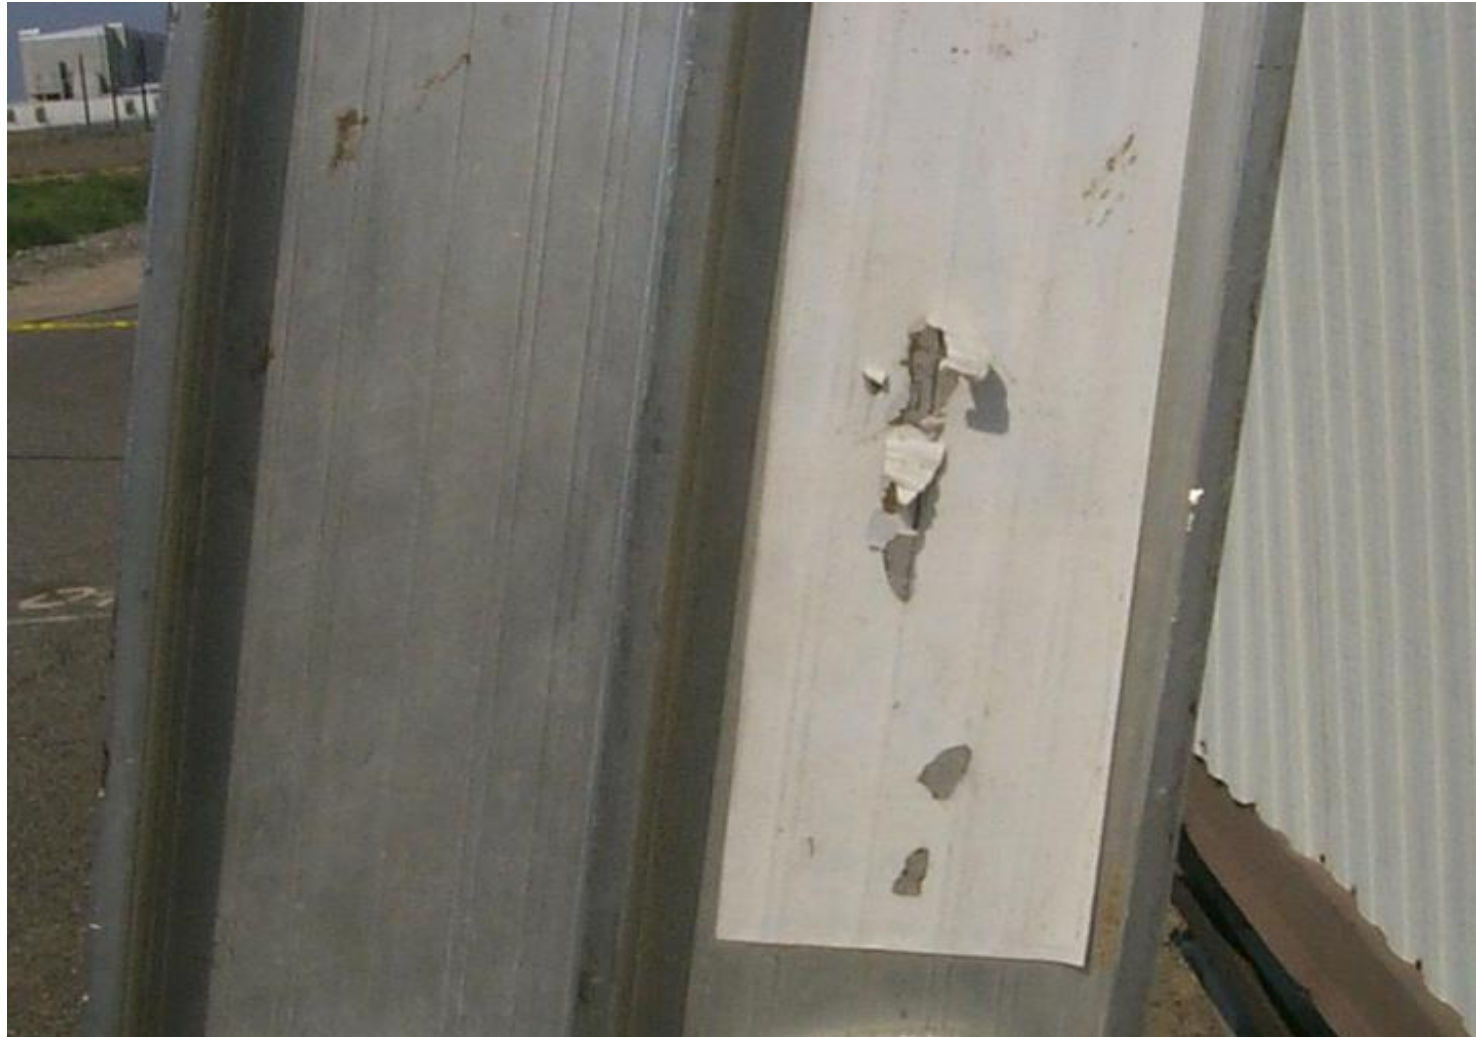
Ladder was found in a stable configuration against the wall, but no one witnessed AMTR employee's actions while on the ladder.	<b>(b)(11)</b> Ladders shall not be moved, shifted, or extended while occupied.	<b>(2) (k)</b> Ladders shall not be moved, shifted, or extended while occupied.		<b>A1</b> Do not shift, reposition, or extend portable ladders when the ladder is occupied.	Unknown
No energized lines were located in the vicinity. All electrical connections to MO-392 had been disconnected. Labels on ladder were	<b>(b)(12)</b> Ladders shall have nonconductive siderails if they are used where the employee or the ladder could contact exposed energized electrical equipment, except as provided in 1926.951(c)(1) of this part.	<b>(2) (l)</b> Ladders shall have nonconductive side rails if they are used where the employee or the ladder could contact exposed energized electrical equipment, except as provided in the following:  <b>(i)</b> Portable metal or other portable		<b>A1</b> Do not use metal or metal-reinforced portable ladders when the ladder is occupied.	Non-compliant on WAC (2)(ii) "conductive" warning was illegible, however, no lines were energized in the vicinity

Exhibit 2-3, Faded label on ladder used at MO-392, south wall.
