64 IN-SERVICE MOISTURE CONTENT OF HARDBOARD LAP SIDING IN SOUTHERN FLORIDA

C. Carll, A. Tenwolde, V. Malinauskas, M. Knaebe, and
P.G. Sotos

U.S. Forest Products Laboratory, Madison, WI, USA

Proceedings of the Eighth International Conference
on Durability of Building Materials and Components, 8dbmc

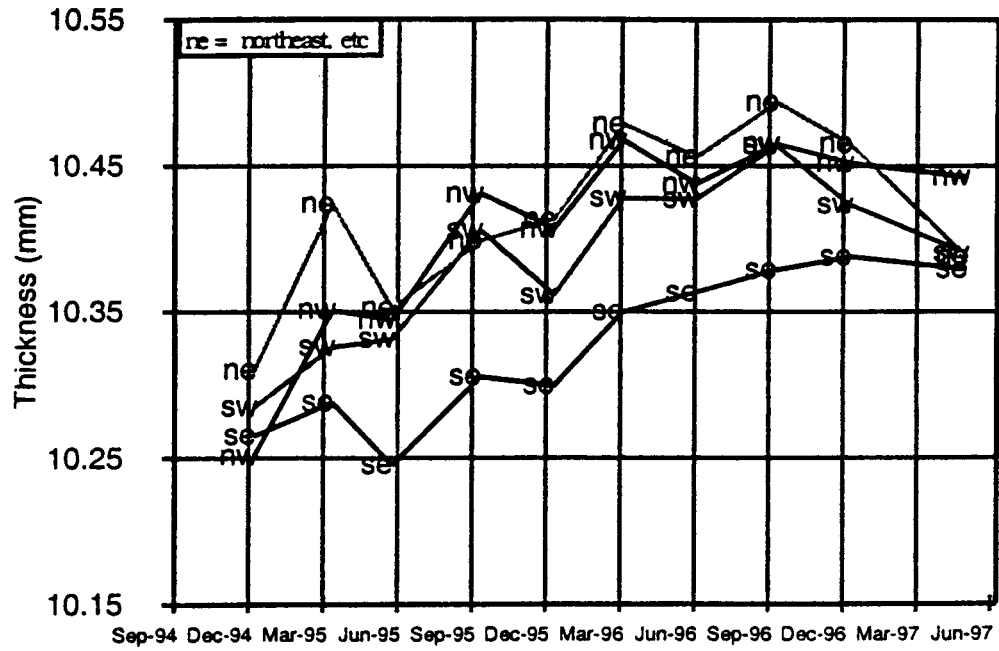
Fig.1(a): Results of thickness measurements on building with gutters, by wall orientation

Figures 1A and 1B show the results of the in-place thickness measurements. Thickness increased very little after March 1995 (3 months of exposure) and after March 1996 (15 months of exposure) no long-term increase is apparent. Based on an estimated initial thickness of 10 mm (0.4 inch), thickness swell stayed below 3% over the entire exposure period, while the average thickness swell was about 2%. Figures 1A and 1B also show a seasonal fluctuation in thickness, with some shrinkage during summer and swell during winter. Generally, siding on the shady sides of the buildings was thicker than boards on the sunny sides. Neither finish system, nor building (building with gutters versus building with overhangs) showed any consistent significant effect on in-place thickness.

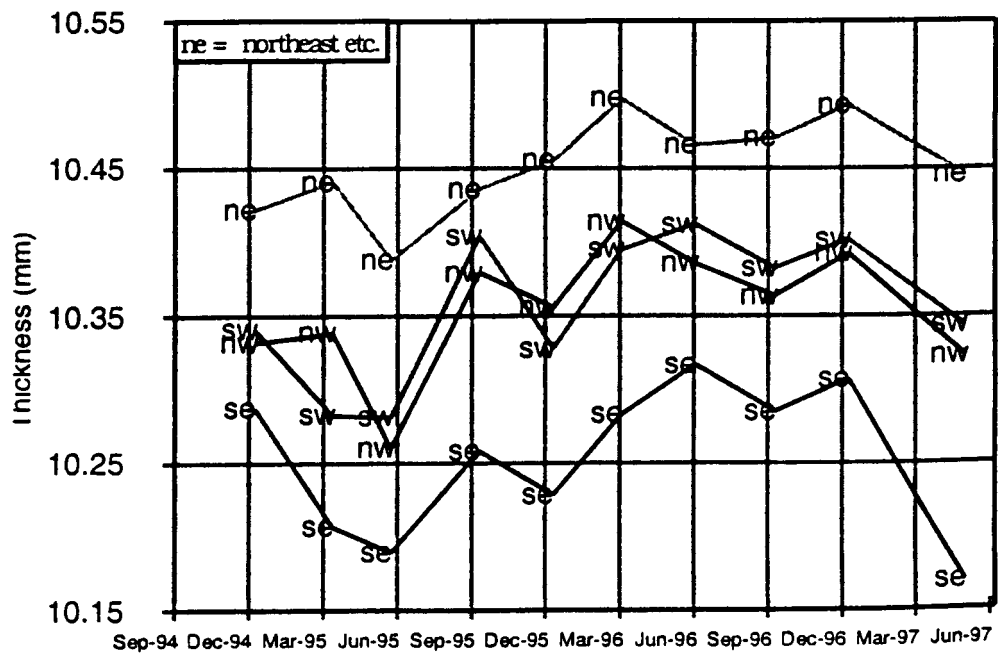
Fig. 1(b): Results of thickness measurements on building with overhangs, by wall orientation

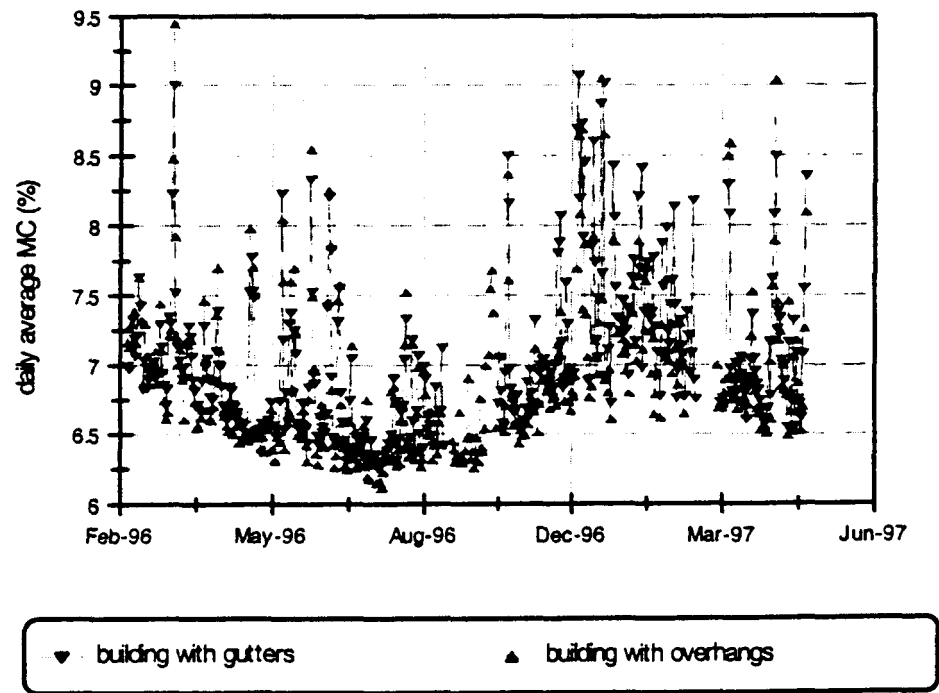
Moisture pin data indicated that the siding remained below 9% MC over the monitoring period. Figure 2 shows daily average MC for all moisture pin readings on each building from February 10, 1996 until termination of data collection on May 6, 1997. Data collected prior to February 10, 1996 are not presented because of the calibration and instrumentation problems mentioned previously. Figure 2 shows a few short periods with a daily average MC above 9%. These corresponded with rain events, and, as indicated previously, are probably erroneous. The seasonal fluctuation in MC level shows a similar trend as fluctuation in in-place thickness data, i.e. lower MC in summer, higher MC during winter.

Fig. 2: Daily average moisture content readings from moisture pins, from February 10, 1996 through study completion

The data show no discernable differences between buildings, nor between finish treatments (BS, BF, NS, or NF). No differences were apparent in MC of siding on different wall constructions, nor was there an apparent effect of wall orientation. Furthermore, siding boards on the bottom course were not wetter than siding boards in other locations. However, most of the moisture pin data were close to the lower measurement limit of the instrumentation, hampering our ability to discern actual differences in moisture content.

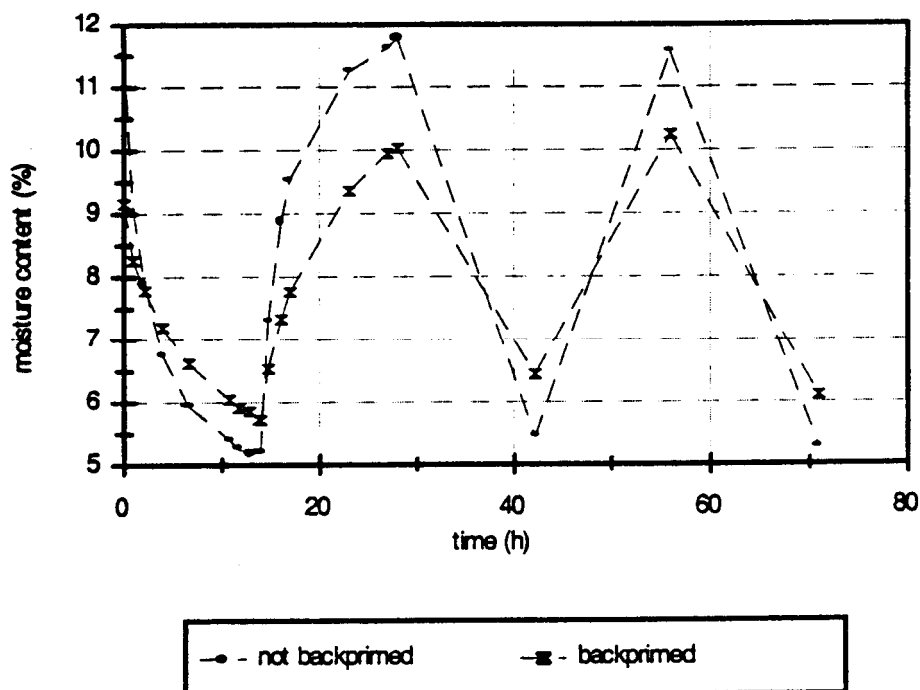
Figure 3 shows that backpriming significantly retarded both vapor sorption and desorption, i.e. backpriming retards both wetting and drying. Site-collected data suggest that heavy rains occurred in the months prior to siding removal, and dry weather the week prior to removal. At the time of removal backprimed siding consistently had a slightly higher MC possibly because it had not yet fully dried.

Fig. 3: Average MC of siding with, and without backpriming, when exposed cyclically to 30% and 90% RH
