INVESTIGATION REPORT

VENT COLLECTION SYSTEM EXPLOSION

TECHNIC INC.

REPORT NO. 2003-08-I-RI

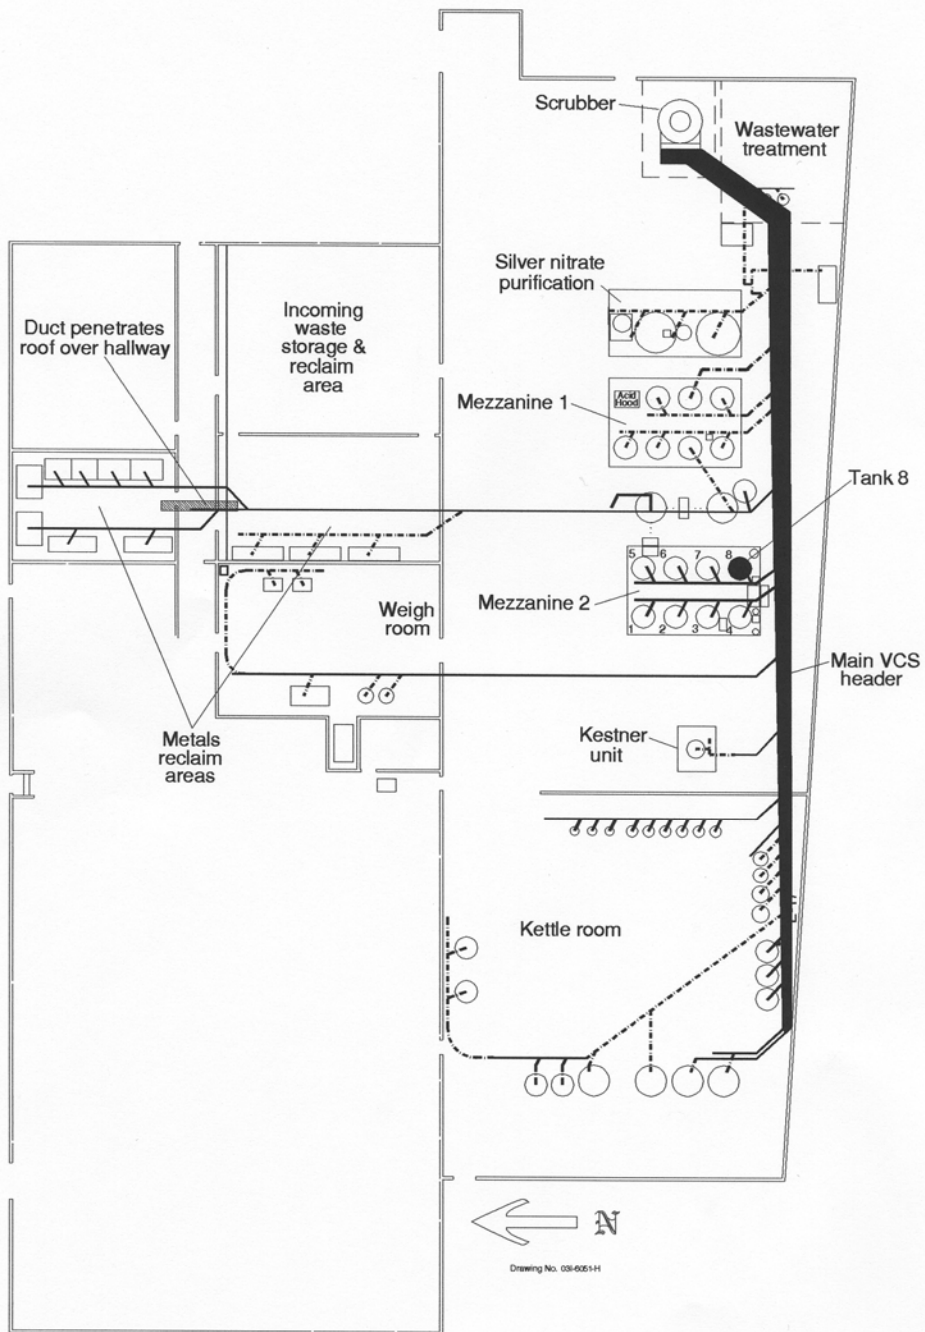
Figure 3. Vent collection system as of February 7, 2003 (modifications to original design are shown by dashed lines).

From April 2001 until the date of the explosion, additional kettles were added in the kettle room, and the baghouse in the weigh room was disconnected in an attempt to increase the duct capture efficiency of the packaging equipment. Discussions with the loss prevention carrier revealed that none of these modifications were submitted to the carrier for review.

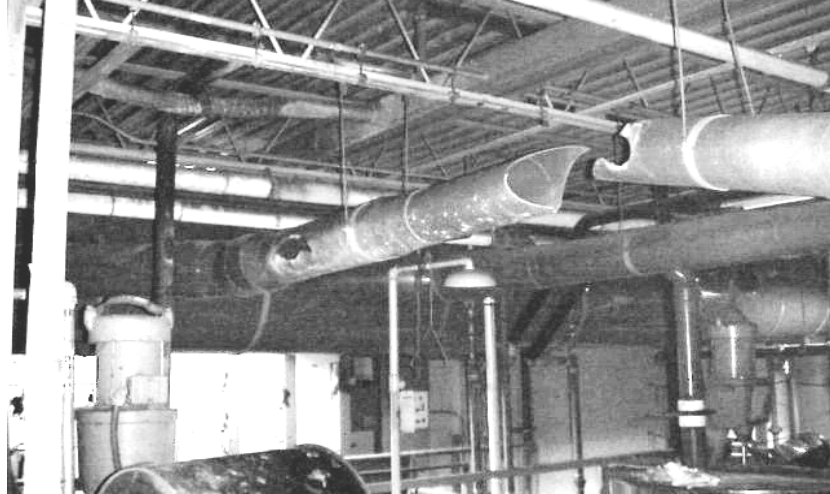
Figure 5. Large fracture of 10-inch branch duct above mezzanine 2 production area.

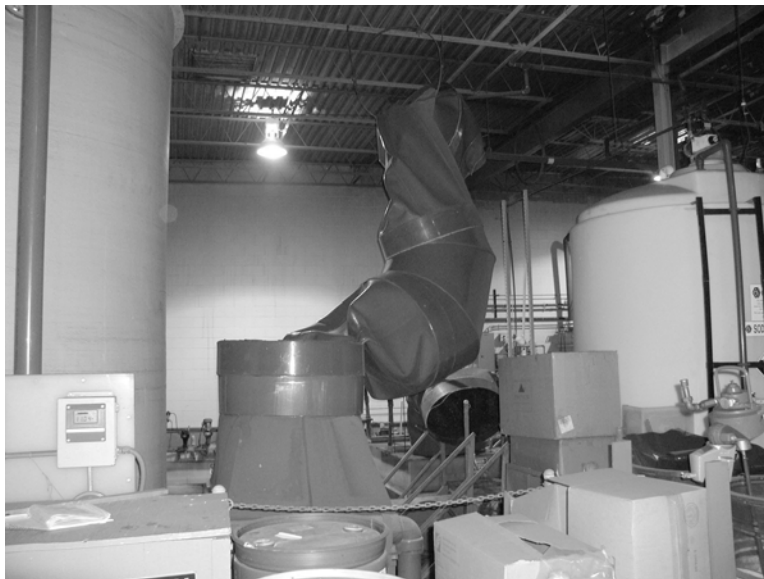
Figure 8. Collapsed 36-inch-diameter main header at scrubber along east wall.

The fire destroyed approximate 50 feet of the main header. No explosion or fire damage was identified upstream of mezzanine 2.

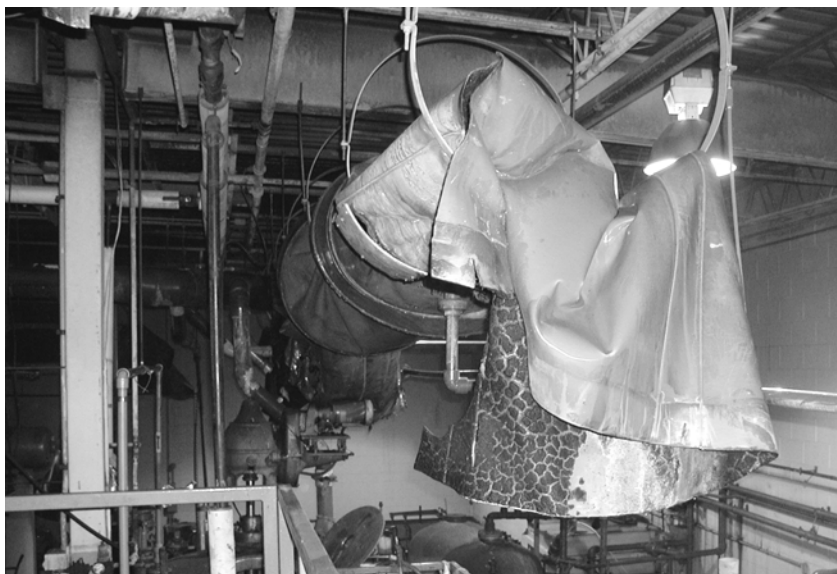
The initial explosion likely ignited fuel (e.g., dusts or accumulated residue) inside the main header. The resulting flame moved downstream toward the scrubber, causing at least one additional explosion. The presence of shiny, blistered char inside the duct indicates that the fire burned intensely for an extended time (Figure 9).⁷

Figure 9. Blistered char inside 36-inch-diameter main header adjacent to mezzanine 1.

⁷ Char is a carbonaceous material that has been burned and has a blackened appearance. When char is shiny with interlaced cracks, it is commonly referred to as “alligator char.”

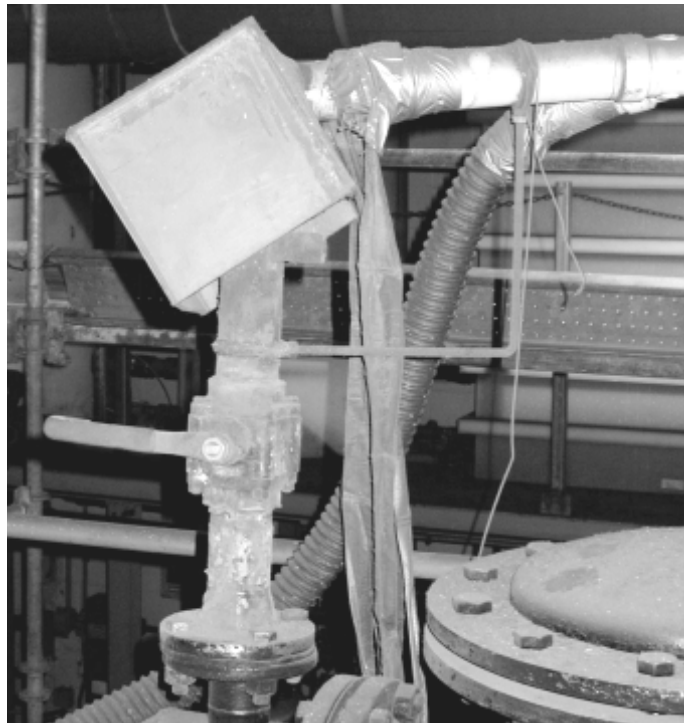
- Kestner unit: Interviews with employees revealed that during occasional process upsets, fumes from this distillation vessel overwhelmed the vent collection system and vented into the plant. In-house maintenance personnel connected the Kestner unit to the vent collection system as shown in Figure A-1. This unit was in full operation on the day of the explosion.
- Mezzanine 1: Employees stated that on occasion dark red smoke overwhelmed the vent collection system and escaped through the loose-fitting tank access door into the plant (Figure A-2). On the day of the explosion, three batches of silver nitrate were being held on mezzanine 1 for future use, but none were being processed.

Figure A-1. Kestner unit exhaust ventilation.

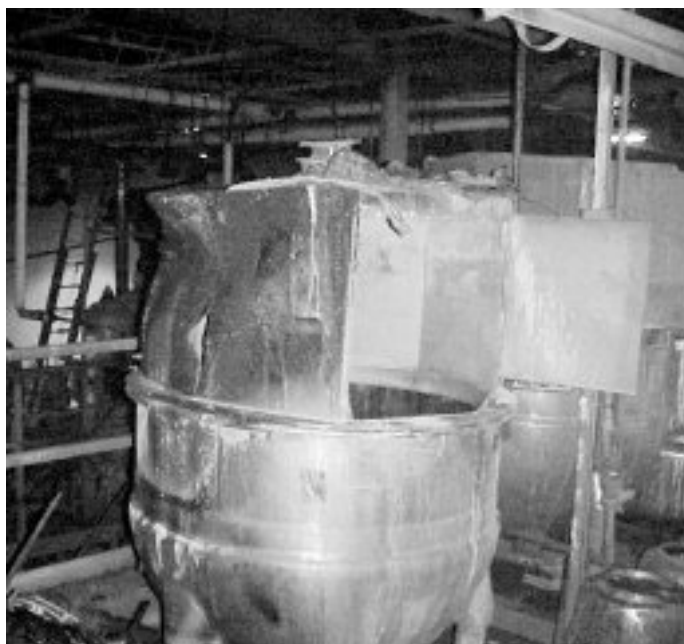
Figure A-2. Silver nitrate reactor on mezzanine 1 with open tank door (following explosion and fire).
