DPC Enterprises Chlorine Release

Festus, Missouri August 14, 2002

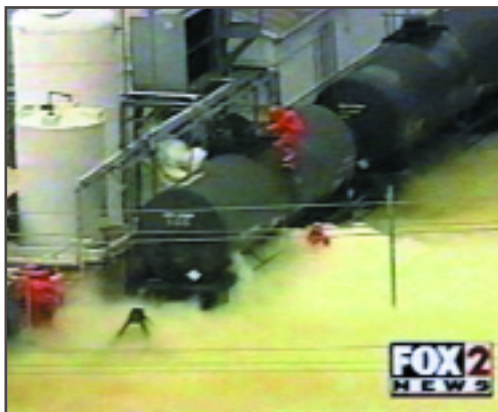
After three hours, responders were able to shut off the chlorine leak.
