U.S. CHEMICAL SAFETY AND HAZARD INVESTIGATION BOARD

# INVESTIGATION REPORT

## DUST EXPLOSION

### WEST PHARMACEUTICAL SERVICES, INC.

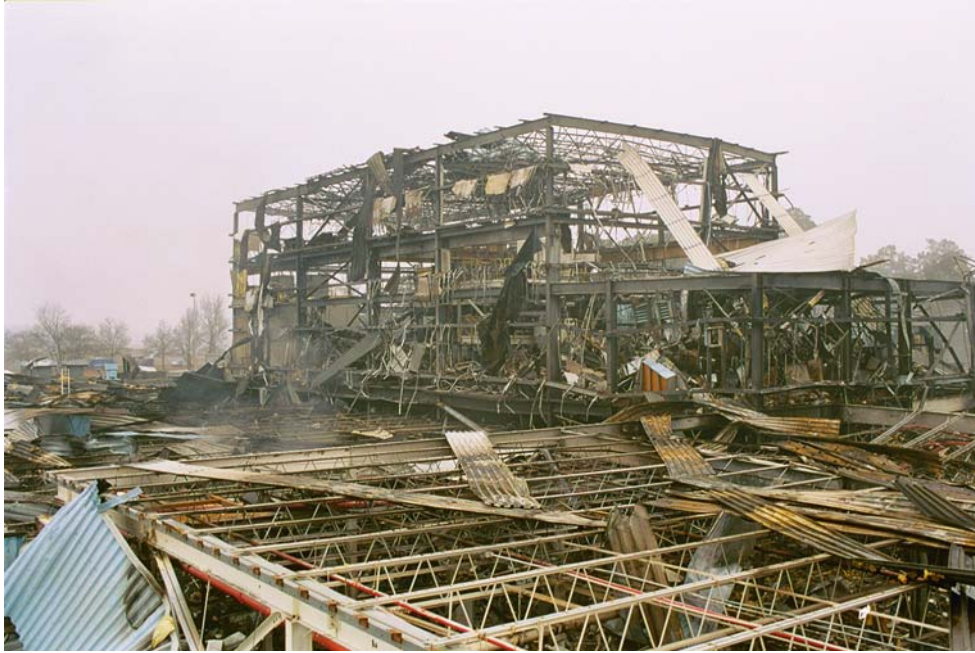
The explosion and ensuing fire heavily damaged the compounding section of the Kinston facility. Photographs below and in the remaining sections of this report show the extent of damage. All exterior sheathing on the compounding structure was destroyed. Masonry block walls were knocked down, the warehouse collapsed, and the building structure was rendered mostly unusable (Figures 6 and 7).

Figure 6. Roof of facility, with two-story compounding section in background.

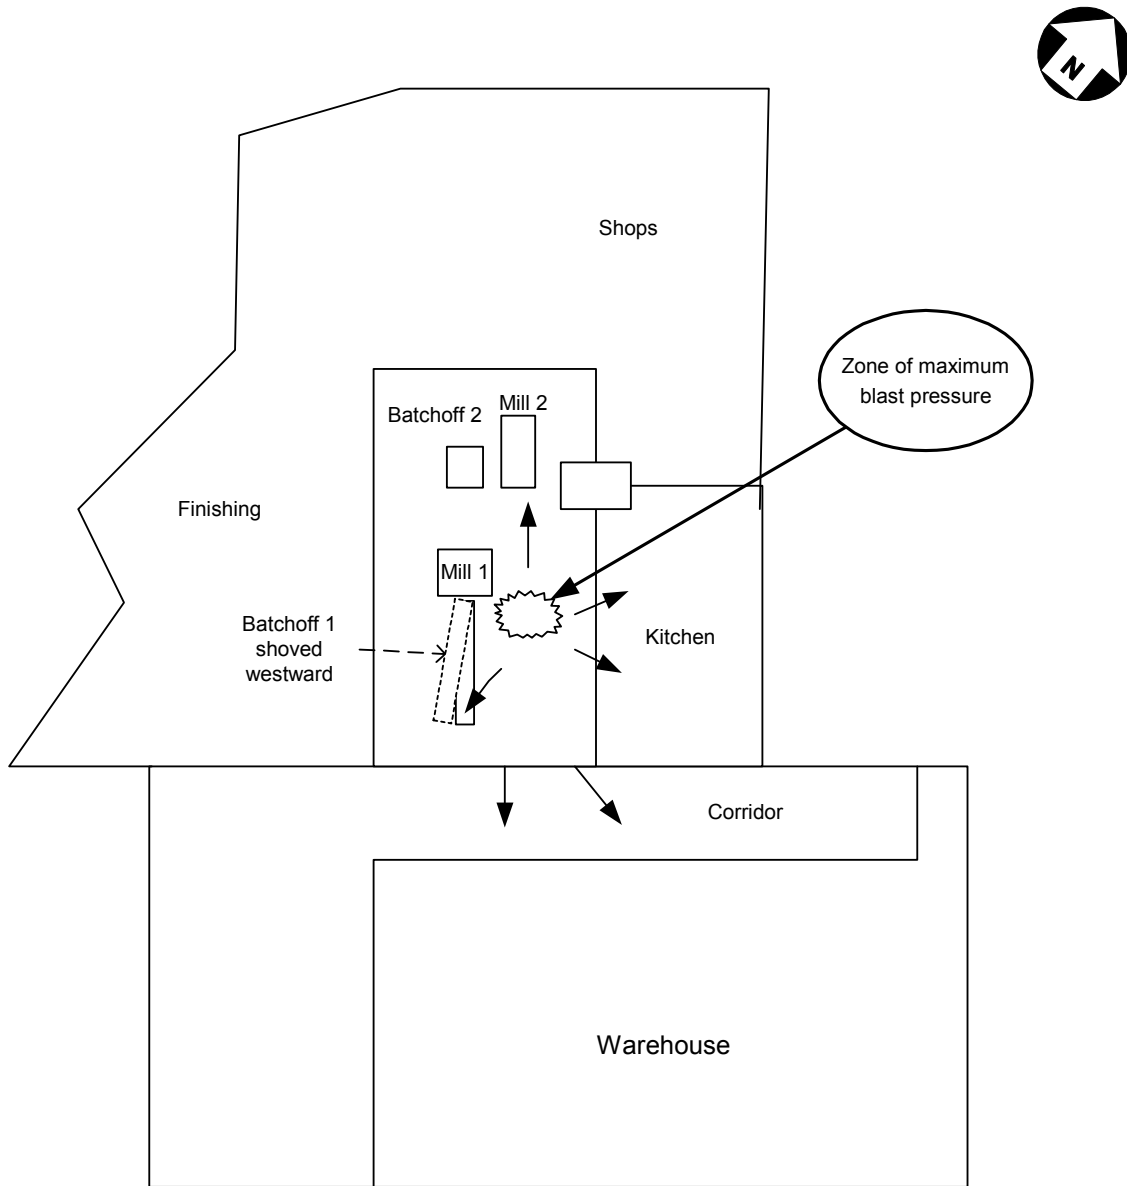
CSB investigators determined that the January 29 explosion occurred in the compounding section of the plant. Moreover, the location of the highest pressure was determined to be just east of mill #1 (Figure 9). Force vectors derived from observed damage to the building and surrounding equipment indicate that the largest pressure developed in the compounding section and emanated spherically outward (Figure 10). Appendix B describes the damage patterns CSB used to estimate the directions and magnitude of explosive force.

Figure 9. Estimated zone of maximum blast pressure.

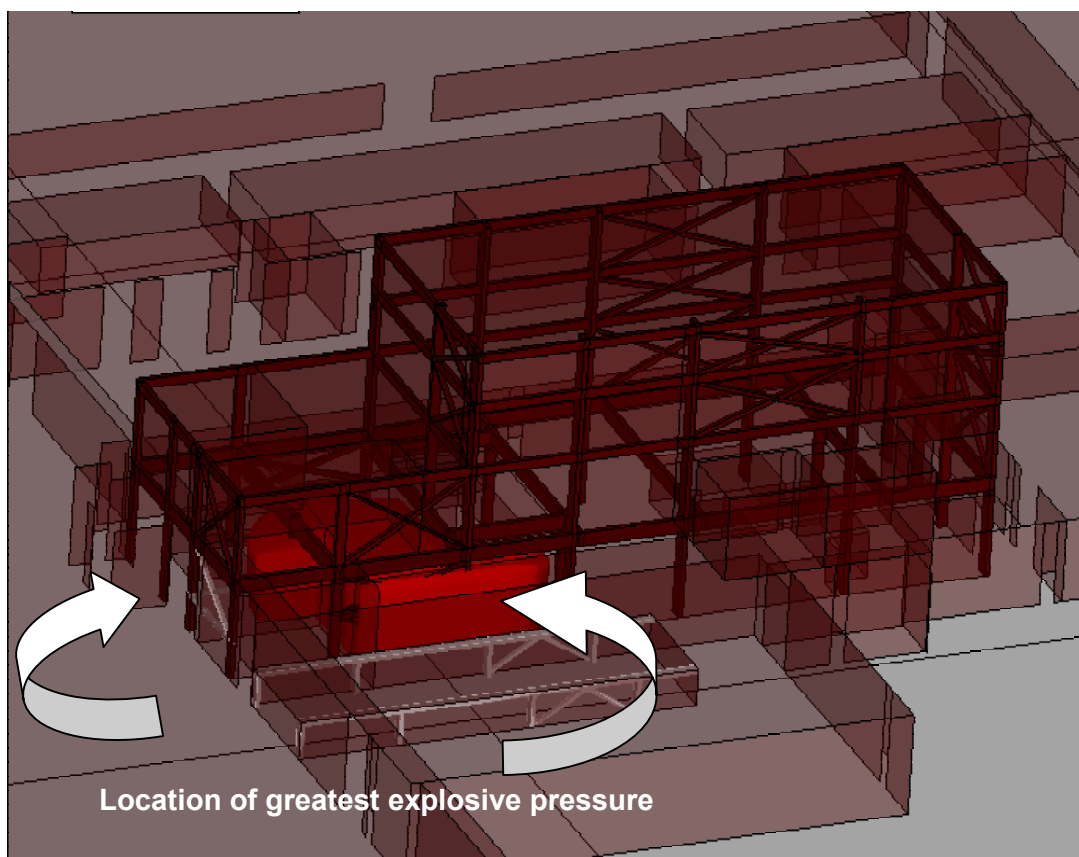
Figure 10. Location of maximum explosive force.

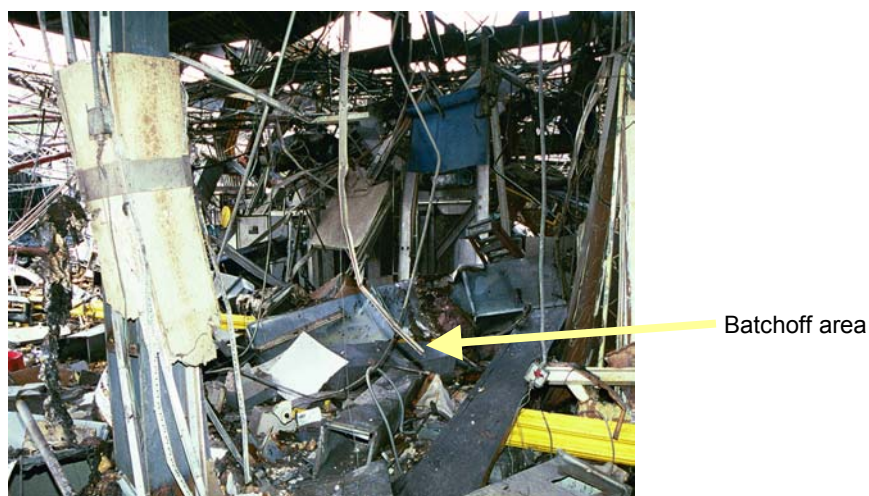
The extent of damage to the Kinston facility made it extremely difficult to definitively determine the event that dispersed the dust or what ignited it (Figure 11). Investigators focused on the most pertinent hazard—the accumulation of combustible dust—and considered the initiating event as a matter of secondary importance. CSB was unable to determine whether any of the following theories may have been the actual initiating event:

Figure 11. Extensive damage and debris near mill and batchoff machine #1.

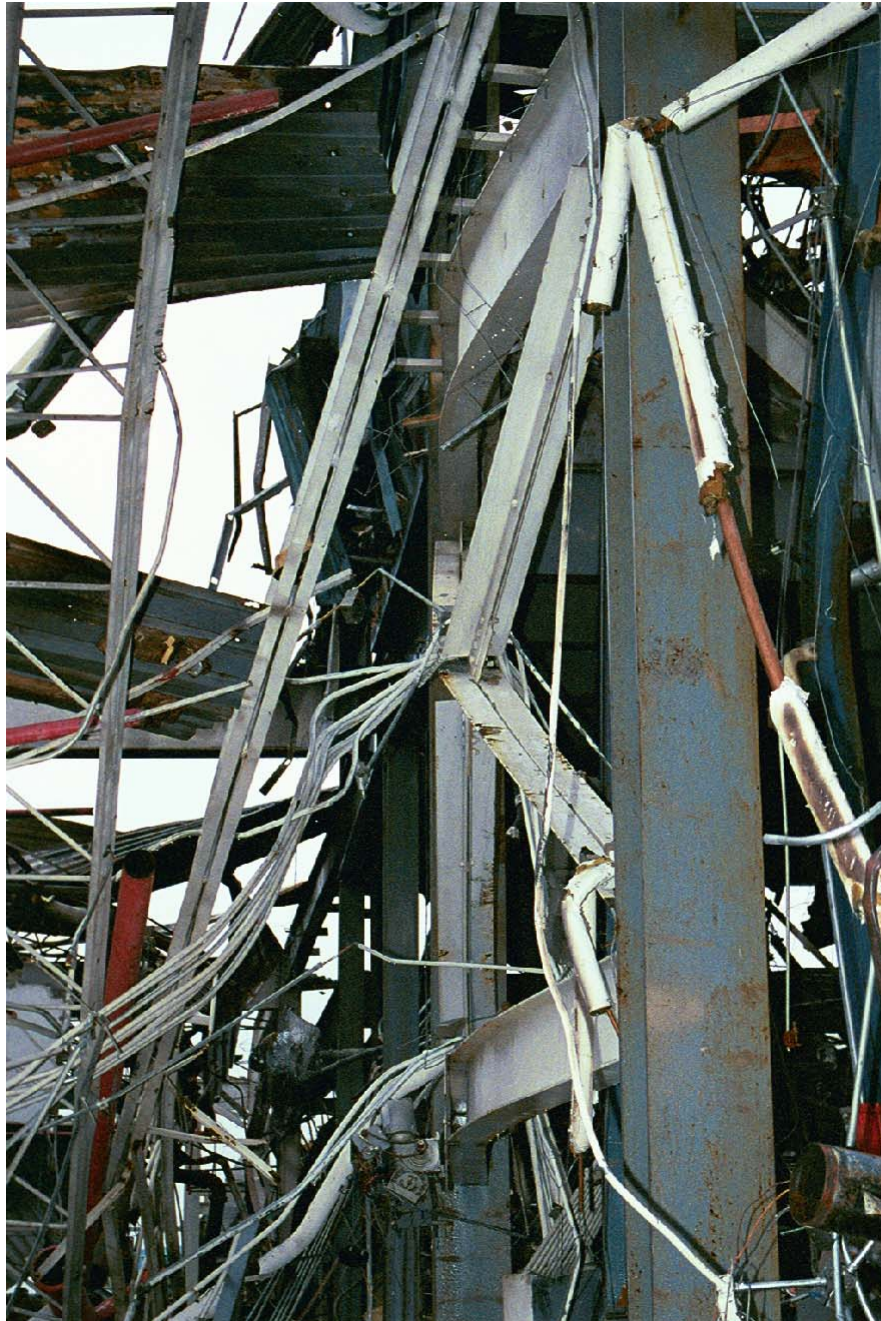
Figure B-1. Beam and cross bracing deflected southeastward toward warehouse.

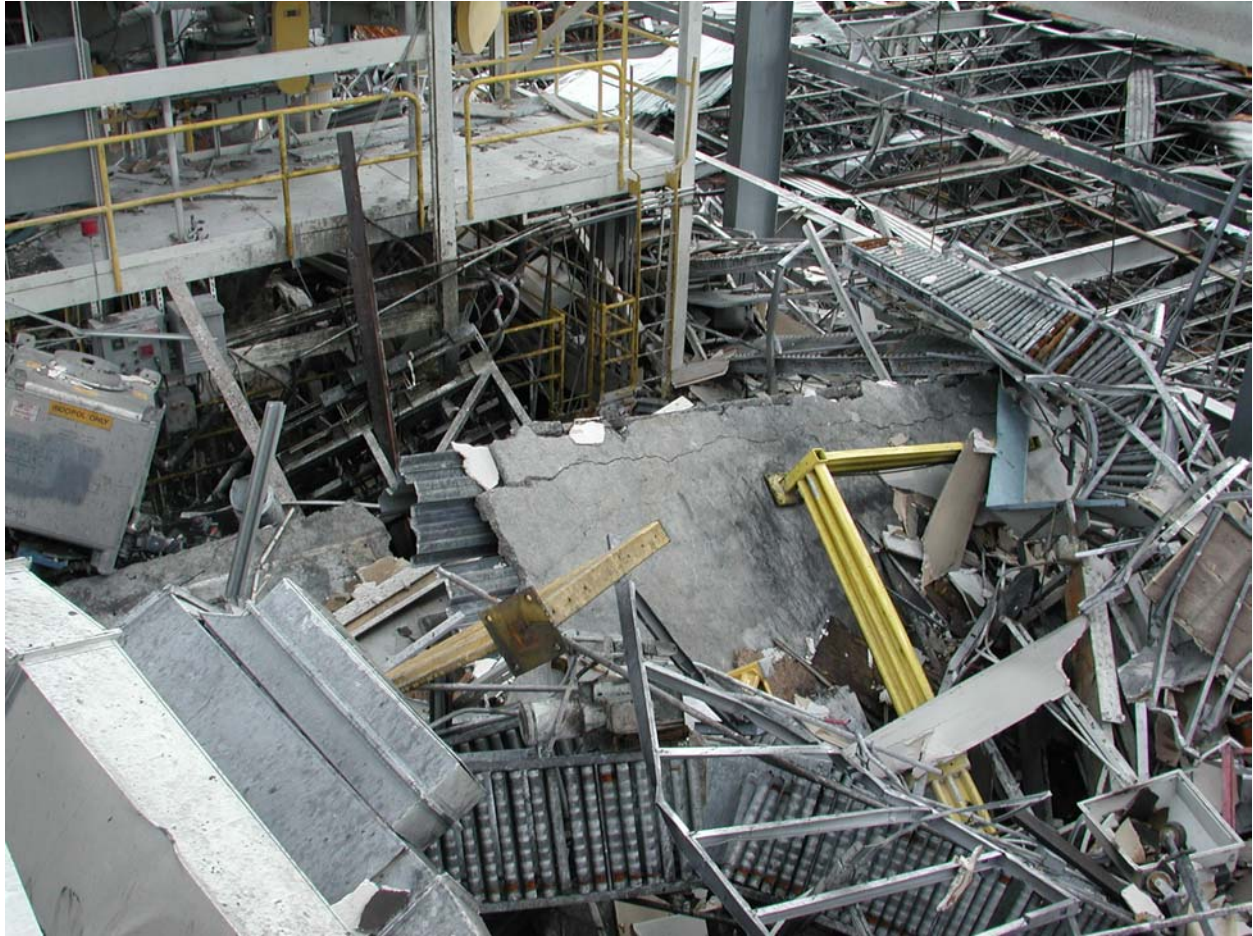
Figure B-2. Area between mixers #1 and 2. (Note upward heave of broken concrete floor.)

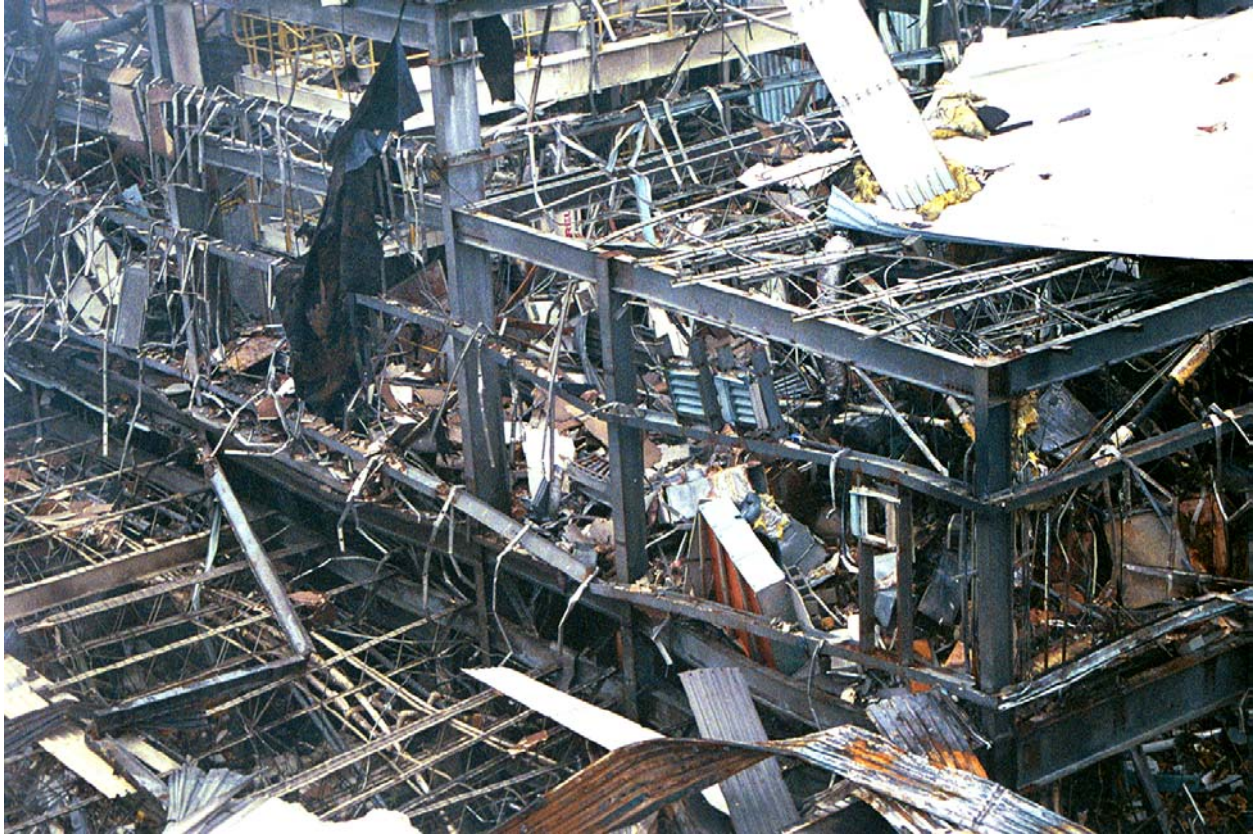
- The force of the blast displaced batchoff #1—a machine that weighs several tons—several feet to the southwest.
- To the immediate east of this area, the two masonry walls of a hallway used to conduct tours of the facility were blown northeastward into the kitchen. Structural steel in this area was deflected in the same direction.
- To the southeast, masonry walls for an elevator shaft and stairwell were blown southeastward toward the warehouse. Structural steel and cross bracing were deflected in the same direction (Figure B-1).
- The upper-level concrete slab flooring directly over the mill #1 and batchoff #1 area was heaved in an upward direction. The floor northwest of this area between the two mixers was also heaved (Figure B-2).
- Structural steel for the wall adjacent to batchoff #1 was deflected to the southwest (Figure B-3).

Figure B-3. Southwest wall of compounding area deflected outward.
