TVA'S POWER PLANT MAINTENANCE PROGRAM - PHILOSOPHY AND EXPERIENCE

T. H. Gladney
Assistant Director of Power Production

H. S. Fox
Chief, Power Plant Maintenance Branch

Tennessee Valley Authority
Chattanooga, Tennessee

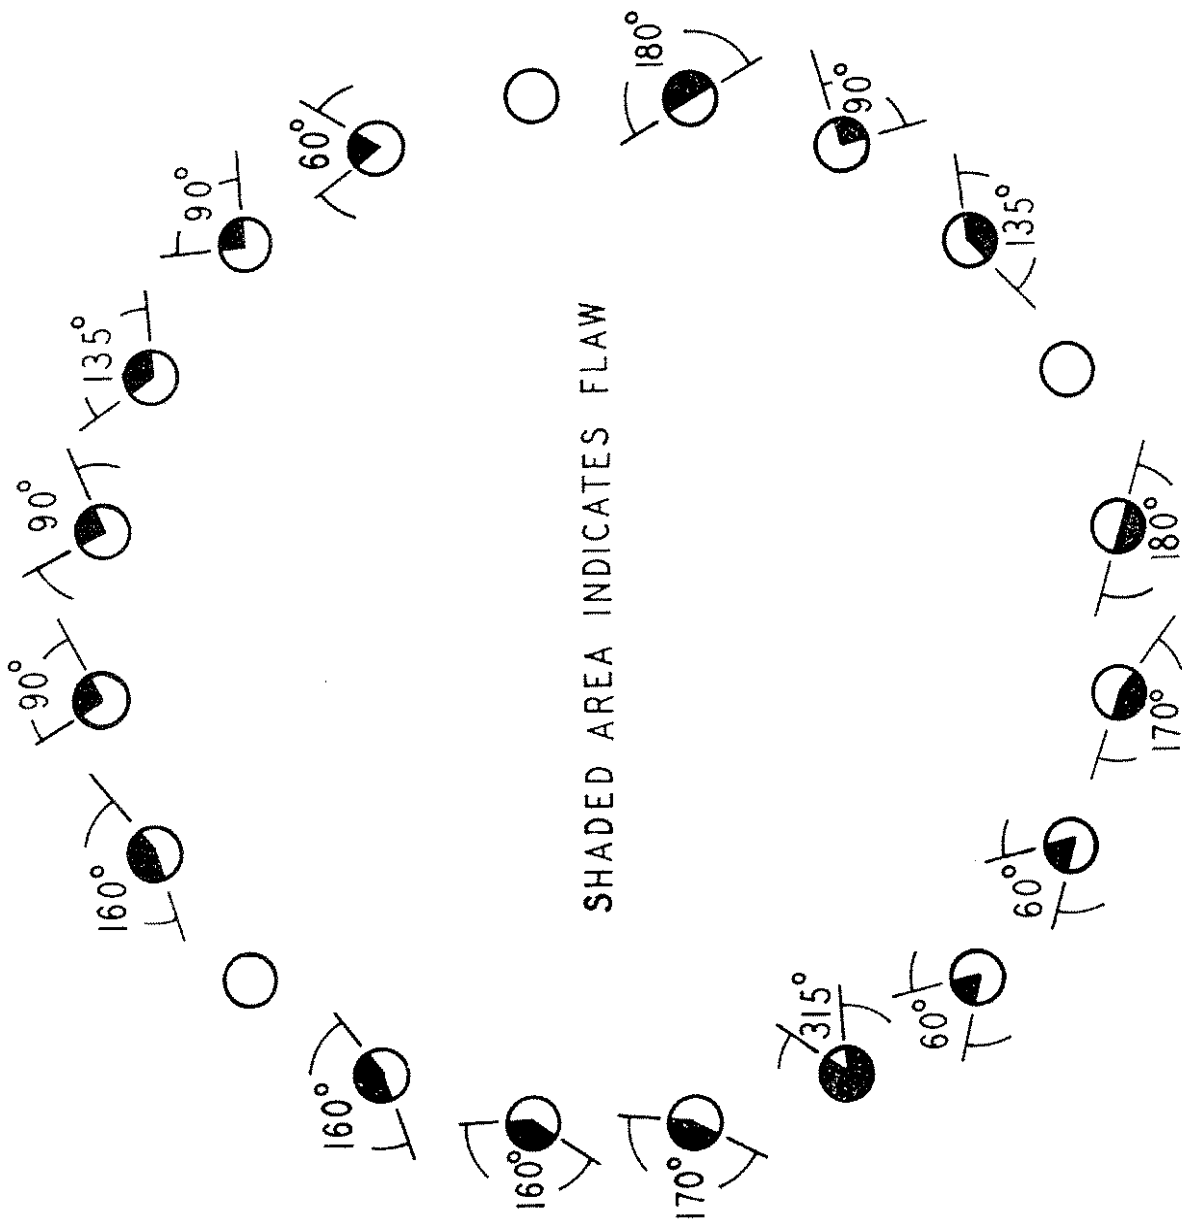
FIG. 5

All bolting in the turbine stop and intercept valves and the high-temperature sections of the turbine shell is checked by ultrasonic techniques during each inspection outage. When this practice was first instituted, it was not uncommon to find 50 percent or more of the bolts in a valve cover cracked or completely broken. Thermal cycling from frequent startups and stretch cycling the bolts for turbine inspections add to the problem of bolt breakage. Valve-cover cupping from temperature differentials overloads the stud's outer edge and results in cracking in this area.

A typical situation when ultrasonic inspection was first instituted in which several studs were cracked in the first one or two threads below the flange surface of an intercept valve is shown in Fig. 5.

CRACKED STUDS IN INTERCEPT VALVE

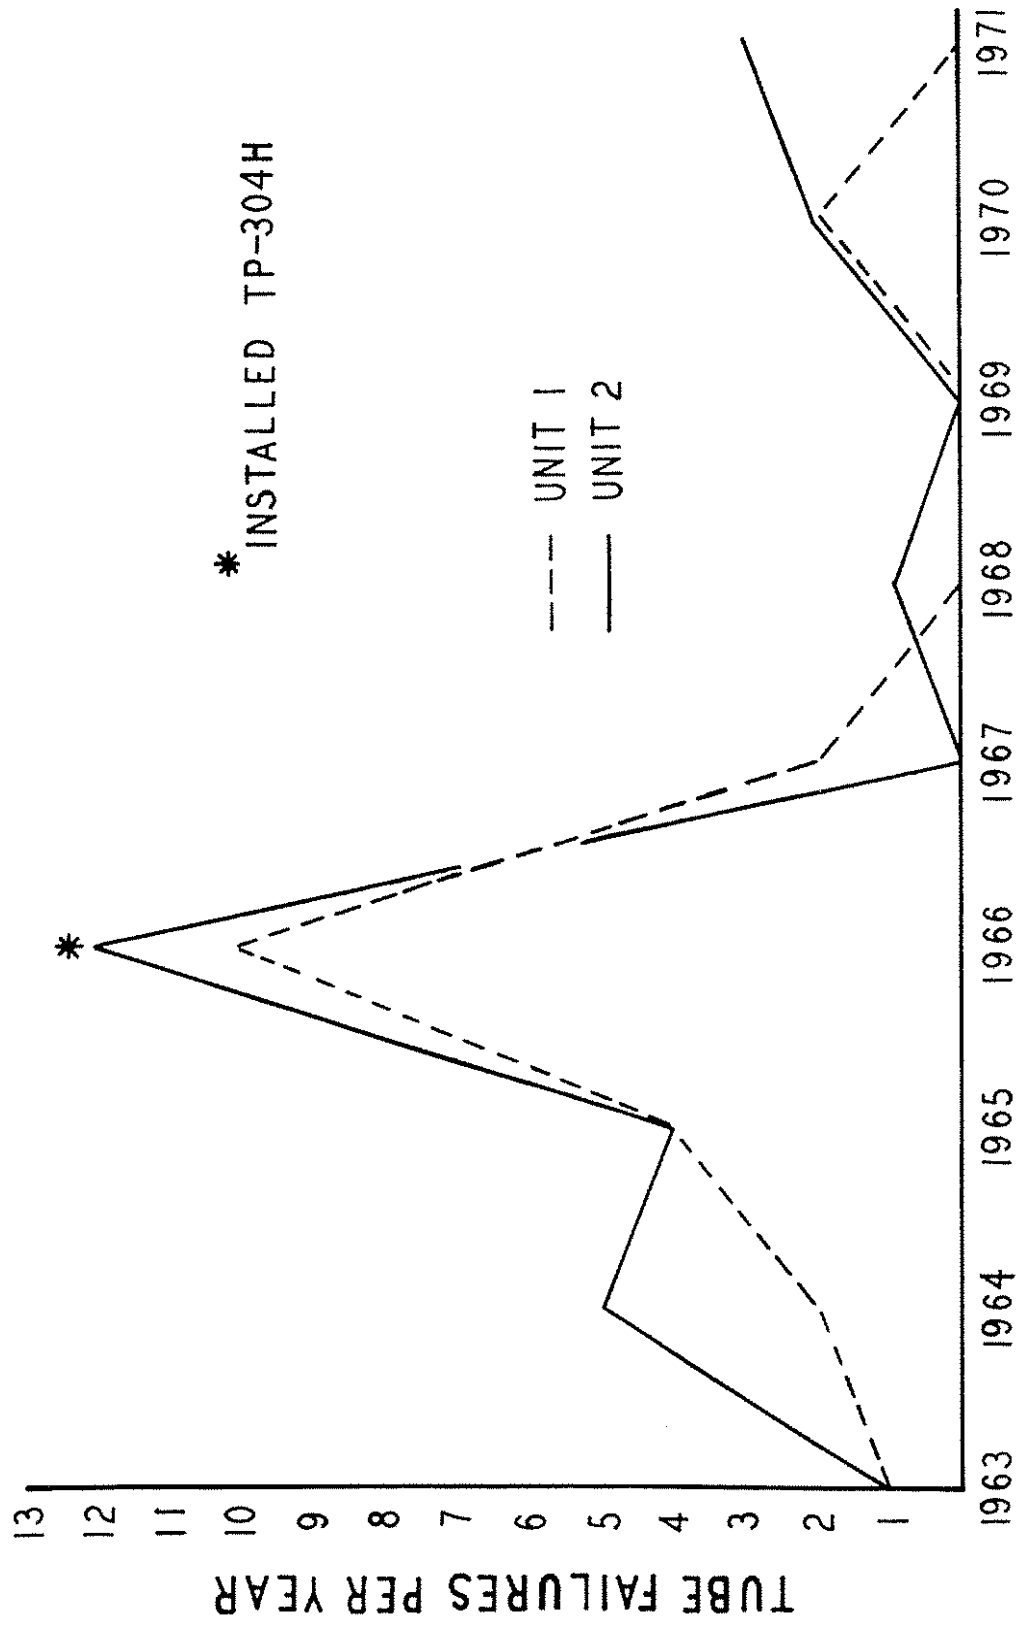
FIG. 6

TUBE FAILURES - BEFORE AND AFTER MODIFICATION

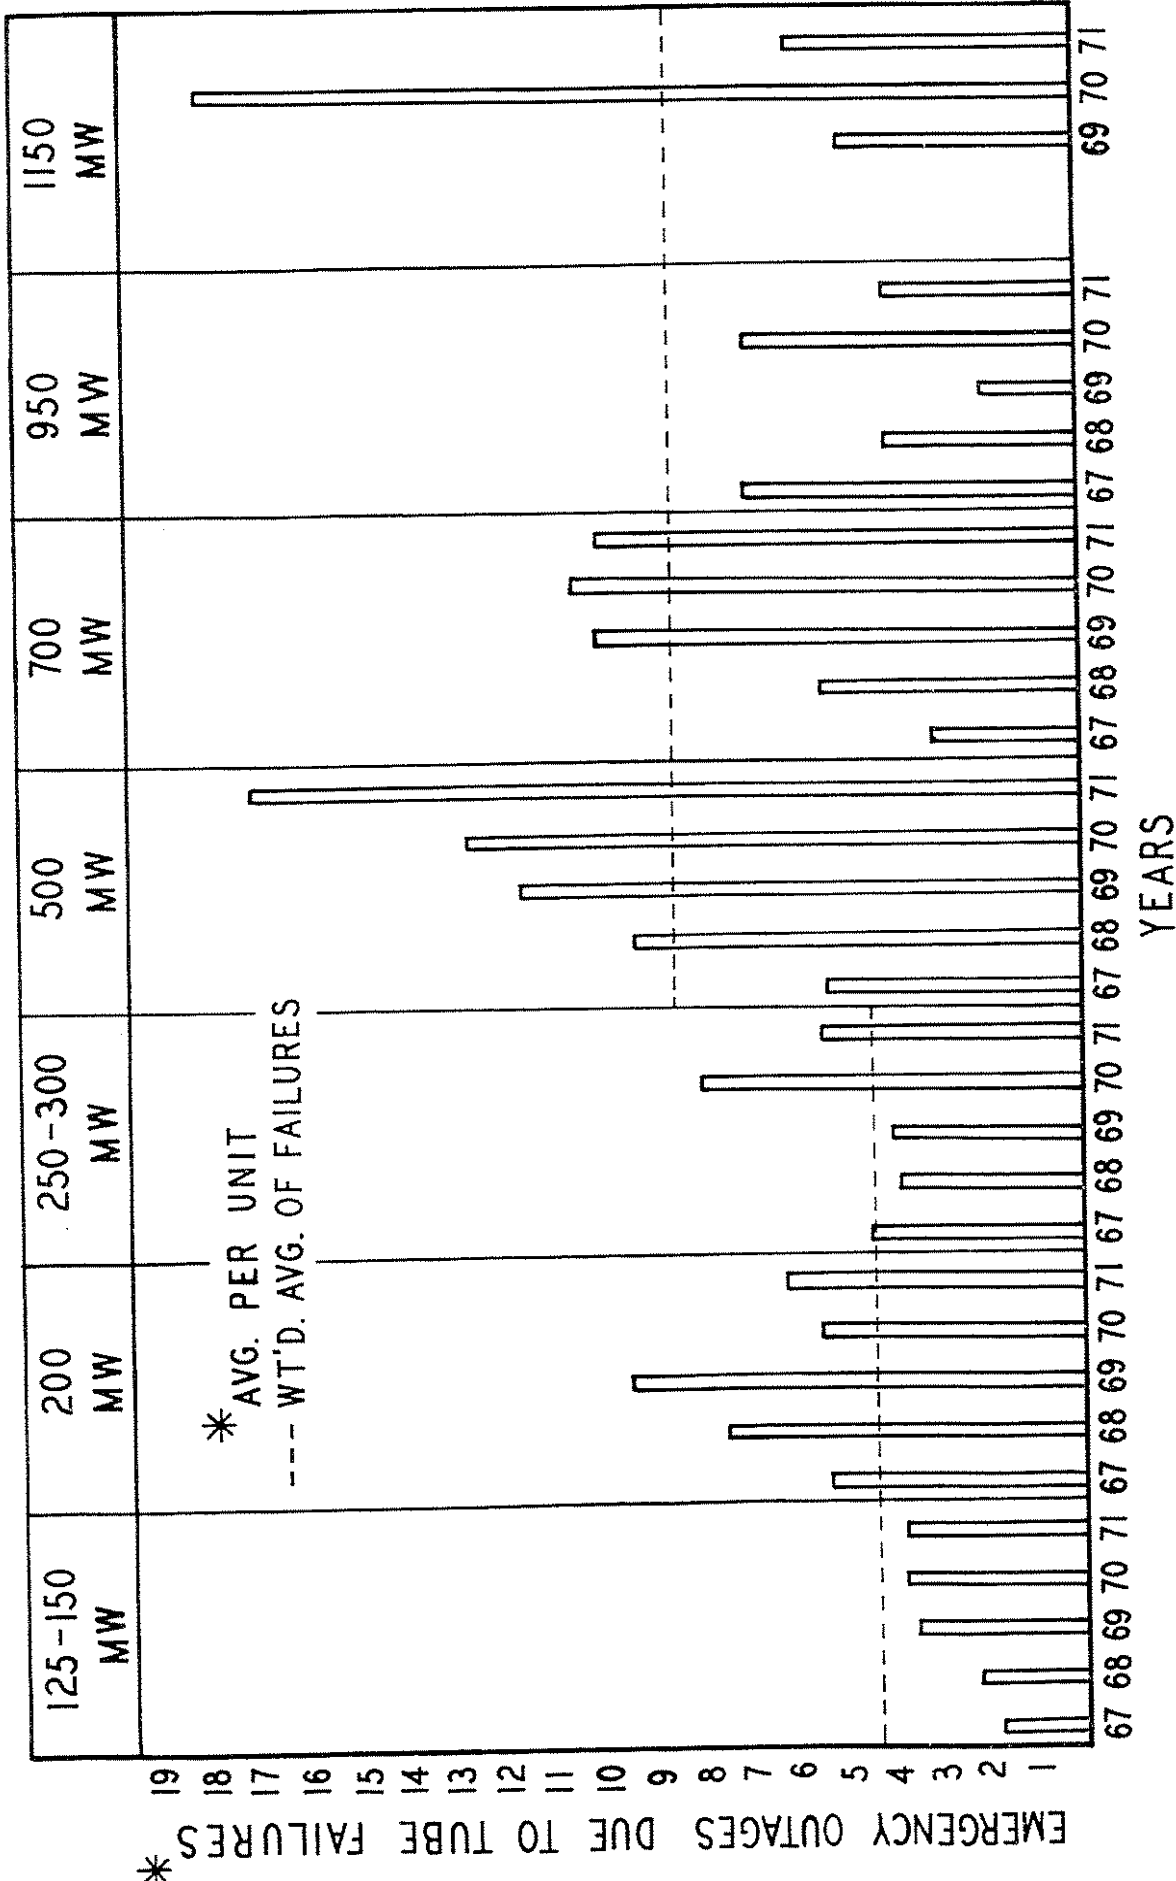
TUBE FAILURE COMPARISON BY UNIT SIZE
 FIG. 7

An annual average of 350 steam generator forced outages has been experienced over the past 4 years in 57 operating units ranging in size from 125 MW to 1150 MW. Of the 350 outages, approximately 300 were caused by tube leaks or failures.

In an effort to maintain unit reliability, major replacement or rehabilitation in areas where excessive tube failures occur is made after an evaluation based on loss of generation, cost of repairs, and damage to the unit from frequent startups and shutdowns indicates it is justified. The central office staff maintains a record of all tube failures and makes frequent evaluations of the trouble areas along with comparisons between plants to determine when major repairs should be made. Figure 6 shows an example of steam-generator outages because of tube failures before and after major tube replacement. Figure 7 is a weighted-average study showing that failures on larger units are somewhat higher than on units below 500 MW,

even though the study compares the new large units with the smaller steam generators where the tubing has approximately 100,000 operating hours.
