# In-Place Detection of Decay in Timber Bridges-An Application of Stress Wave Technology

Roy F. Pellerin and Jeff A. Lavinder (Authors), Washington State University  
Robert J. Ross and Robert H. Falk, USDA Forest Products Laboratory  
Norbert Volny, Volny Engineering

A study was recently conducted to assess the technical feasibility of using stress wave nondestructive evaluation methods to locate decayed members in timber bridges.

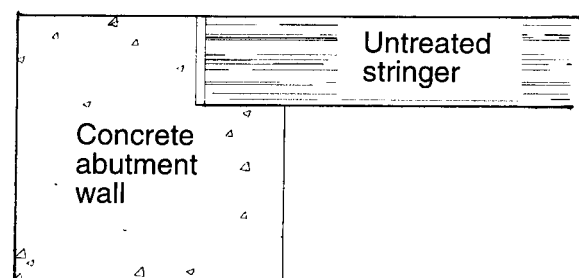
Figure 1—Drawing of wall and stringer.

an environment where decay could flourish in every one of the stringers. The stringers' ends decayed at approximately a 45° angle and were starting to slip off of the wall.

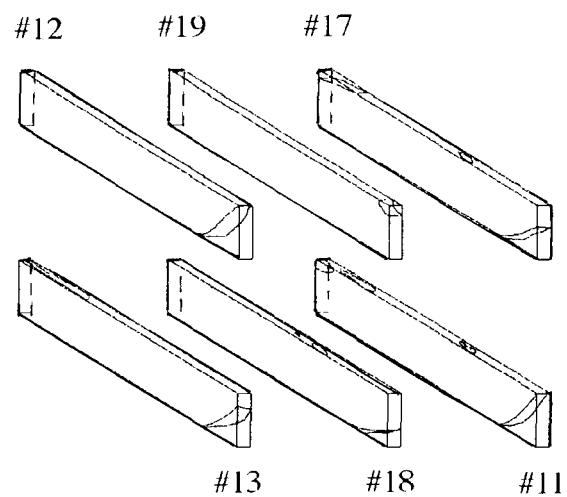
Figure 2—Sketchs of Bridge 529 stringers and decayed areas.

**Testing at the Wood Materials Engineering Laboratory**— Six stringers and five deck planks were brought back to the WMEL at WSU and reanalyzed. All of the stringers were again visually inspected for decay. The ends of the stringers had excessive decay where they sat on the abutment wall. It was observed that a couple of the stringers had decay pockets along the top where the deck planks were secured. The stringers were sketched and the visual decay marked on the drawings (Figure 2).

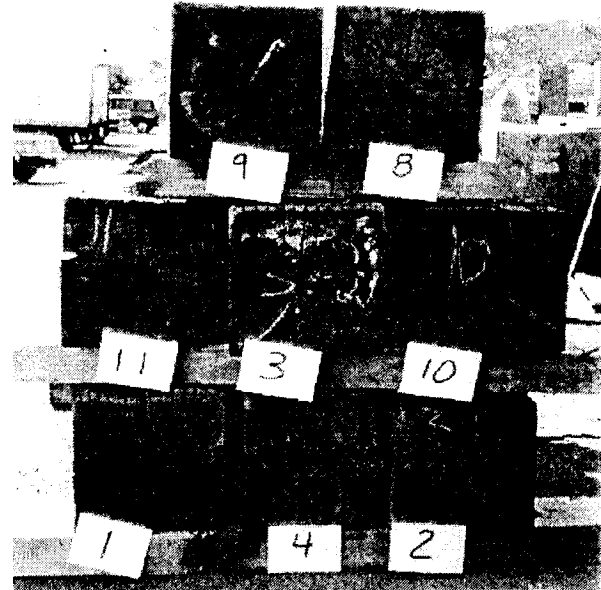
**Figure 6—Tops of Columns**

**Laboratory Evaluation of Bridge 117—** The laboratory evaluation at the WMEL began with a visual inspection of all the components. The stringers, decking and caps appeared to be structurally sound. Column inspection revealed excessive decay to most of the bottoms and a few of the tops. Figure 6 shows the tops of the columns and the decay damage; Figure 7 shows the bottoms of the columns.

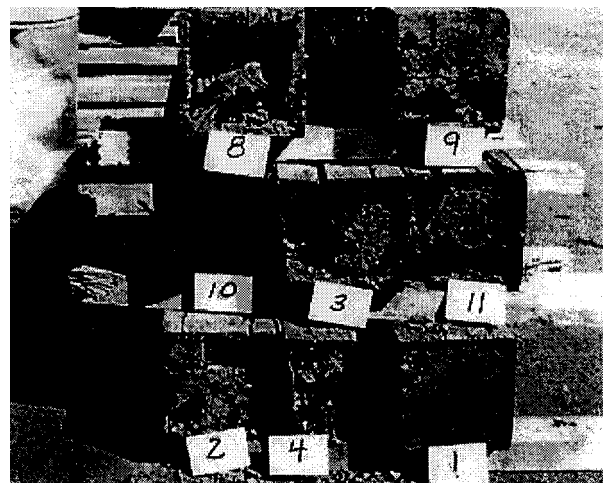
**Figure 7—Bottoms of Columns**

In the laboratory the columns were evaluated from side to side and front to back. The field times were side to side transmission. Front to back times were taken to help map out possible decay areas. Many of the bottom ends of the columns were so badly degraded that it was not possible to get stress wave times.

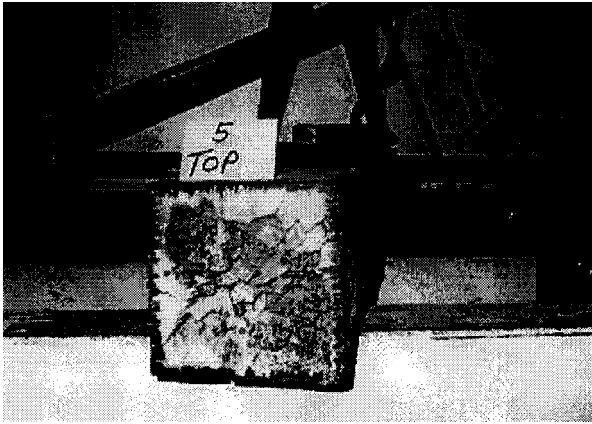
Figure 9—Top of column five

All but four of the columns were loaded to failure in compression. The setup for the compression test can be seen in Figure 8. Figures 9 and 10 show the top and bottom, respectively, of column 5 before testing. Before the compression test was performed, the ends were squared. The top of the column can be seen to have extreme rot in the center and only a shell of good wood holding the column together. Creosote penetration of the column top was minimal. The bottom of the column did not show any visual signs of severe decay. However, the stress wave analysis showed that the entire column was decayed.

Reasons for the deterioration of the columns were obvious when the laboratory evaluation was completed. As can be seen in Figures 9 and 11, the penetration of the creosote was poor in the tops of the columns when compared to the penetration in the bottoms (Figures 10 and 12). All of the columns had both ends squared for the compression test. After squaring the ends, it was hypothesized that the columns had been 'cut to fit' when they were being placed. The tops were cut so they would fit the bridge at the time of construction. Additional treatment had been applied to the tops after they were cut, but the penetration was poor. Essentially, this created a treated column with the top being penetrated more easily by moisture. The treated shell helped keep the moisture in, accelerating the decay process. The hypothesis is backed by the fact that all of the bottoms were decayed in the columns (Figure 7) where the moisture was locked in. With the exception of column 5, the tops of the columns showed little visible decay. Both the stress wave evaluation in the field and in the laboratory spotted excessive decay in all of the columns.

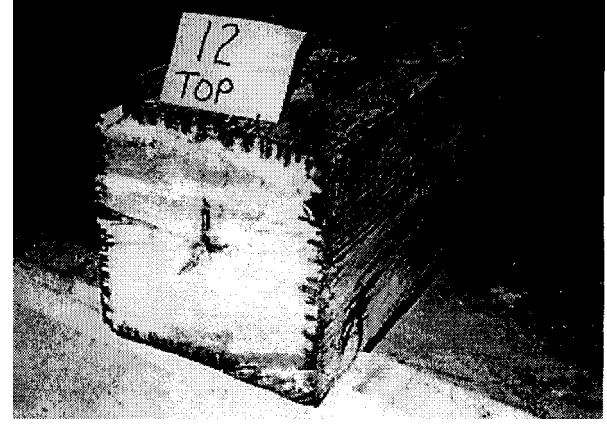
Figure 11—Top of column 12

Column 12 was a corner column, as was column 5, that did not have a large amount of decay, compared to column 5. After the ends were squared the column was visually inspected for internal decay. The visual inspection showed that there was no decay present. However, the stress wave analysis showed that there was a pocket of decay in the bottom end of the column. Figures 11 and 12 show the top and bottom of column 12.

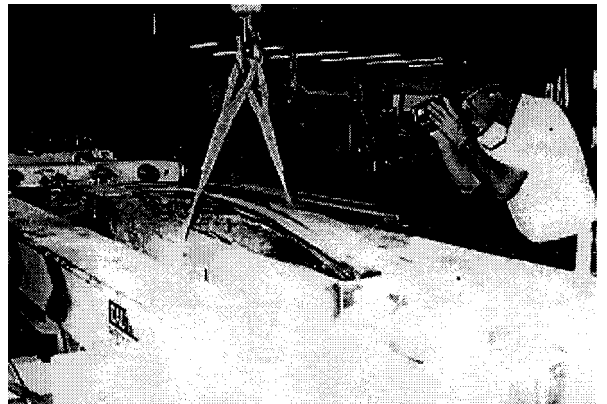
Figure 13—Column #5 at failure in the compression test

The columns were loaded until failure. Column 5 failed abruptly (Figure 13) at an ultimate load of 37.5 kips. The National Design Specifications (NDS 1991) Supplement tabulates compression parallel-to-grain values for Douglas-fir Larch as 700 psi for No. 2 grade in Table 4D. Adjusting for loading rate and changing the tabulated fifth percentile to the median value, the capacity should be 258 kips. The load duration factor can be calculated from Figure 14 (National Design Specifications 1991). The columns' low capacity is a direct result of the extensive decay in the column. Decay had completely deteriorated the interior of the column. Figure 15 shows column 5 after the compression test.

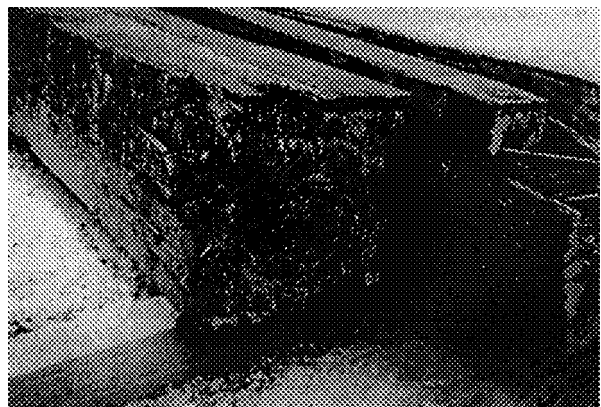
Figure 16—Column #12 after failure

Column 12 was loaded to an ultimate load of 172.0 kips. The column failed by a compression failure where the end was decayed (Figure 16). The visual inspection failed to identify the decayed area. However, the stress wave evaluation of column 12 showed a high stress wave time at the point that it failed in compression. The decay pocket can be seen in Figure 16 on the upper left corner of the picture.
