Research Paper FPL-RP-550

Field Performance of Timber Bridges

7. Connell Lake Stress-Laminated Deck Bridge

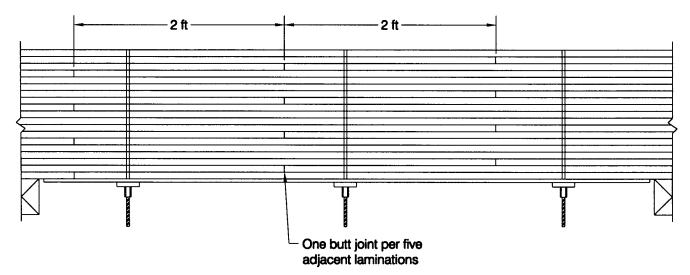
Figure 3—Butt-joint configuration used for the Connell Lake bridge. A butt joint was placed transverse to the bridge span in every fifth lamination. Longitudinally, butt joints in adjacent laminations were separated by 2 ft.

At installation, the deck was approximately straight between abutments. At the conclusion of monitoring, 2.5 in. of sag was measured, mainly as a result of the butt-joint spacing and partially as a result of creep. Sag has been more pronounced on stress-laminated decks designed with a 2-ft longitudinal butt-joint spacing, regardless of the lamination moisture content. Whereas, little or no sag has been observed in stress-laminated decks with a 4-ft butt-joint spacing when the moisture content of the laminations remained close to the FSP. Previous research has shown that creep causes a loss of camber when the moisture content level is high (Ritter and others 1990).

- A sag exists in the bridge's deck and is likely due to the butt-joint pattern and creep. This highlights the importance of a deck design that uses an alternative to the West Virginia University butt-joint pattern, such as one butt joint in every fourth transversely with
 4-ft spacing between butt joints in adjacent laminations. In addition, a deck design should include camber to counteract the effect of moisture content resulting in creep.

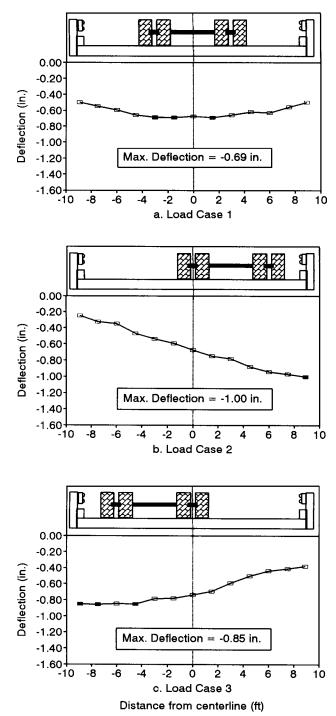
We compared load cases 2 and 3 using a mirror image of load case 2 (Fig. 15). Assuming uniform material properties, symmetric loading, and accurate deflection measurements, the deflection should be the same. As shown, there are differences up to 0.15 in. that are most pronounced at the bridge edges. Given the locations of the deflection differences and the relative orientation of the plots, it is likely that the truck loading was slightly eccentric, which resulted in a greater loading for one wheel line compared with the other.

Figure 15—Comparison of load cases 2 and 3.

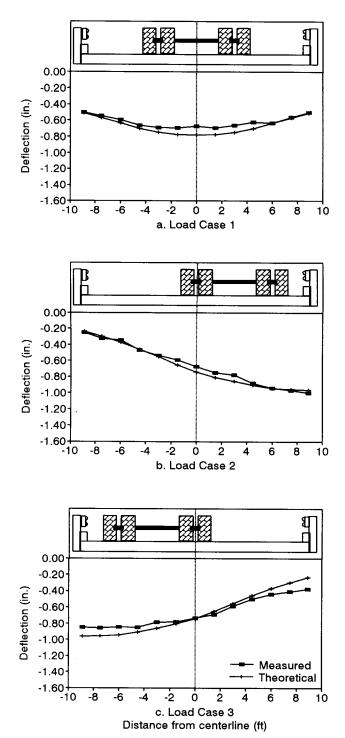
The measured load test deflections compared with theoretical deflections are shown in Figure 16. The measured deflection is generally less than the theoretical deflection, even though the analysis considered approximately 50 percent of the wearing surface in the deck thickness as a result of partial composite action. Research has not been performed to assess the effects of a diagonal timber plank wearing surface that covers an entire stress-laminated deck. Although it is likely that the moment of inertia is affected, the effect on other analytical parameters is unknown.

Figure 16—Theoretical deflection compared with measured deflection under the actual applied load using an orthotropic plate analysis.
