**OVERSEAS PRESENCE**

**Conditions of Overseas  
Diplomatic Facilities**

Statement of Jess T. Ford  
Director, International Affairs and Trade

Highlights of [GAO-03-557T](#), testimony before the Senate Foreign Relations Committee

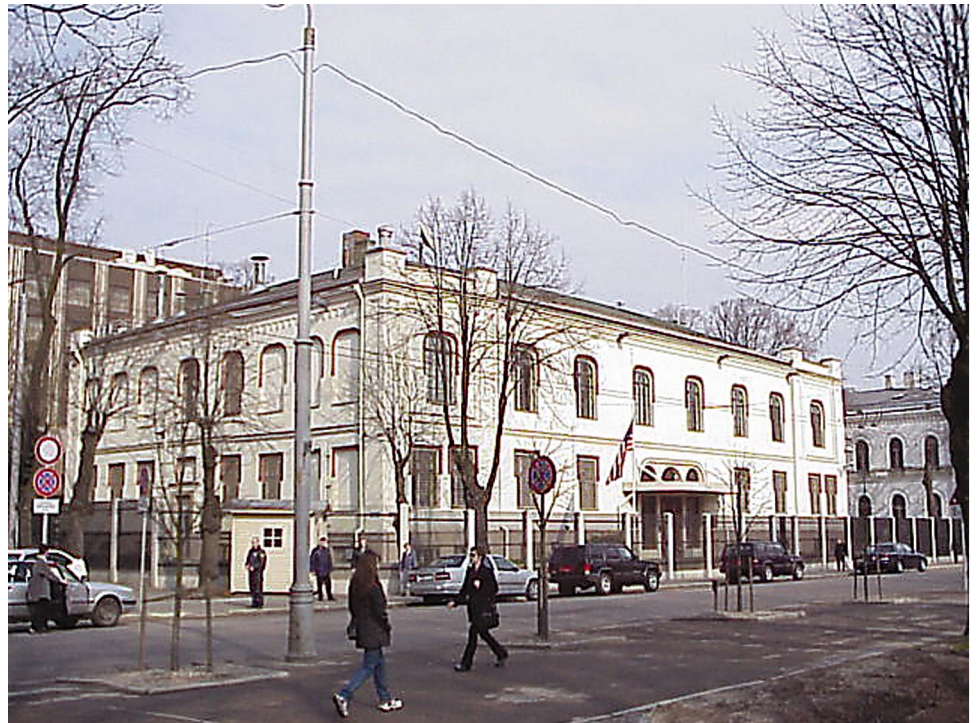
**Figure 6: Insufficient Setback at a U.S. Embassy**

As shown in figure 4, only 28, or 11 percent, of the primary buildings meet the 100-foot setback standard. More than half of the primary buildings have less than 15 feet of setback—these buildings are virtually perched on the street. Figure 6 is an example of a post with limited setback.

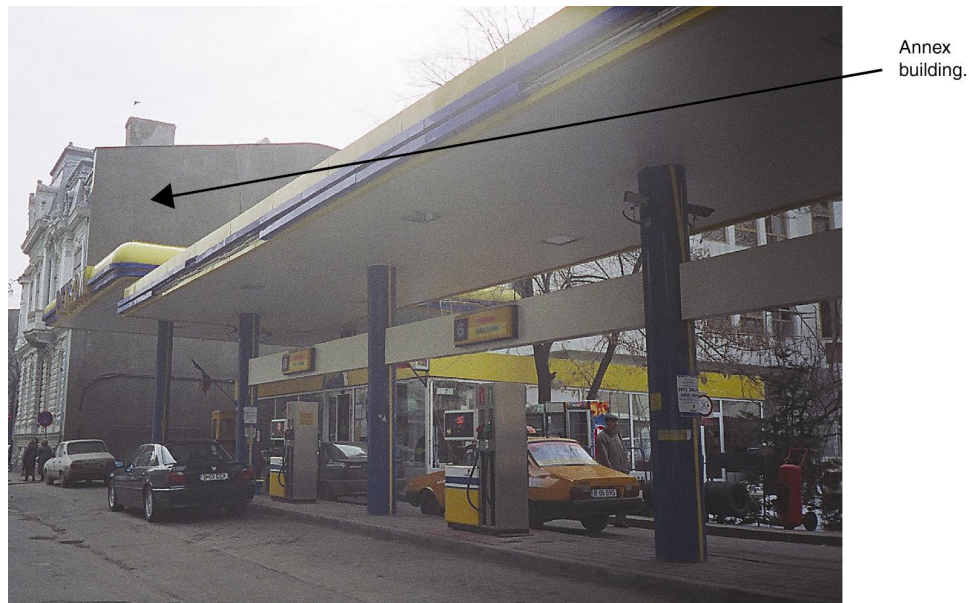
**Figure 7: Public Gas Station Behind an Embassy Building Poses Security Concern**

At the four posts we visited, all of the primary office buildings have limited setback from the street and several annex buildings have no setback. As shown in figure 7, one of these buildings is adjacent to a public gas station, which could exacerbate the effects of a bomb attack.

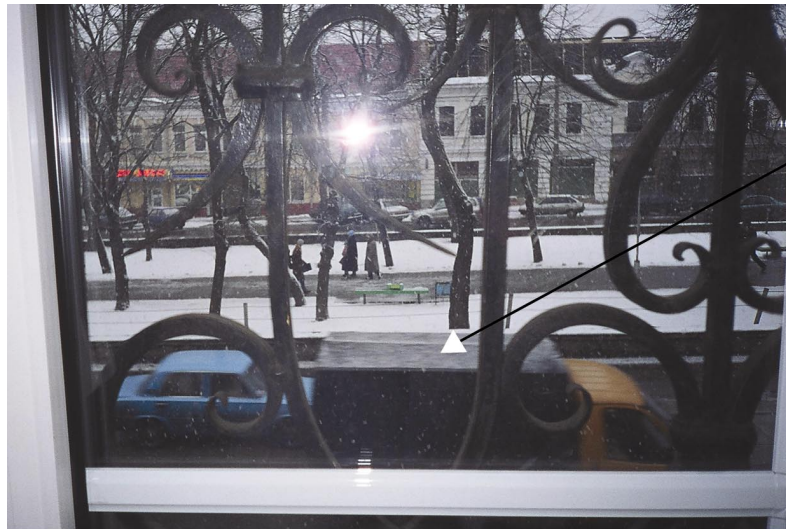
**Figure 8: View from Annex Office Showing Traffic Flow Nearby**

Another building, with little setback, is located next to a main thoroughfare. Consequently, public traffic, including trucks and buses, routinely travels within feet of U.S. government office space. At three of the four posts we visited, the embassy had secured host government cooperation in closing at least one street surrounding the primary office building; however, embassy officials at one location noted that these agreements were temporary and could be revoked at any time. Moreover, the embassies had not been able to close streets running next to all of their facilities, such as office annexes. For example, figure 8 depicts the view from a senior official's office in an annex building where post officials were unable to close the main thoroughfare that runs directly in front of the building.

Large truck passing near office.

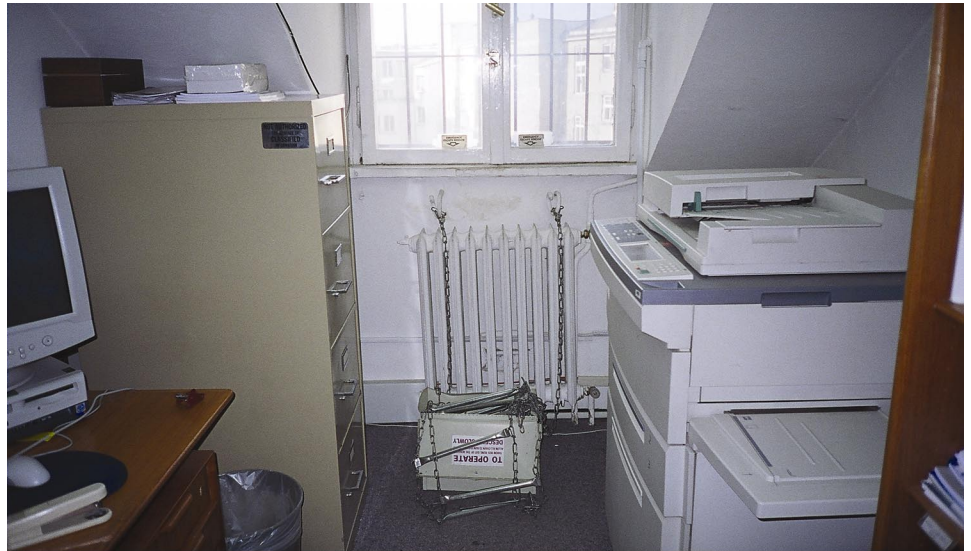
**Figure 11: Chain-link Ladder Serves as Fire Escape for 6<sup>th</sup> Floor Embassy Employees**

State Department data show that many buildings are in poor condition. At 133 posts, the primary office building has certain fire/life safety deficiencies. At one post we visited, the fire escape for the 6<sup>th</sup> floor of the chancery was a chain-link ladder strapped to a heating radiator (fig. 11). OBO fire officials explained that a number of posts were unable to meet fire standards, such as sprinkler systems and proper number of exits, due to the structural limitations of the building. This underscores the Department's position that many buildings are in a condition that will not allow a security and safety upgrade.
