**FY01**

**Department of the Interior  
Aviation Accident Review**

# Mesa Verde NP, CO

## Bell 206L-1

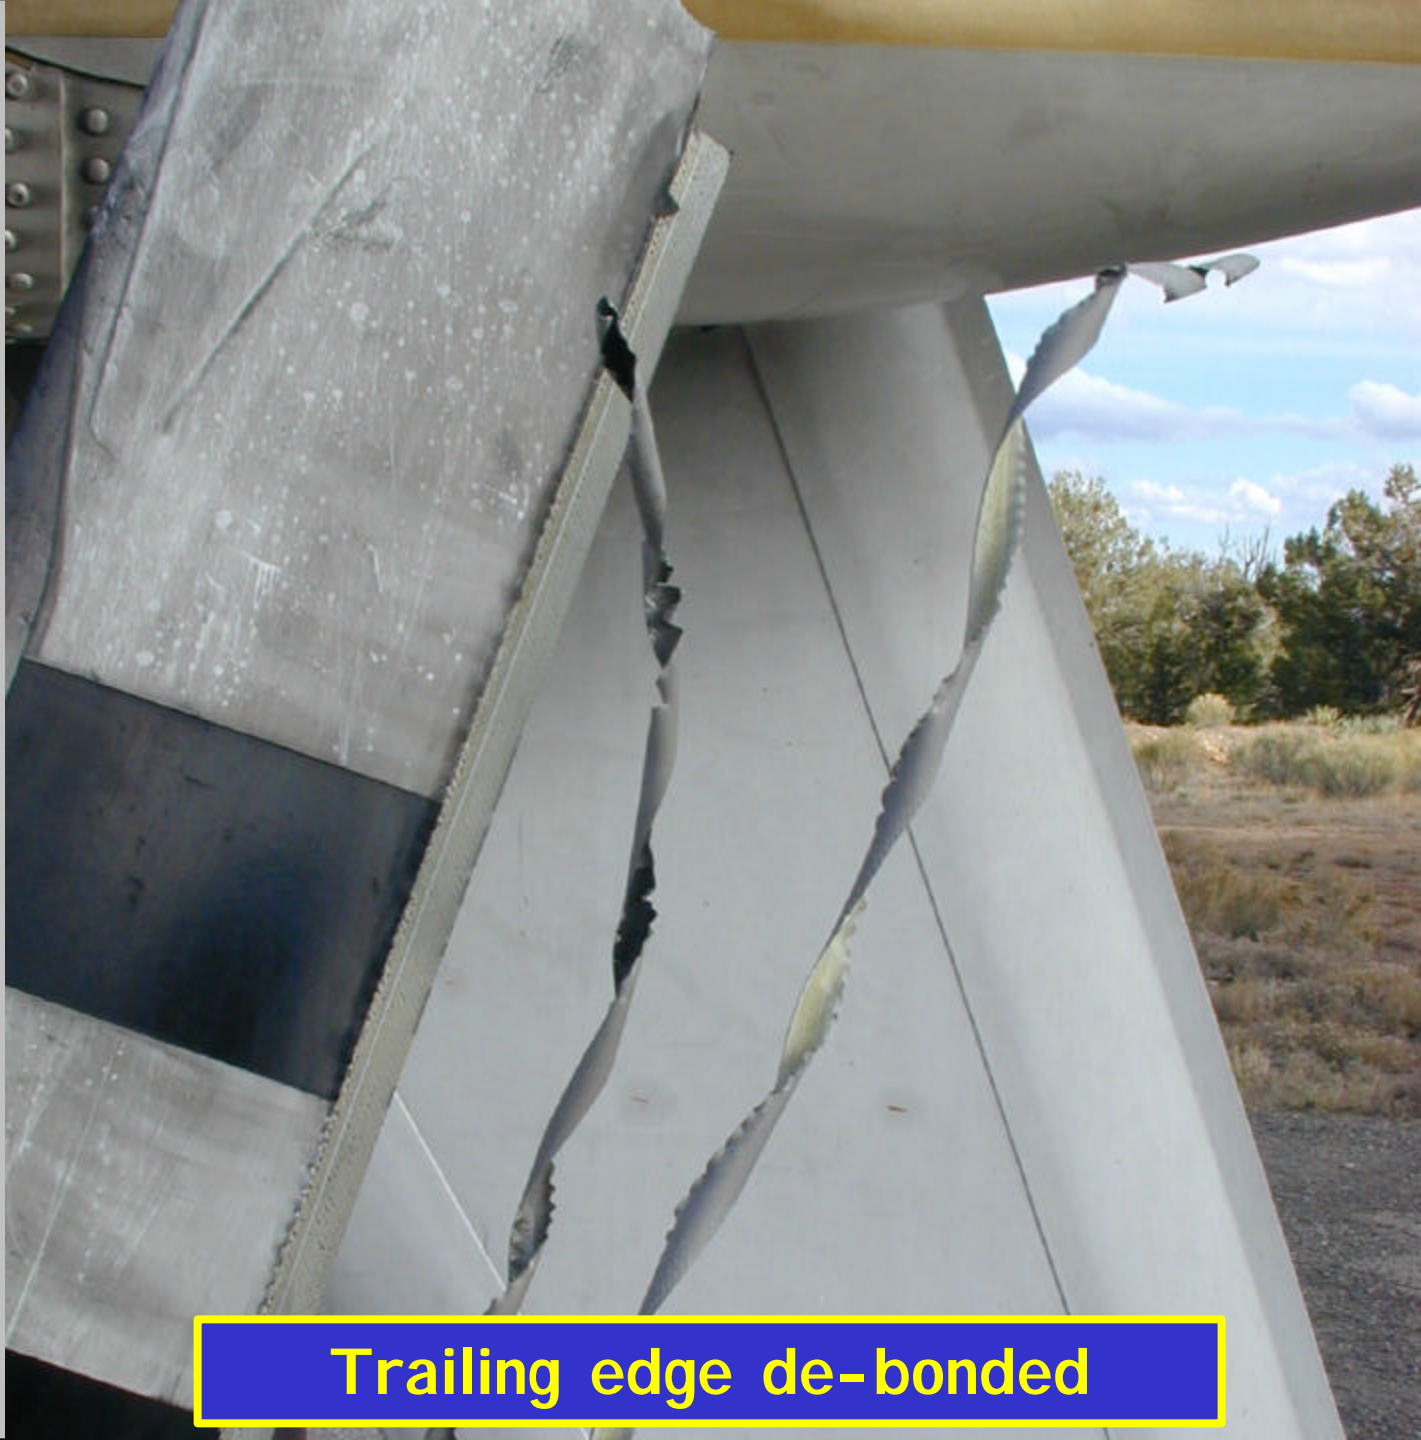
**Trailing edge de-bonded**

Trailing edge de-bonded

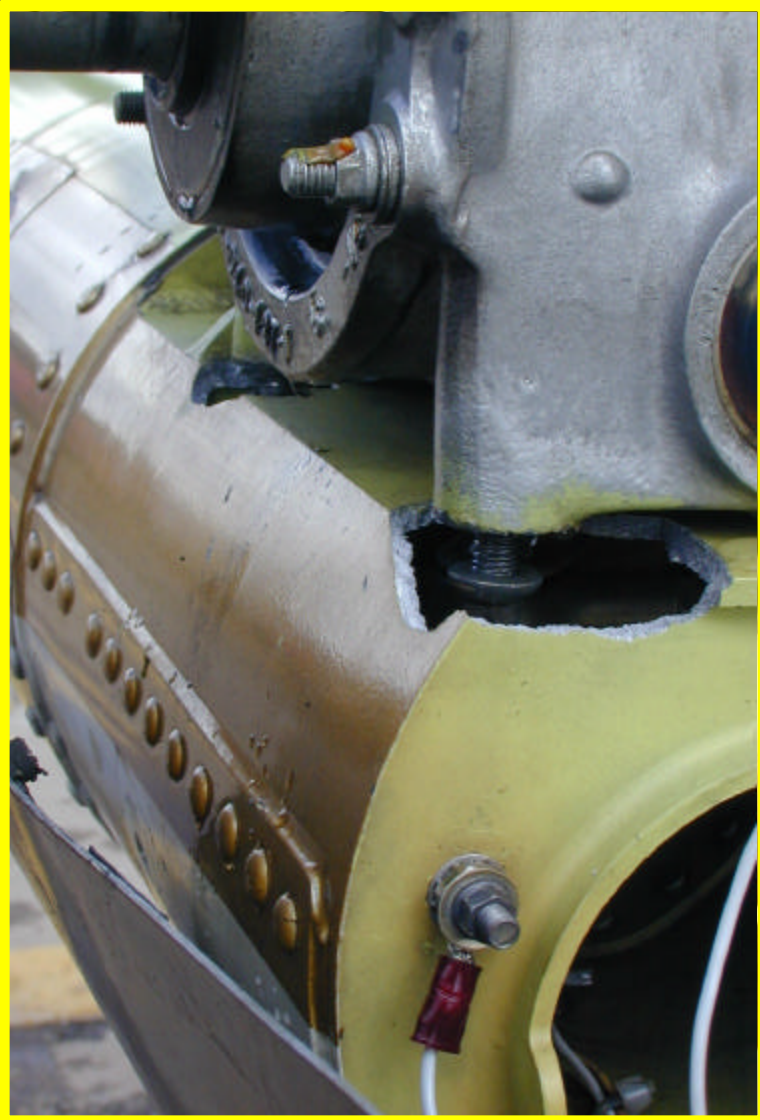
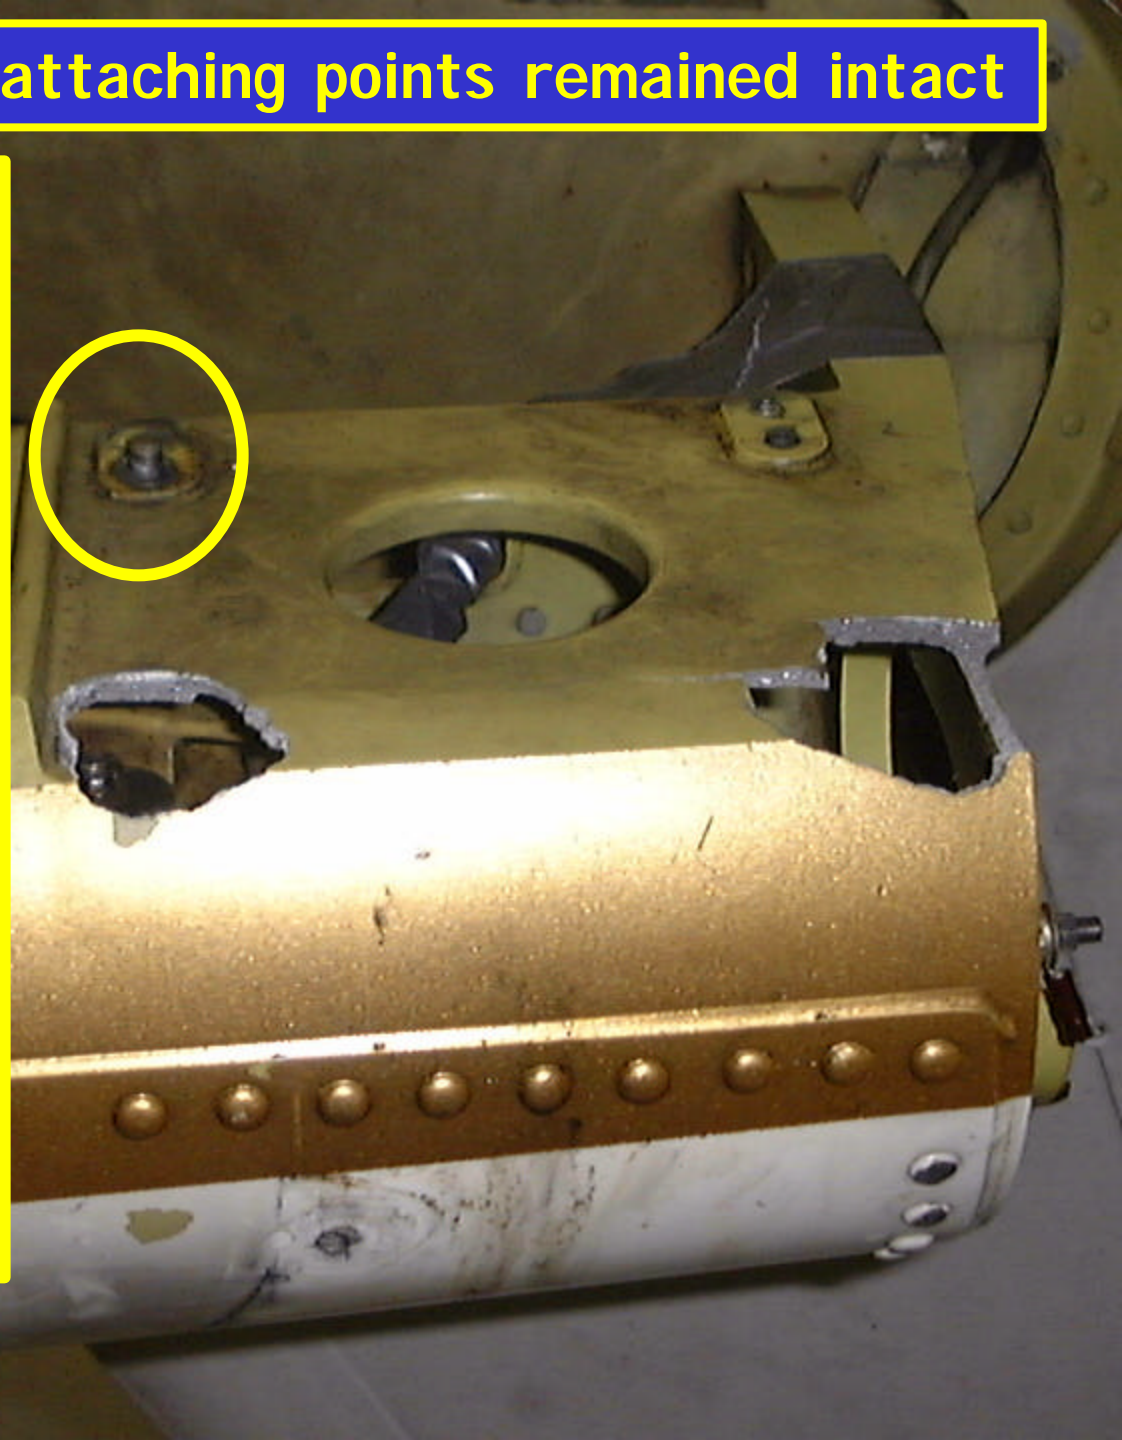
Only 1 of 4 gearbox attaching points remained intact

- The manufacturer's use of improper materials, and inadequate quality control of the tail rotor blades during the manufacturing process, which resulted in fatigue failure of the blade.

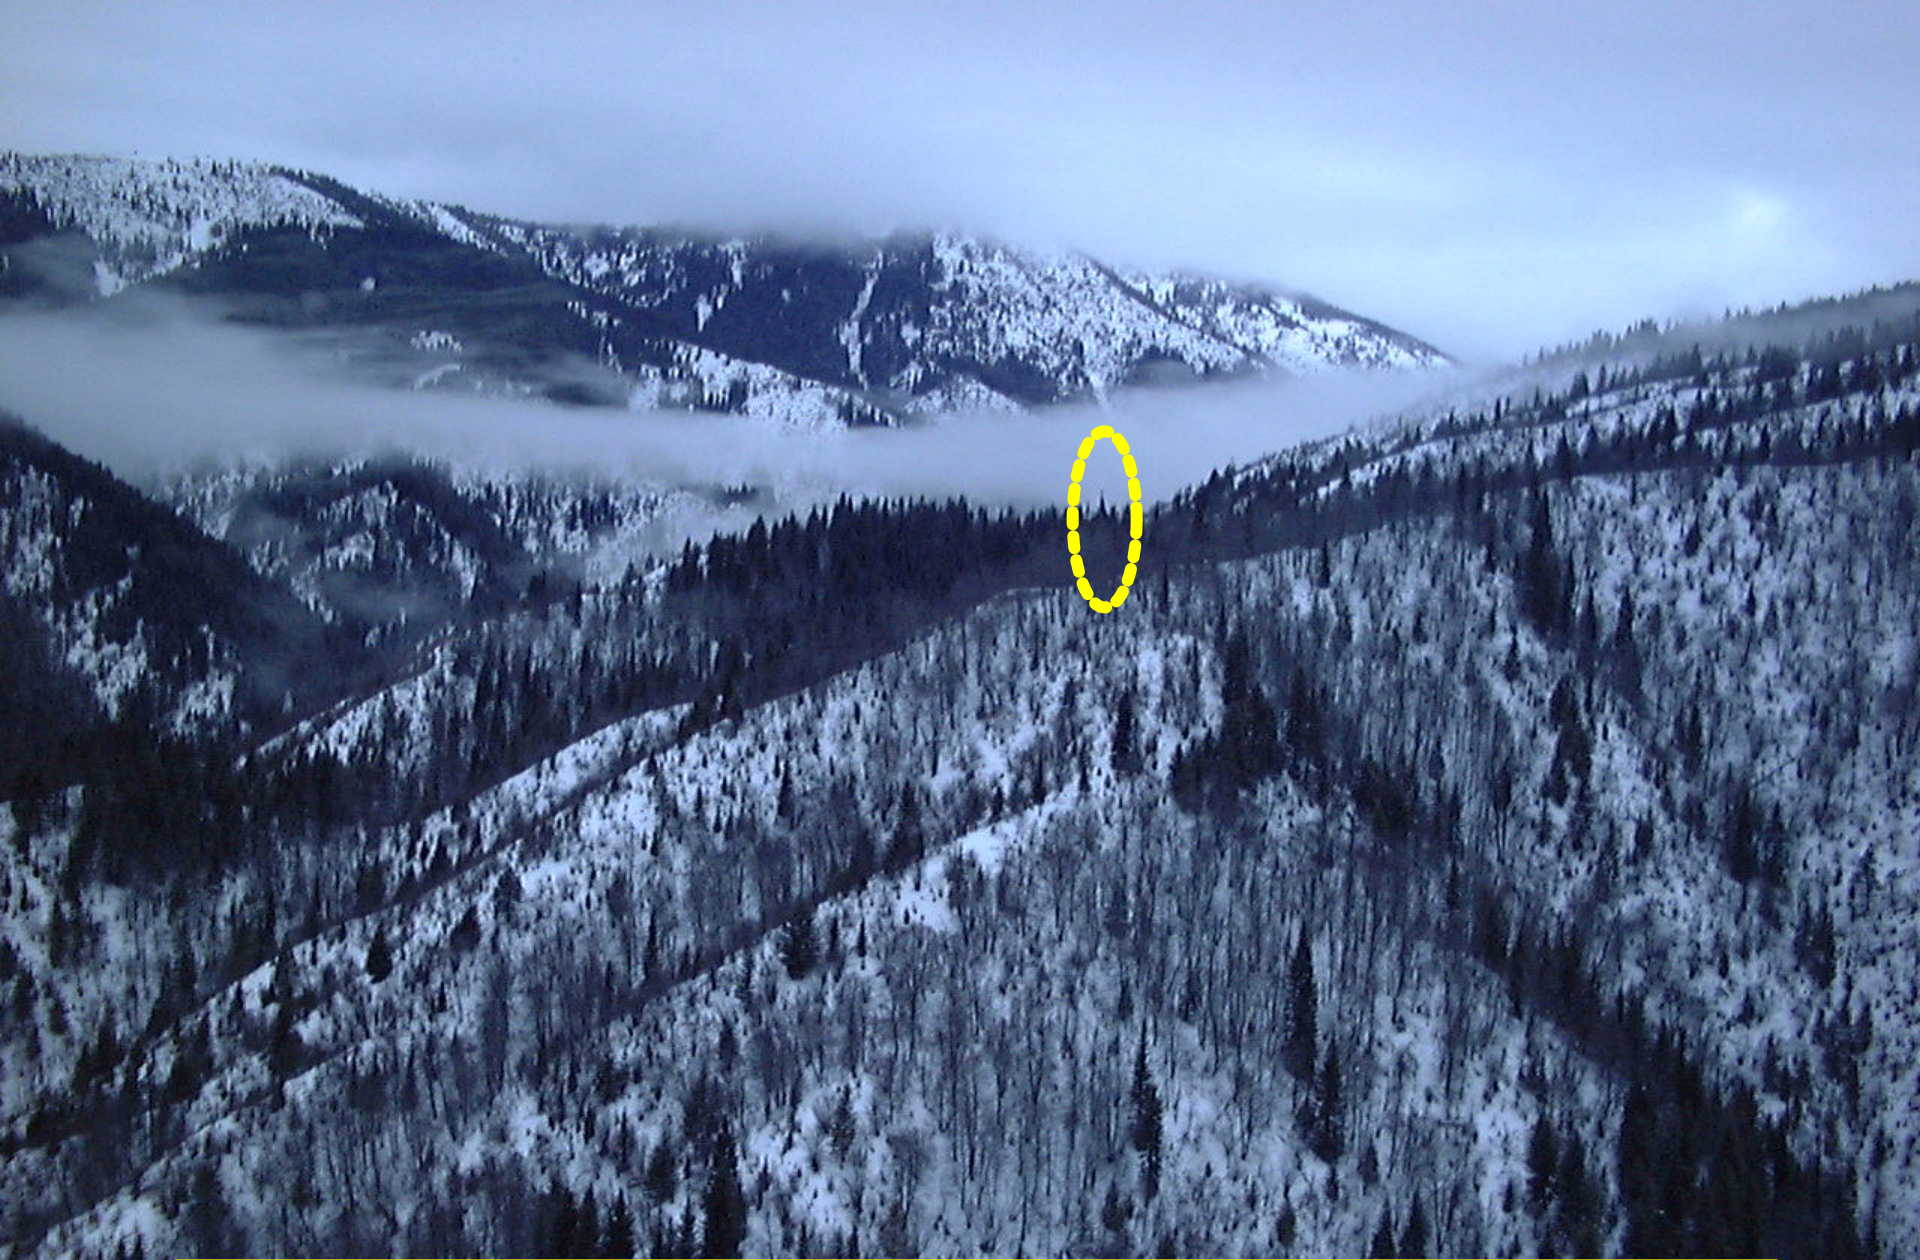
View approaching mishap site,  
can you spot the snag?

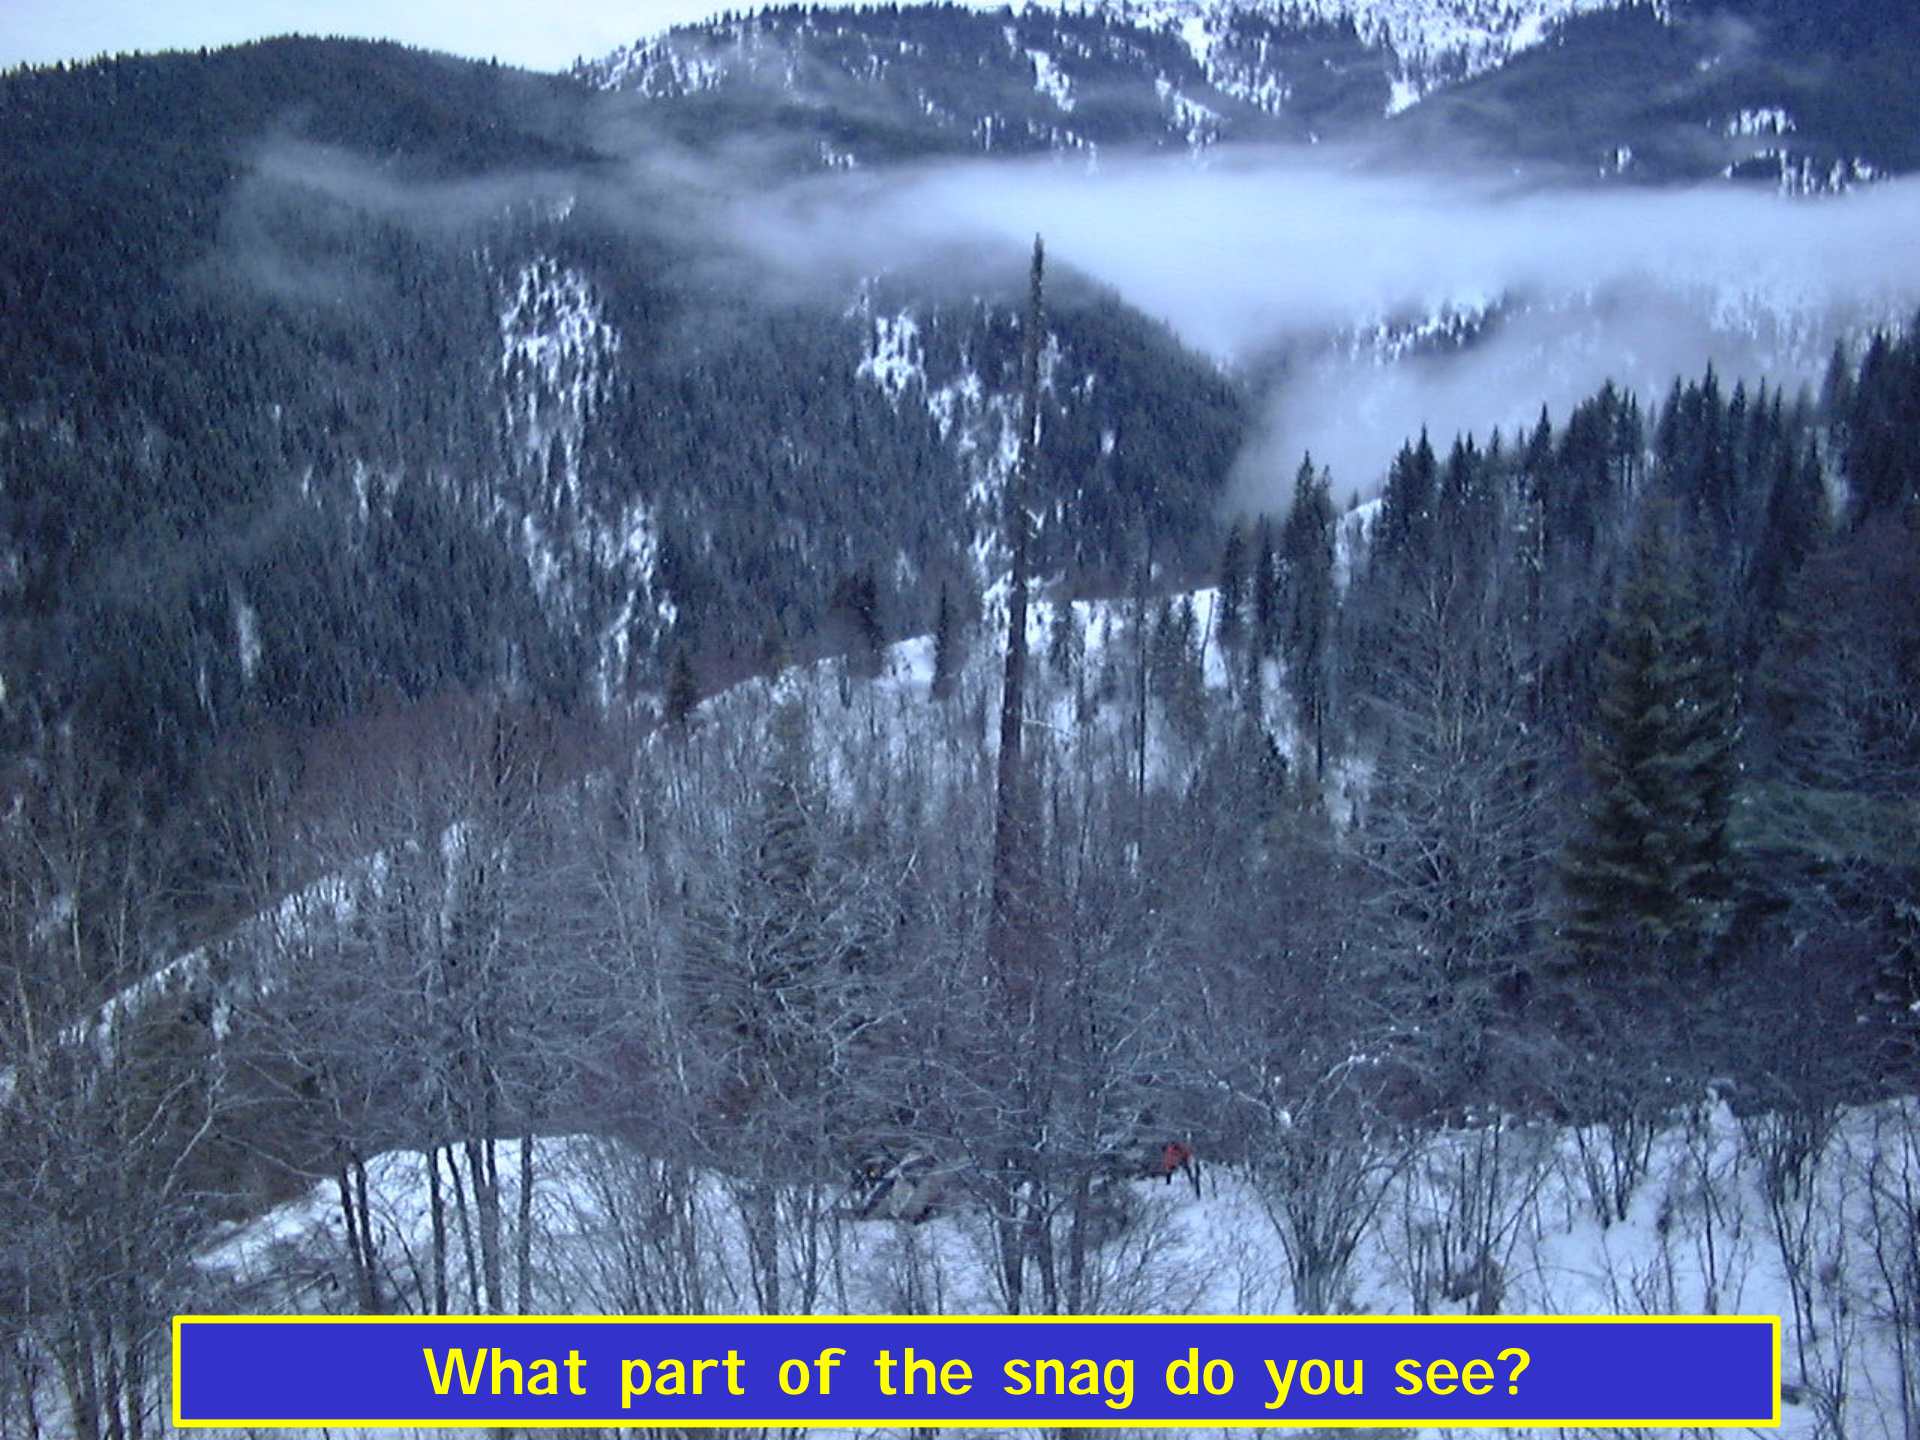
What part of the snag do you see?

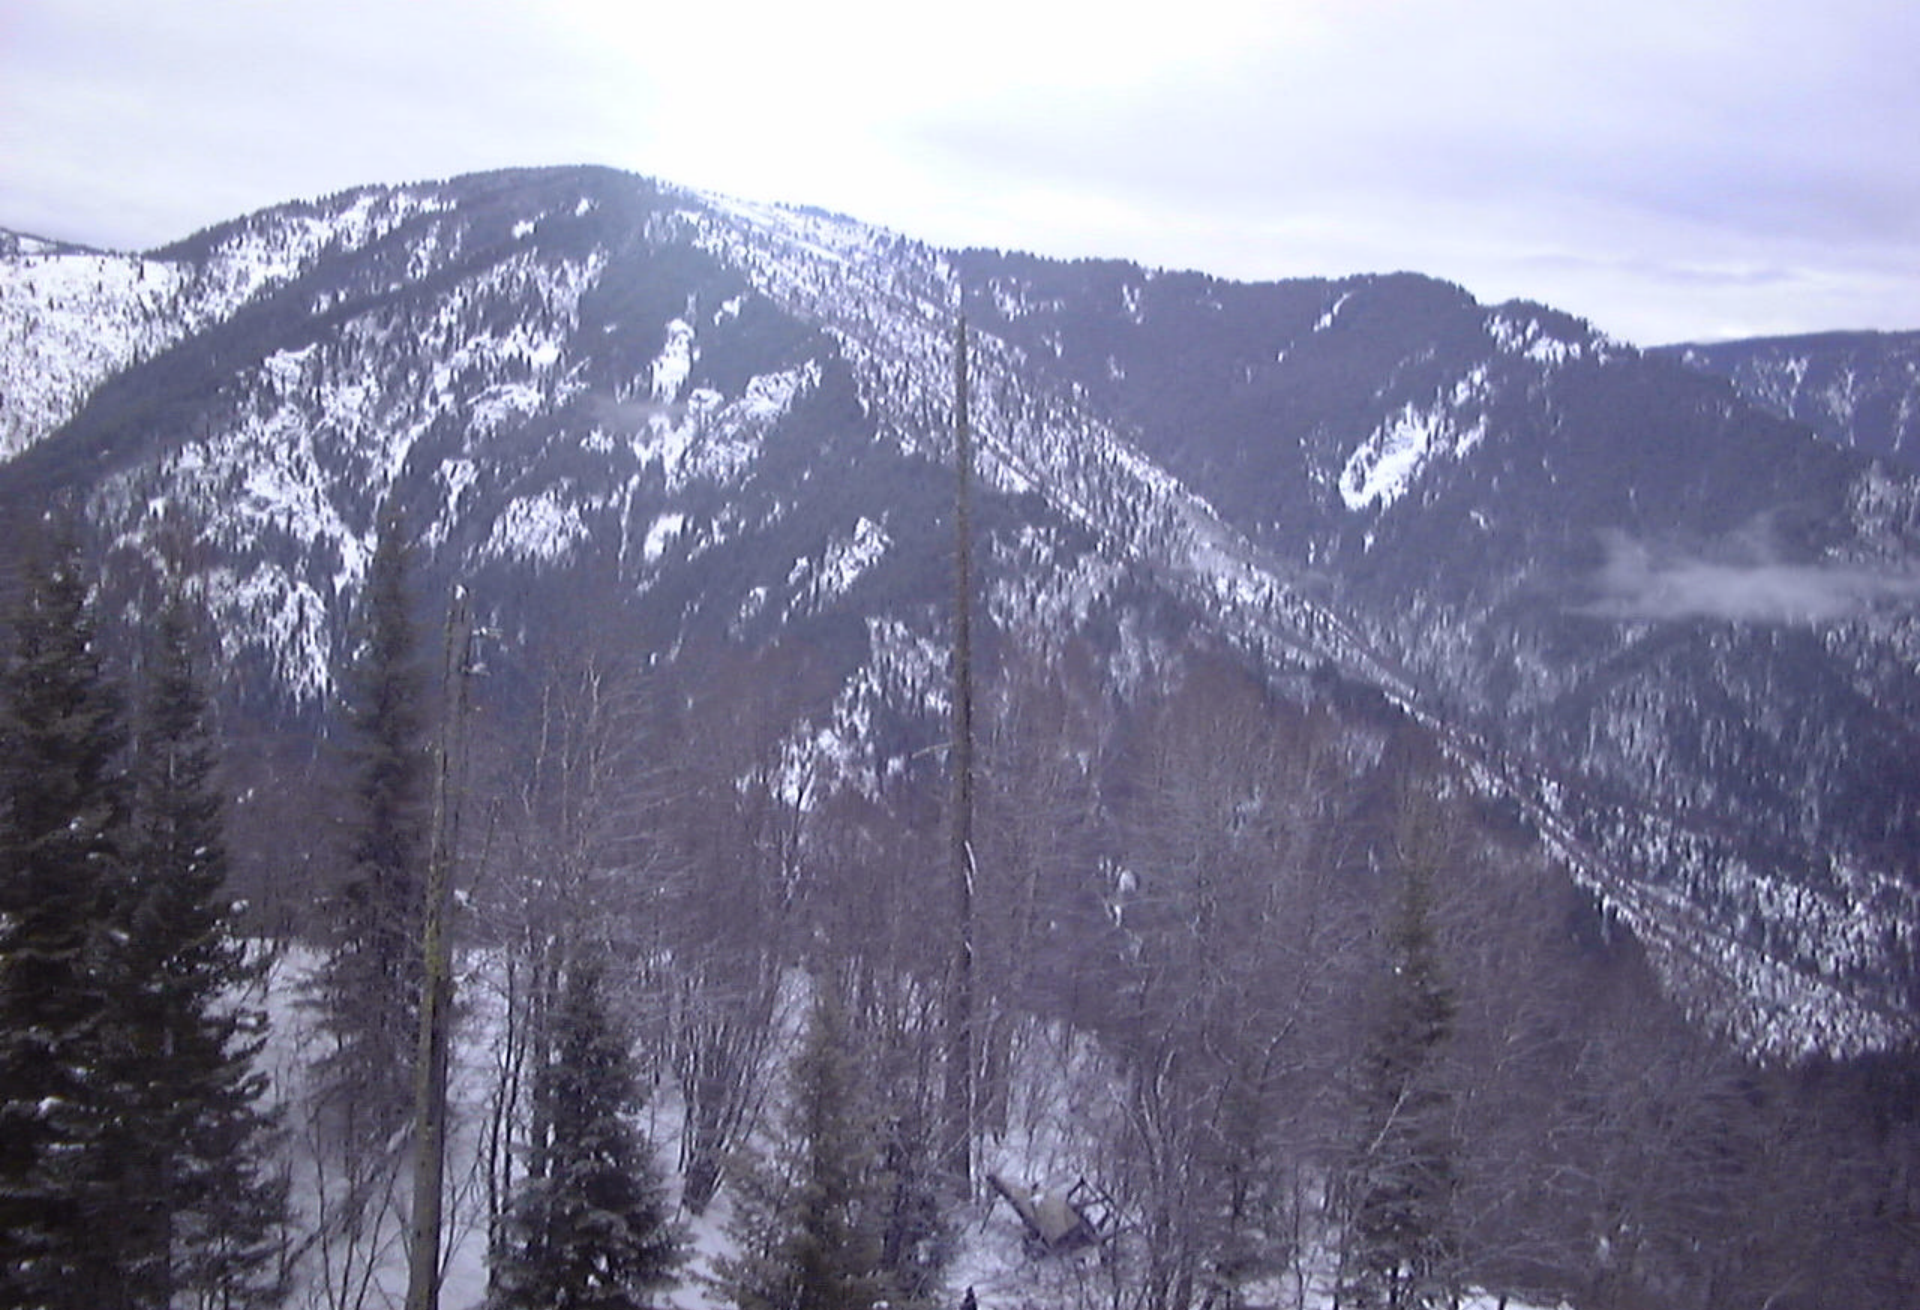
Even now it is almost invisible.

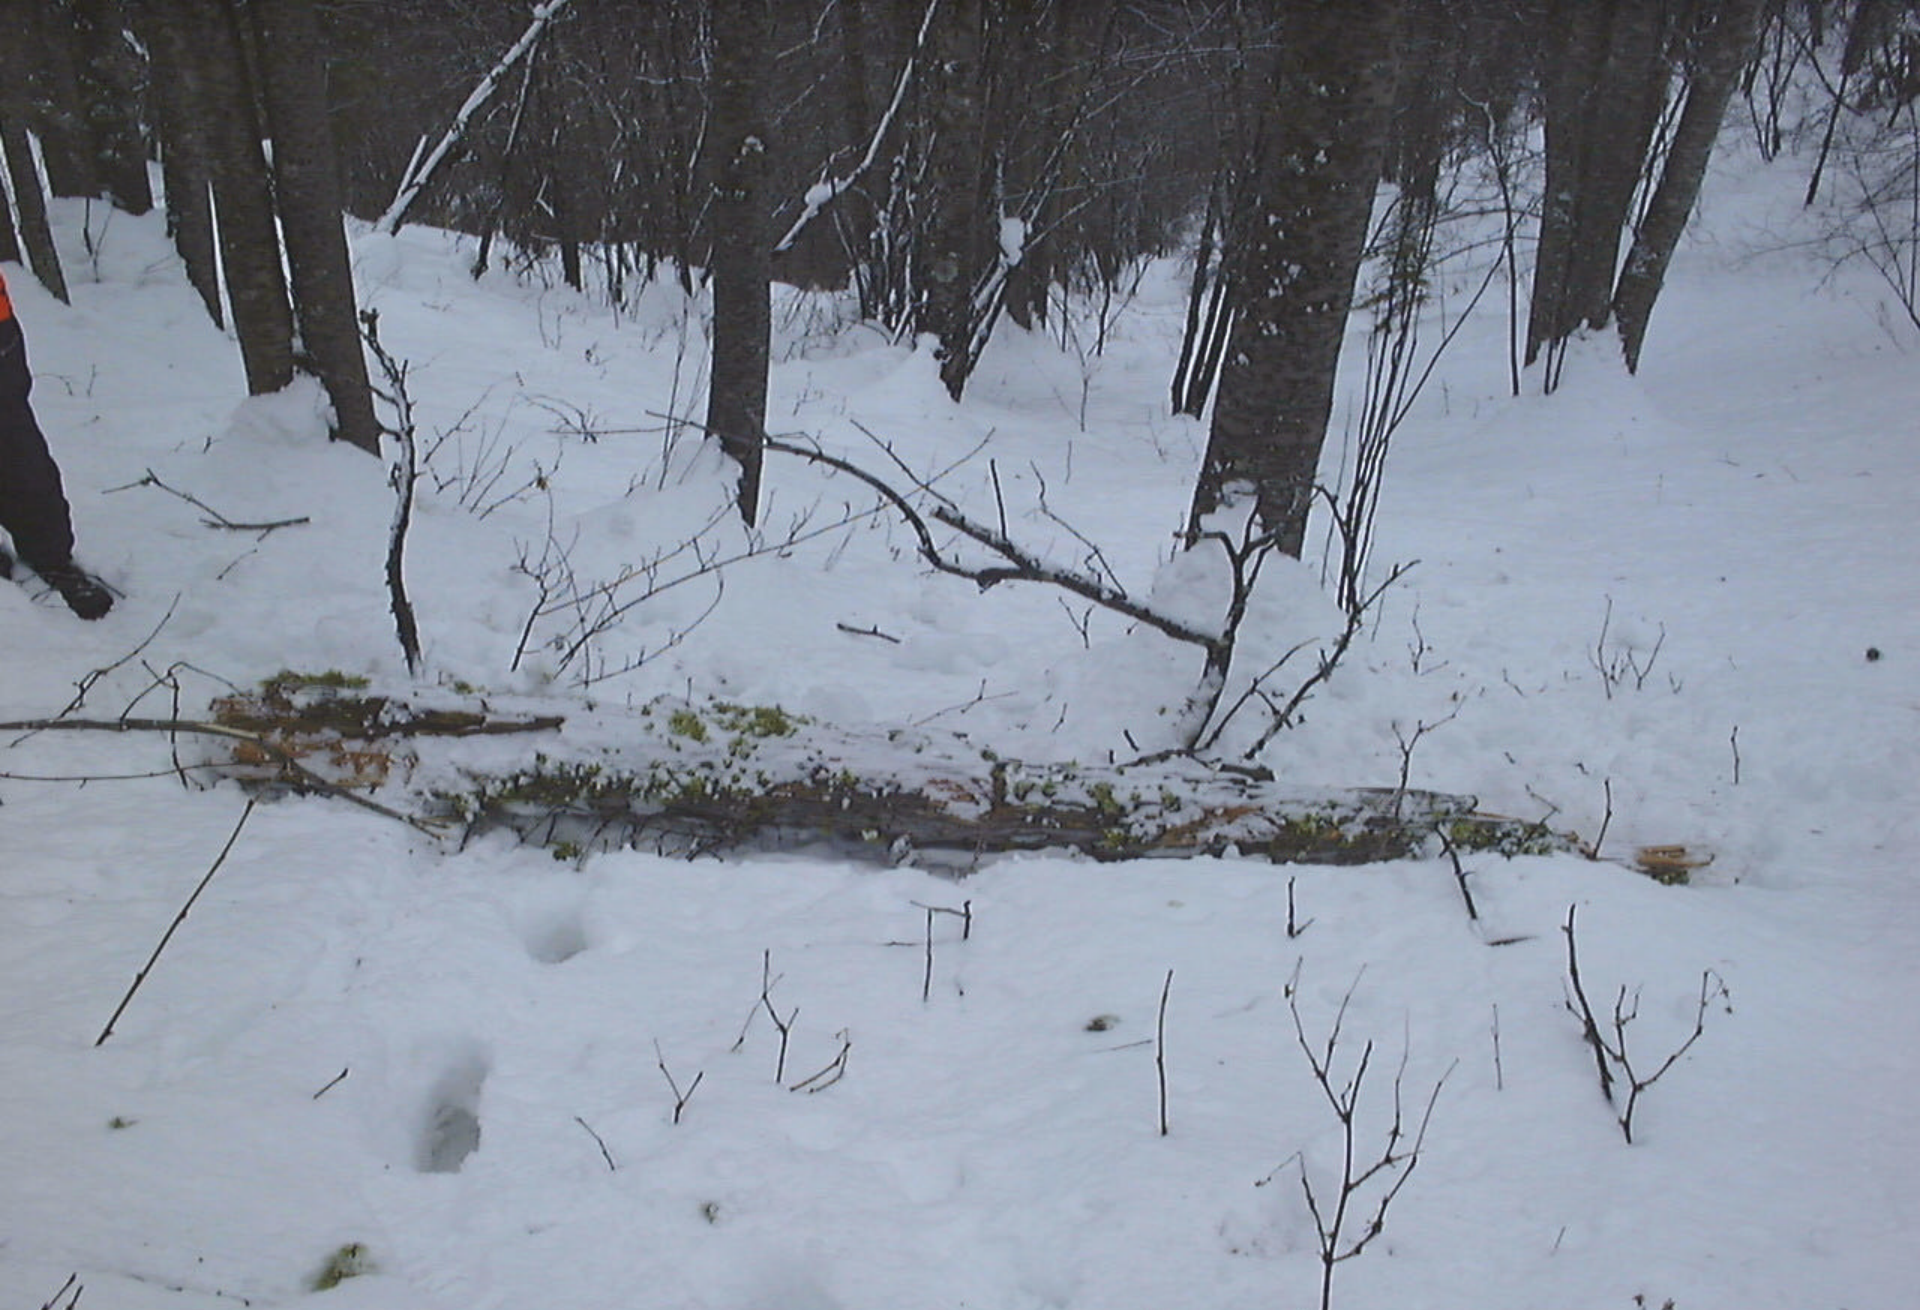
**Impact knocked off the top 12 feet of the tree.**

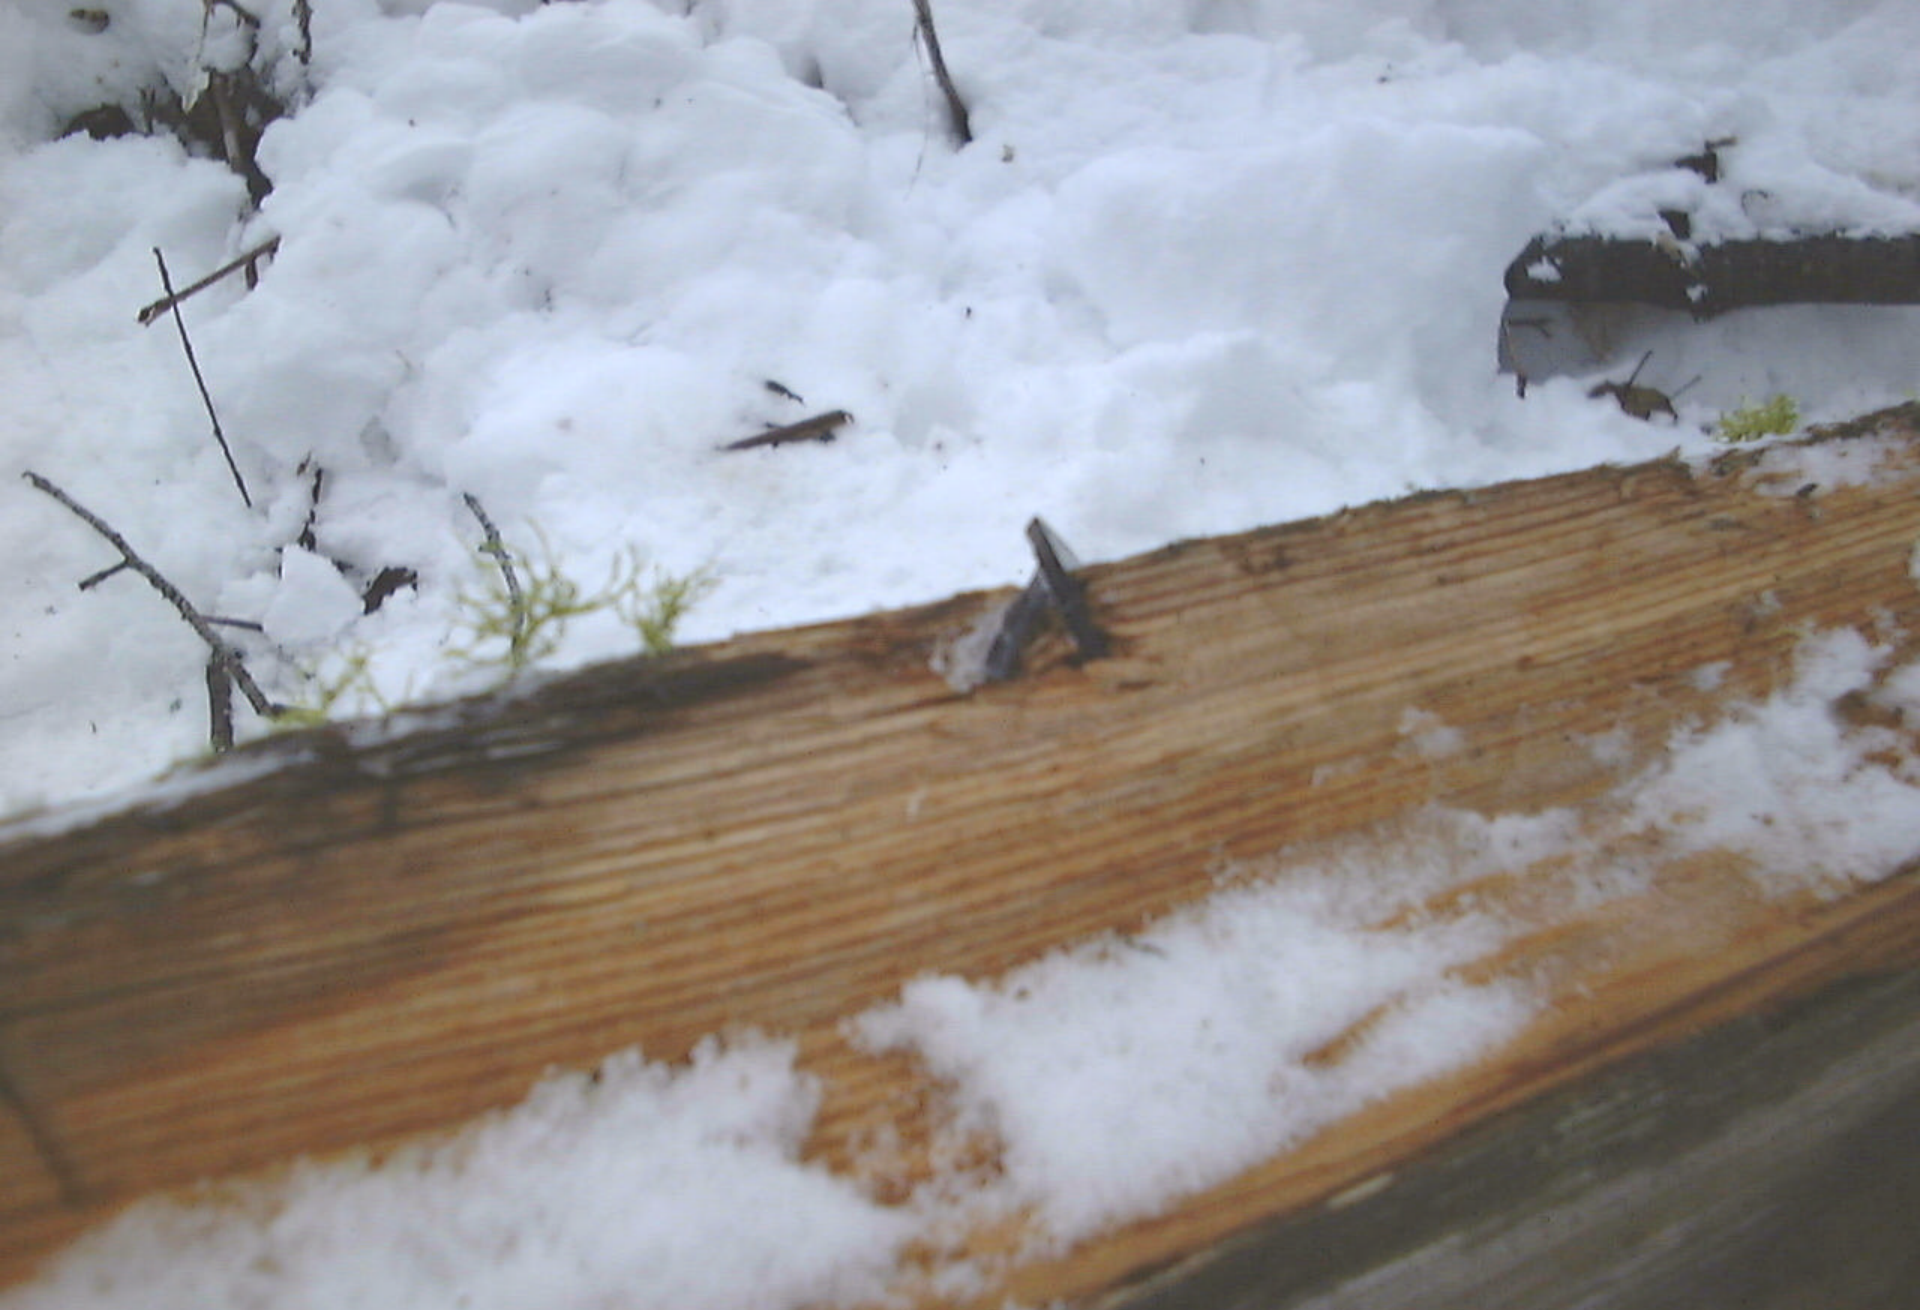
**Plexi-glass from chin bubble**

**Aircraft impacts inverted**

**Rear passenger escapes**

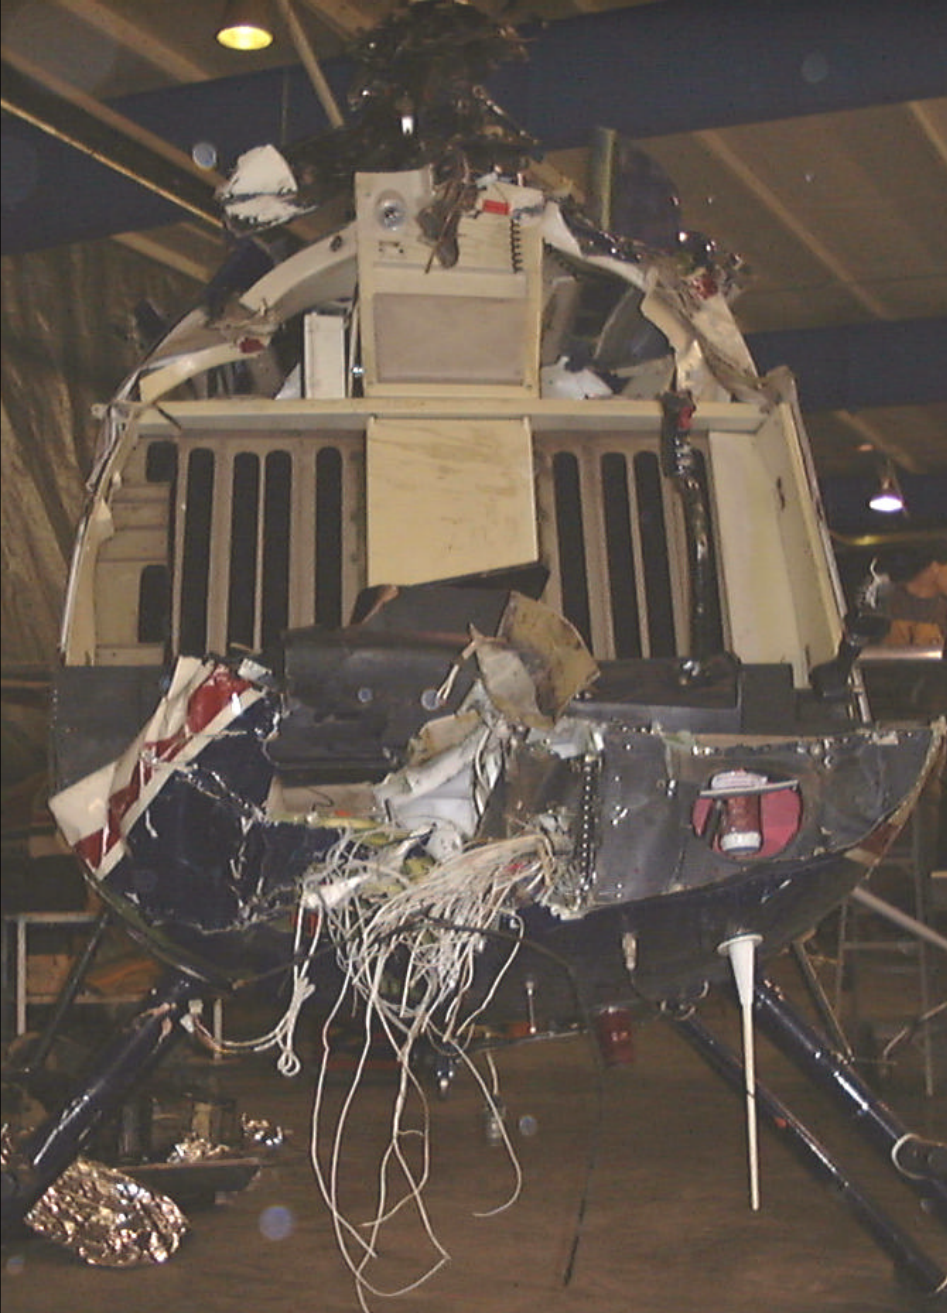
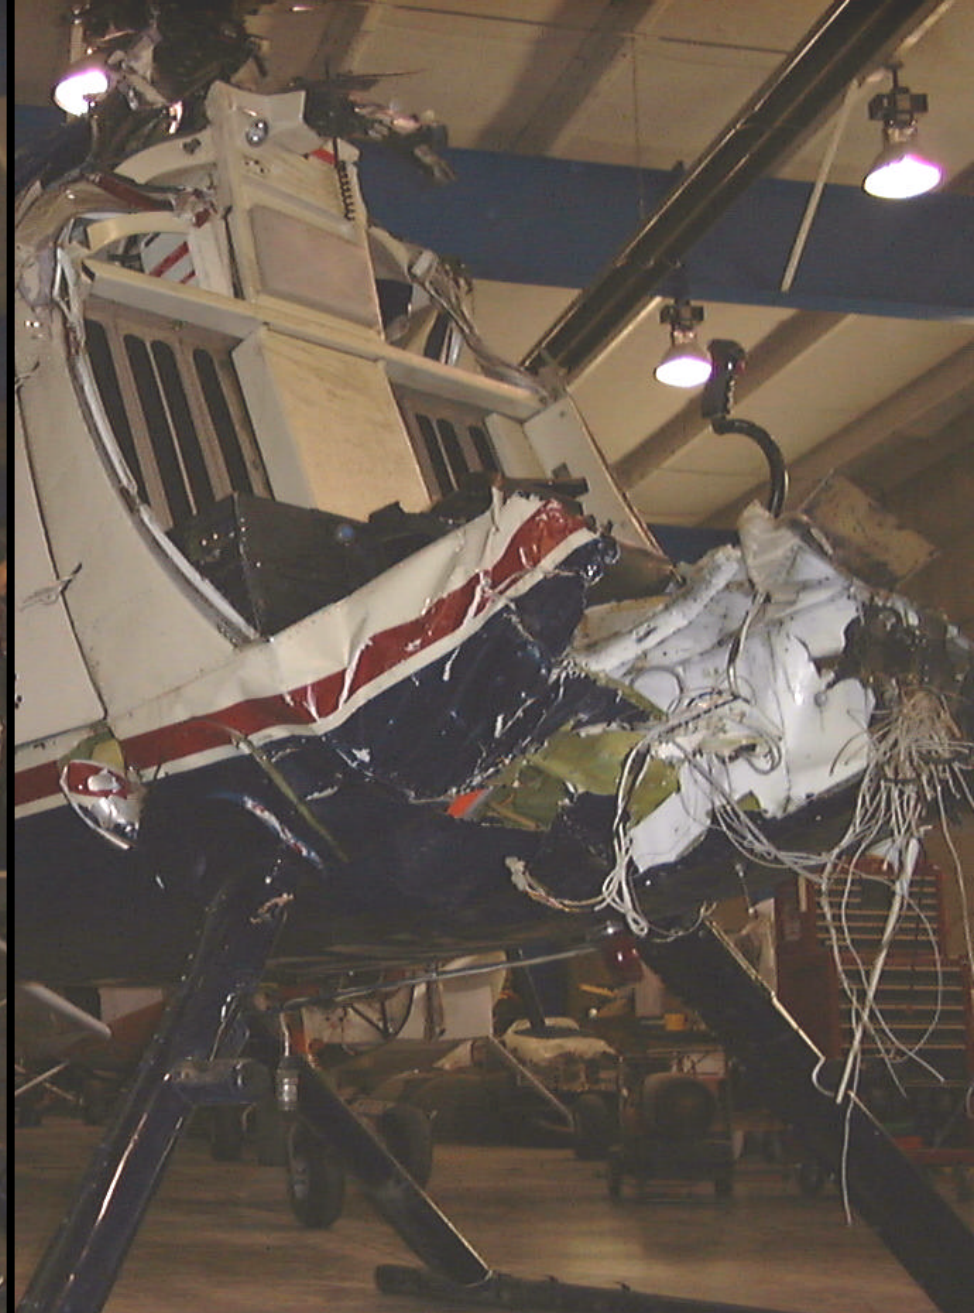
Primary impact to fuselage

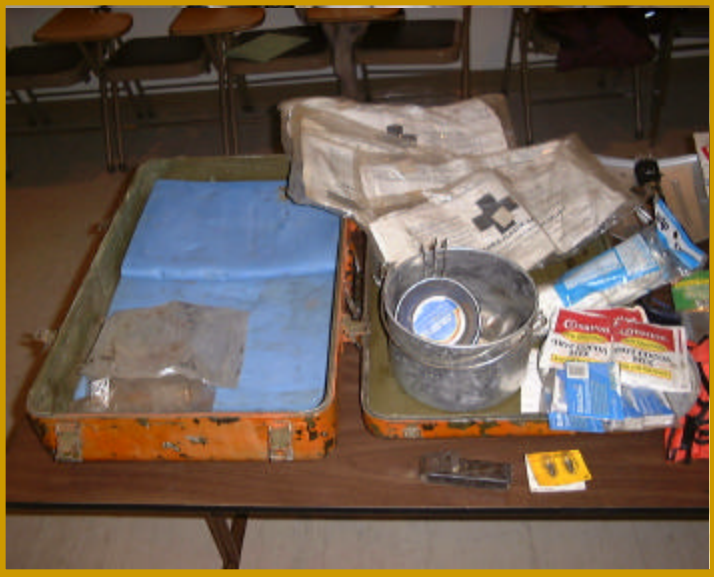
If it isn't secure,  
it can hurt you...

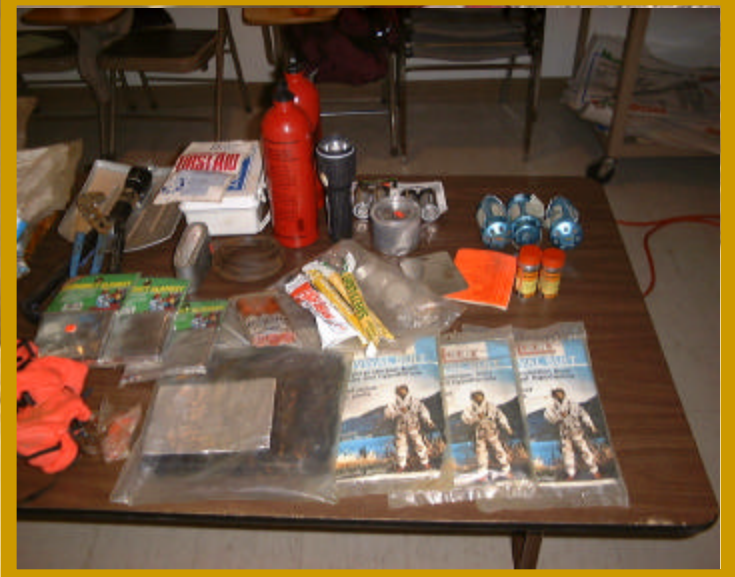
and if you don't know how to use it,  
it can't help you

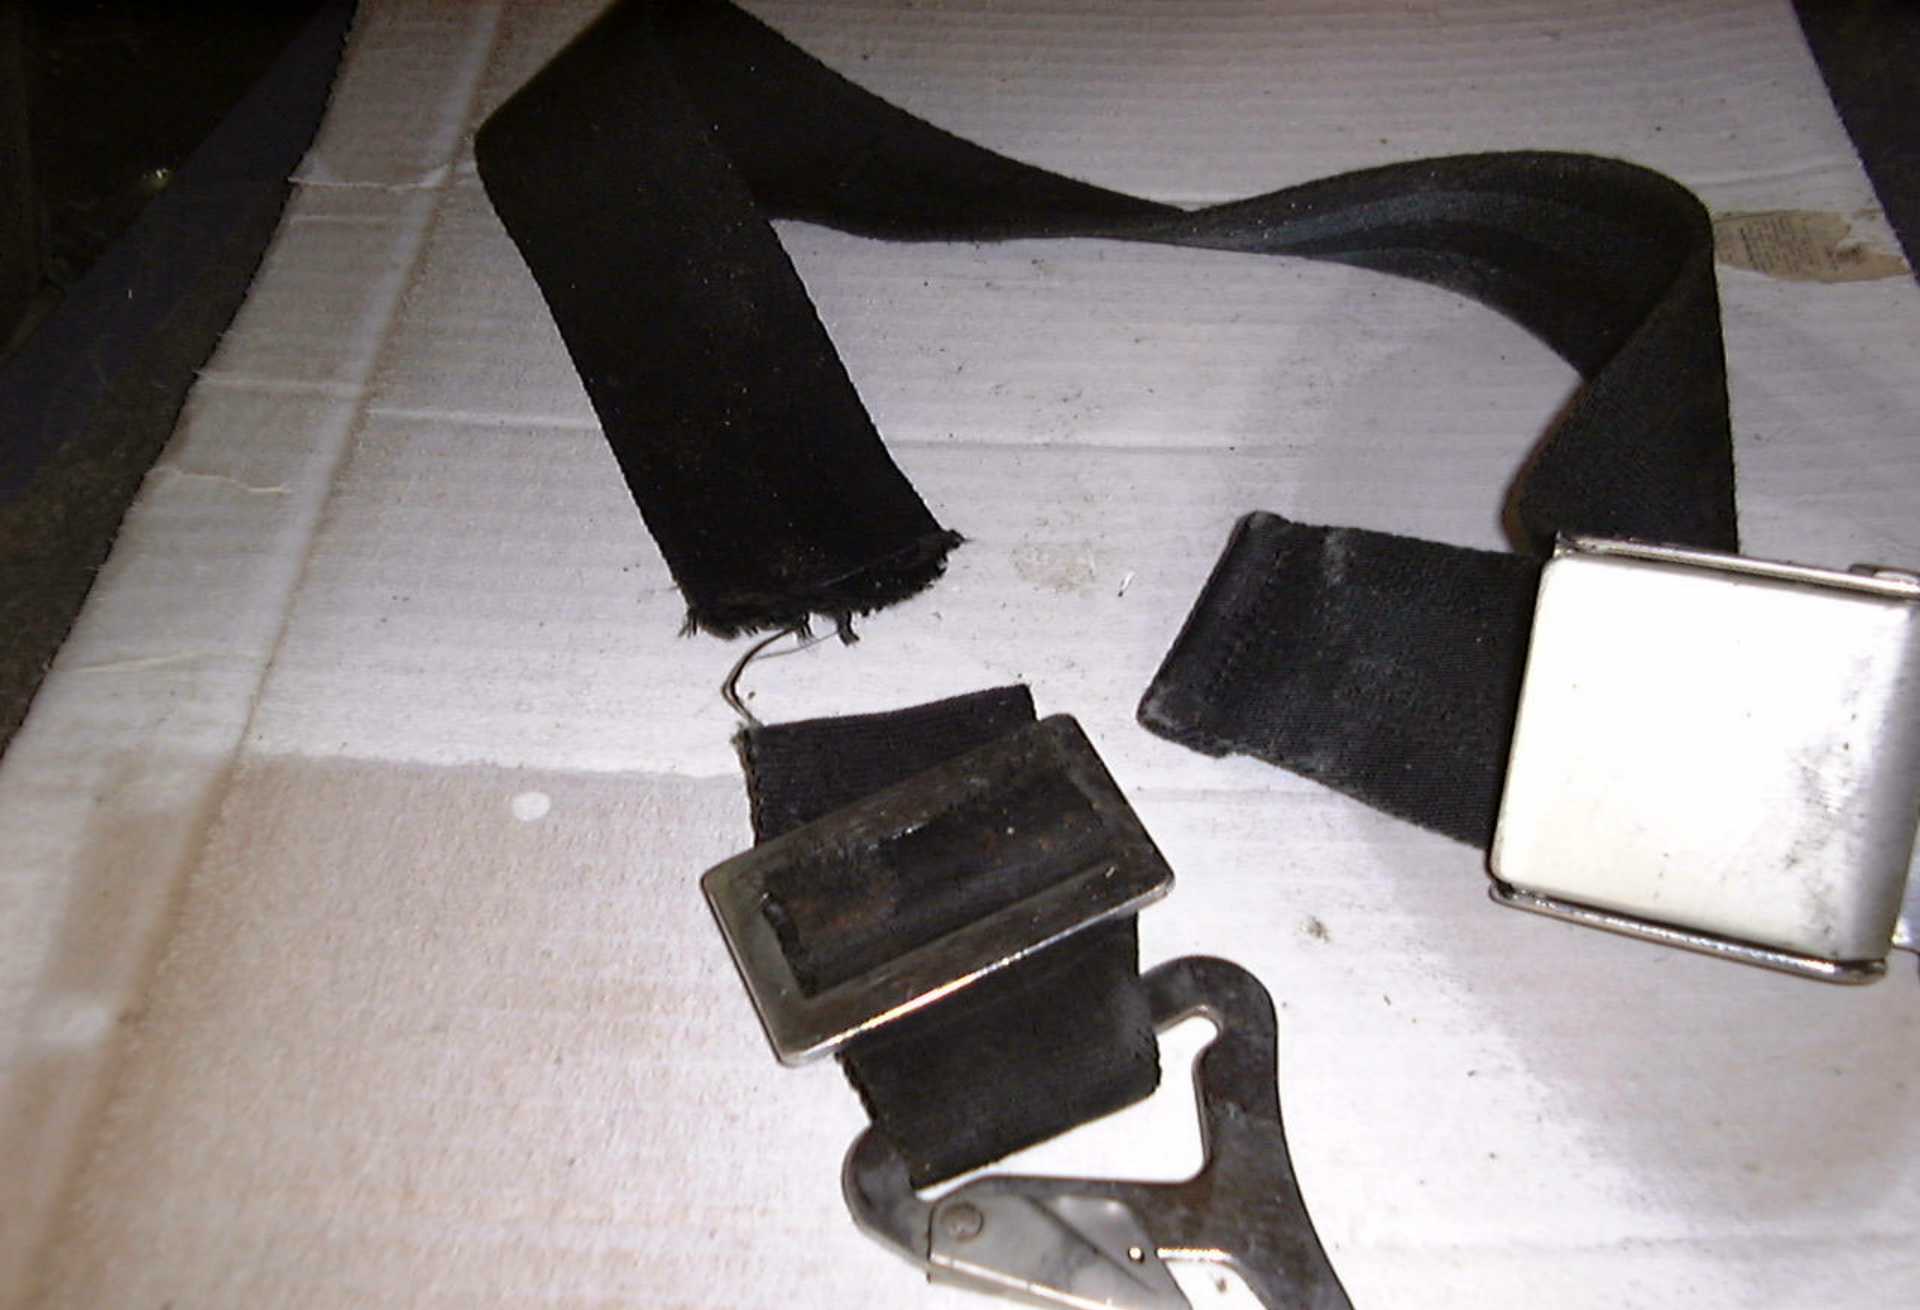
**Seatbelt failed during crash sequence**
