**FY01**

**Department of the Interior  
Aviation Accident Review**

# Mesa Verde NP, CO

## Bell 206L-1

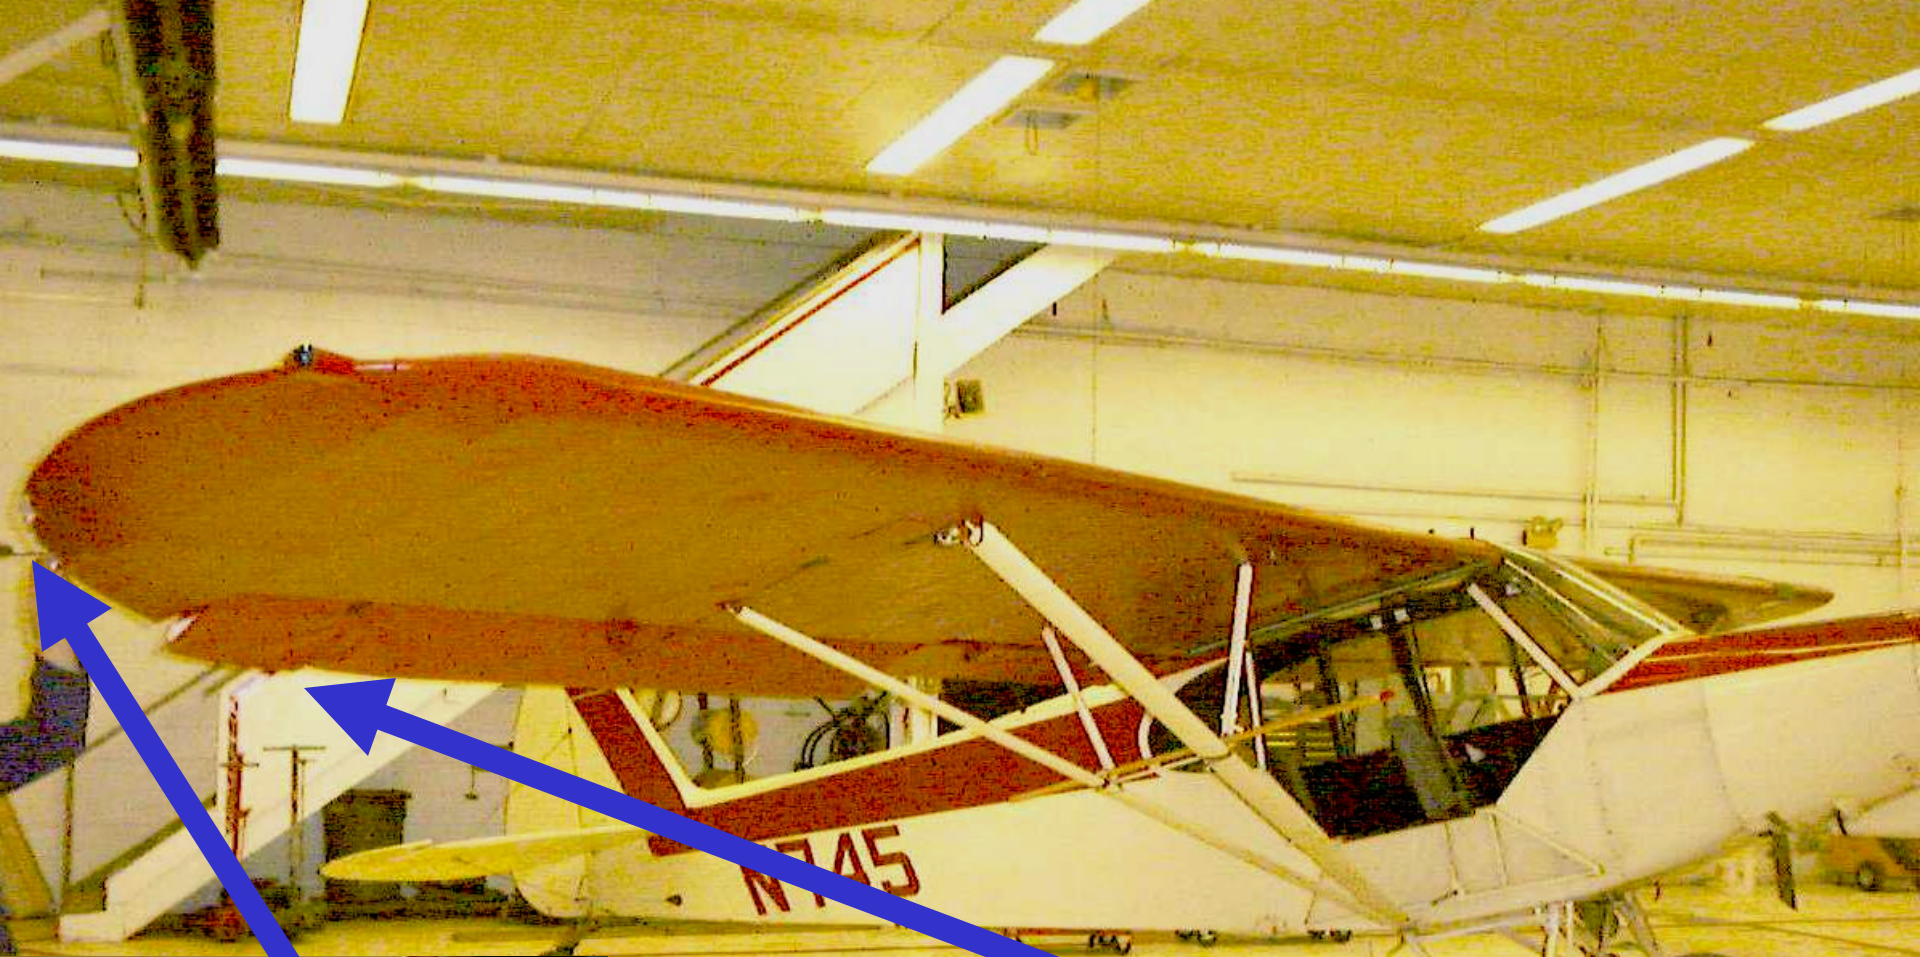
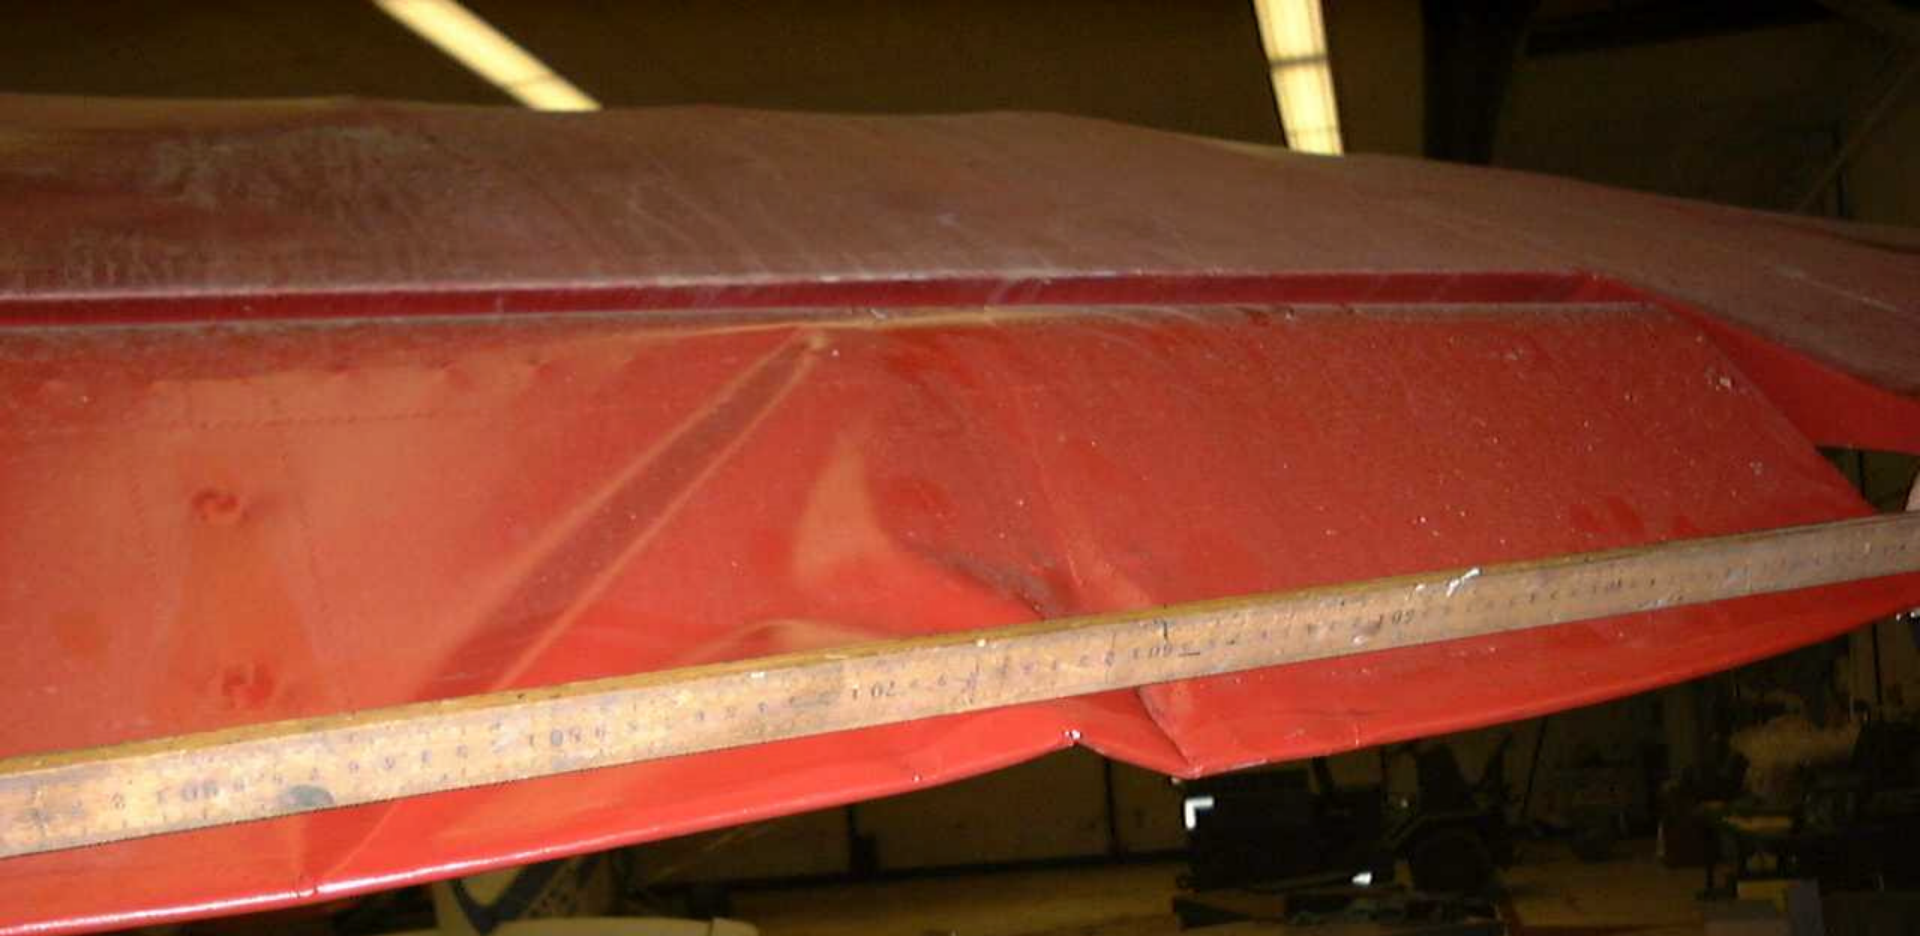
A tundra tire equipped PA-18, N 745, sustained substantial damage during a downwind landing at the King Salmon airport, AK.

**Do not continue flight or mission until the problem is inspected and cleared by approved maintenance personnel**

**If you break it, park it !**

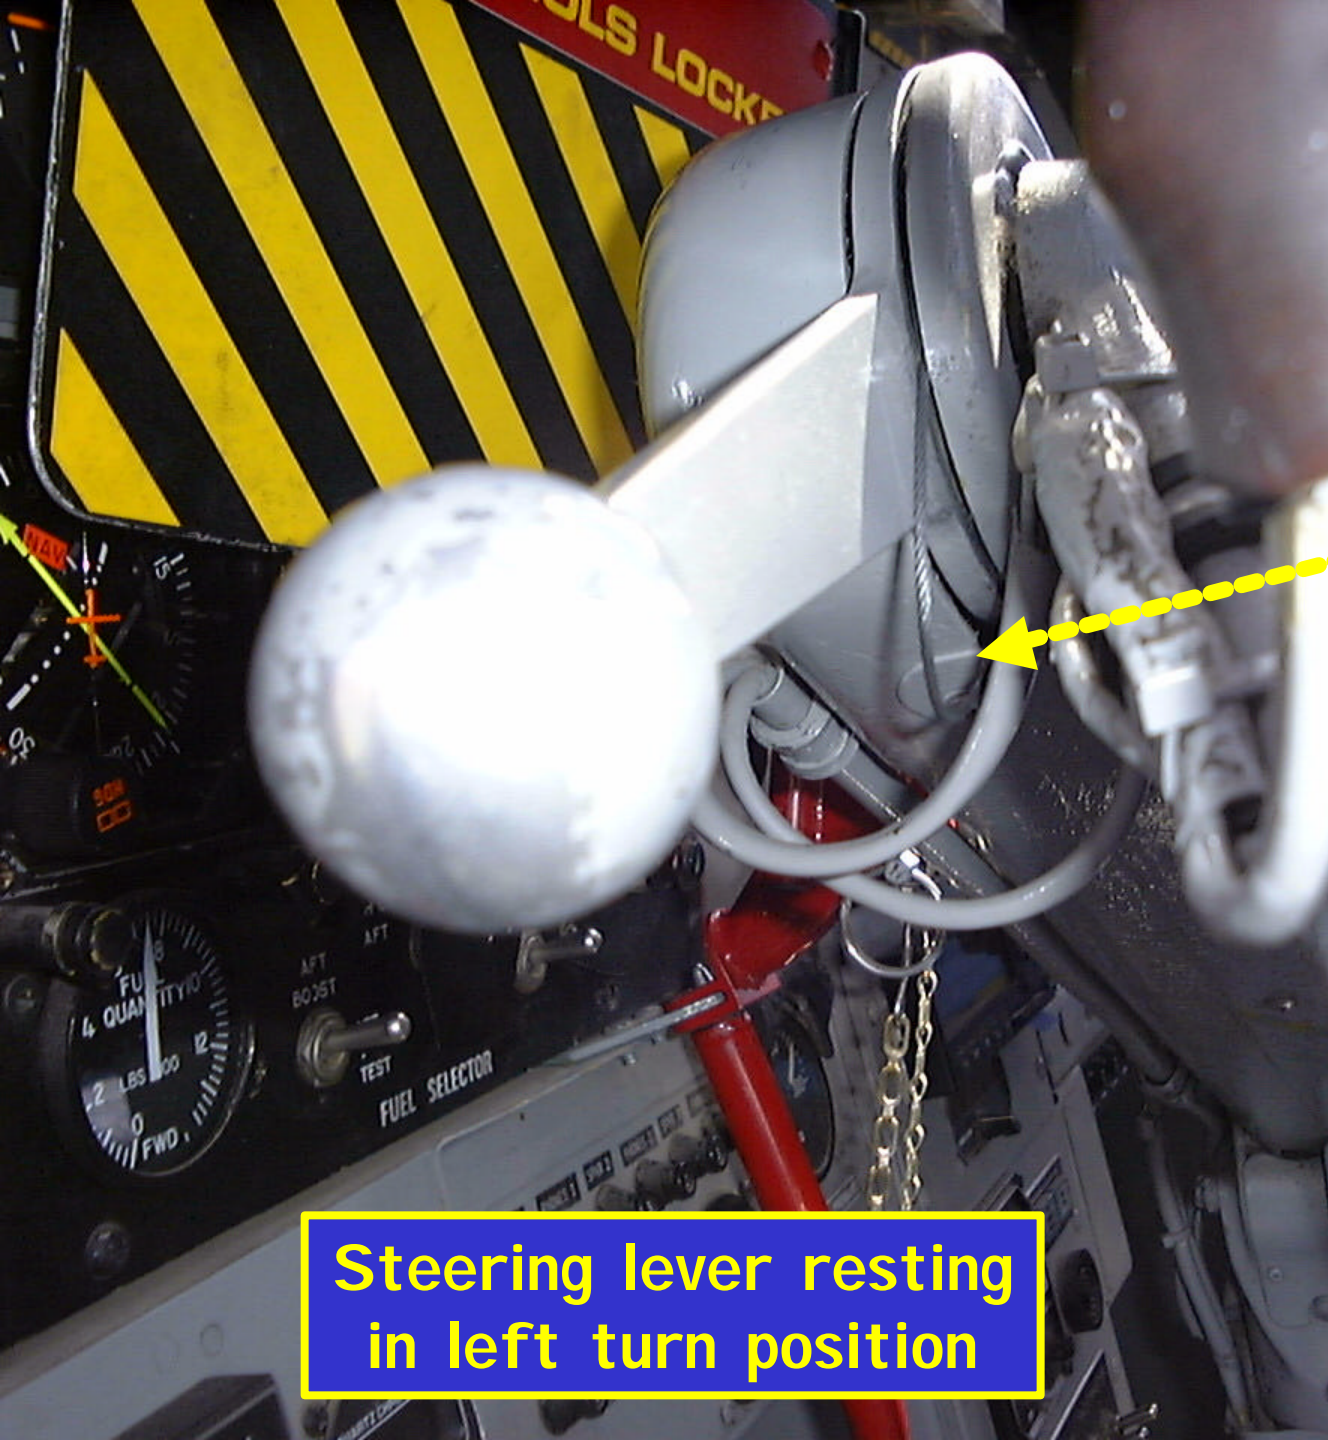
**Steering lever resting in left turn position**

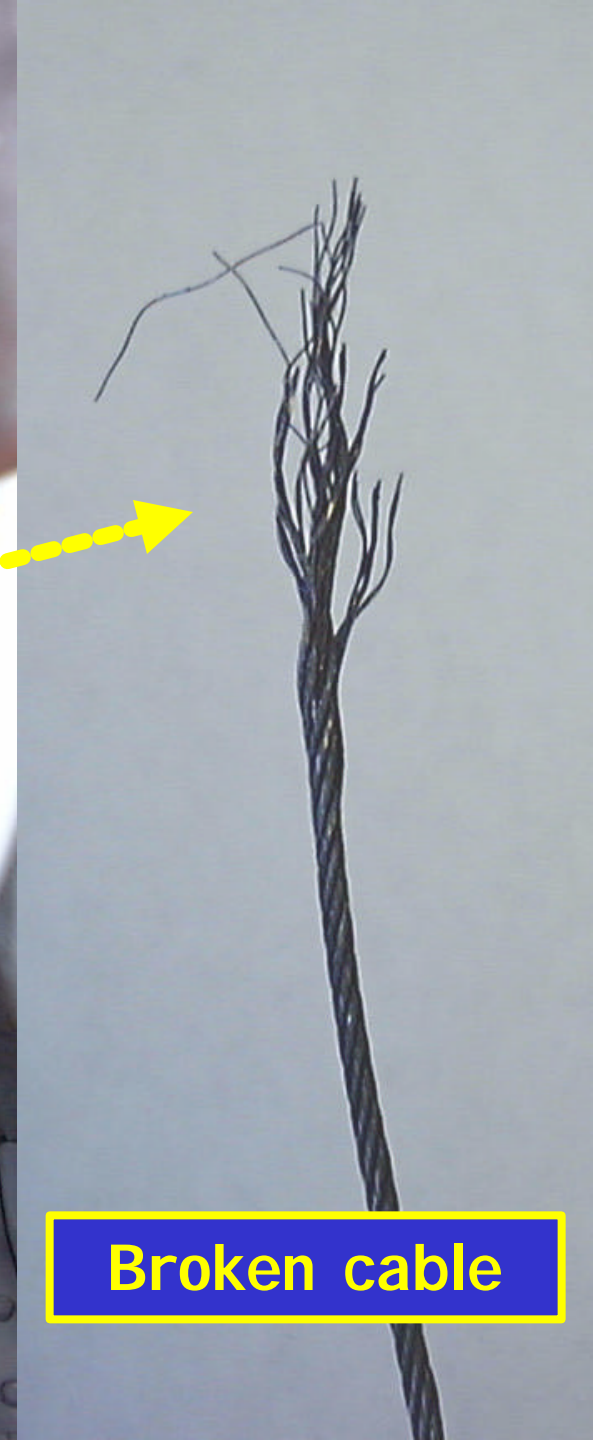
According to the NTSB metallurgical analysis of the nose steering cable revealed evidence of pre-existing metal fatigue.

**Broken cable**

**“Fatigue failure of the nose wheel steering cable during the landing roll. ”**

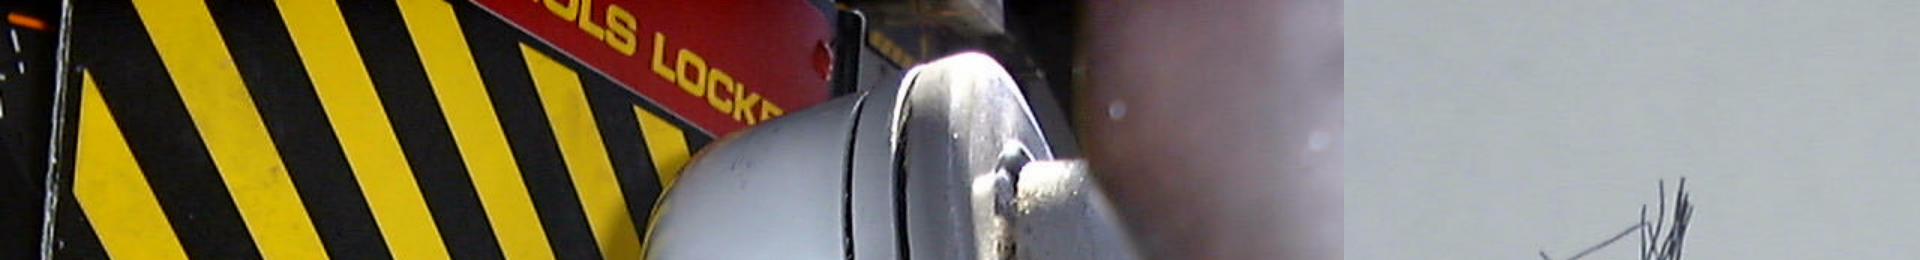
**Directional control should be maintained with rudder.  
Nosewheel steering and brakes should be used only  
at taxi speeds.**

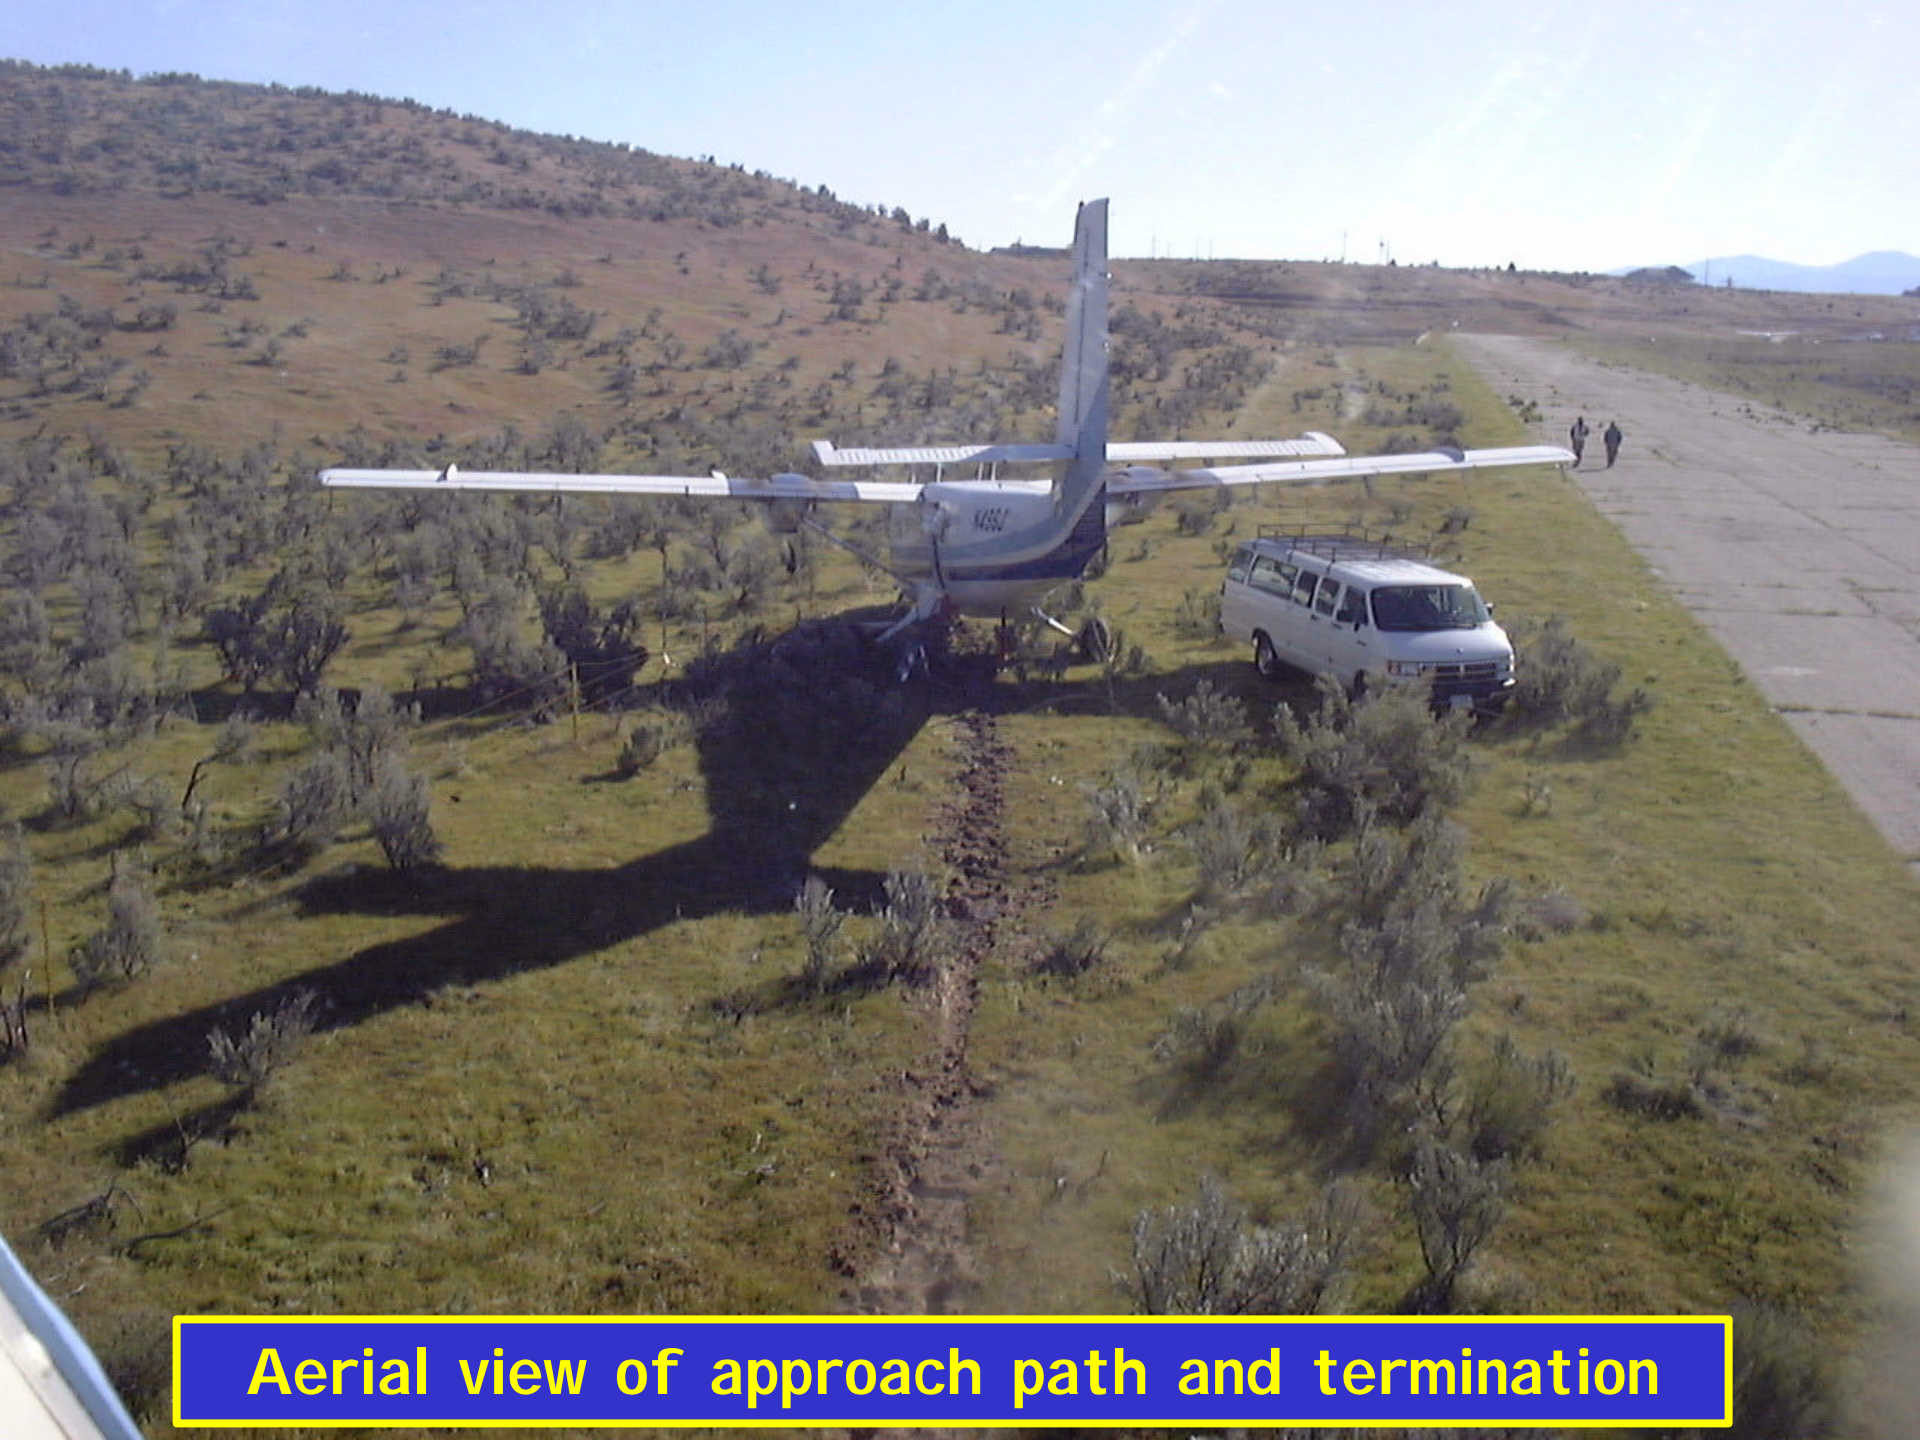
**Aerial view of approach path and termination**

**Acft stops 1190' after touchdown**

**Acft left runway 950'**

**Skid marks veer left 750'**

**Steering failed 420'**

**Touchdown to pavement 330'**

**Initial touchdown**

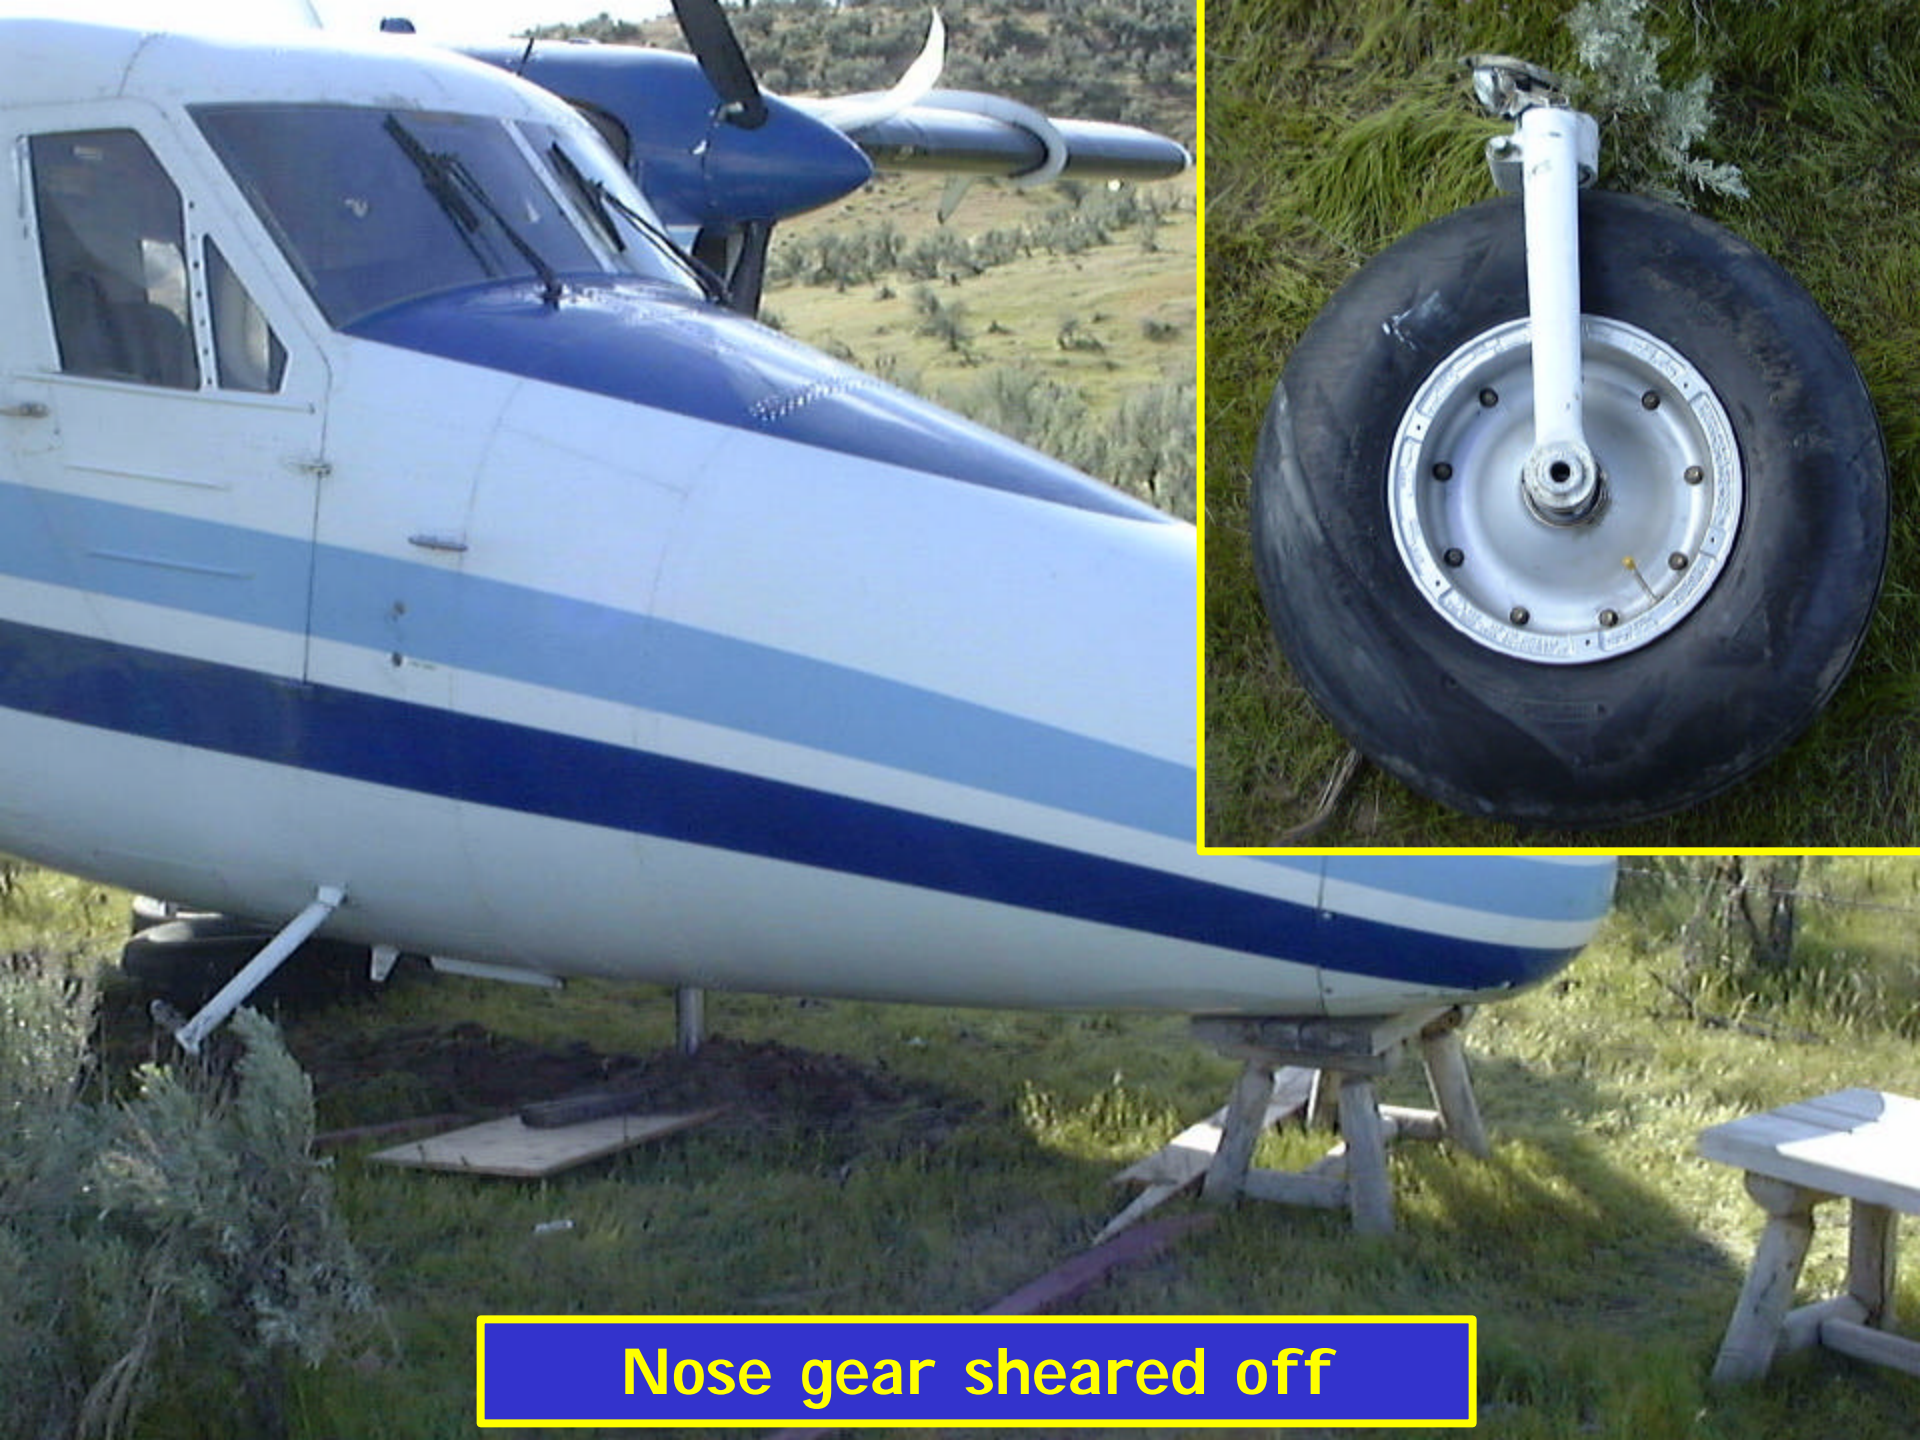
**Nose gear sheared off**

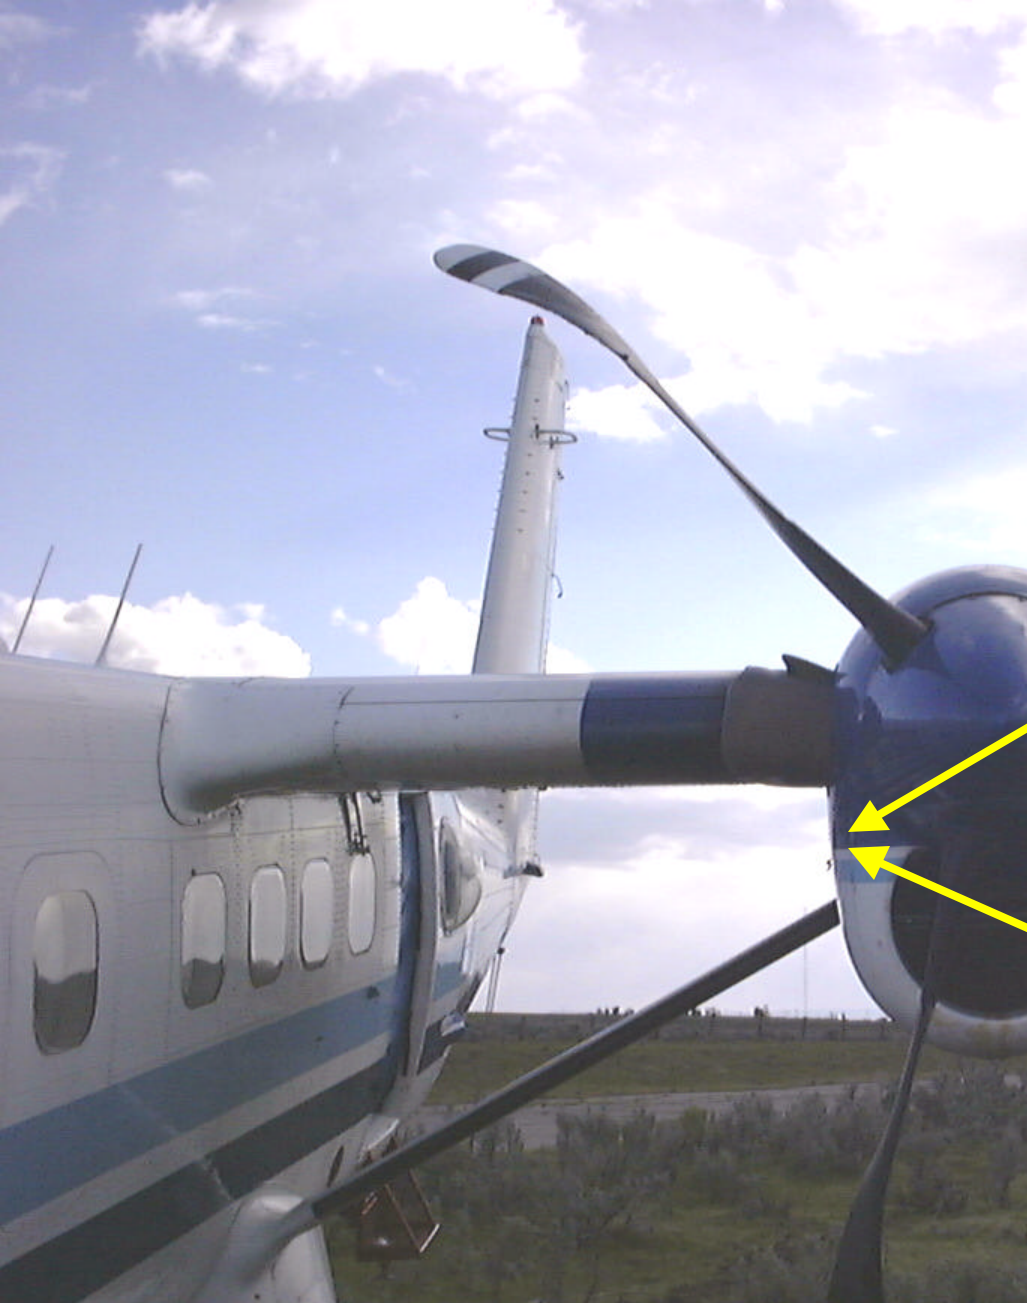
**Propeller and structural damage**

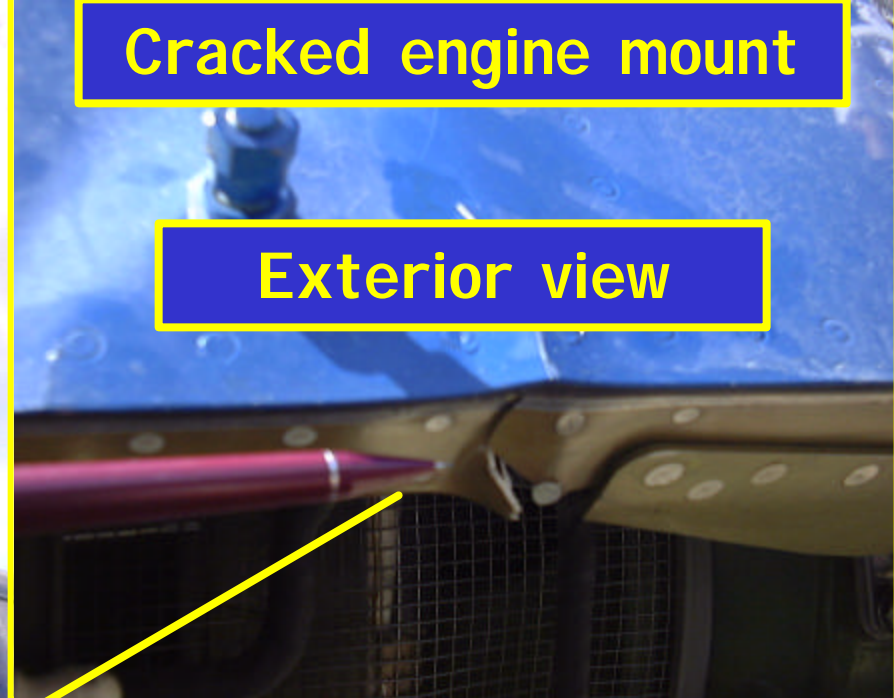
**Exterior view**

**Cracked engine mount**

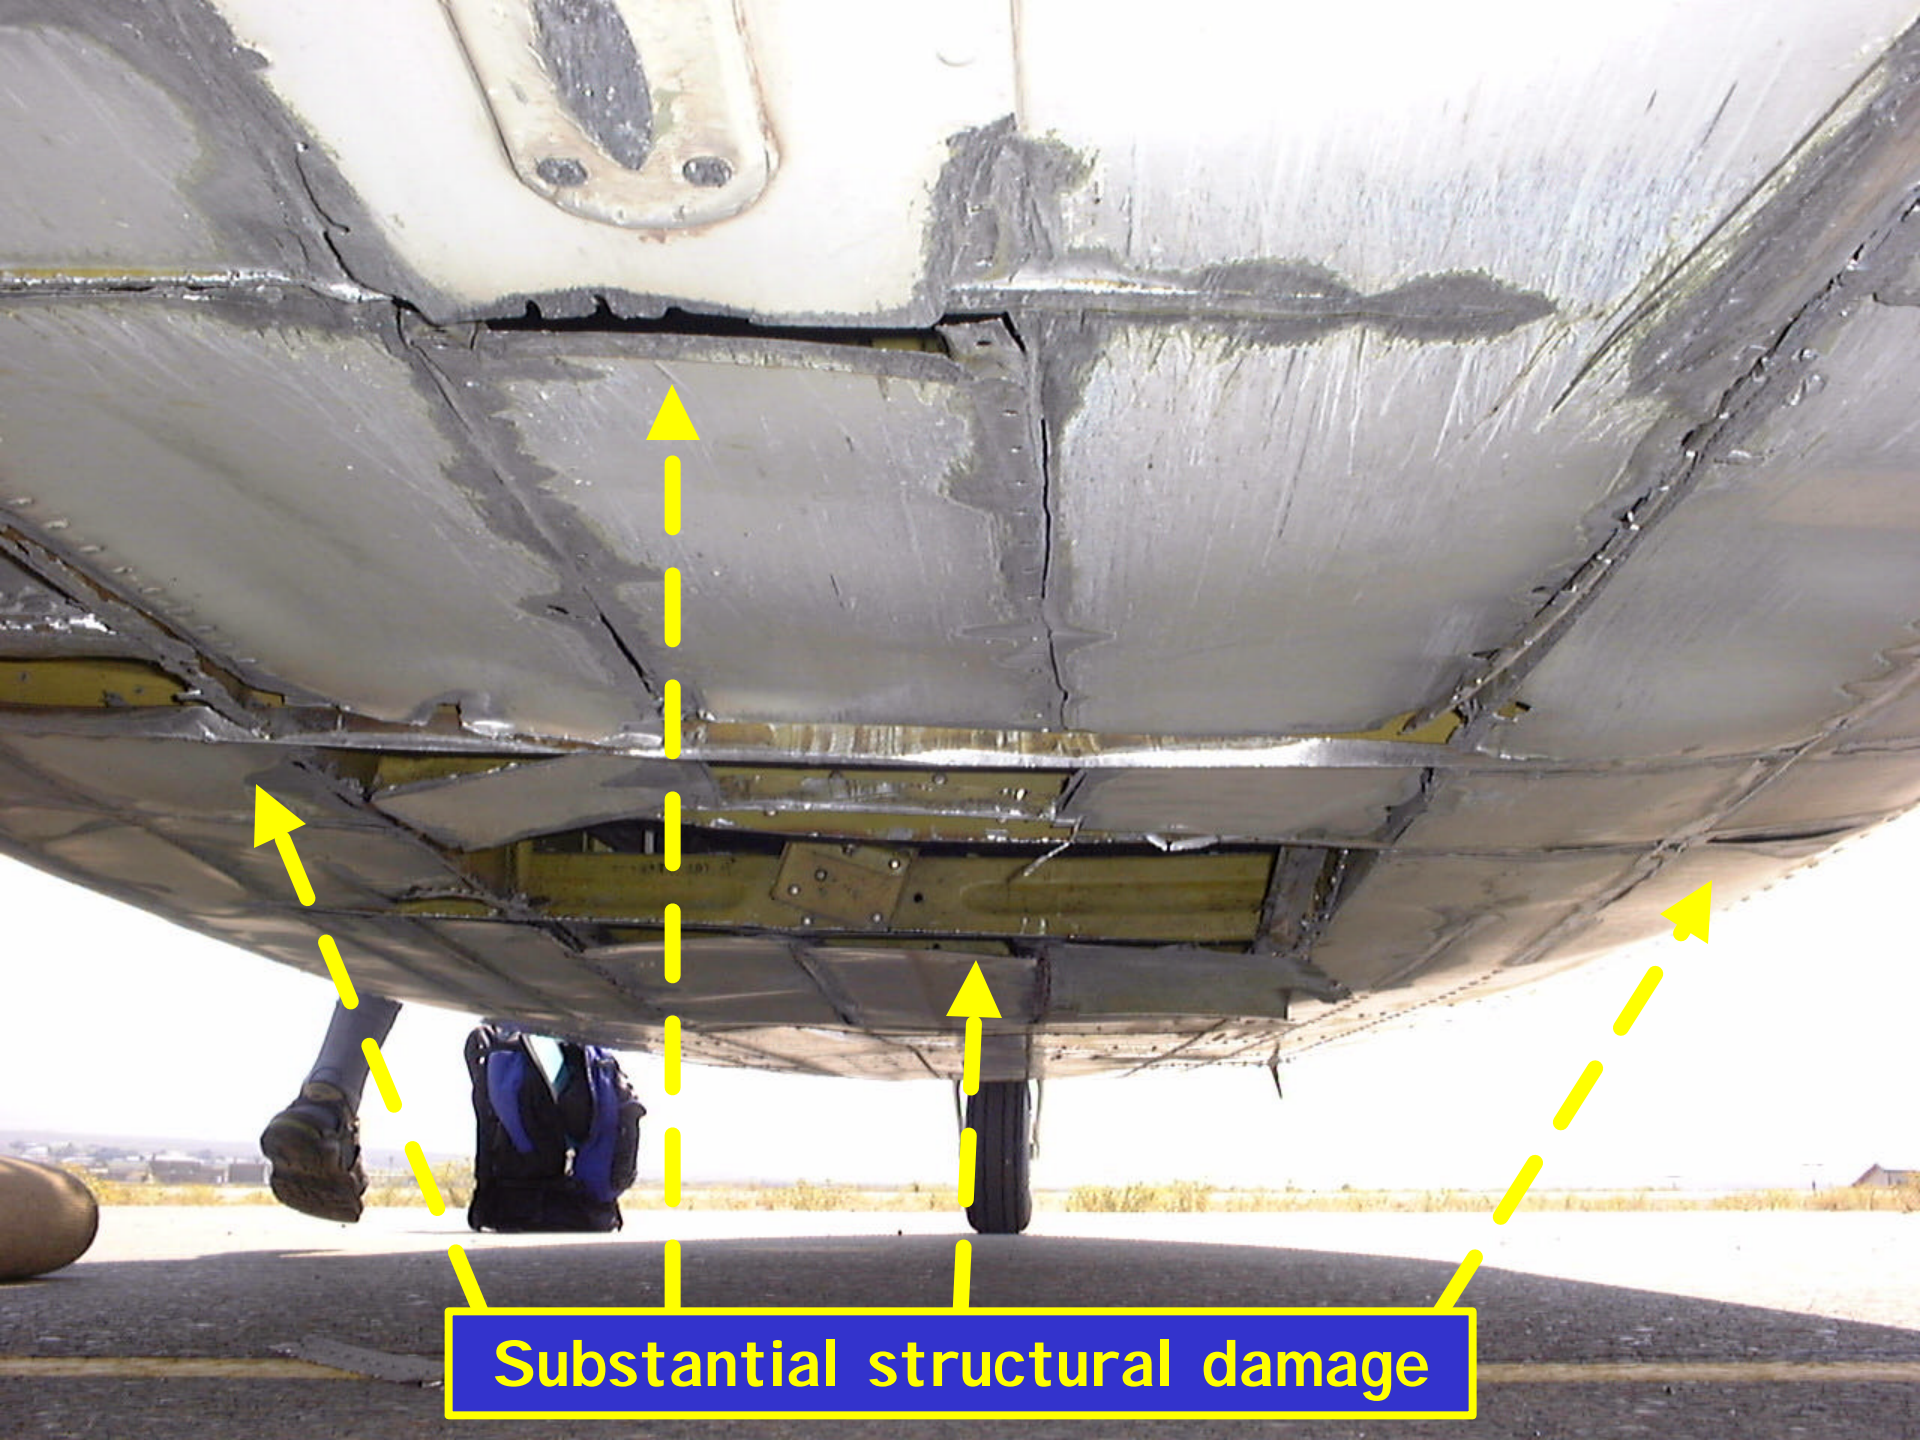
**Substantial structural damage**

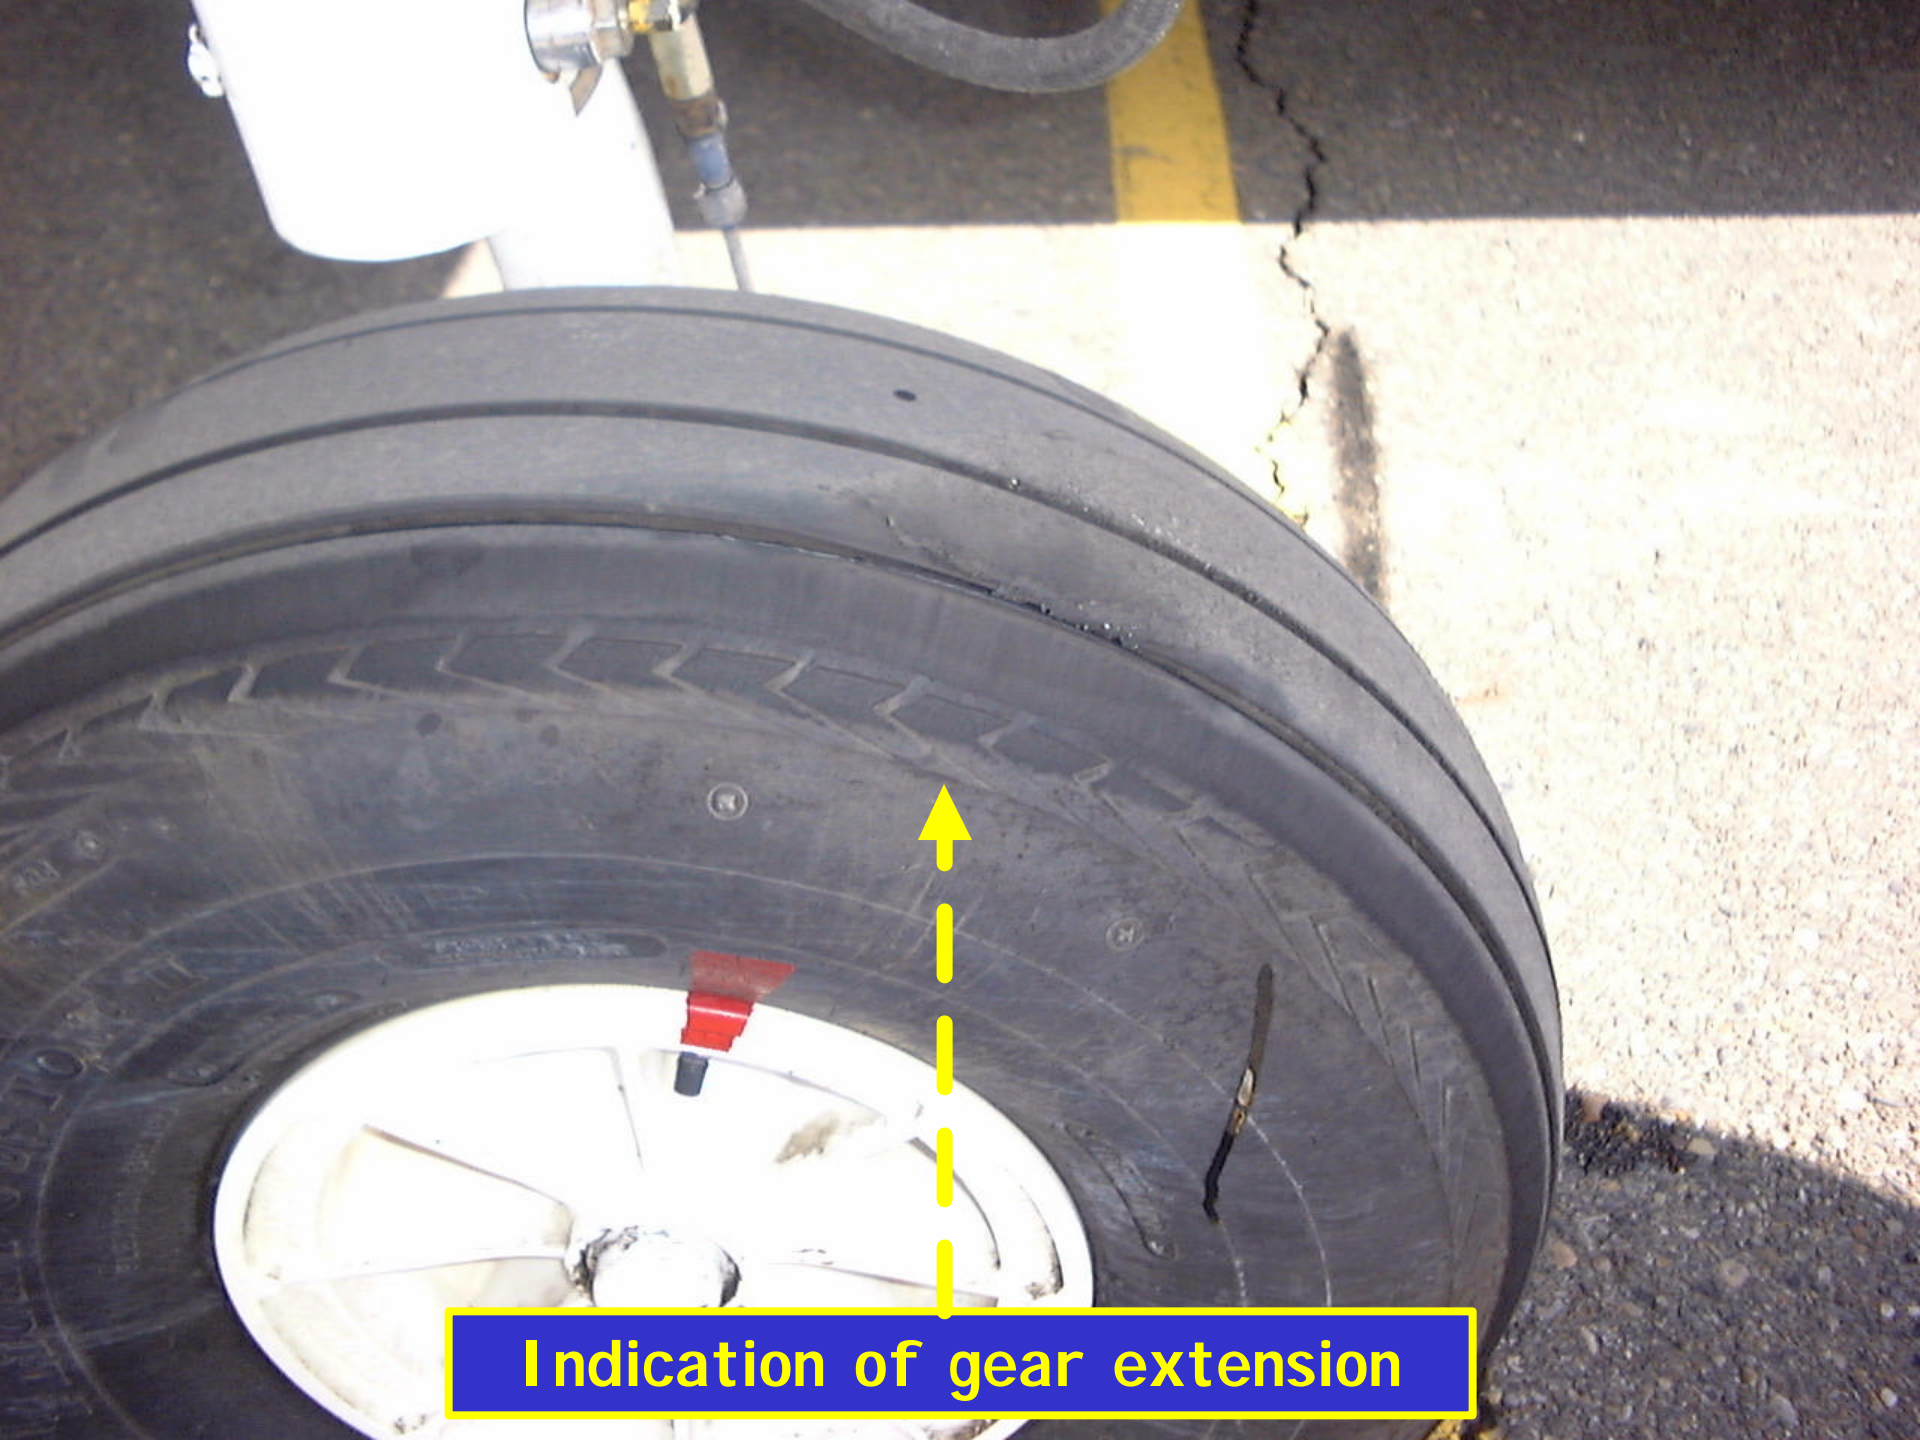
Indication of gear extension

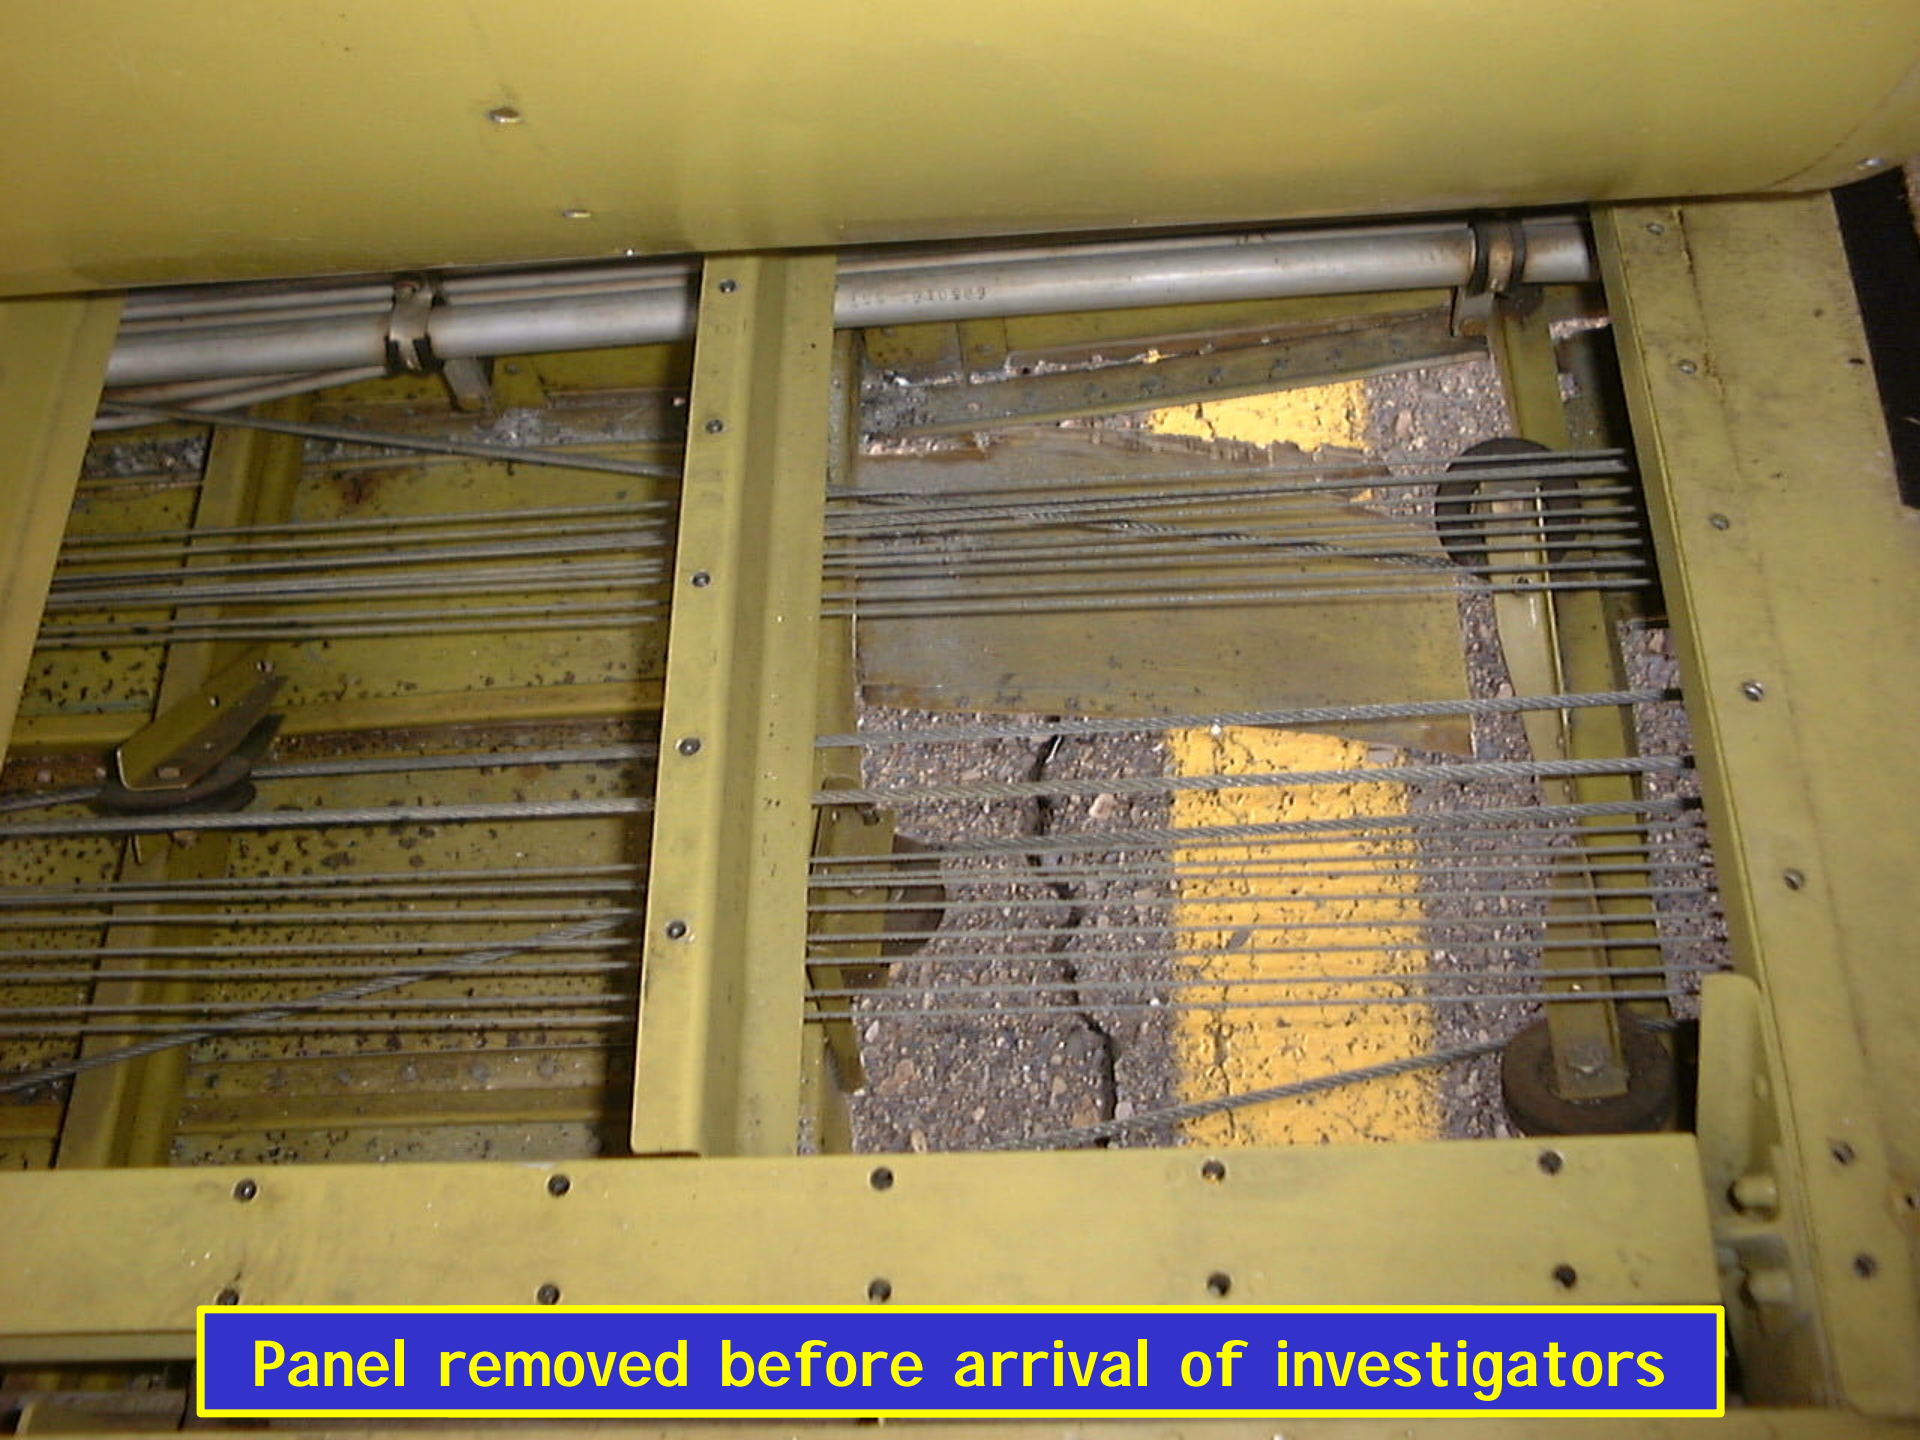
Panel removed before arrival of investigators
