Aviation Accident Review

Department of the Interior Aviation Accident Review

Office of Aircraft Services

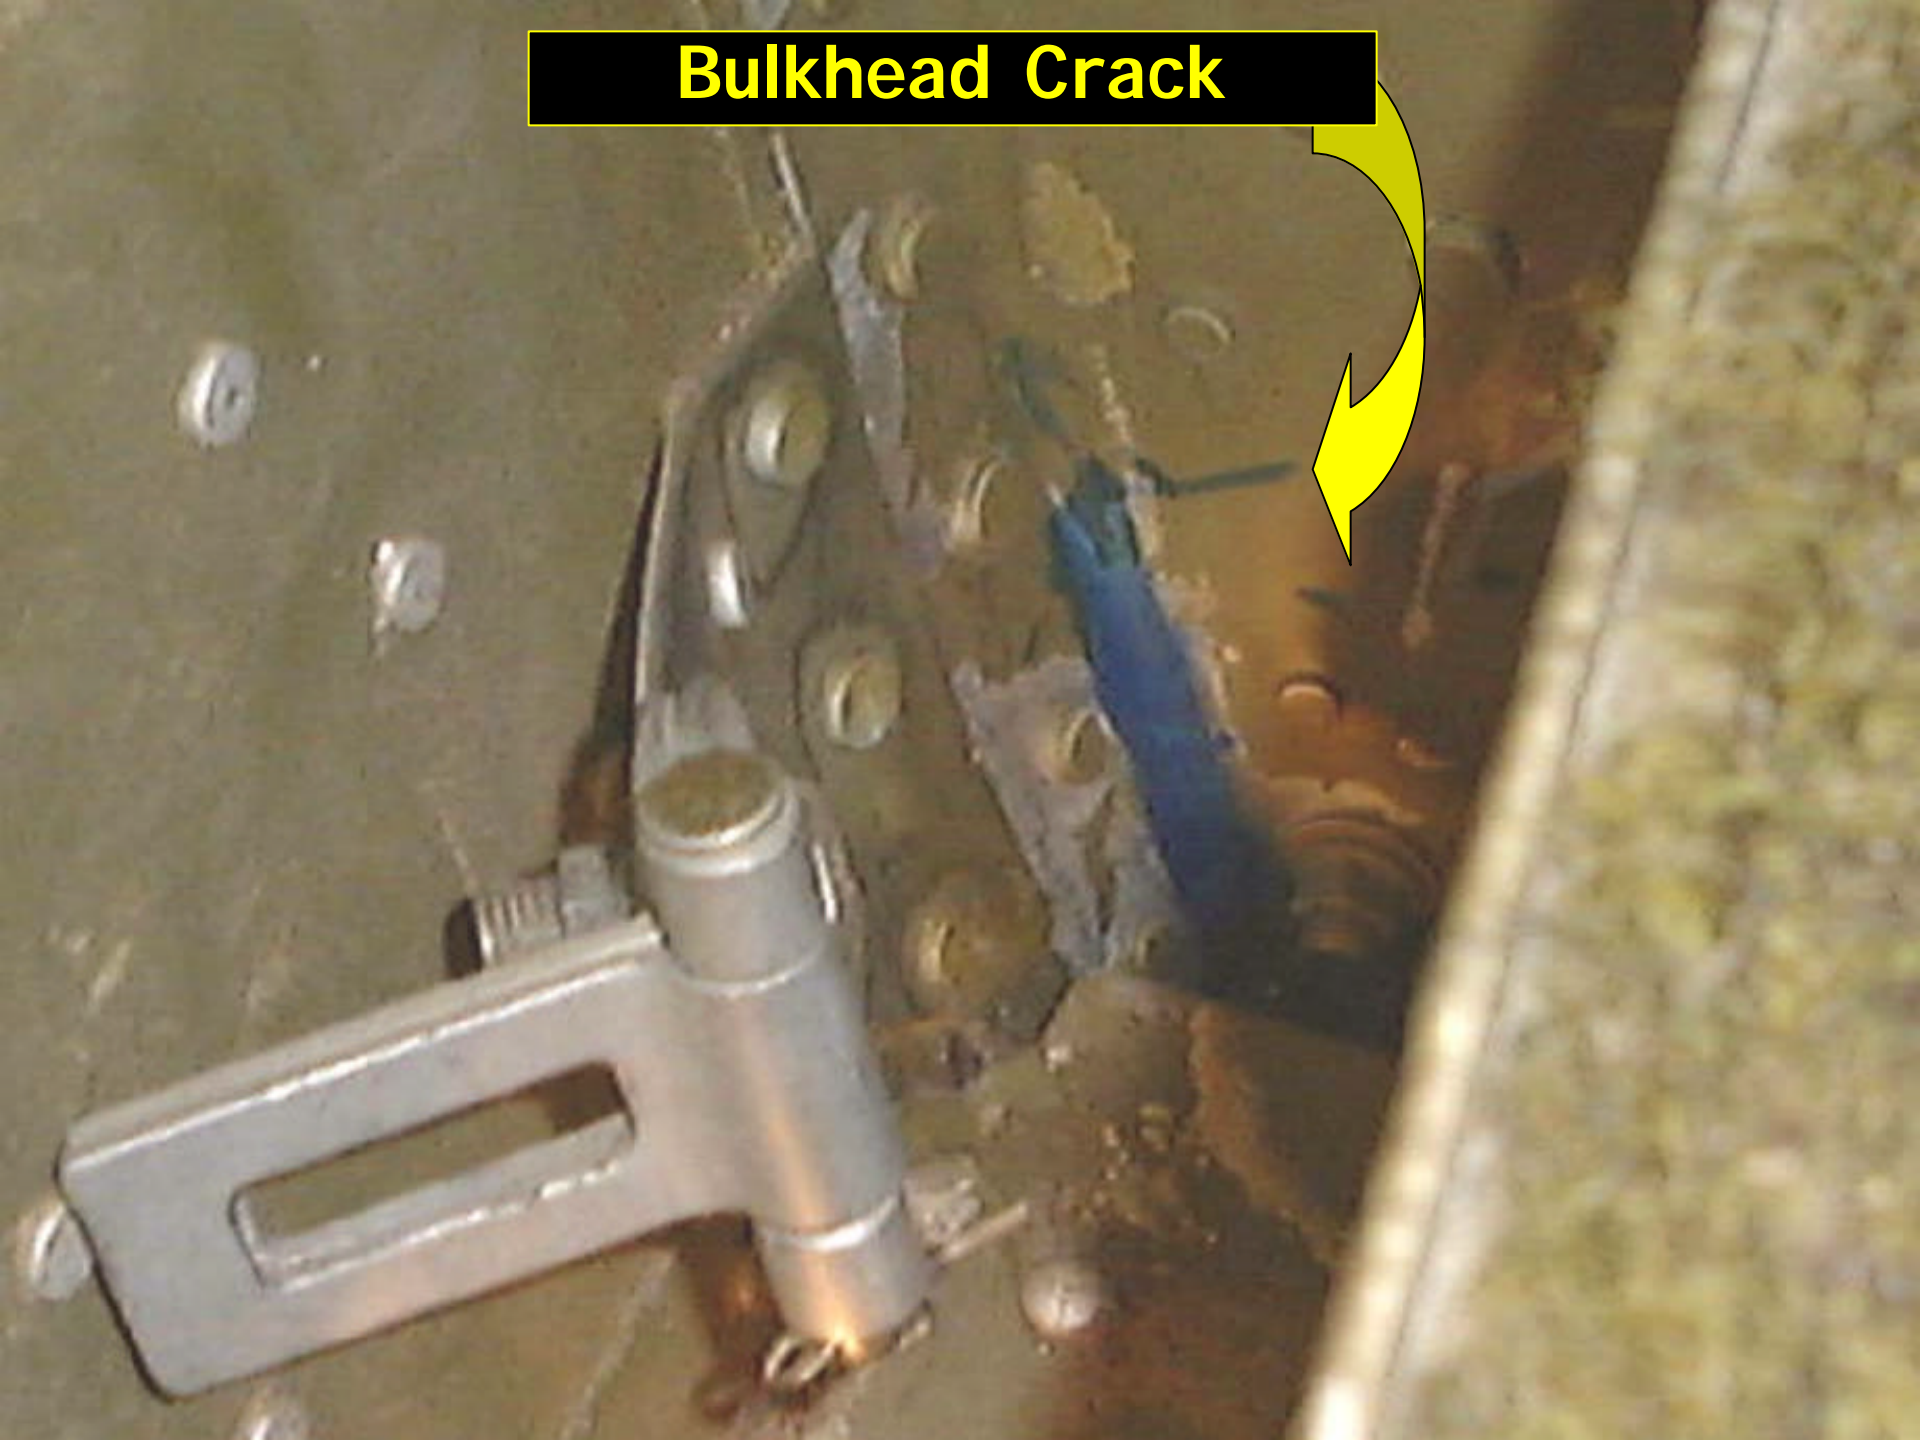
Inspection revealed one of the fuselage bulkheads sustained substantial damage.

Bulkhead Crack

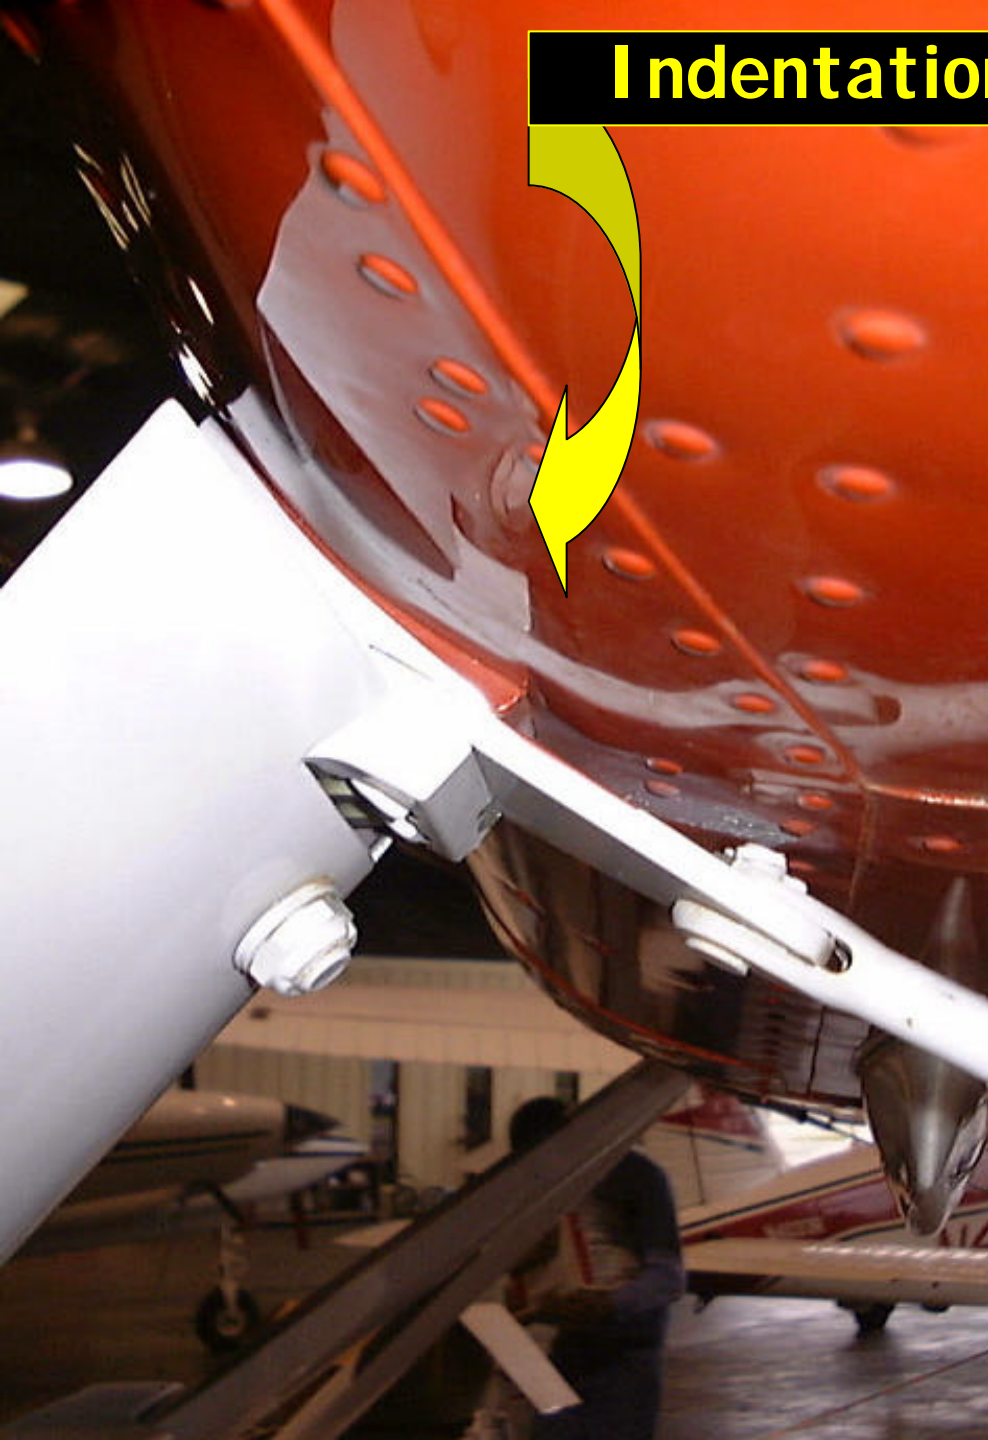
Indentation in Skin

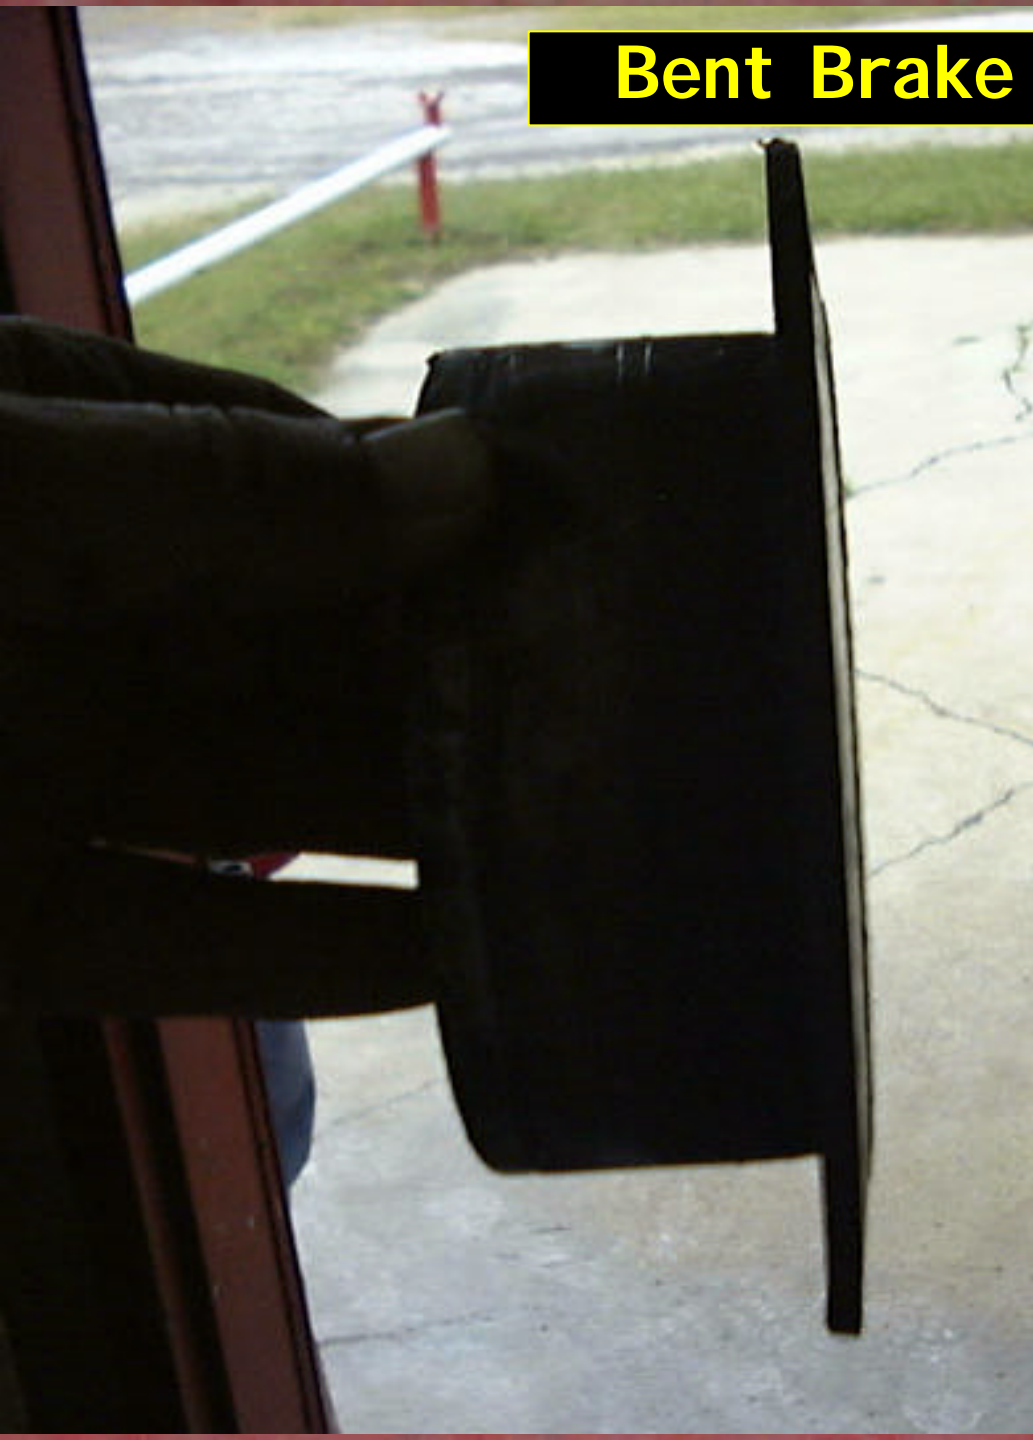
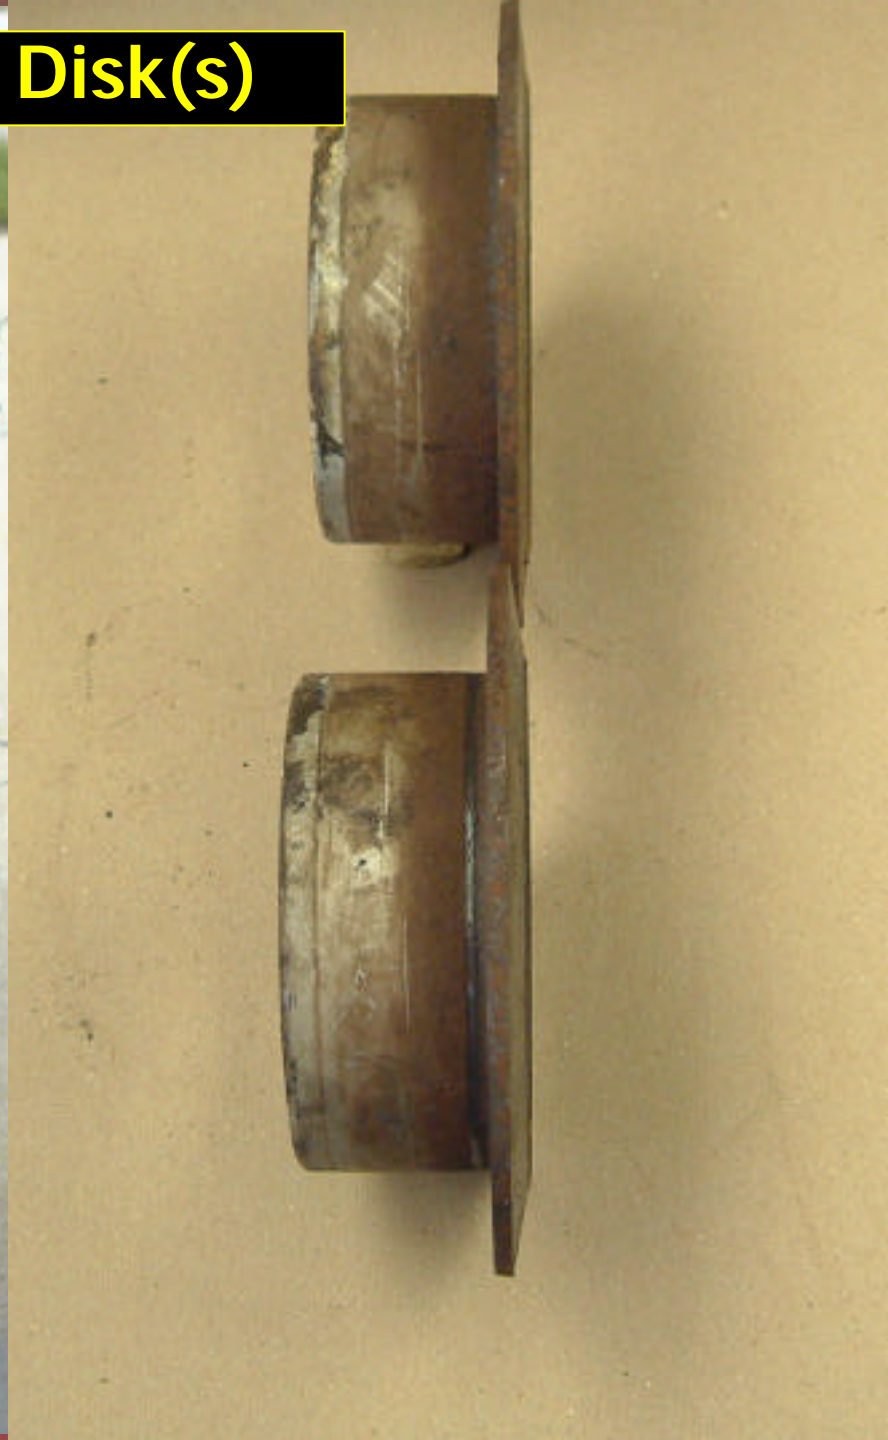
Landing Gear Bolts

Sheared Bolts

Bent Bolts

Necking down at bend

Bent Brake Disk(s)

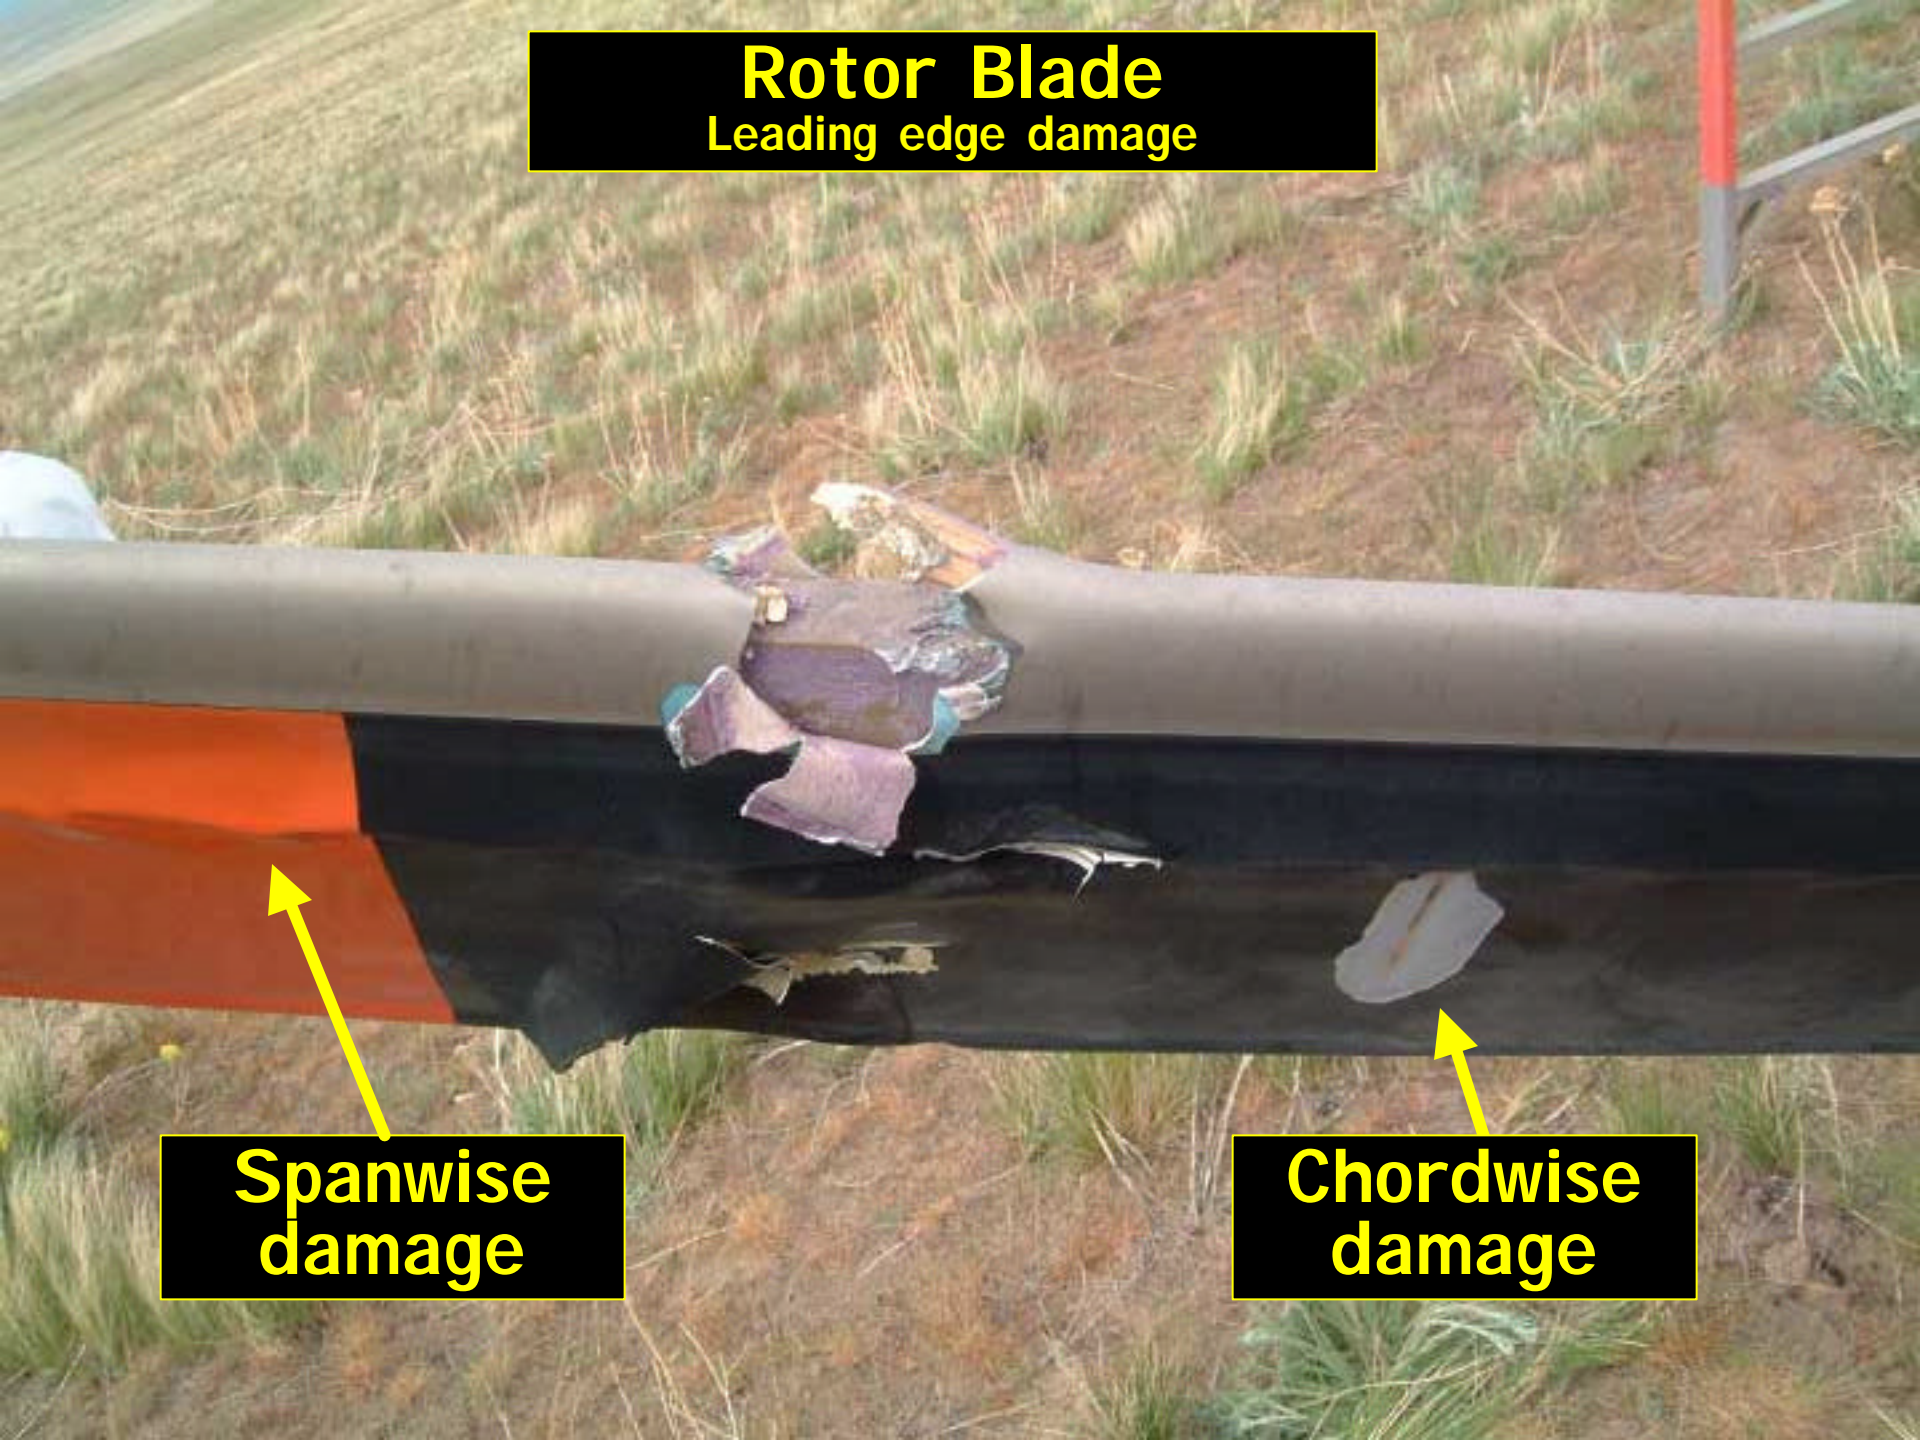
Rotor Blade

While using a net gun on an elk capture mission one of the net's weights struck the red main rotor blade causing substantial damage.

Leading edge damage

Spanwise
damage

Chordwise
damage

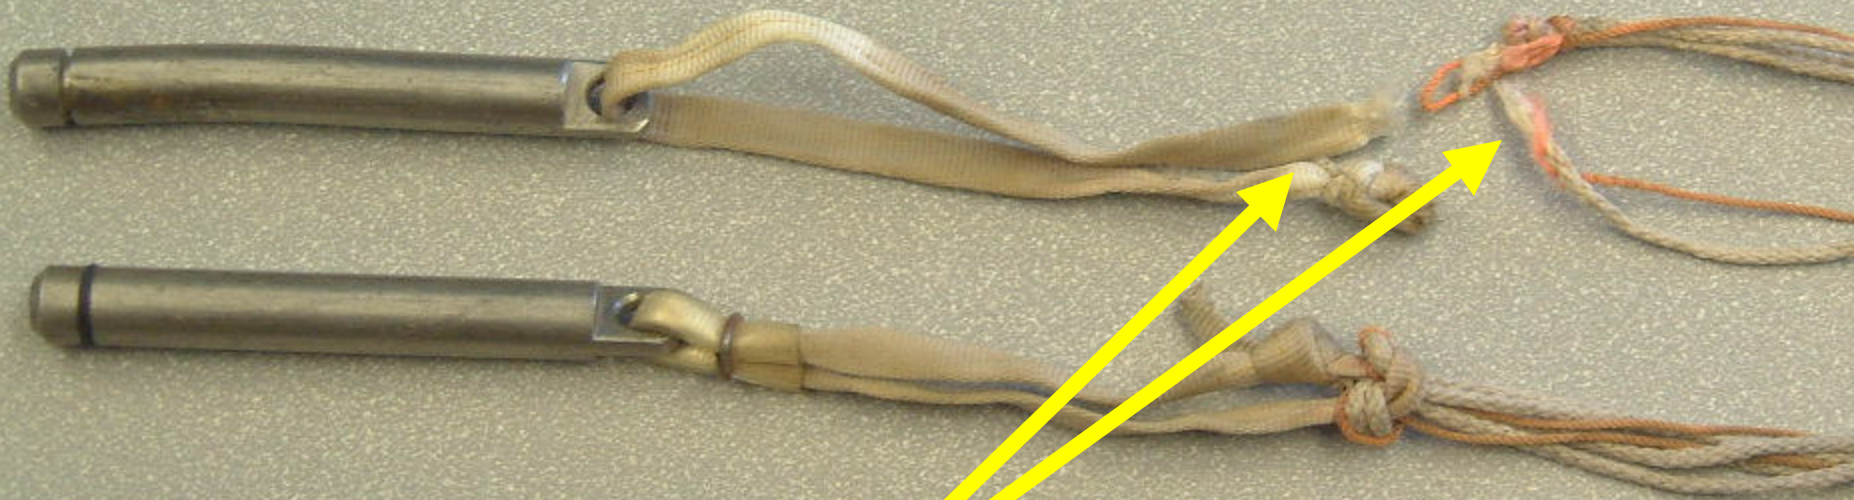
Net Weight with Lanyard and Net

Note two points of failure

“Failure of the netting material securing a net weight while maneuvering.

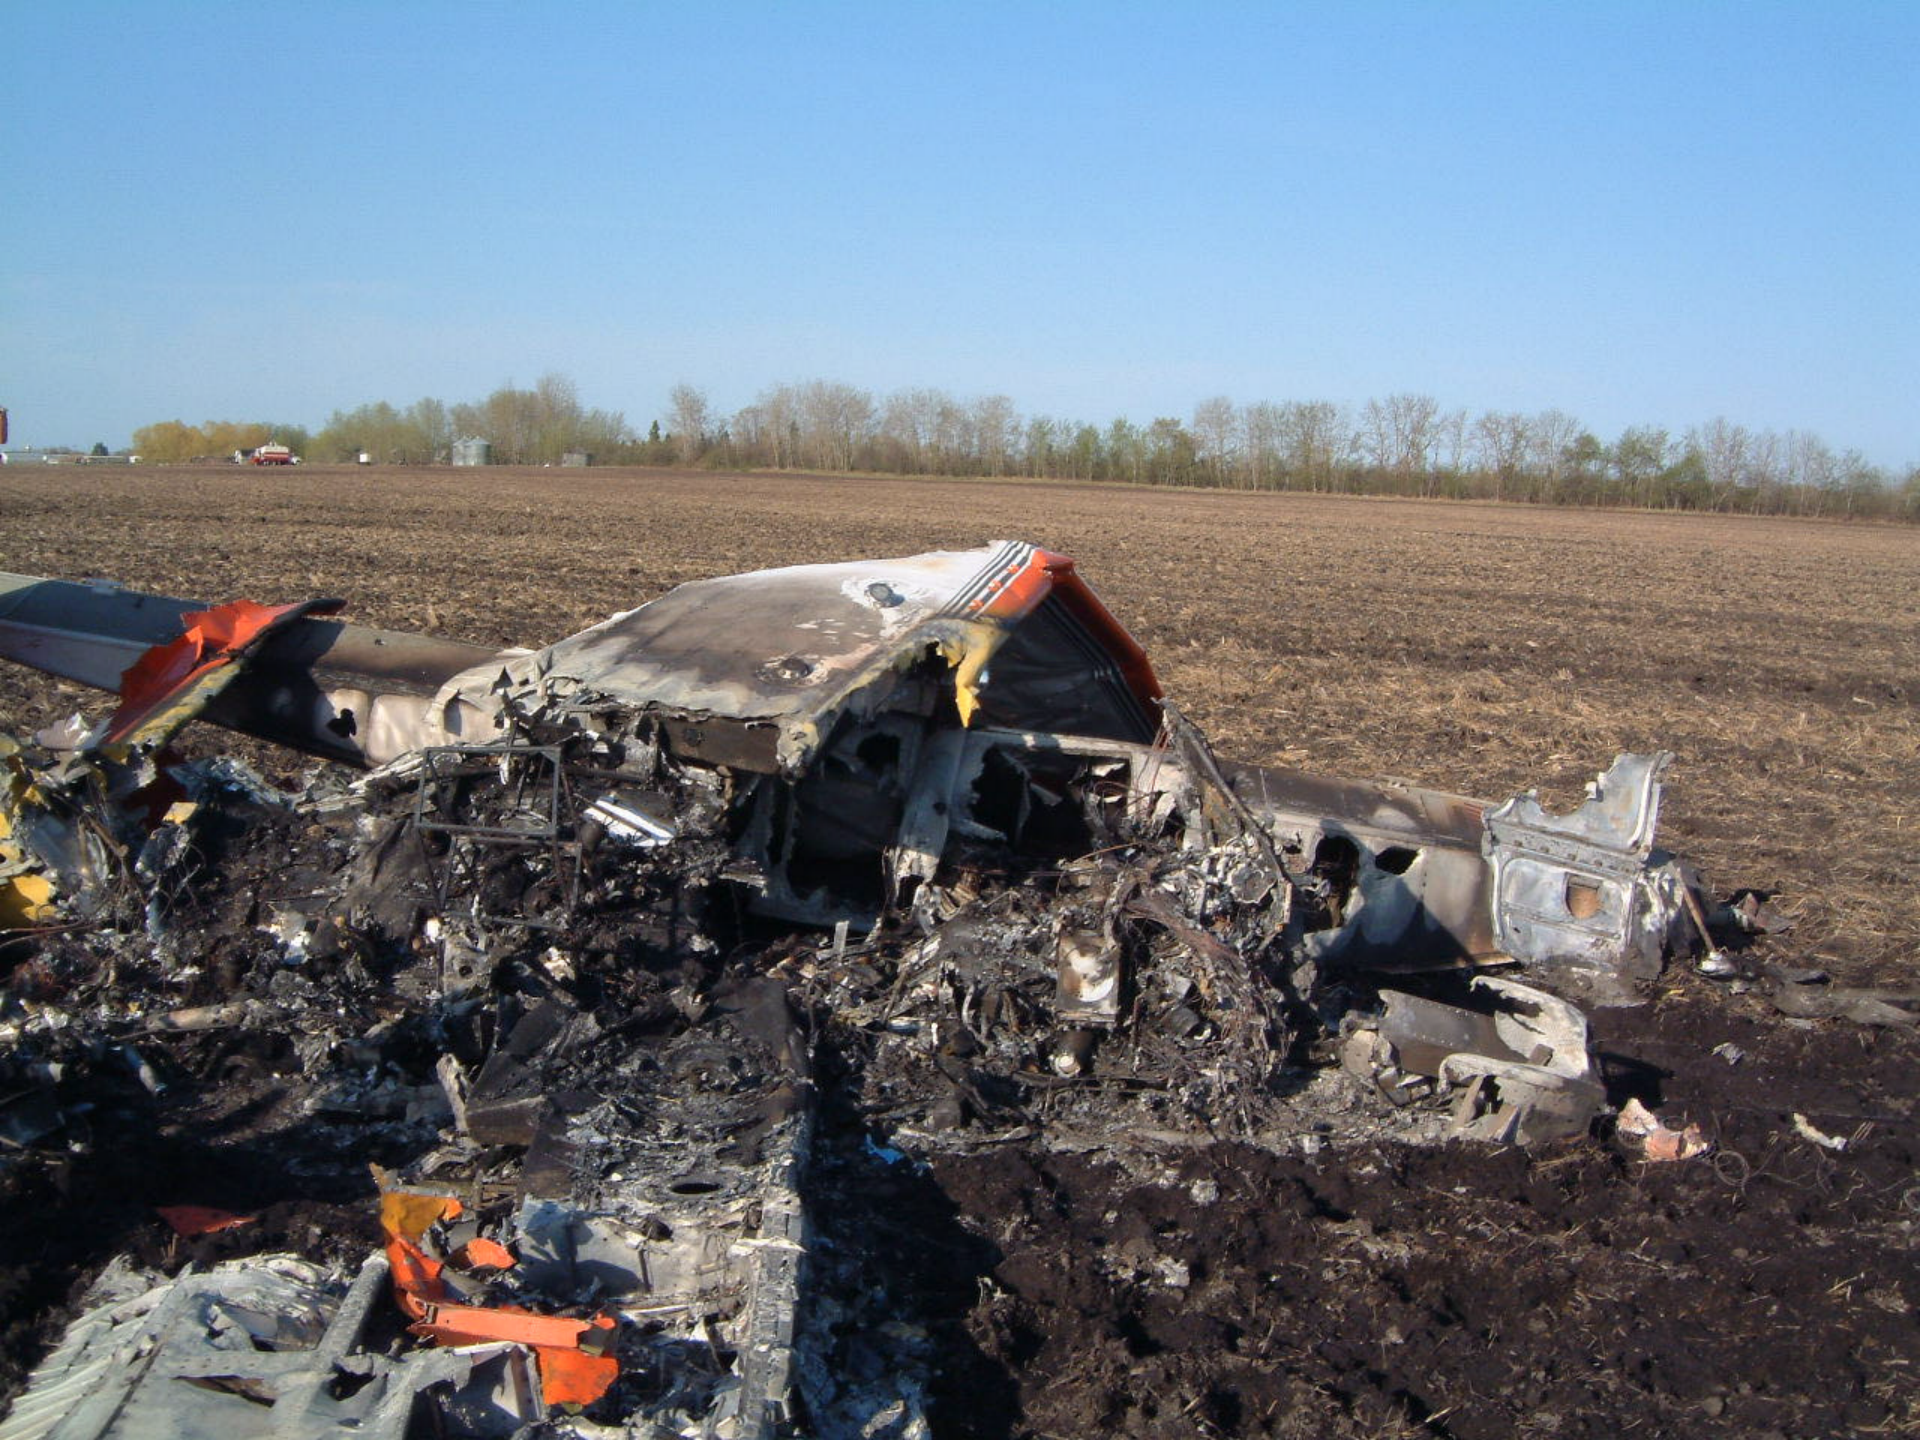
Prop impact

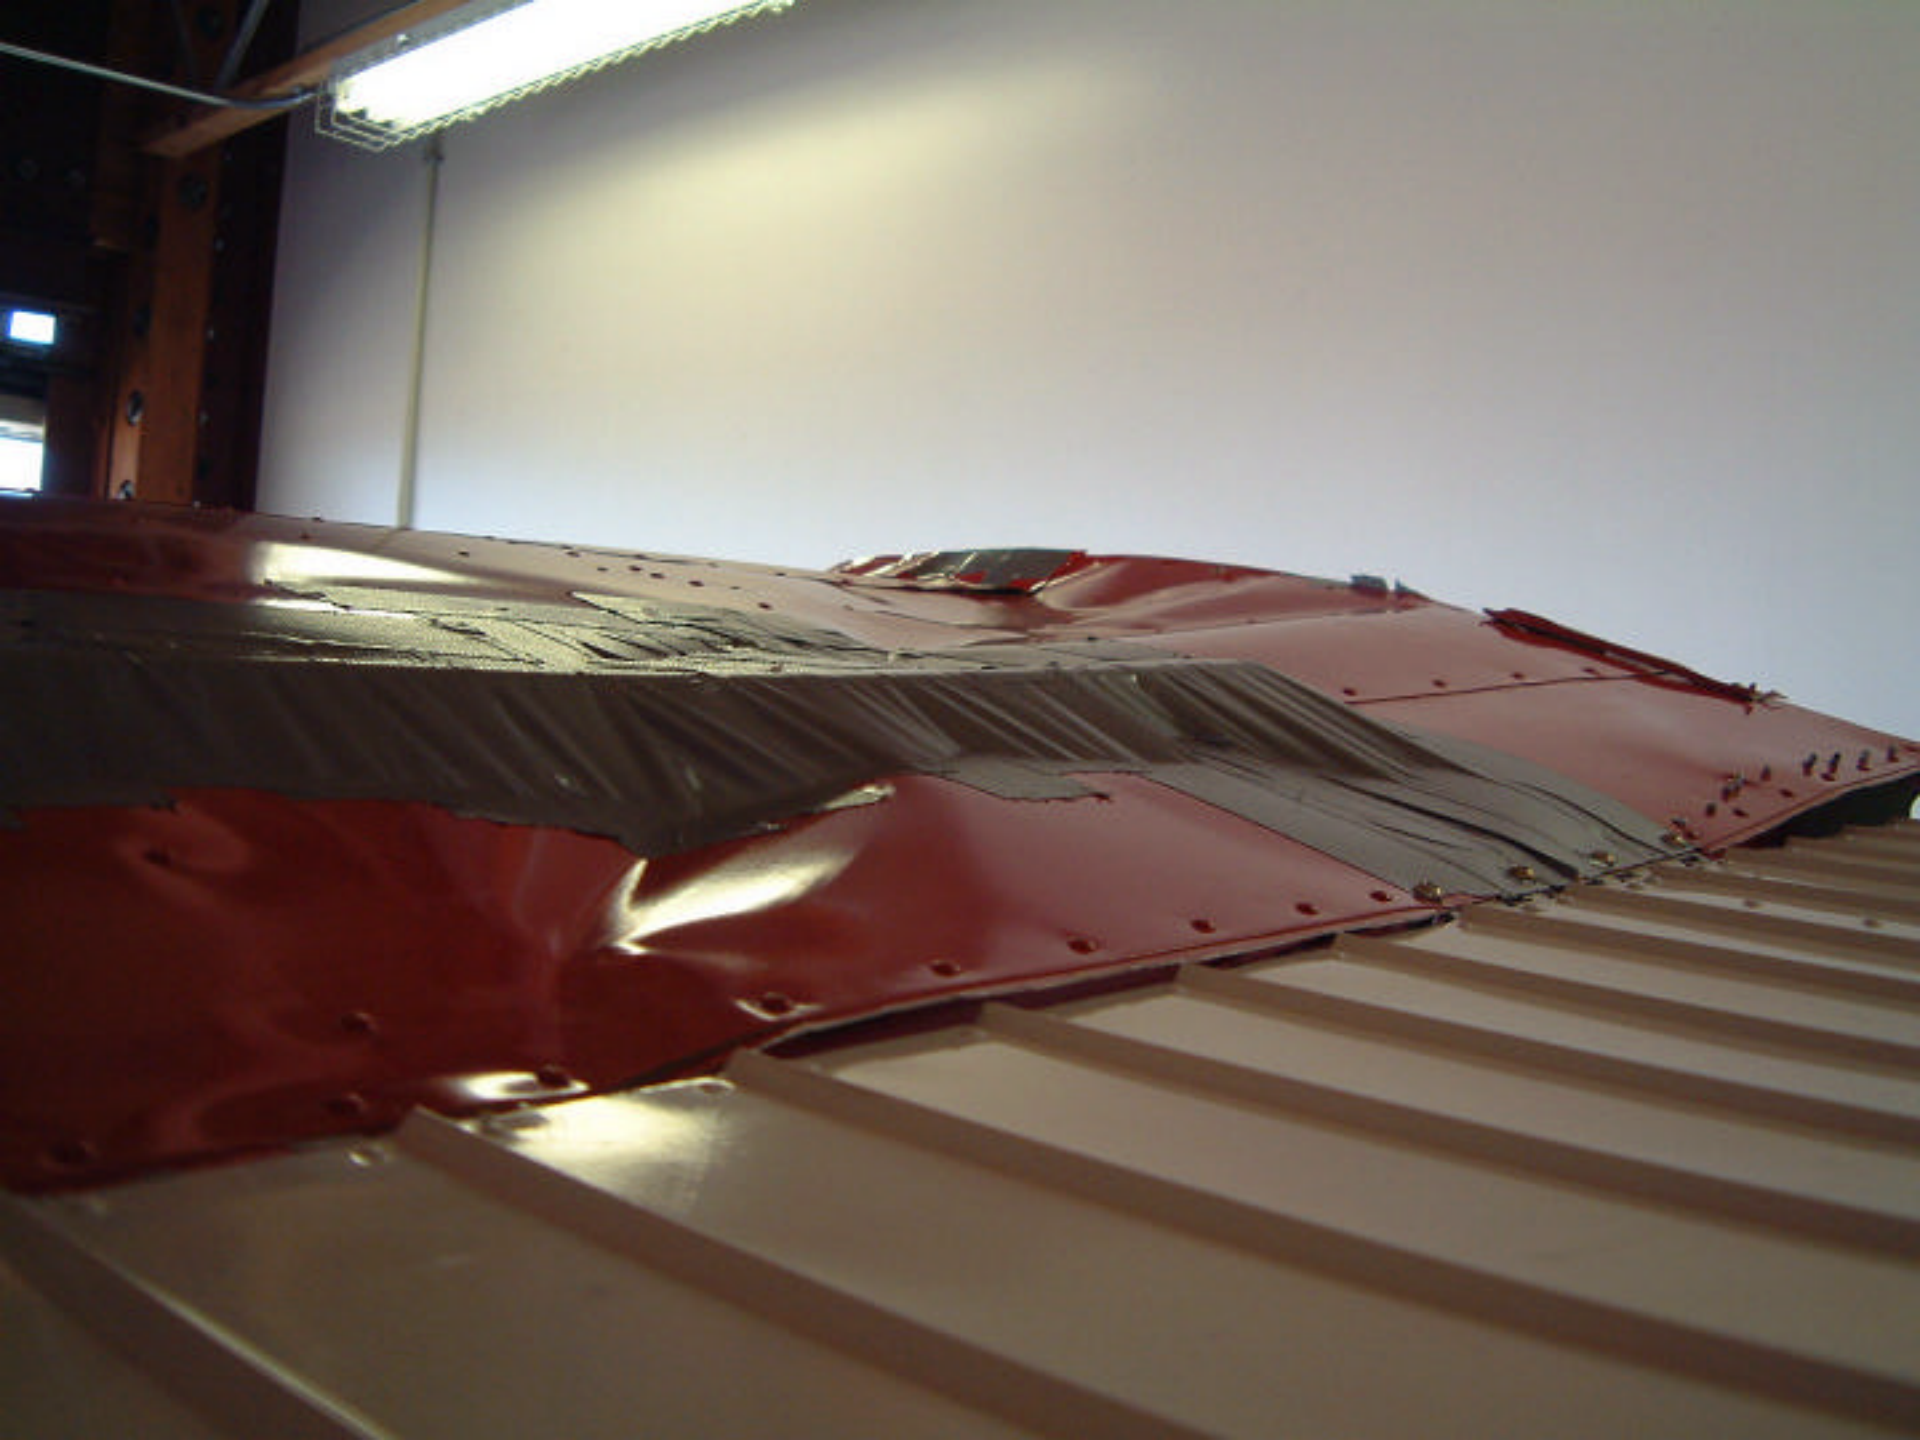
**Field repair
to leading edge
of right wing**

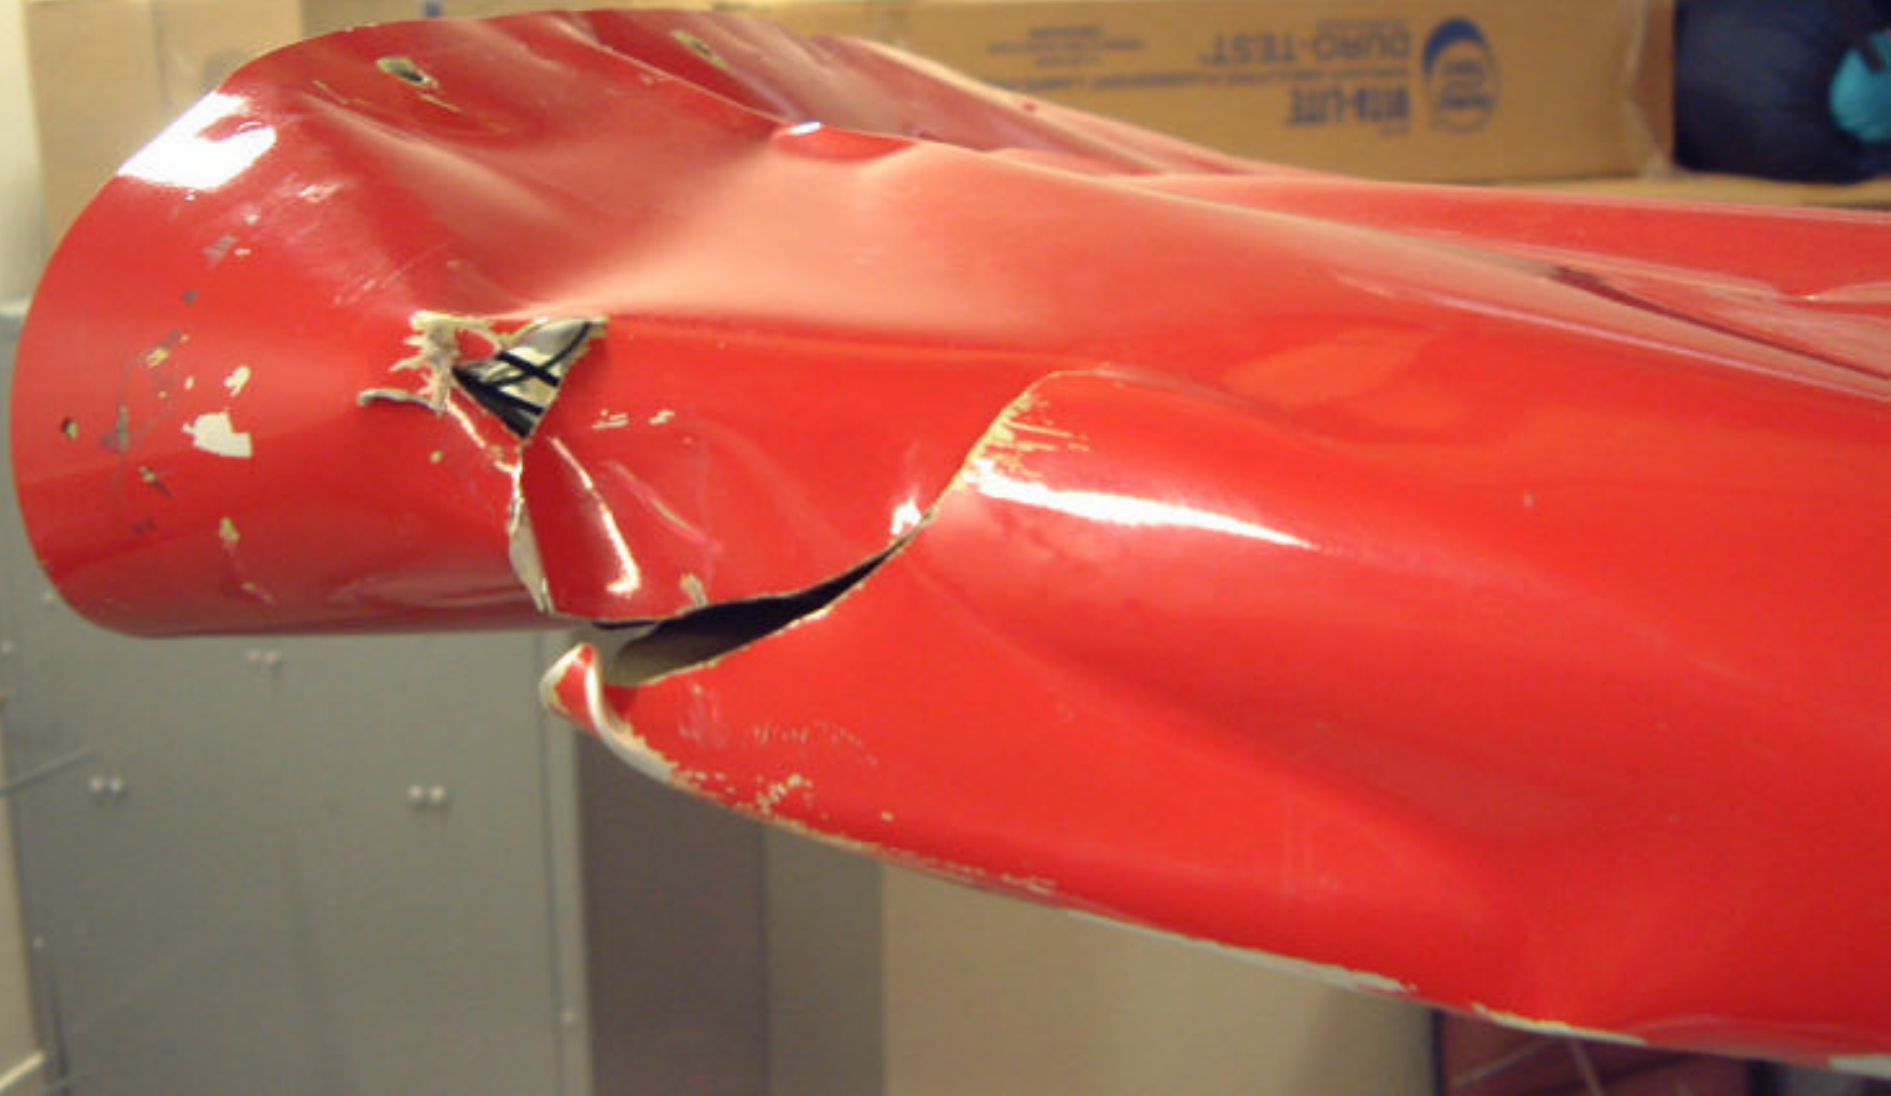
**Damage to leading edge
of right wing
(duct tape removed)**

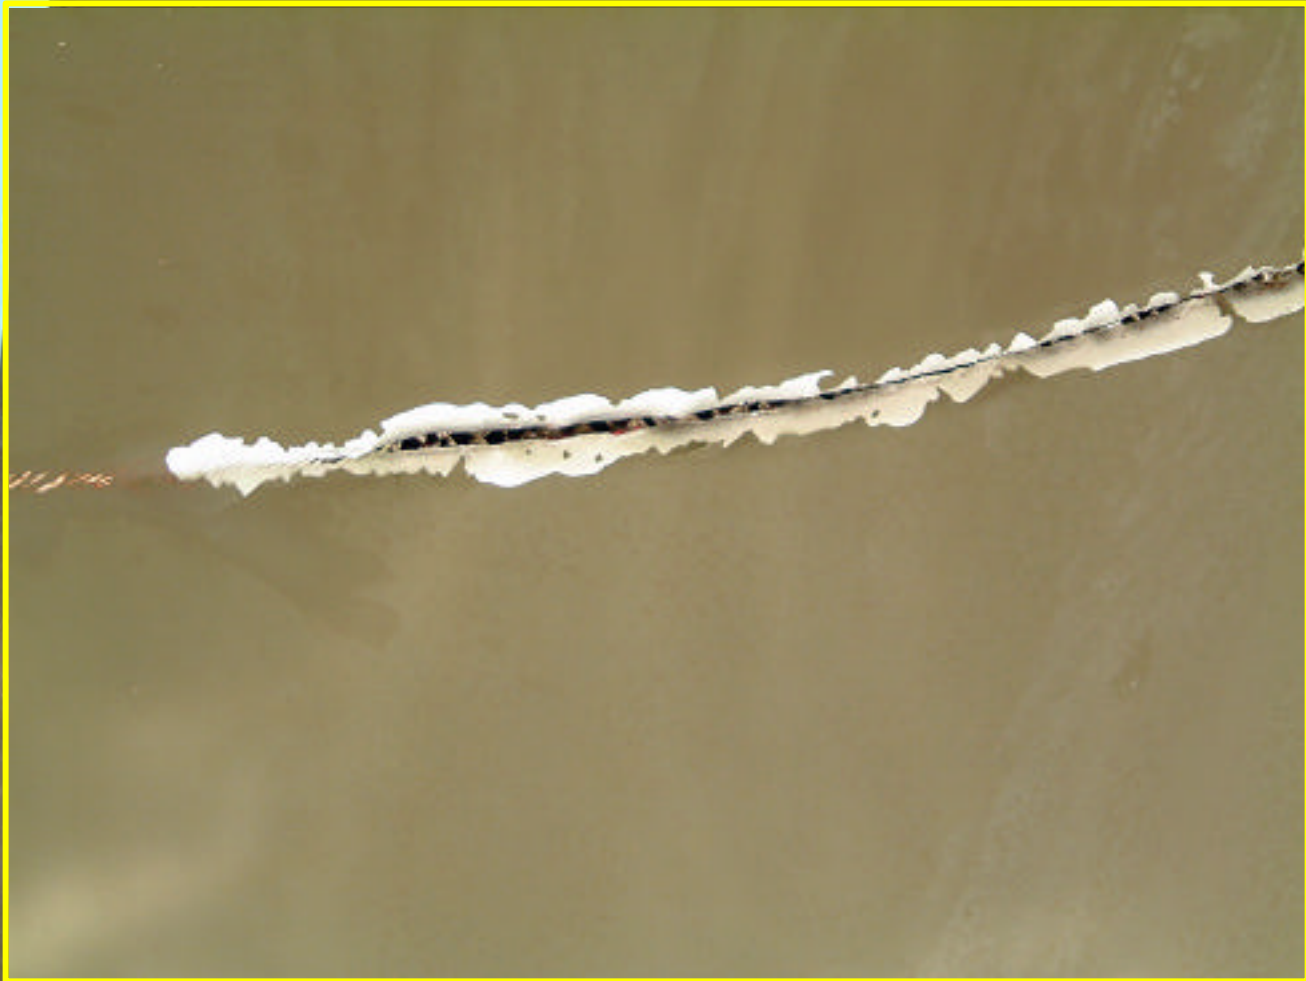
Main Rotor Damage

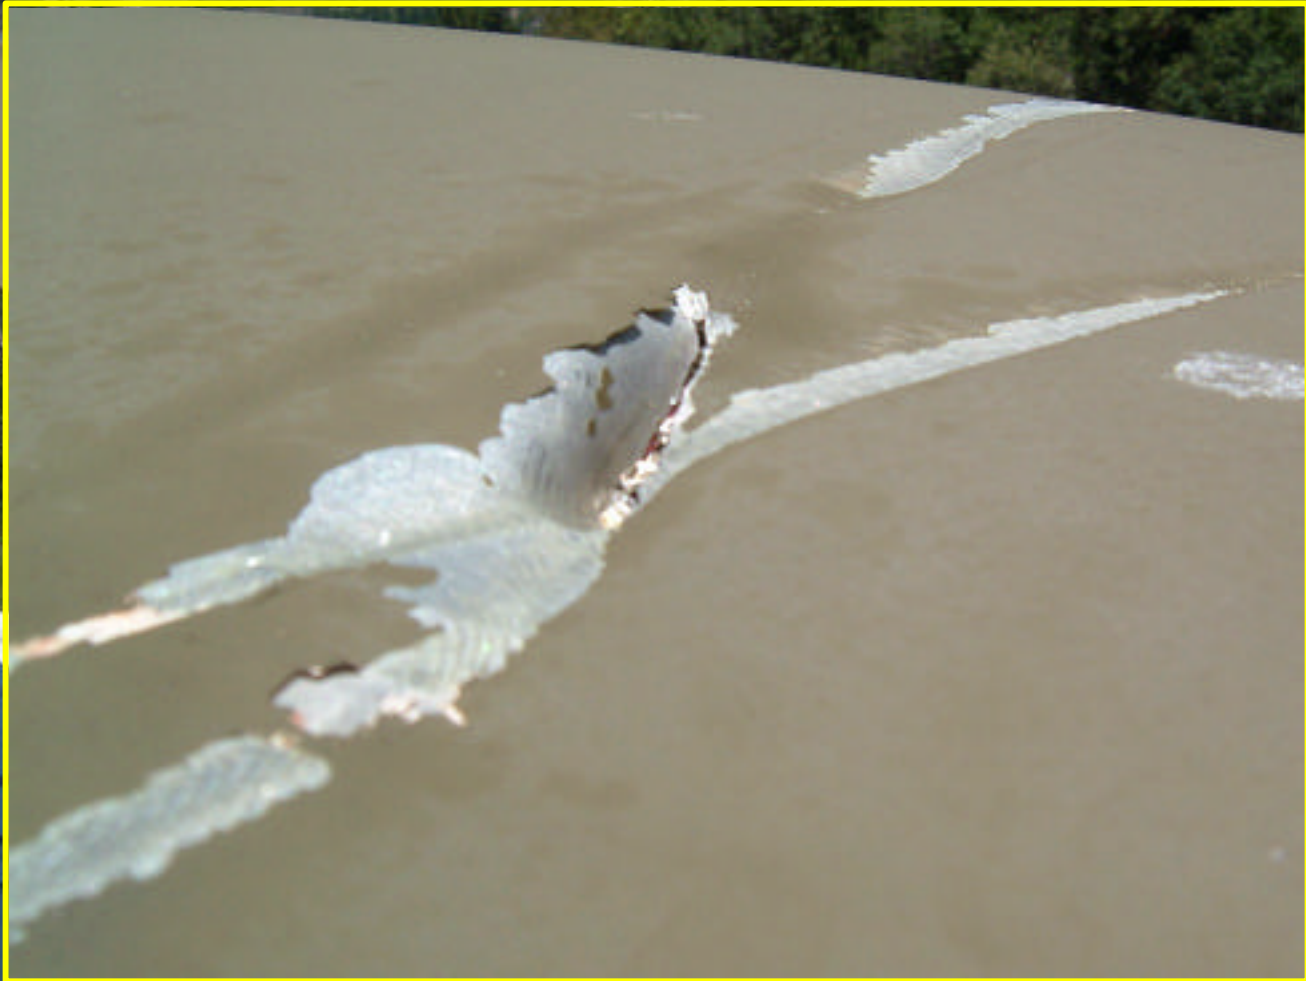
Main Rotor Damage
