FY 1998 Accident Review

**Department of the
Interior**

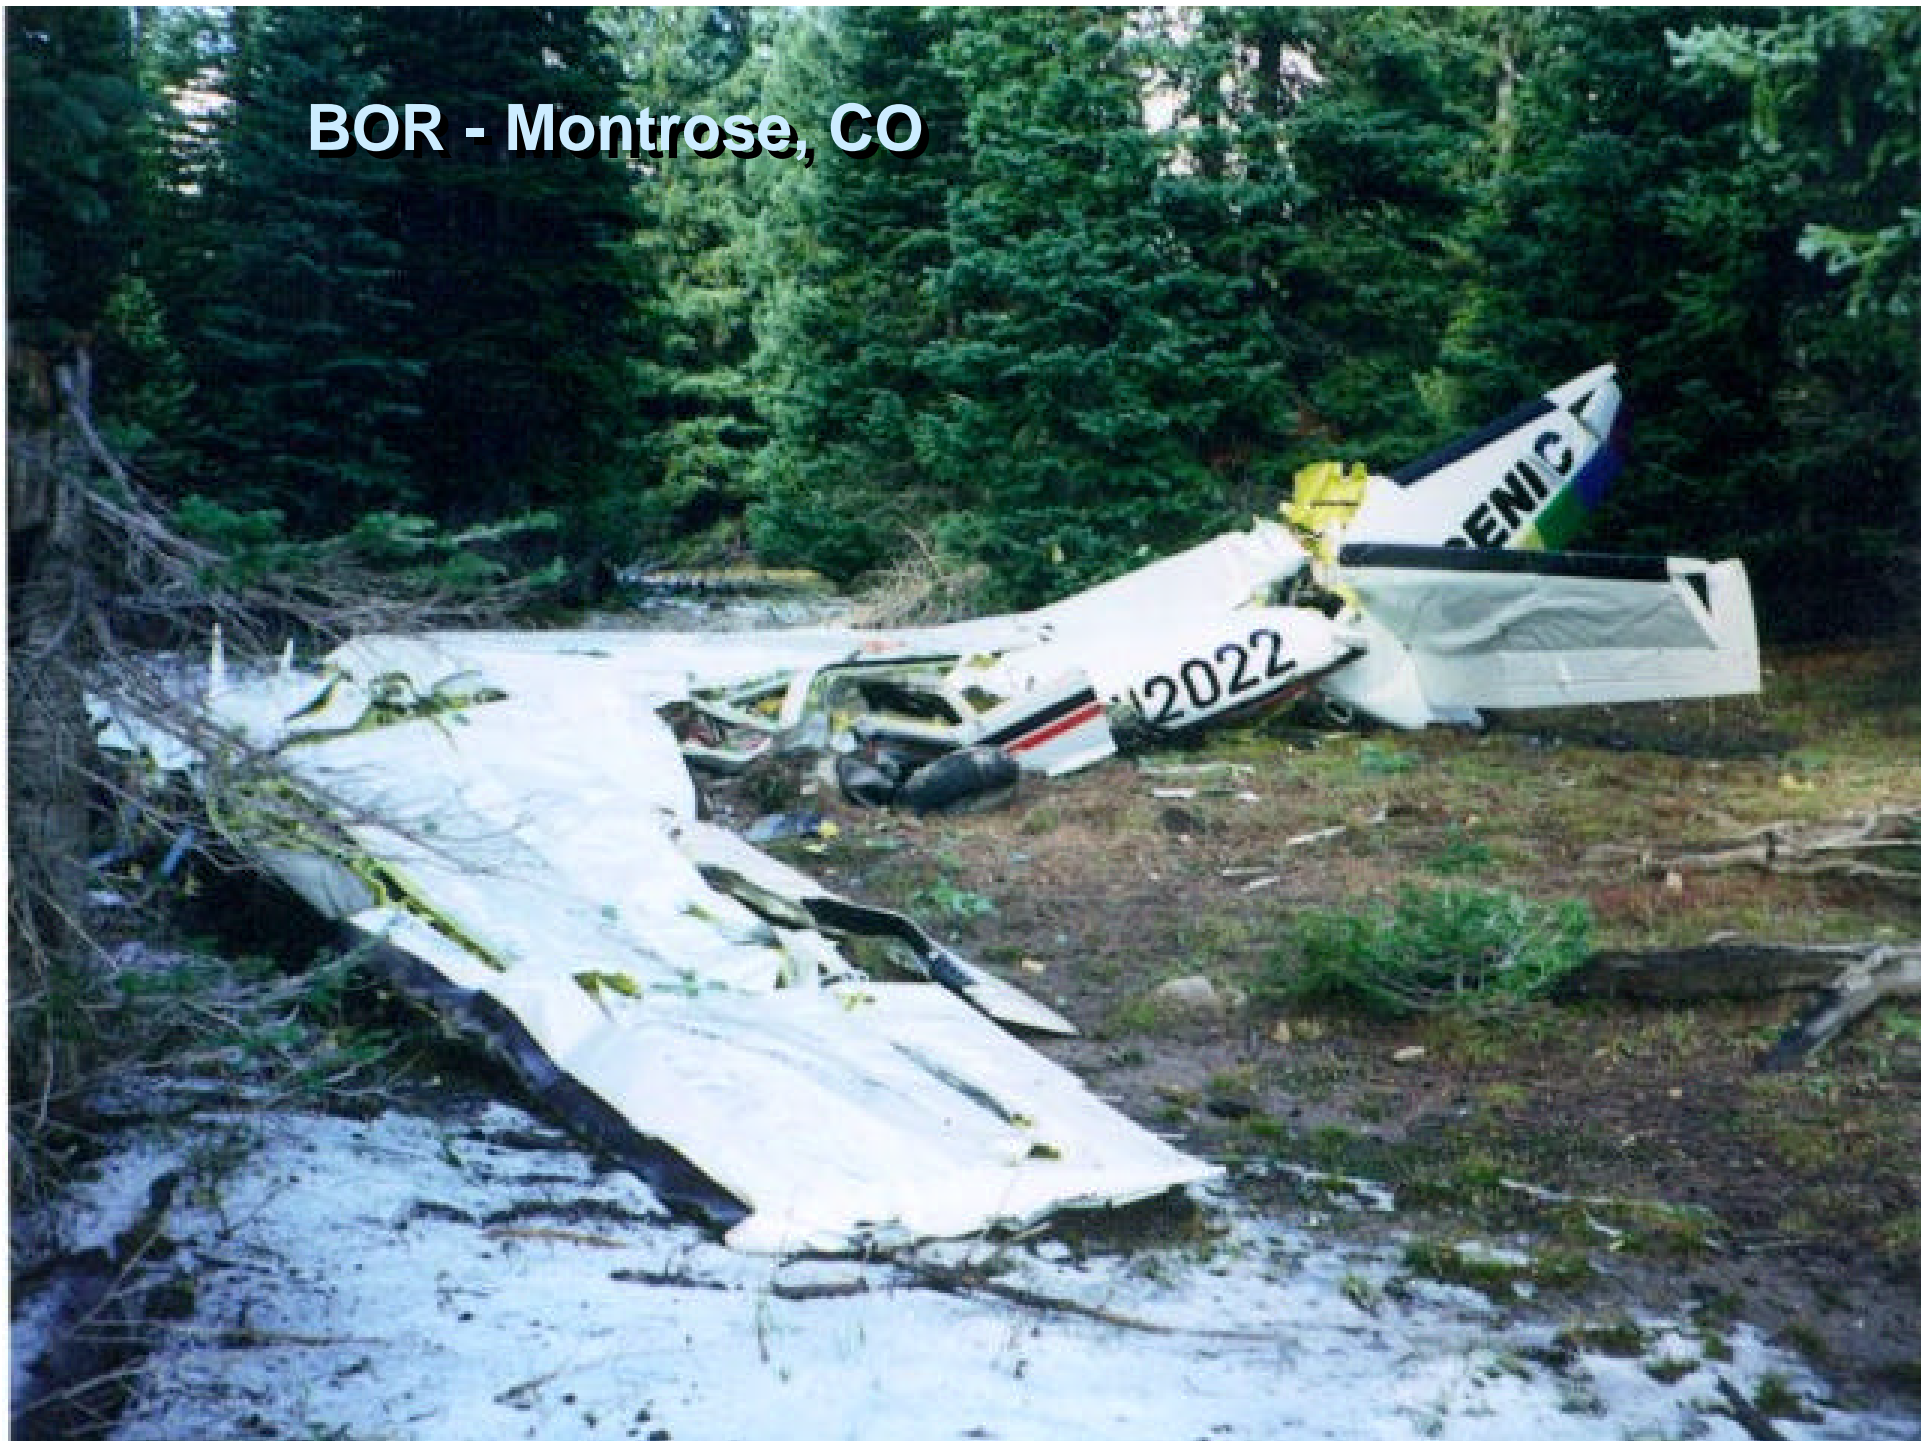
BOR - Montrose, CO

- ***Narrative:*** Lost control during climb out and collided with terrain. Witnesses indicate the plateau at the accident site was obscured with clouds. Climbed to 15,400' and then disappeared. Search party located airplane wreckage about 48 hours later. All of the victims were located within the airplane fuselage.

- ✓ Search for overdue aircraft delayed.
- ✓ **Pilot failed to confirm departure time.**
- ✓ FAA had no record of flight plan.

- ✓ Received 3 notices of Disapproval of Application for an ATP rating.
- ✓ **Proficiency Check 4-22-97.**
- ✓ No instrument time since 1994.
- ✓ **No current IFR qualification.**

- ✓ **O2 not used.**

- ✓ **124.5 lbs.. over certificated takeoff weight.**
- ✓ Wt. may have had adverse affect on climb performance.

- ✓ **ELT did not activate.**
- ✓ **No pre-existing failures or conditions prevented normal engine operation.**
- ✓ **Source of pilot's weather briefing could not be determined.**

- ✓ No evidence of prior knowledge of the Montrose, area, specifically the Uncompahgre Plateau.

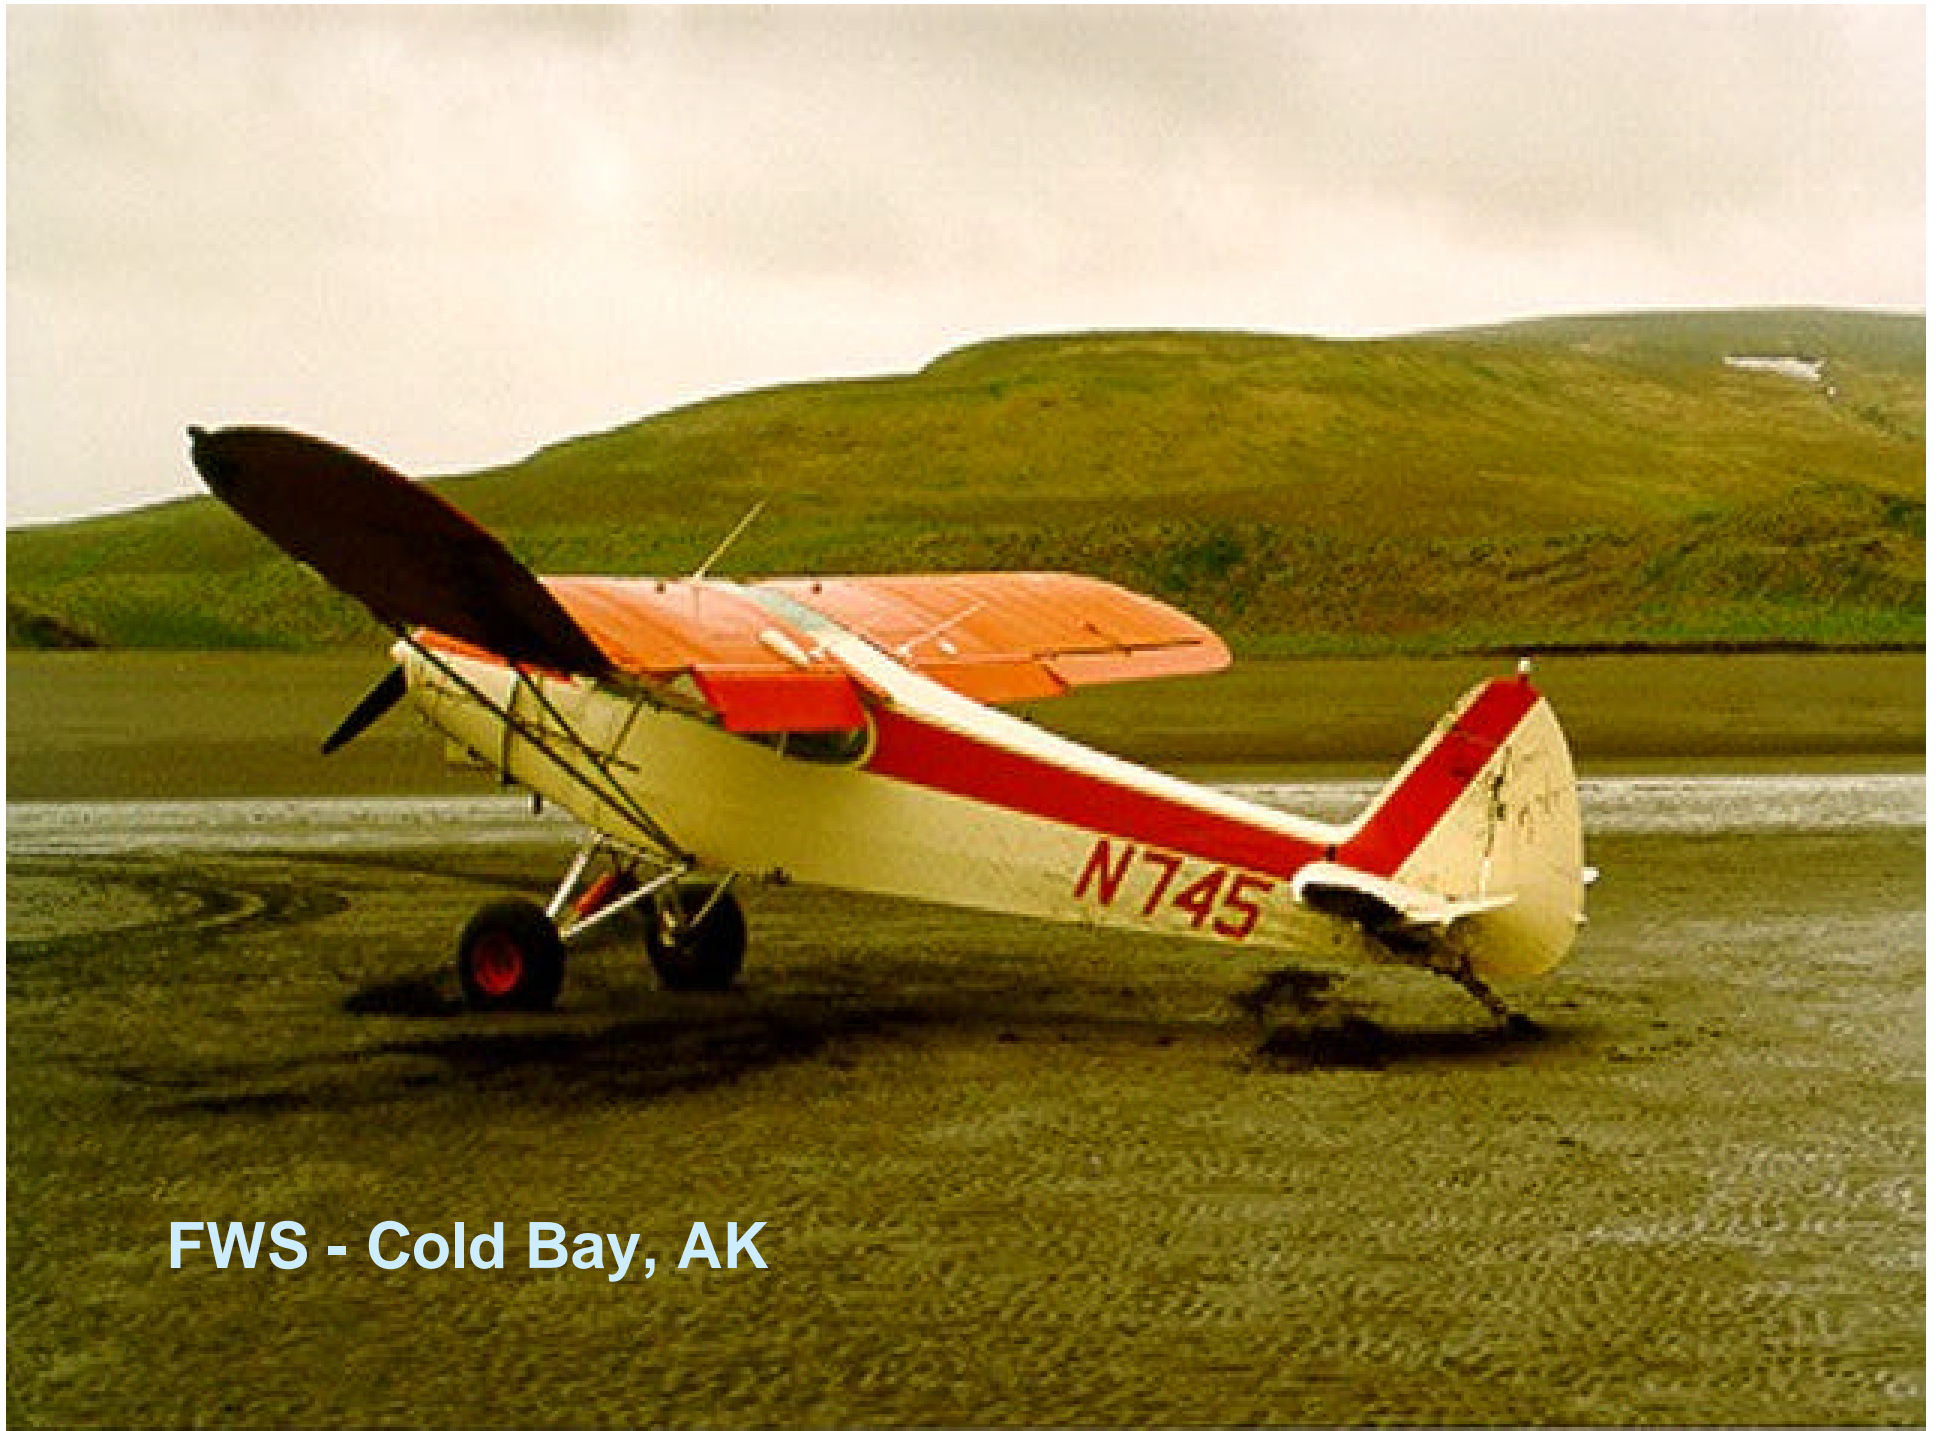
FWS - Cold Bay, AK

- ***Narrative:*** During takeoff, the airplane lifted off and drifted to the right, toward the shore. The aircraft was substantially damaged as a result of the ground loop to the right. Aircraft completed a turn of approx.. 160-degrees from the original departure path.

- ✓ **No beach takeoff & landings since initial training.**

- ✓ **On takeoff roll, aircraft veered to the right.**

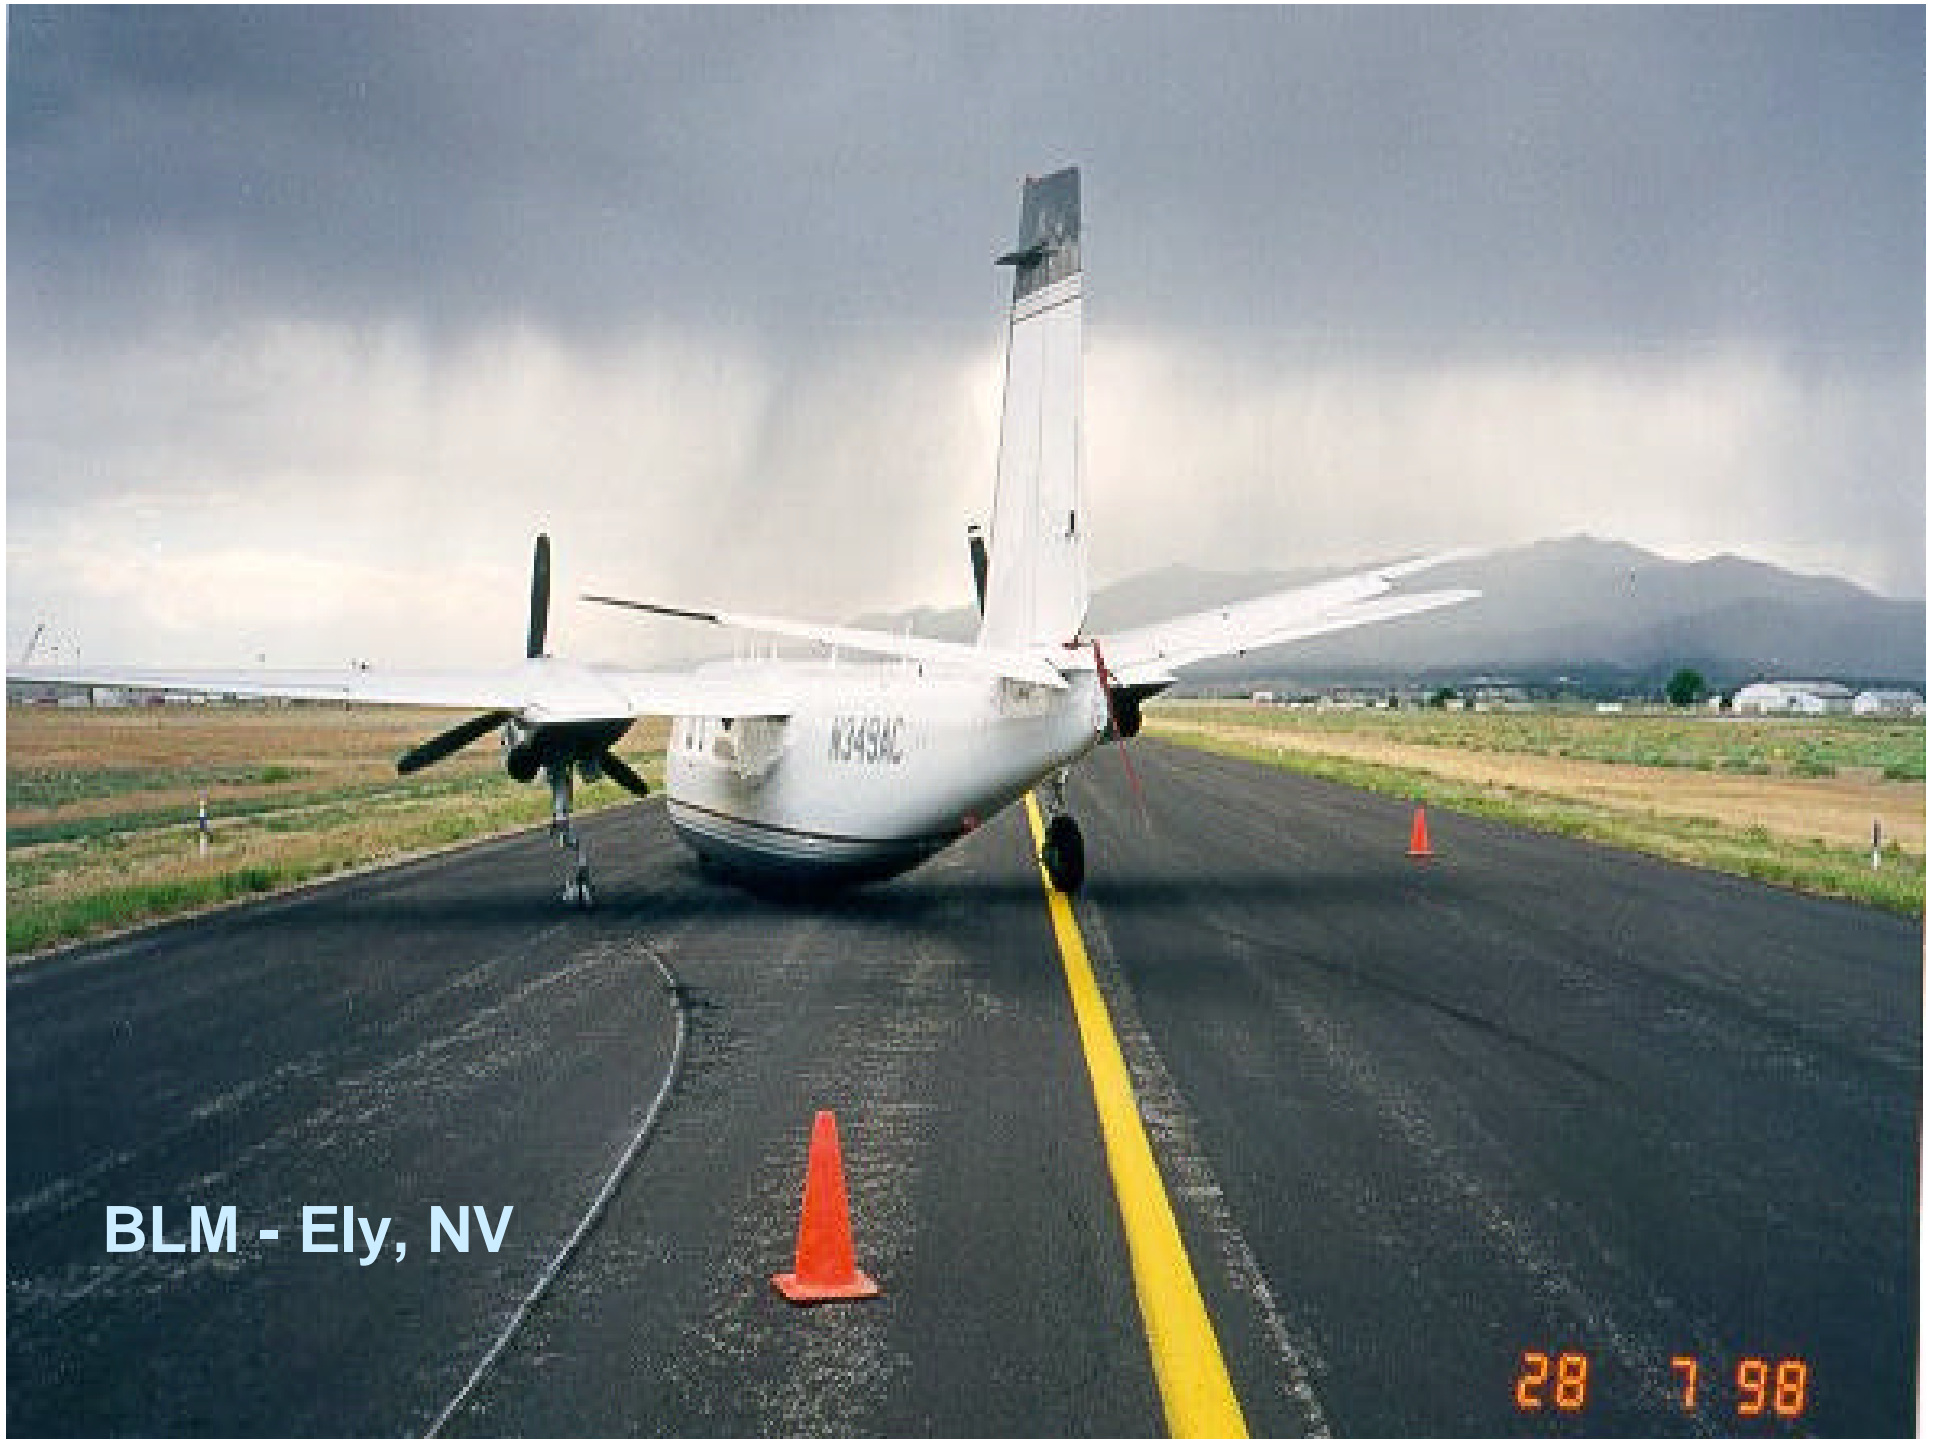
BLM - Ely, NV

- ***Narrative:*** According to the pilot and observer's statements, they were taxiing out for departure when the left wheel came off it's axle. As the strut grounded on the taxiway, the wing damage occurred. Left wing and fuselage crown skin was wrinkled, several wing ribs were damaged. Air pressure in right tire was 125 psi.

- ✓ **Right tire was inflated to 125 psi.**
Normally 80 psi.

- ✓ **Conducted week prior.**
- ✓ **Pilot requested mechanic to inflate tires, “both looked low”.**

- ✓ **Damage to left wing spar indicative of hard landing.**

- ✓ **Lugs from left wheel half could not be found after extensive search.**

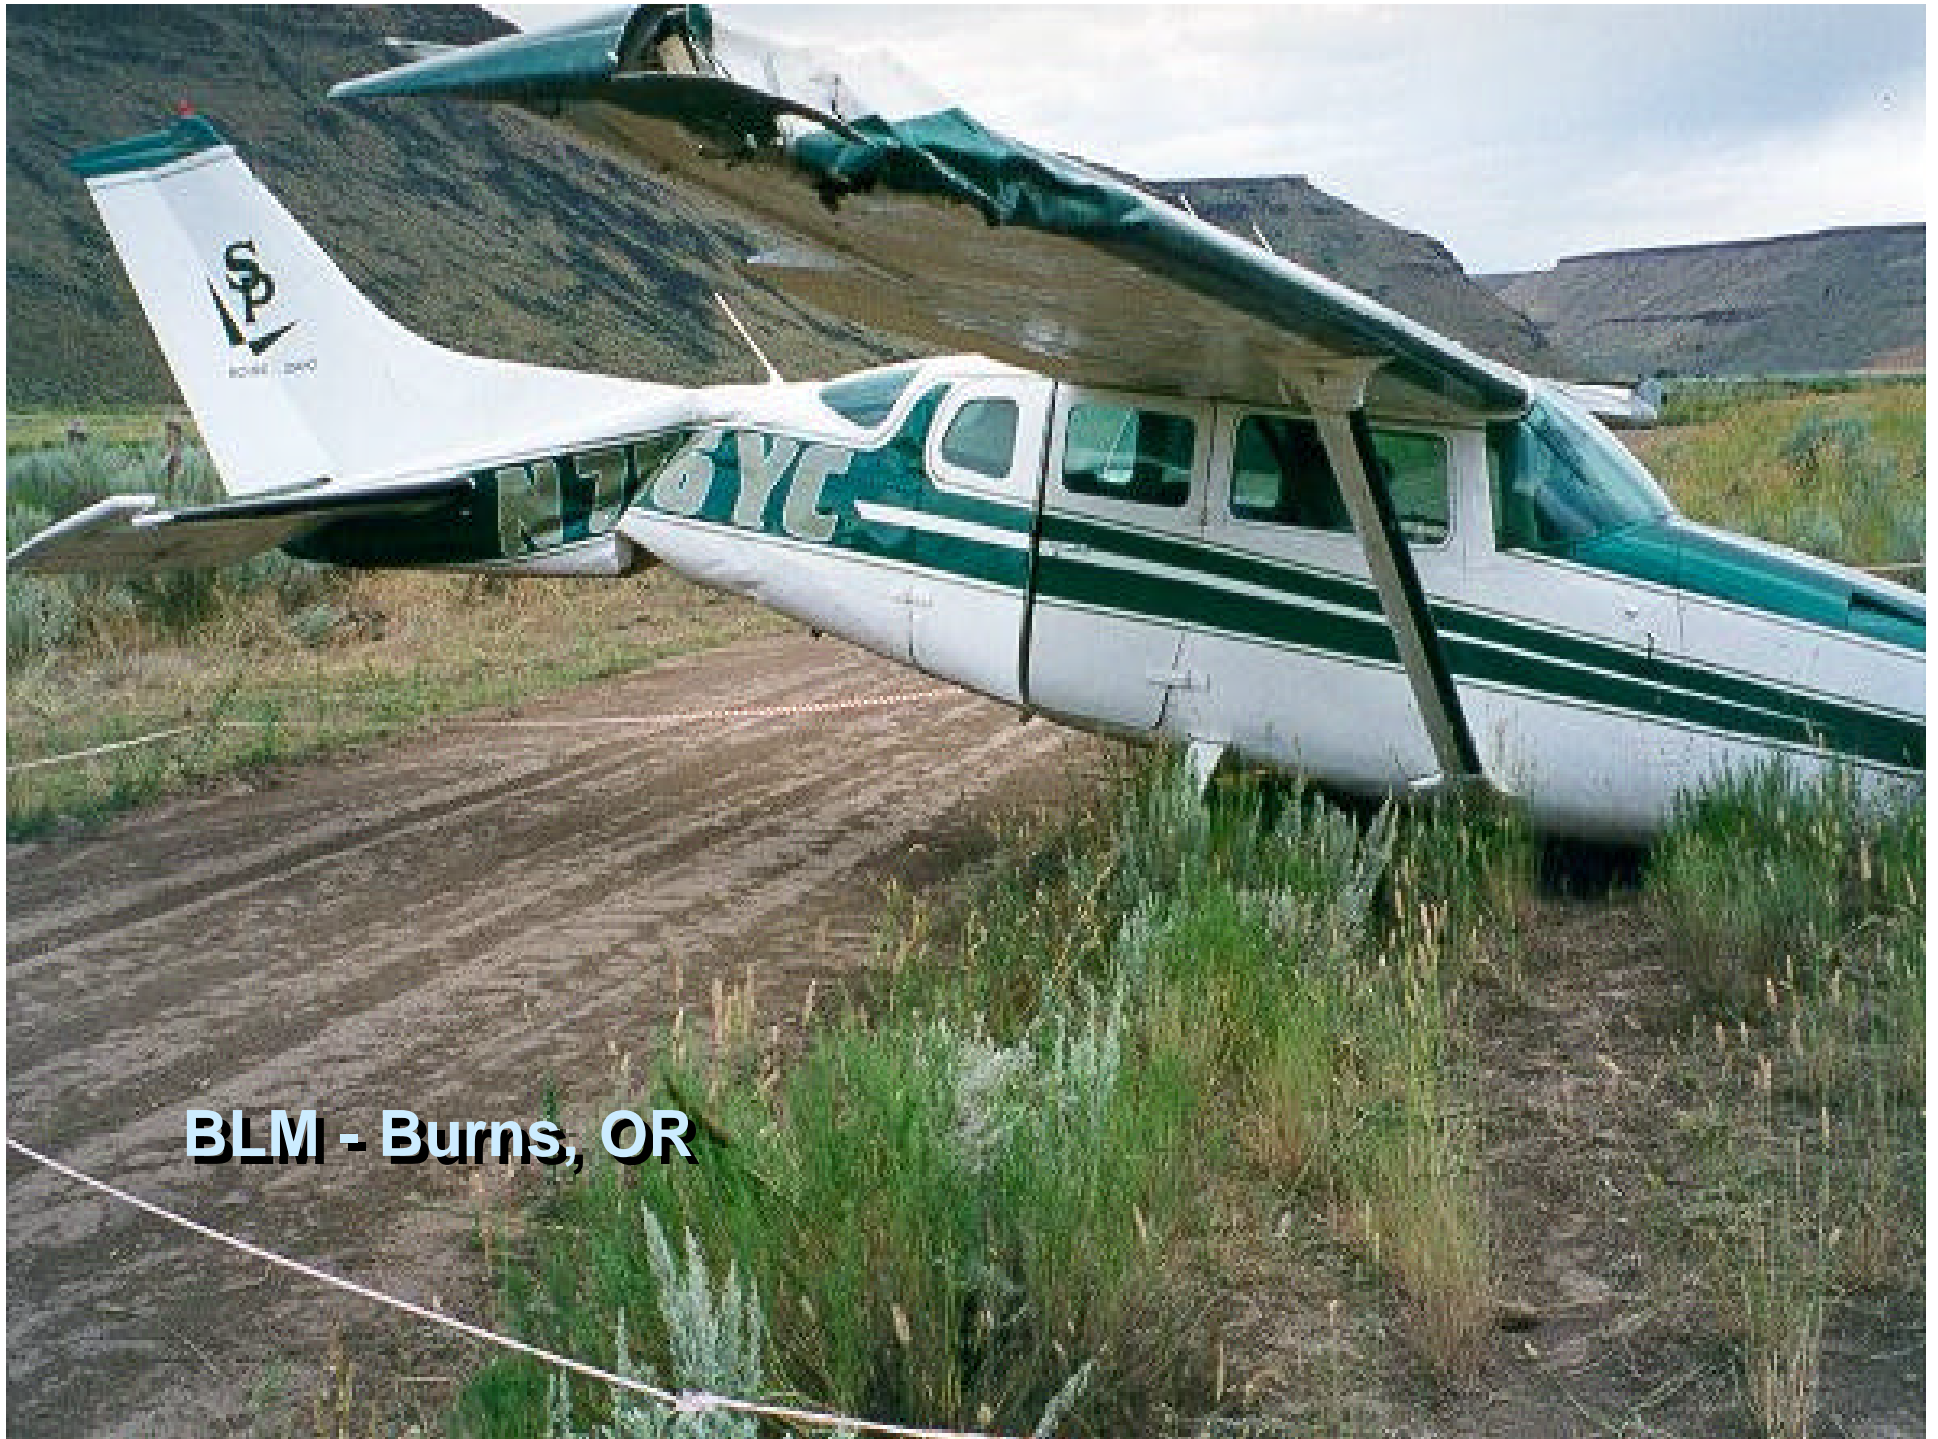
BLM - Burns, OR

- ***Narrative:*** Pilot reported to dispatcher that the engine had experienced a loss of power. Initiated a forced landing to a country road. During the landing roll, the airplane collided with a barb wire fence.

- ✓ **Engine crankshaft failed due to failure of #2 bearing. Engine was within 10 hours of TBO.**

- ✓ **Pilot sustained minor facial injuries hitting instrument panel.**

- **Emergency Egress Problems**
 - ✓ **Pilot unable to easily open right rear door due to flap setting.**
- **Aircraft ELT**
 - ✓ **ELT activated. Pilot subsequently turned it off, hampering rescue.**

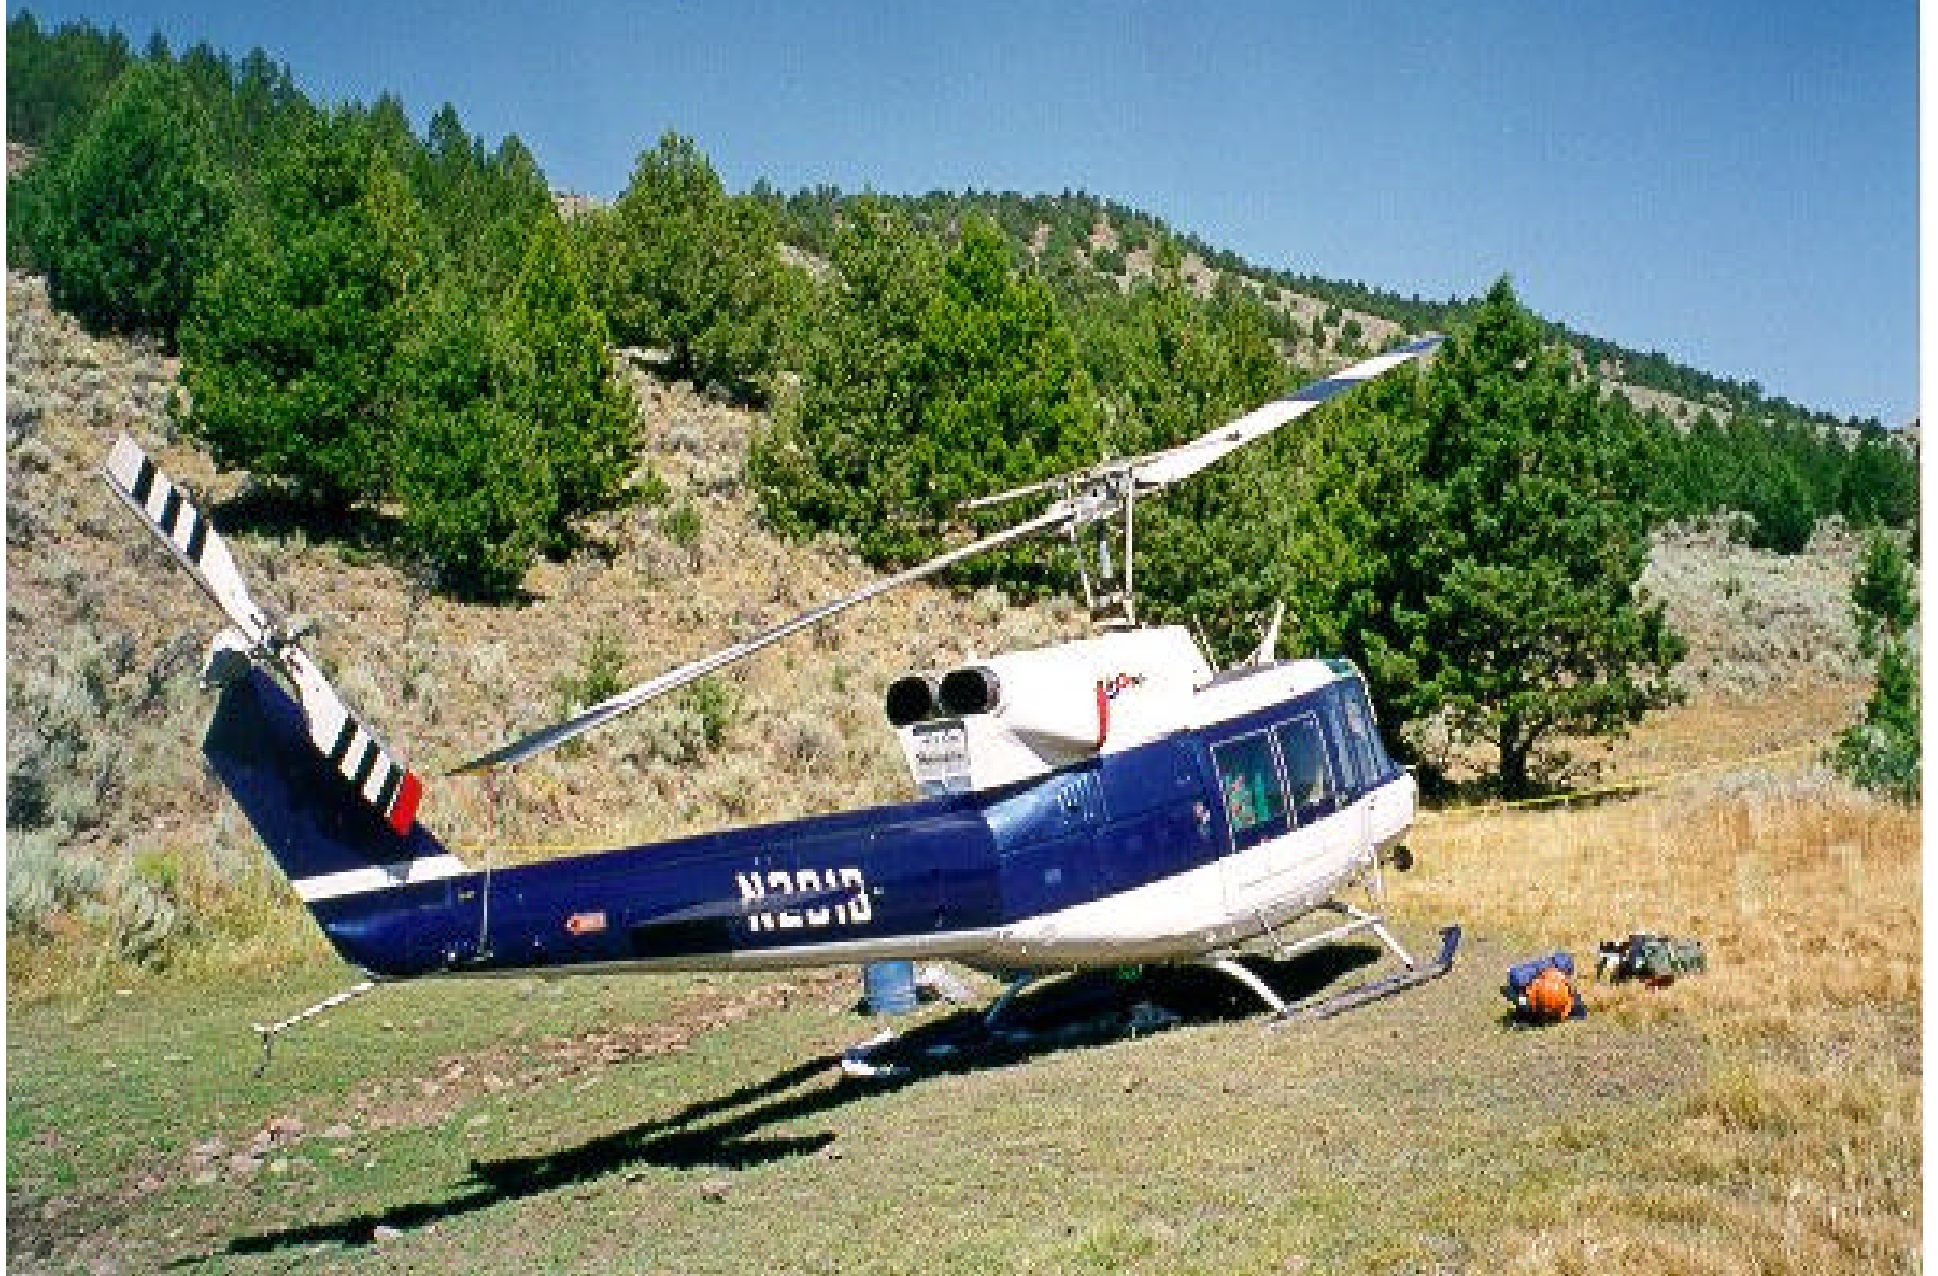
BLM - Juntura, OR

- ***Narrative:*** Pilot began to transition into a climb, perceived a loss of lift followed by a “low RPM” audio warning. Began maneuver towards nearby beach and attempted to release the bucket. Initial release unsuccessful. Second attempt detached cable from hook.

- ✓ **Pilot perception of engine failure while dipping water.**

- ✓ **Engine flight-idle stop sheared as a result of the cargo hook contacting fuselage and/or throttle linkage.**

- ✓ No apparent problems, except to throttle linkage.
- ✓ No problems with fuel filters or fuel control.
- ✓ Cargo hook found operational.

- ✓ **Angle of longline may become acute if bucket is dragged or snagged beneath surface.**

- ✓ **Recommend aircrew check bottom of A/C during preflight.**

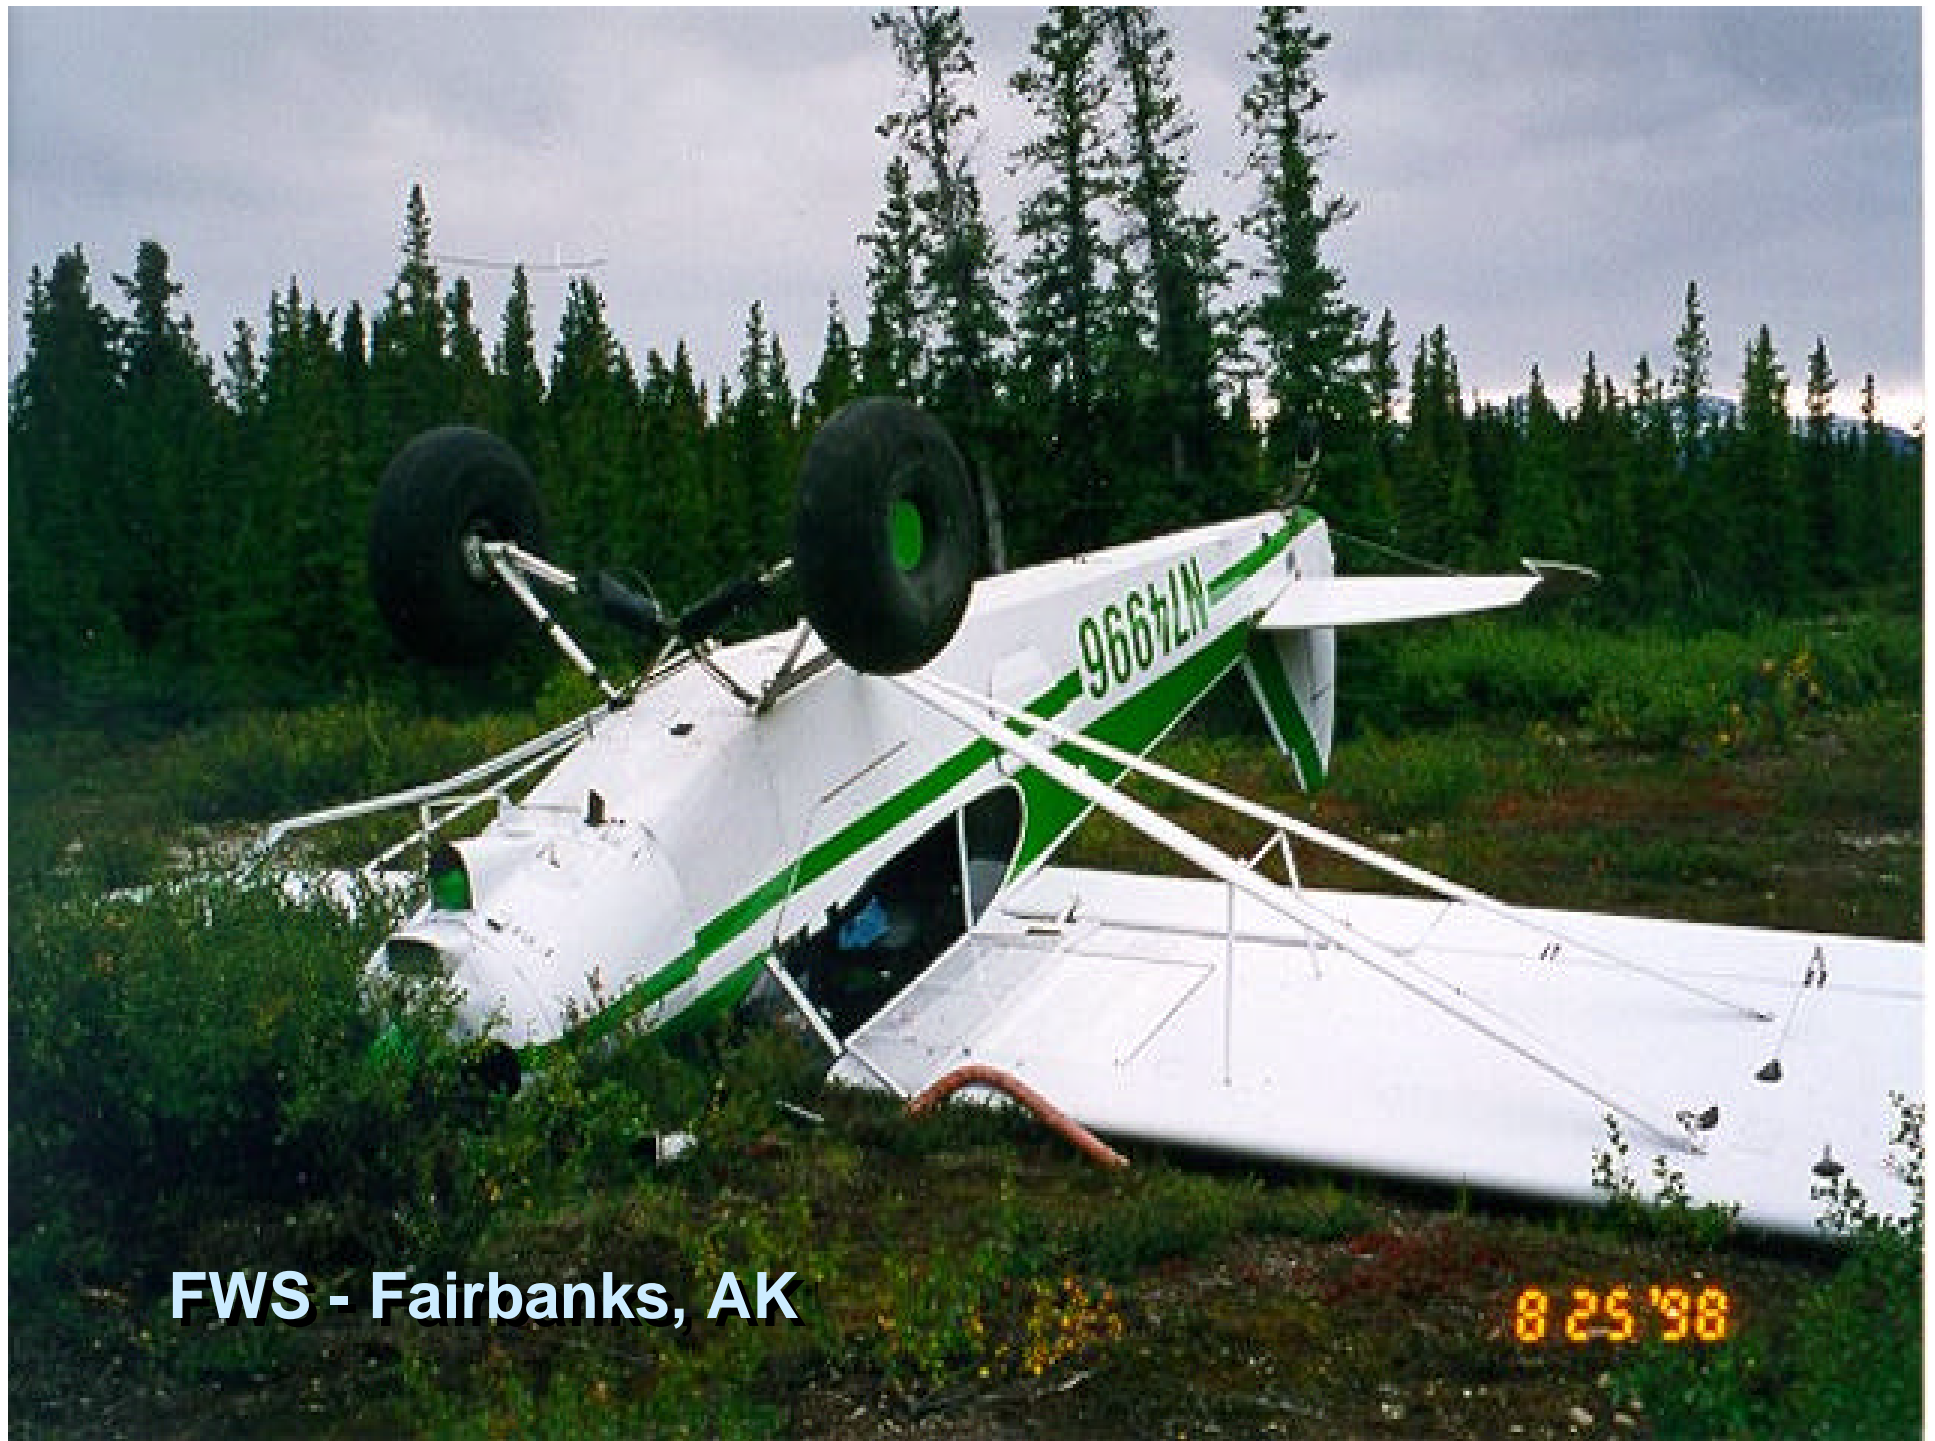
FWS - Fairbanks, AK

- ***Narrative:*** Pilot began takeoff. About halfway down the airstrip, he lowered the flaps. The airplane momentarily became airborne, but did not climb. Pilot then raised the flaps, and applied heavy braking. The airplane nosed over at the end of the strip.

- ✓ Insufficient flight plan. OPM 98-2 stated that pilots shall file and operate "...c) IAW a bureau-approved flight plan program..."

- ✓ **Flight plan not activated.**

- ✓ Aircraft did not climb fast enough to clear obstacles.

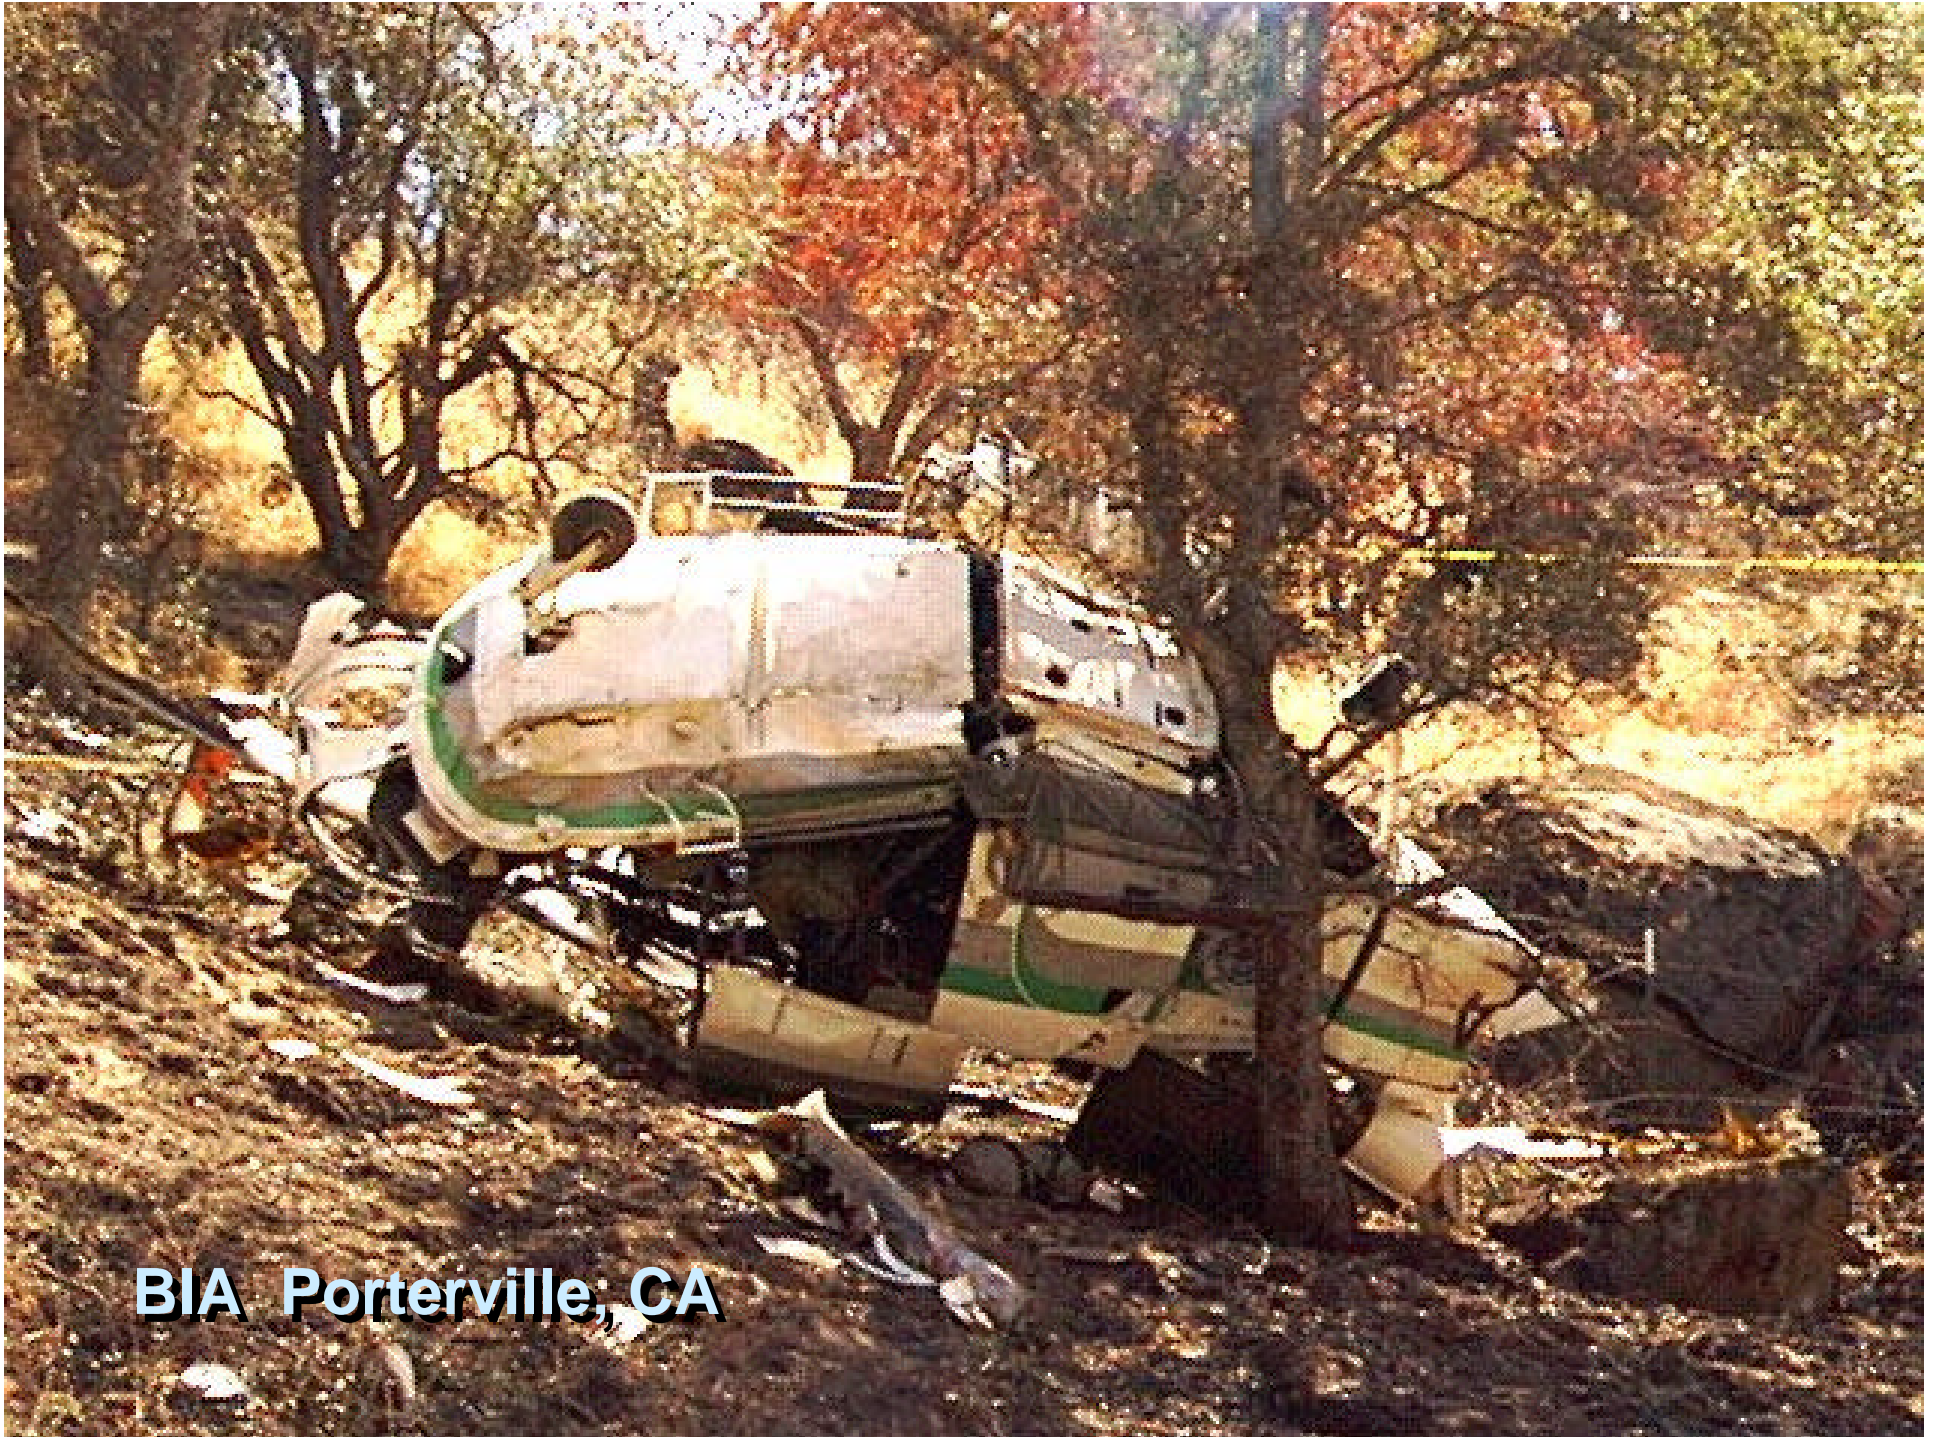
BIA Porterville, CA

- ***Narrative:*** Witnesses saw the helicopter fly down the side of a ridge with the water bucket on a 100' longline. The bucket became entangled in some trees and the line snapped and wrapped around the tail rotor. The tail rotor gearbox separated and the helicopter spun to the ground and rolled down the slope.

- **Human Factors**
 - ✓ Pilot stated, “he rushed” due to initial attack.
 - ✓ **Family member on ground crew.**
- **Procedure**
 - ✓ Pilot failed to ensure longline and bucket clear of obstacles prior to departure for next load of water.
