FY 1998 Accident Review

**Department of the
Interior**

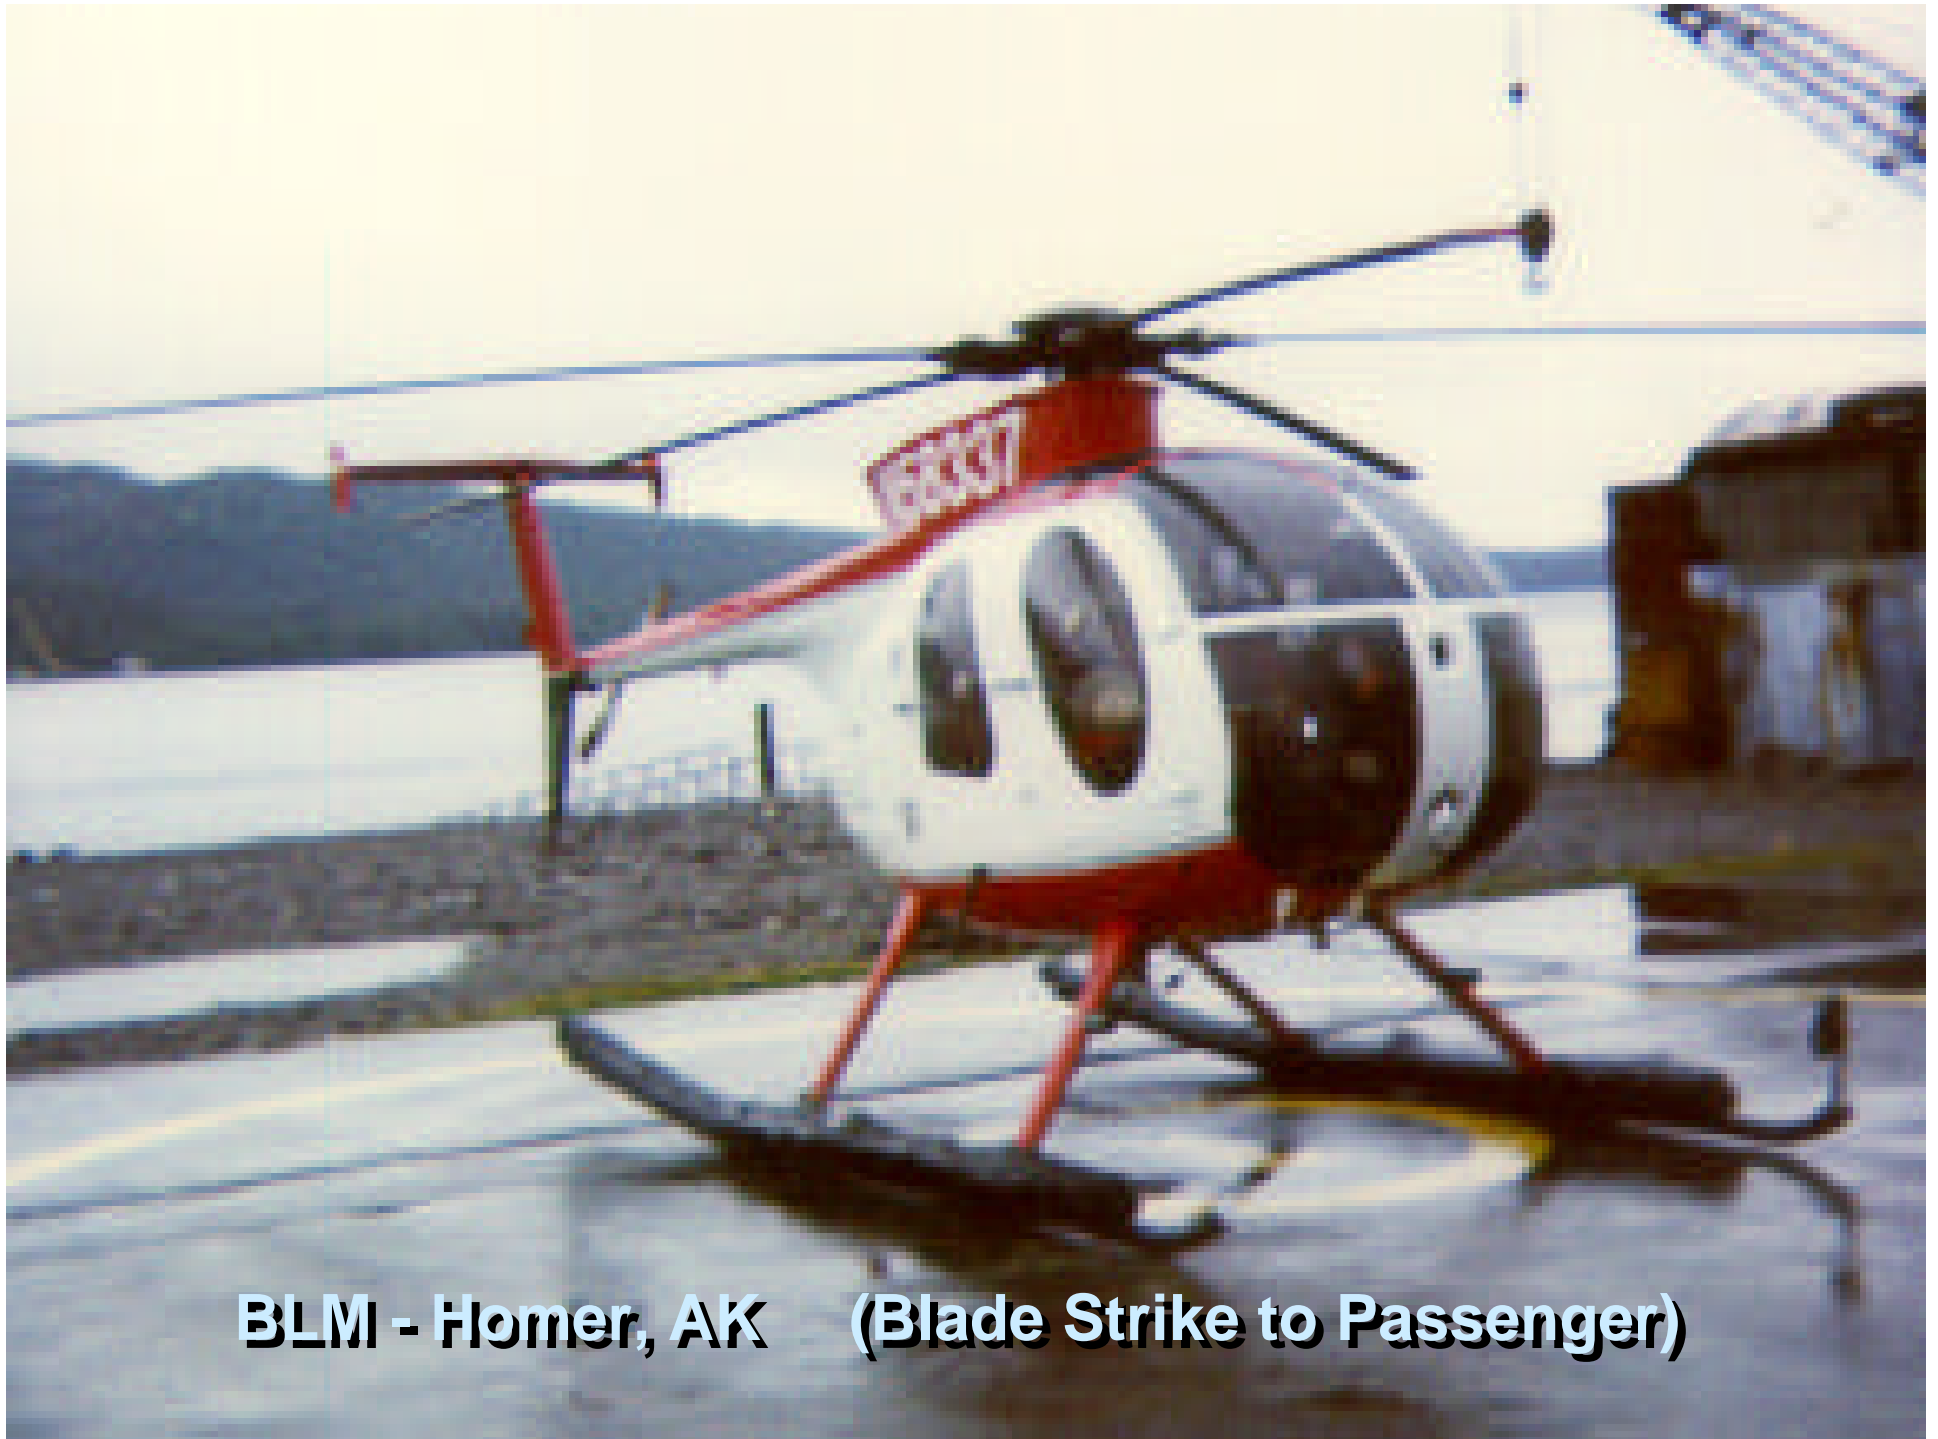
BLM - Homer, AK (Blade Strike to Passenger)

- ***Narrative:*** After completing a toe-in landing, the pilot signaled that passengers could exit the helicopter. The first passenger exited off the front of the skid, and walked uphill into the turning rotor blades. The helicopter immediately began to vibrate violently. The pilot relocated to a landing site and shut down the engine.

- ✓ Pilot briefed passengers on aircraft exiting from toe-in landing.
- ✓ **Pilot's attention divided.**

- ✓ Passenger struck by 2 main rotor blades. Not wearing helmet.
- ✓ **Sustained serious injury and survived.**
