FY 1999 Accident Review

**Department of the
Interior**

Aztec, NM

Air Tractor AT-400

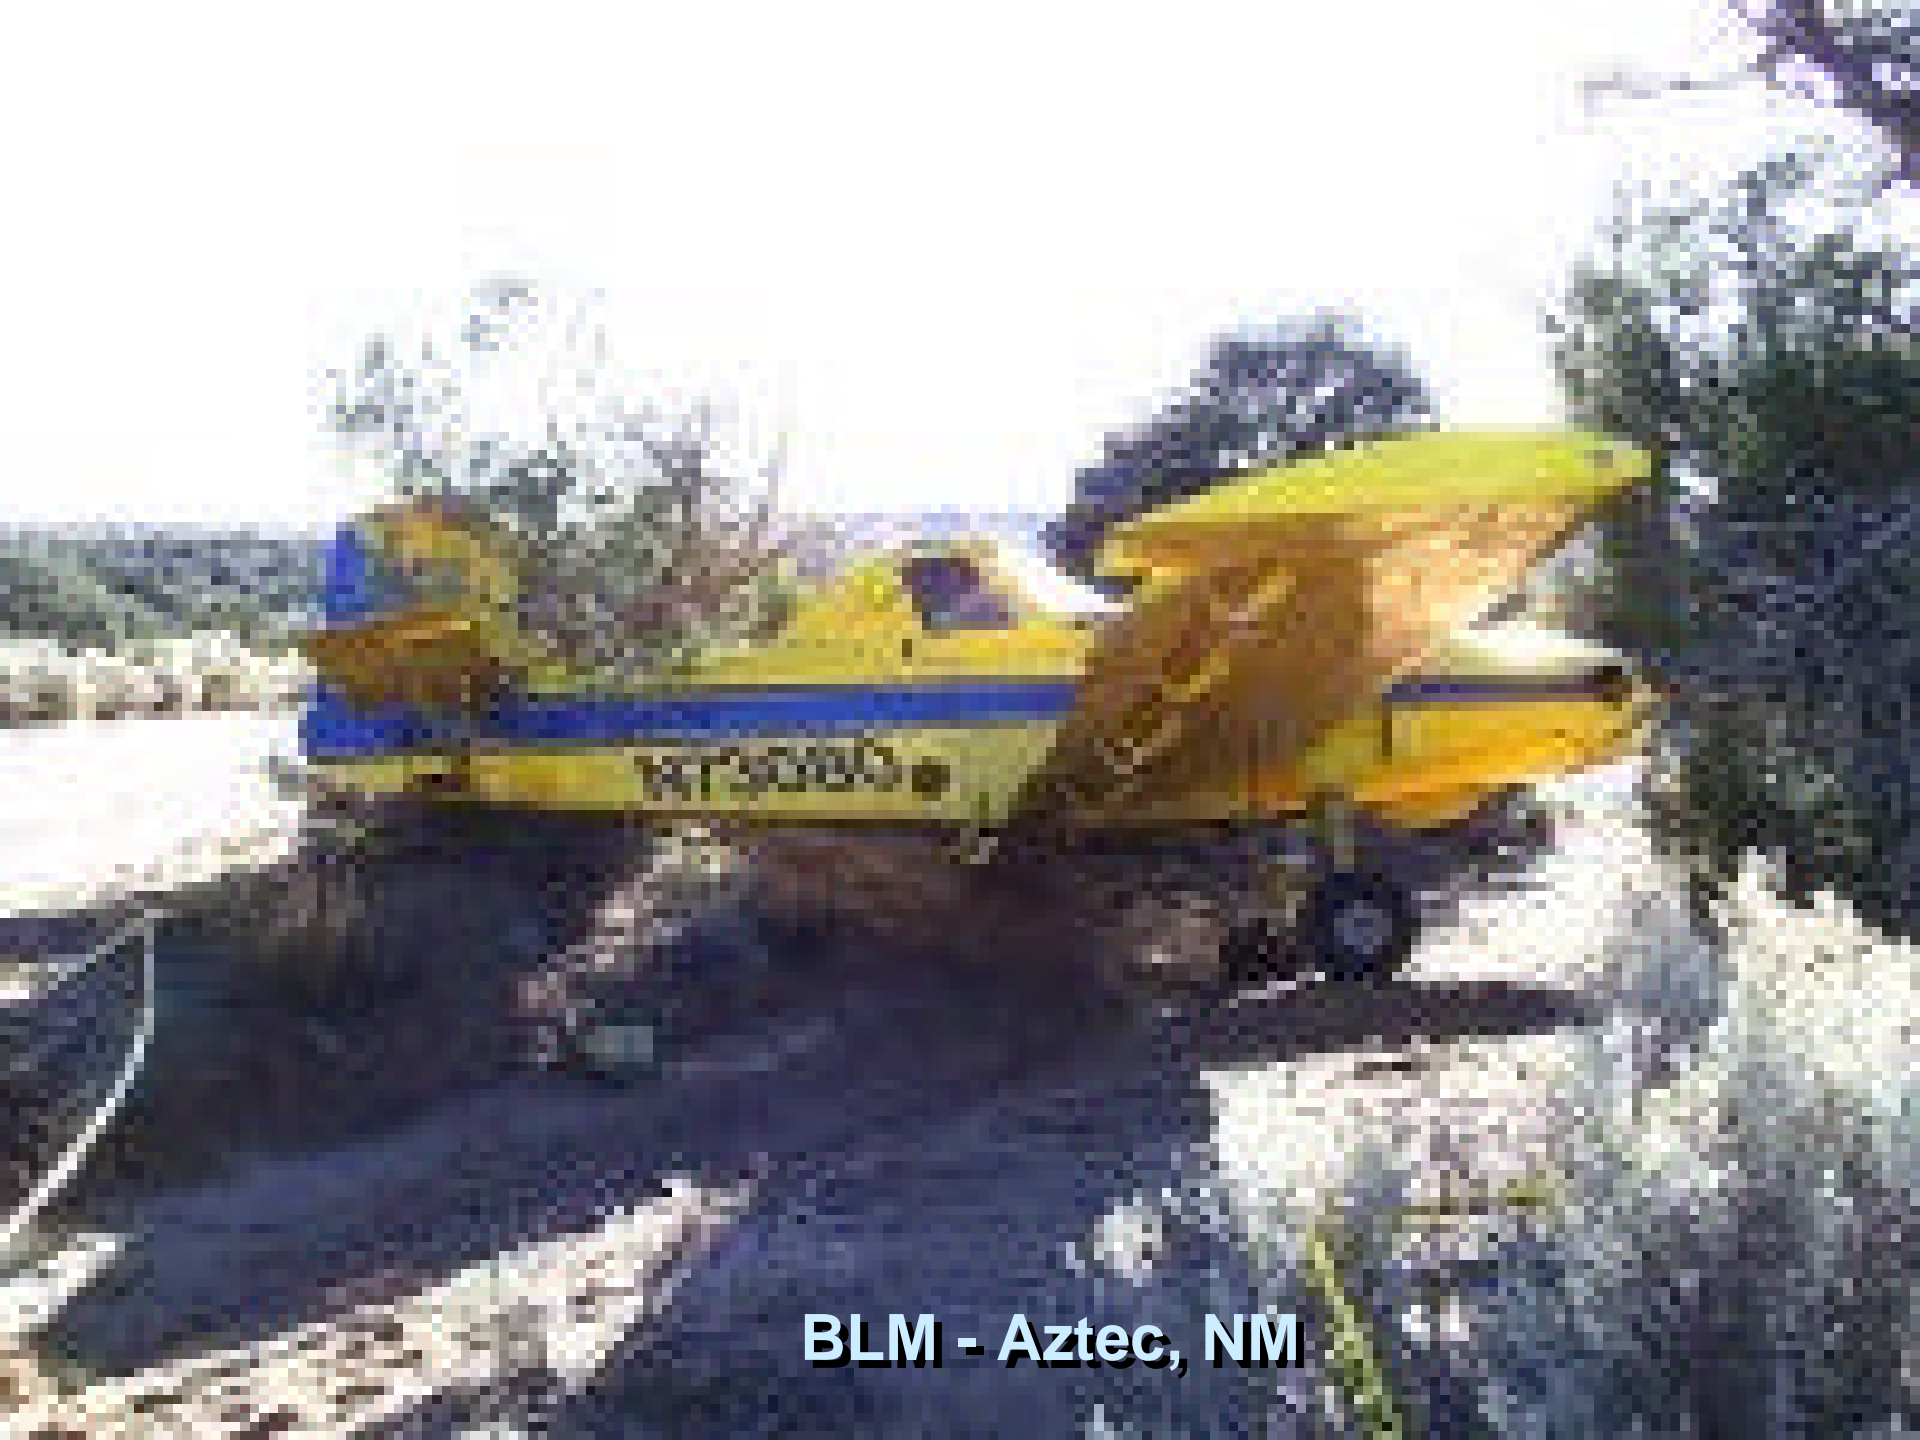
BLM - Aztec, NM

**Narrative:** The engine lost power due to oil starvation. A forced landing ensued and when the wheels contacted the ground, the airplane nosed over. The pilot reported the oil dipstick was not secured.

**Pilot reported the oil
dipstick was not
secured.**

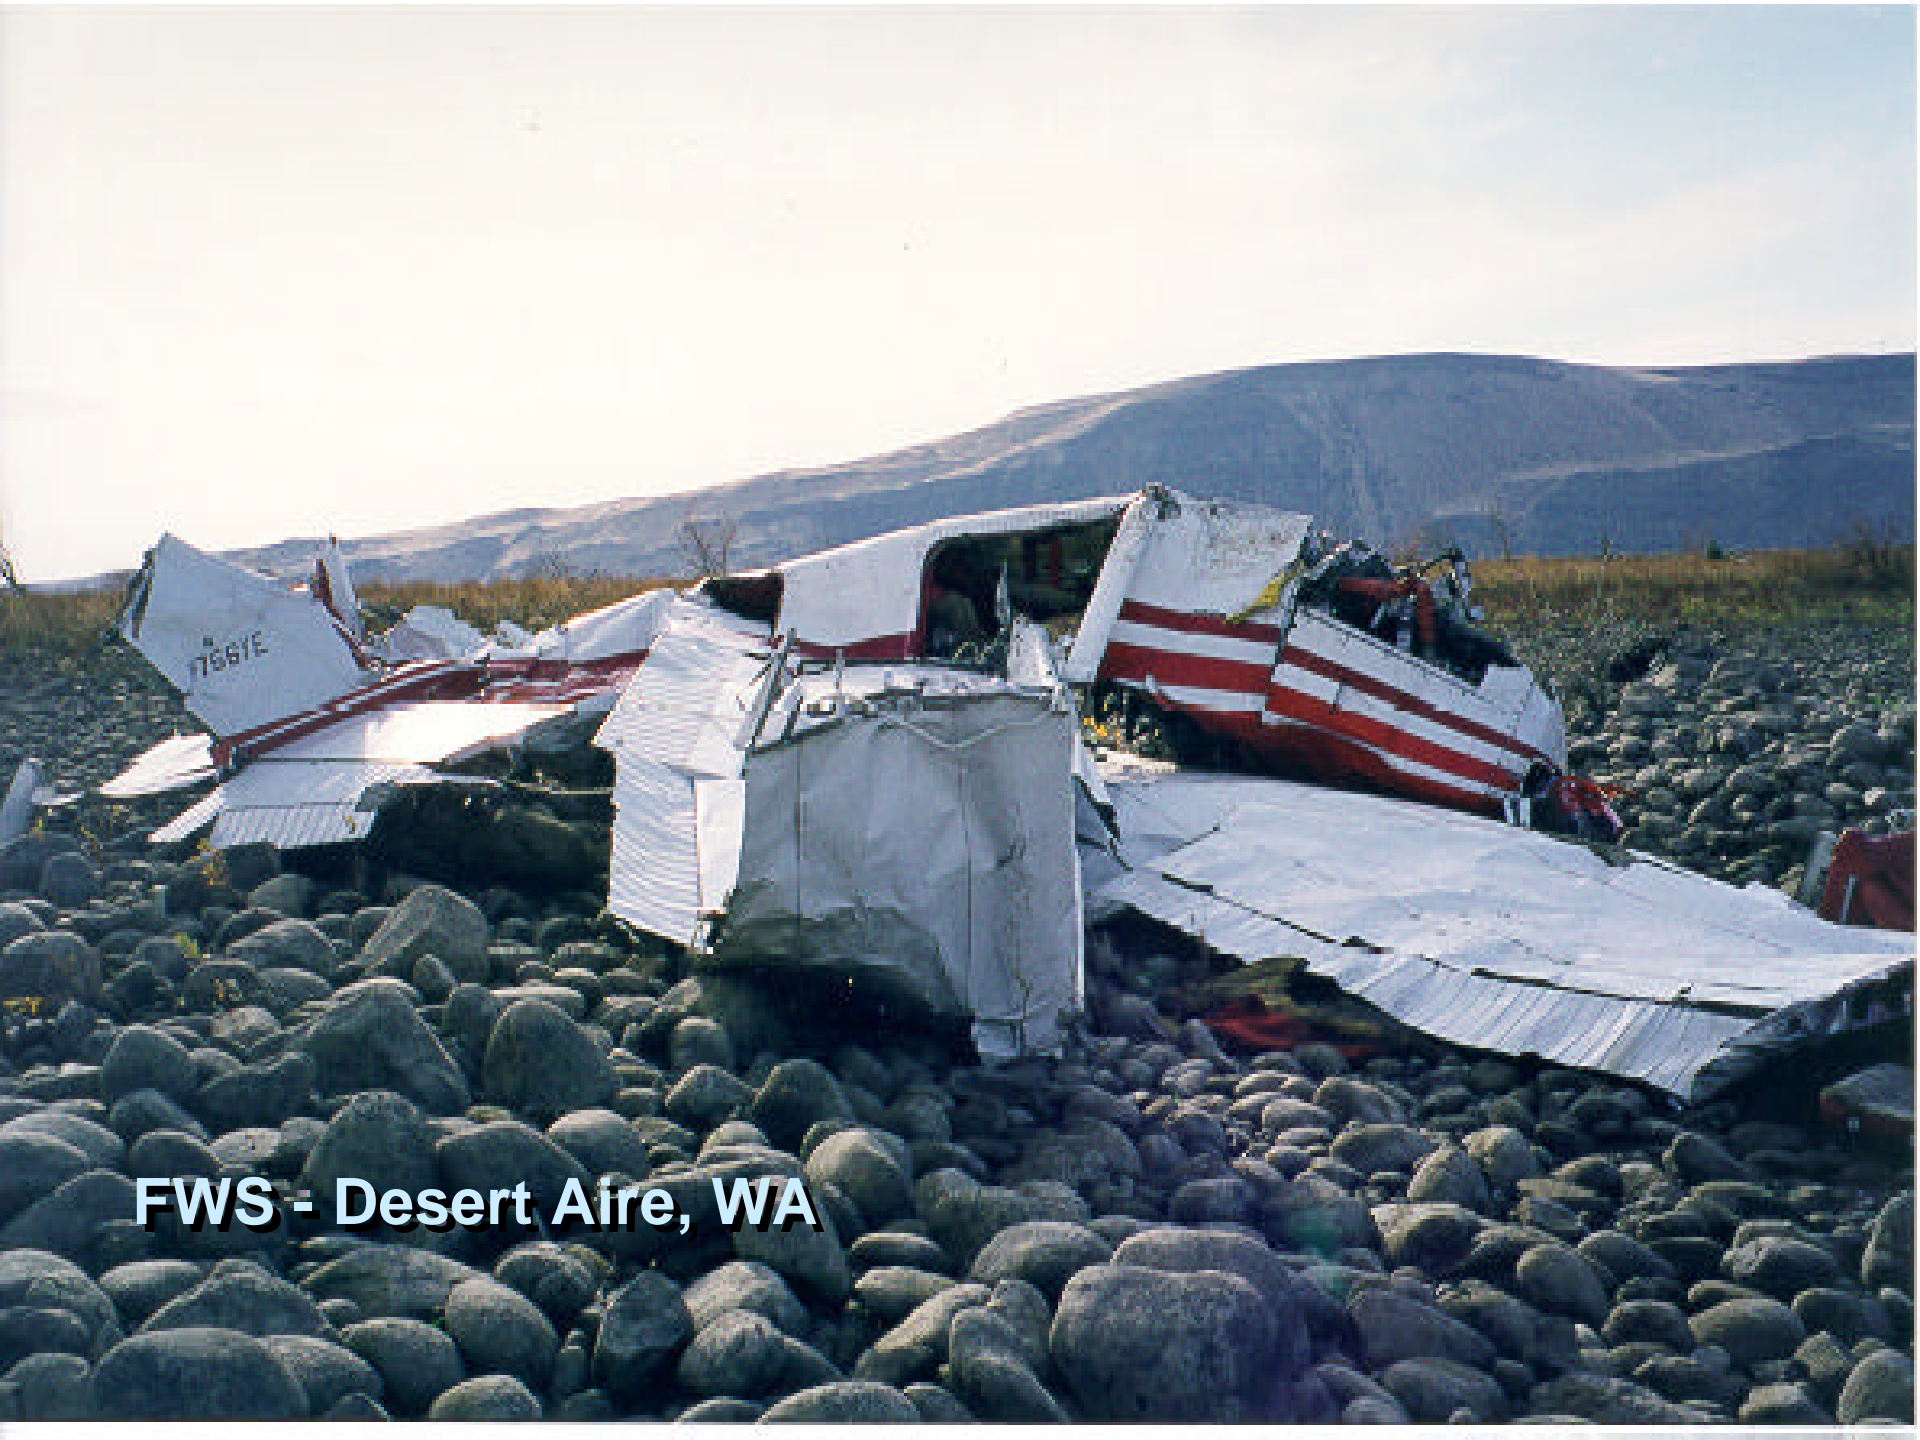
FWS - Desert Aire, WA

**Narrative:** During a waterfowl survey, aircraft struck power lines across river and sank. After the aircraft sank, the pilot was able to escape sustaining serious injuries. The two observers did not escape from the submerged aircraft and were fatally injured. Airplane struck and severed a 5/8 inch diameter cable running between the tops of the westernmost group of towers.
