FLASH

Factual Lines About Submarine Hazards

August 2002 - September 2002

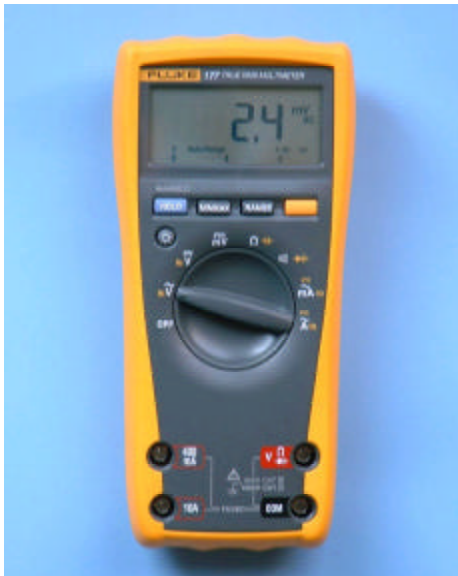
ALSAFE 016/02 (COMNAVSAFECEN 261435Z AUG 02) advises that the Fluke Corporation is recalling fluke multi-meter models 175, 177, and 179. The affected

multi-meters have a significant time delay in displaying actual AC voltage readings. This delay can lead to misinterpretation of displayed readings by the user thus causing risk of electrical shock.

The recalled models are yellow and black, have "Fluke" and "175", "177", or "179" on the front, and serial numbers below 79000000 (on back of meter under the hinged stand).

Commands with affected multi-meters should contact the Fluke Corp.

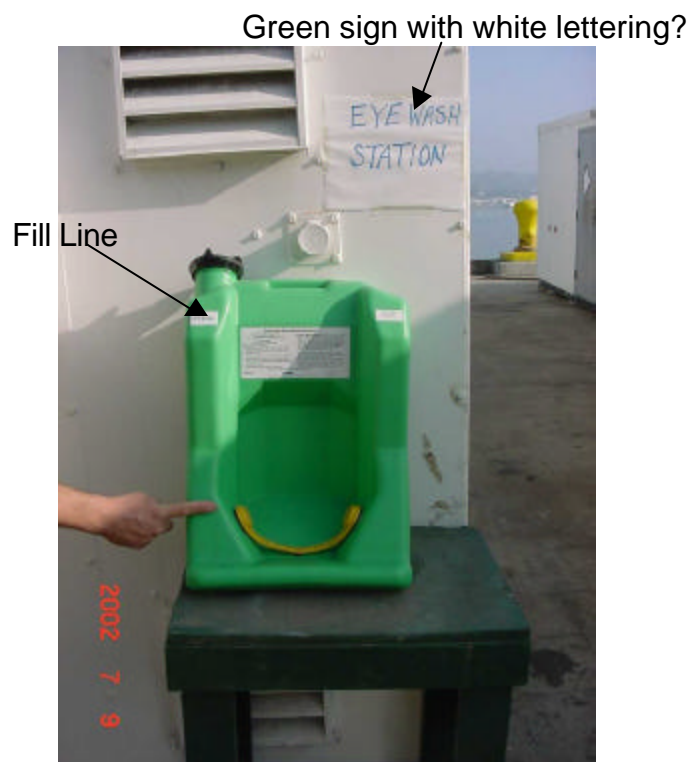
How many times have you, through your daily work routine, passed by emergency eyewash stations on a pier? How many times have you noticed the lack of PMS on the same eyewash stations, or worse yet, the lack of fluid? Were they clearly marked?

Recently we, at the Naval Safety Center, had the misfortune of finding several eyewash stations with the above problems. Take a close look at Figure 1 to the right. My colleague is pointing out the current fluid level. The white sticker directly above his finger is the fill line.

All emergency eyewash equipment must be maintained through the Planned Maintenance System (PMS). Eyewash stations must also be clearly marked with a green sign with white lettering stating "EMERGENCY EYEWASH STATION." The signs must be posted in a visible location close to the eyewash unit.

Report all discrepancies like this to the command safety officer for action. He in turn should report the discrepancy to your squadron. By doing your job, you make their job easier. Remember, they're your eyes: you may not get a second chance.

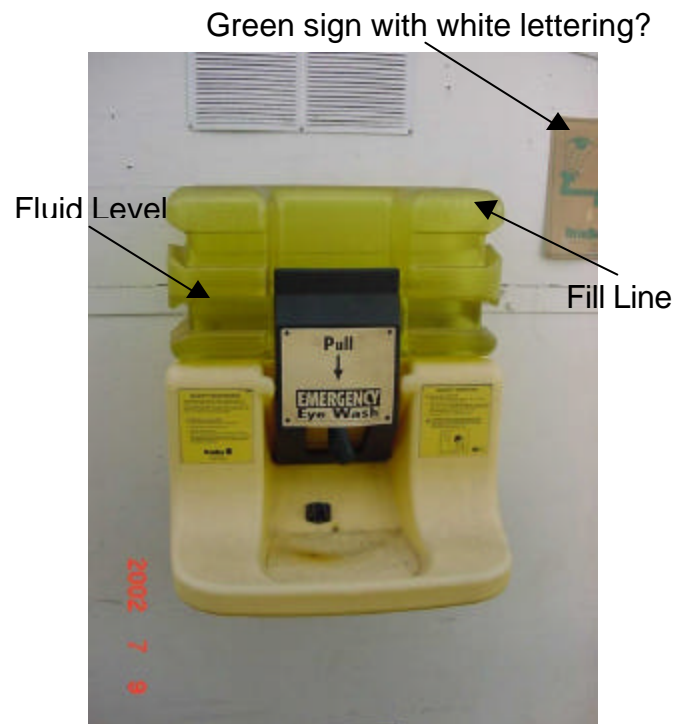
Yes, we have a winner (if only you could still see)!! Do we honestly believe that this eyewash station could possibly meet all the requirements pointed out on pg. 4 and its references?

We found this eyewash station and the one on pg. 4, Figure 1, on the same submarine pier during one of our surveys.

1. Someone was really thirsty.
2. We need to teach the local birds how to take submarine showers.
3. PMS was just not accomplished.
