The Submarine Division of the Naval Safety Center Presents:

FLASH

Factual Lines About Submarine Hazards

June 2001 – July 2001

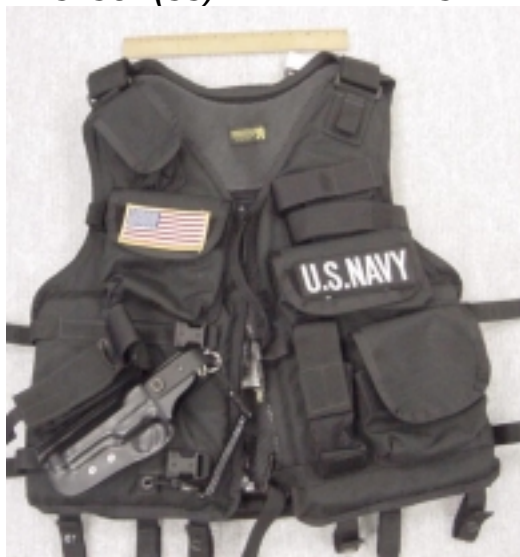
DO YOU USE THIS AS A FLOATATION DEVICE?

Commander, Naval Sea Systems Command has neither tested nor approved as a floatation device, the black, "tactical vest" issued under force protection (FP) allowance equipage lists (AEL) 2-320024501, 2-320024502, and 2-

320024503. This vest was procured for FP tactical purposes only. Although the tag in the vest may say "Tactical Floatation Vest," depending on the weight of the wearer and how the vest is loaded, we suspect it will not provide

sufficient buoyancy if used as the sole positive buoyancy device.

Commander, Naval Sea Systems Command message 160445Z JUL 01 reaffirms the ALSAFE message 221850Z JUN 01 and states that units are to cease using the tactical vest as

a floatation device. If floatation is required, wear an approved floatation device listed in NSTM 077, not the tactical vest. Points of Contact: Mark Campbell NAVSEA 05L4 (202) 781-3619 and A. Woodward NAVSEA 04L41 (202) 781-1854 (DSN prefix 326)

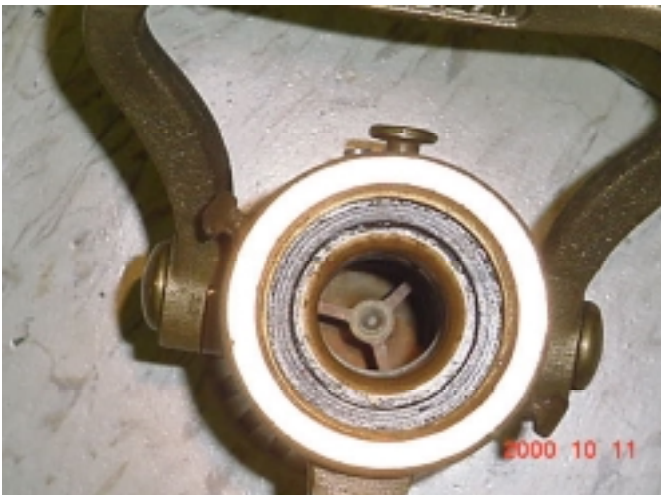
The answer might just surprise you. In this last year, I have found an alarming number of fire hose stations out of commission due to the vari-nozzles being stuck in a low-or no-flow position. The early design 95 and 125 GPM nozzles manufactured by Elkhart Brass are susceptible to this condition due to surface corrosion of the internal parts.

The earlier designed nozzles can be identified by looking through the open valve from the coupling end. ***If a three-legged brass part (stem base (web)) is visible, this is a potentially defective nozzle.***

part. The entire assembly should move freely in and out with approximately one-quarter inch of travel. It is this brass stem base that corrodes to the nozzle body, potentially locking the poppet/stem assembly in a low-or no-flow position. Whether the poppet/stem assembly moves or not (because it may be stuck due to corrosion), you must remove the nozzle from the hose and examine it to determine if it is potentially defective.

Three Legged (Potentially Defective)

If the nozzle is potentially defective, you can repair it by replacing the brass stem base with a stem base made of injection molded Ryton. You can obtain replacement stem bases and repair instructions from:

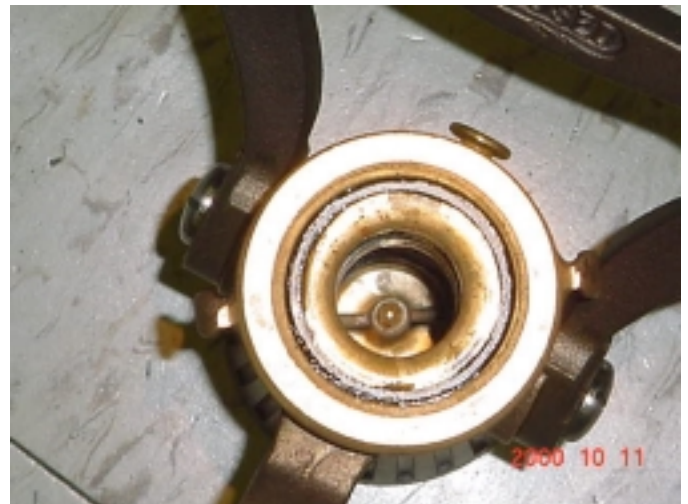
Later model vari-nozzles incorporate a rigid, cast-in-place two-legged-stem base and are not susceptible to this failure.

Later Version (No Action Required)

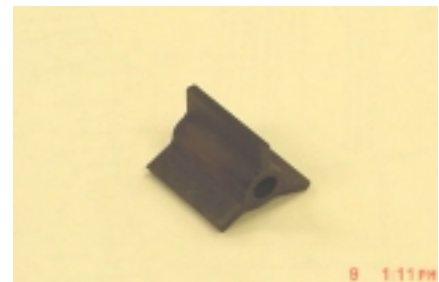
Replacement Stem Base

Provide a shipping/mailling address and specify "Stem Base (Web)" part number 63420000. If further assistance is needed, contact Debbie Welsch at Elkhart Brass (219) 295-8330 Ext. 240. A fee of \$2.25 will be charged for each stem base.

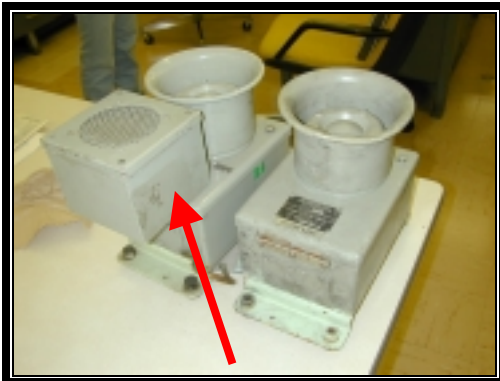
Unapproved Speaker Alteration

The winner of our first Chickenhead Award comes to us directly from the engineering spaces of one of our very own submarines. The arrow points to a speaker box that has been modified and "hooked up" (with the original high noise area speaker) to provide extra volume. Hmm, do you think if you did this to your stereo at home that it would work?
