The Submarine Division of the Naval Safety Center Presents:

FLASH

Factual Lines About Submarine Hazards

October 2001 - November 2001

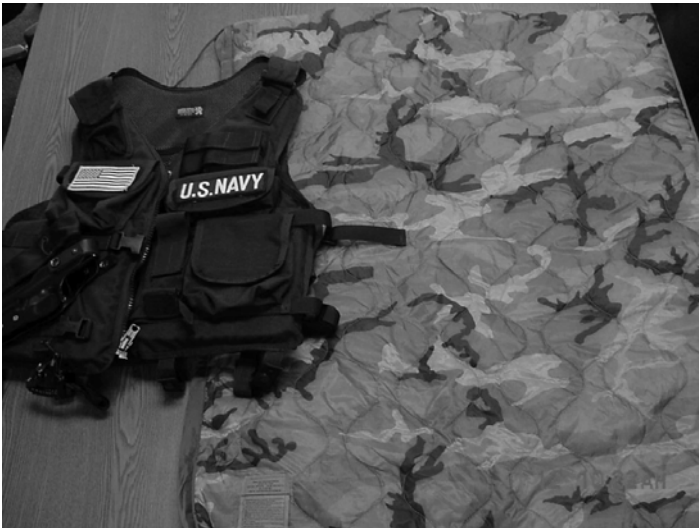
This issue's Chickenhead Award is presented to several items (tactical vest, wet weather poncho liner, innerspring mattress). These items reached the fleet prior to receiving all necessary testing. There are several lessons to be learned from these examples: 1. Stop buying whatever items you want and installing them on the boats just because you think it's a good idea. 2. Feel free to follow all the written standards and procedures that are already in place (Not just the ones you select to follow due to convenience or the lesser of two evils!).

Tactical Vest and Wet Weather Poncho Liner

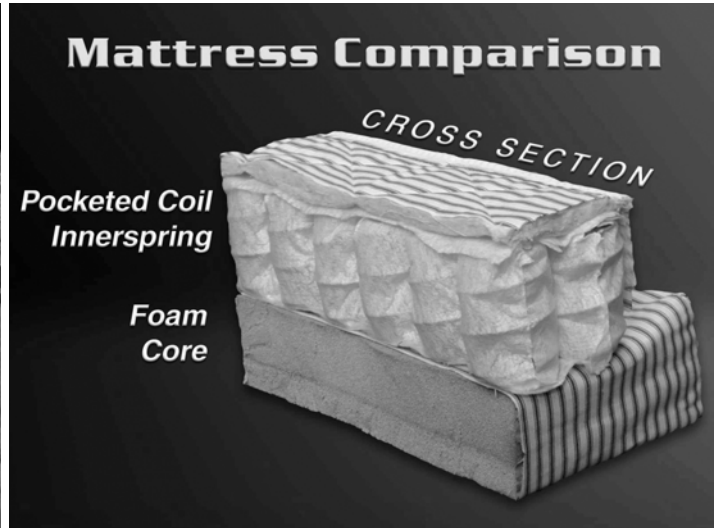
Commander, Naval Sea Systems Command 090559Z OCT 01 (NOTAL) and COMNAVSAFECEN Norfolk Va 101410Z OCT 01 (PASEP) identifies a potential fire hazard associated with innerspring mattresses. The

mattresses in question failed pre-production first article tests and in some cases fire testing. The message lists the stock numbers associated with the discrepant mattresses as well as further guidance and points of contact. Submarines should obtain and review the message, then check all mattresses on board. (By the way, see the "Chickenhead Award" on page 6 for a picture of the mattress.)

Innerspring Mattress
