# SHIPS' SAFETY BULLETIN

JANUARY – MARCH 2004

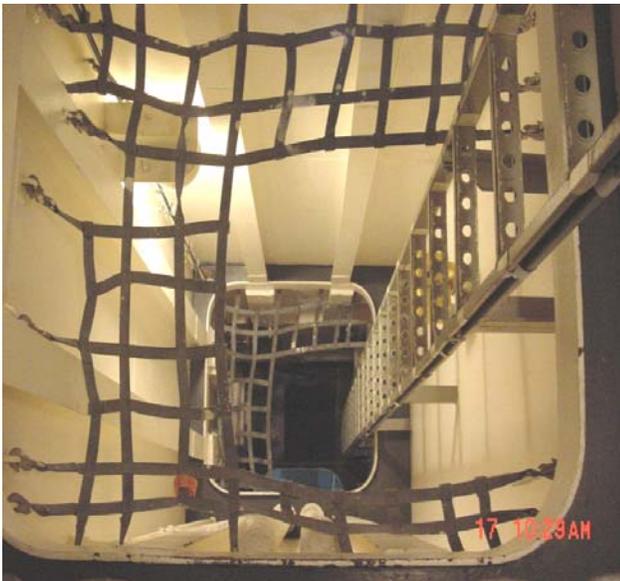
Openings are too wide, nets are missing weight test tags and the nets sag too much, among other safety discrepancies. Many Sailors admit they don't know what specific requirements apply to safety nets.

Most nets originally are manufactured and installed in accordance with specifications. However, problems arise when new nets are fabricated using the old nets as a pattern. The webbing stretches over time, and this causes

each successive set of nets to become larger. Additionally, most nets are custom made for their intended location; putting them in another spot causes them to fit incorrectly.

NAVSEA STD drawing 804-5184163-Rev A shows the proper net design and installation. The drawing specifies the opening is 24 inches wide, and the distance from the ladder to the opposite edge of the net opening is 16 inches plus or minus two-and-a-half inches. The 16 inch opening is often much too large, meaning that if someone were to fall; the net most likely would deflect the individual against the ladder instead of catching him. Rather than minimizing injury, a net with too big an opening could actually increase the risk of injury.

Note 4 of the same NAVSEA drawing also specifies that the natural sag of the net should be no more than four inches.

Maintenance requirement card (R-1) on MIP 6122/001 specifies; any repaired or replaced net must be weight-tested up to 1,000 lbs. Chapter 2 of the *Joint Fleet Maintenance Manual*, CINCLANTFLT/CINCPACFLTINST 4790.3 Rev A, (paragraph 30.2.2.) requires documentation of the test results on a QA-17, recorded in a permanent shipboard log, and a weight-test tag be attached to the net. The tag must include at least the name of the testing activity, the year and month of the test, and the rated load.

The reference for trunk safety nets is section 612e of General Specifications for Overhaul of Surface Ships (GSO). It states that, for every ladder extending through three or more decks, safety nets must be installed beginning at the topmost deck and placed at every other deck. Invest the effort to have your next set of nets manufactured IAW the drawings and properly fitted for the specific area where they will be installed. That effort could save your life or the life of one of your shipmates.

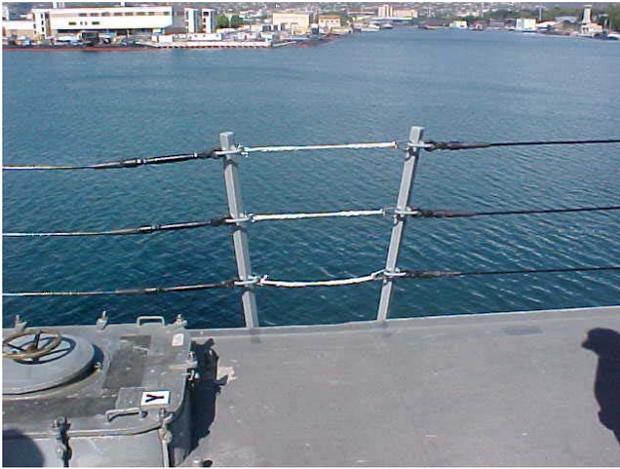
Are your end-run stanchions (like those next to pilot-ladder rigging positions) bent and bowed?

The bracket on the deck and the bracket on the stanchion are designed to have a brace fitted between them to support the stanchion. I have counted as many as 15 missing braces on one ship. Most of the end-run stanchions are bent and the lifelines are slack. If the brace is not in place, then tightening the turnbuckle eventually will bend the stanchion.

Lifeline repair and maintenance references are General Specifications for Overhaul of Surface Ships (GSO), *Liferails, Stanchions, Lifelines and Safety Nets* and PMS MIP 6121 series. Your ship's drawings are in Section 612 of GSO. Meanwhile, Para C0102a of OPNAVINST 5100.19D also requires you to have your commanding officer's permission before removing any permanent lifelines. Division officers and CPOs must pay more

attention to lifeline and life-rail material conditions during space walk-troughs. Make lifelines a CO's focus during your next zone inspection to make sure your ship has them where they are supposed to be, and that they are in working material condition.
