# FLASH

## Factual Lines About Submarine Hazards

April 2001 – May 2001

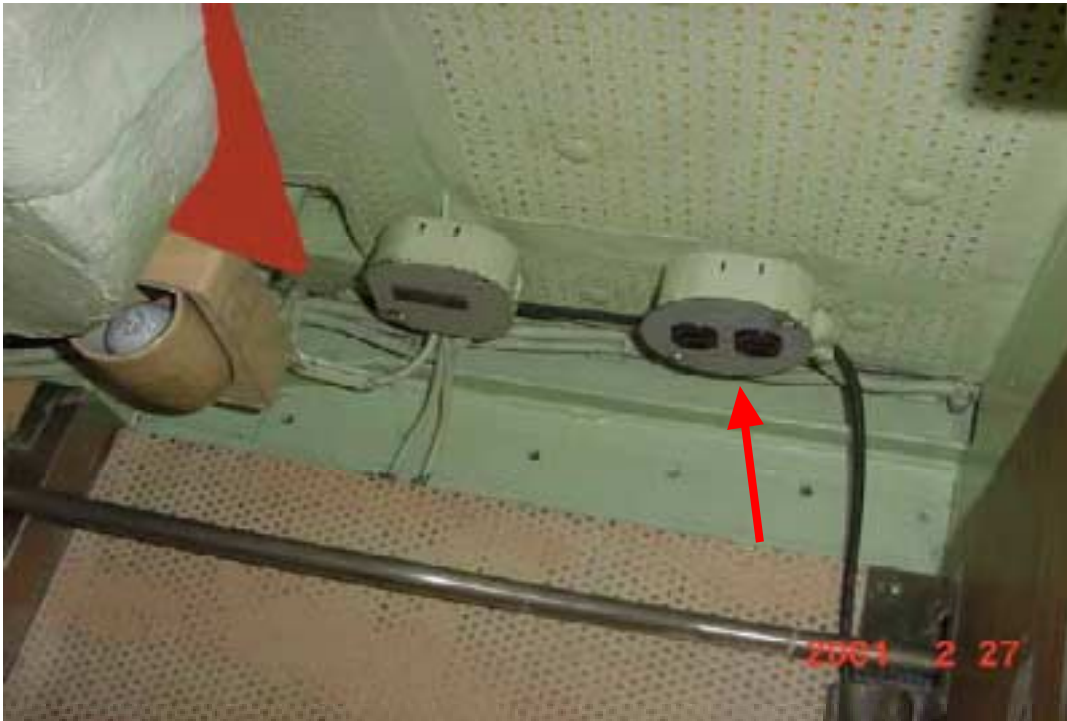
Since the beginning of the fiscal year, we have surveyed twenty-seven submarines. During each survey, we have noted an alarming trend. Sailors have been making illegal modifications to 110vac junction boxes in berthing. An example is shown:

If the command determines that more 110vac outlets are needed to accommodate electronic devices for the crew, submit documentation to the planning yard for the next availability or maintenance period. Ask your squadron for help. Do not allow Sailors to take this task upon themselves to accomplish what they think is the correct answer.

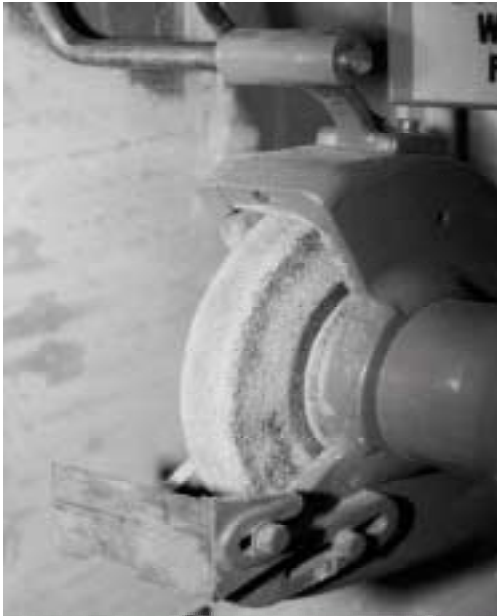
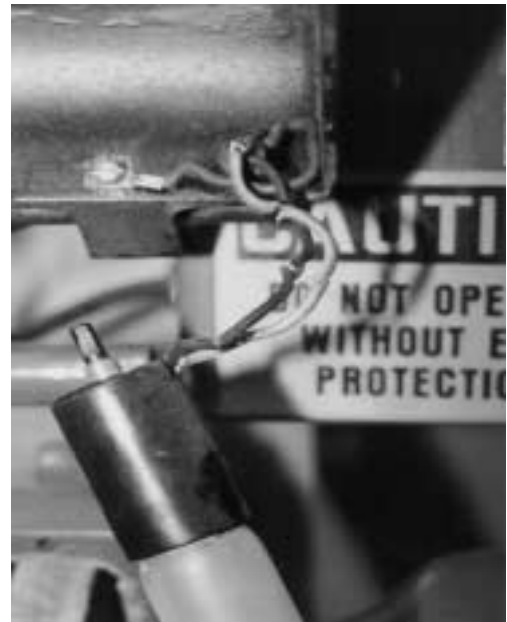
eight questions dealing with the bench grinder in one way or another. We find hazards associated with the bench grinder during almost every submarine survey. The hazards we find represent inattention or disregard for the safety requirements in Chapter D8 of OPNAVI NST 5100.19D. Here are the bench grinder discrepancies found during recent surveys:

- Tool rest not within 1/8" from the grinding or wire wheels
- Build-up of non-ferrous metals found on the grinding wheel
- Bench grinder safety precaution sign not posted
- Eye and noise hazard signs not posted

- Transparent, shatterproof eye shields are loose, missing, or incorrectly mounted over the wheels
- Face shields and goggles not present near the grinder
- Goggles so dirty they are a hazard to wear
- Light bulbs not installed in sockets under shatterproof eye shields
- Light socket wiring chaffed, broken, or having exposed leads
- Grinding wheel hoods not adjusted properly
- Debris bags not attached to back of grinding wheel assemblies

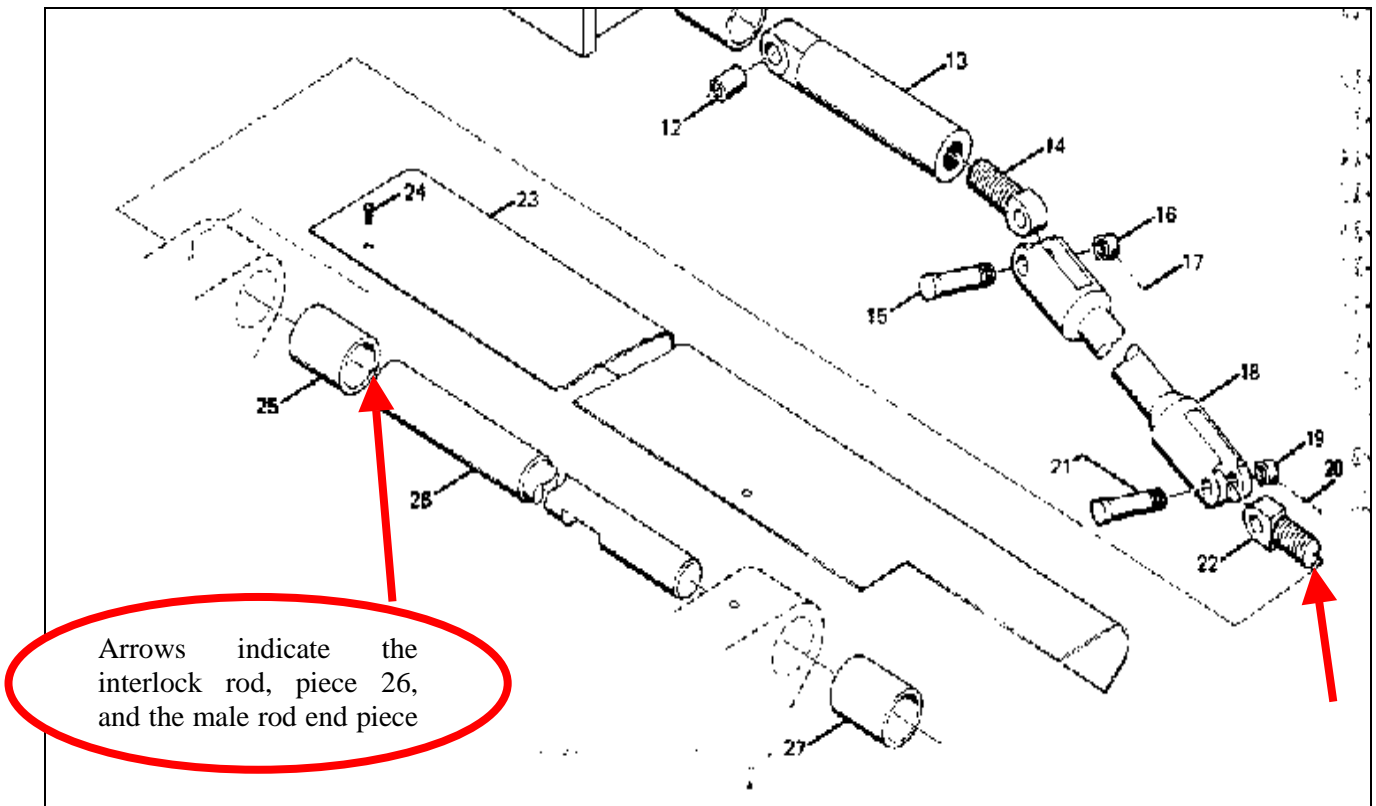
Picture from NAVSEA SG420-BU-MMA-040 for SSN688-Class. Trident-Class similar.

Here's something for you to keep an eye on. On several recent surveys, I have found a problem with the muzzle ball/breech ring interlock tail rod. On these units, the tail rod could be turned by hand (actually unthreaded if desired). This problem could prevent proper

operation of the breech ring and effect travel of the muzzle ball valve. By design, the tail rod is not staked or pinned in place. Instead, it is only held in position with "lock-tite." When were your launcher barrels removed last for muzzle ball valve repairs?
