# Mech

The Naval Safety Center's Aviation Maintenance Magazine

Vol. 2, No. 8, Oct – Dec '99

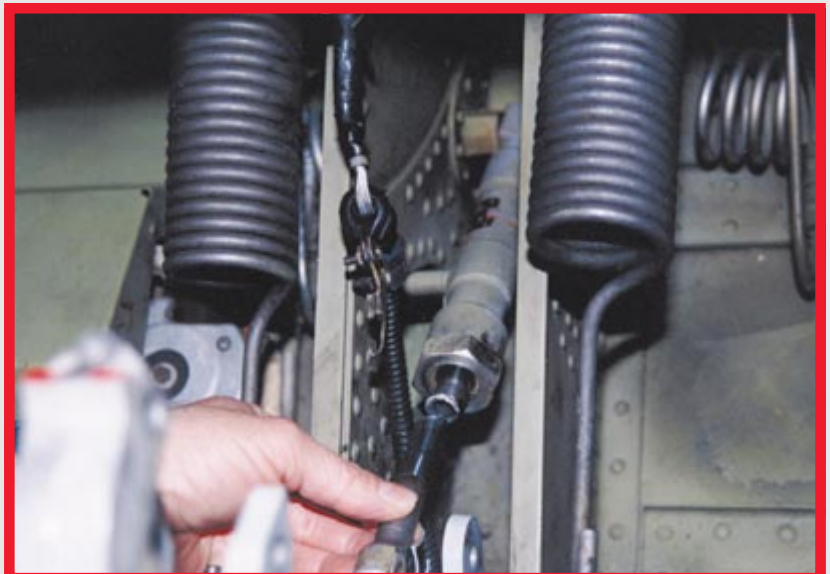
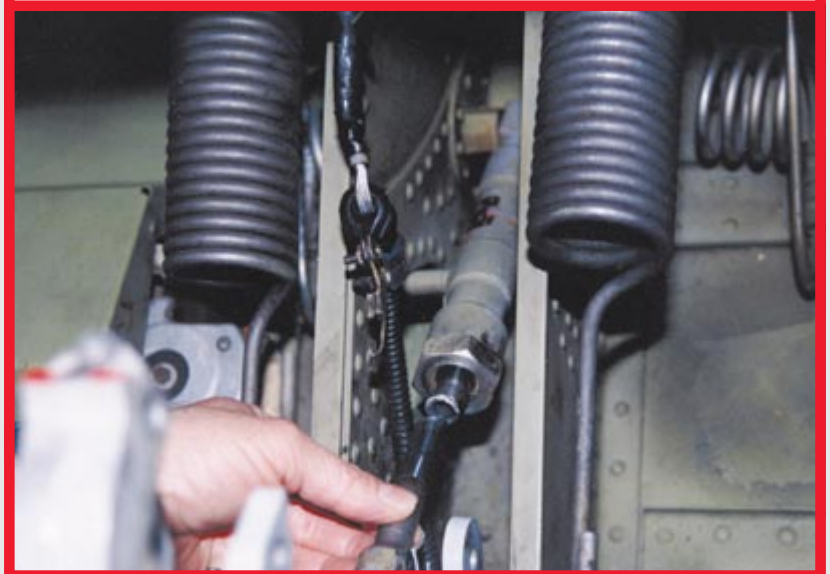
Another metalsmith PO and I began working in the wheelwell, and we saw a cotter pin sticking out of an attaching bolt that wasn't correctly installed in the nose-gear linkage. The other PO tried to remove the pin to reinstall it. Suddenly, the nose-wheel started rolling toward us, and the strut

When a mech tried to remove the pin, the nosewheel started rolling toward him, and the strut began to collapse.

began to collapse. I tried to shift my legs to the side while the wheel was rolling my way, but the other PO backed into me. We quickly ran out of room as the nose gear collapsed. In all my years working on Navy aircraft, I never imagined such a thing could

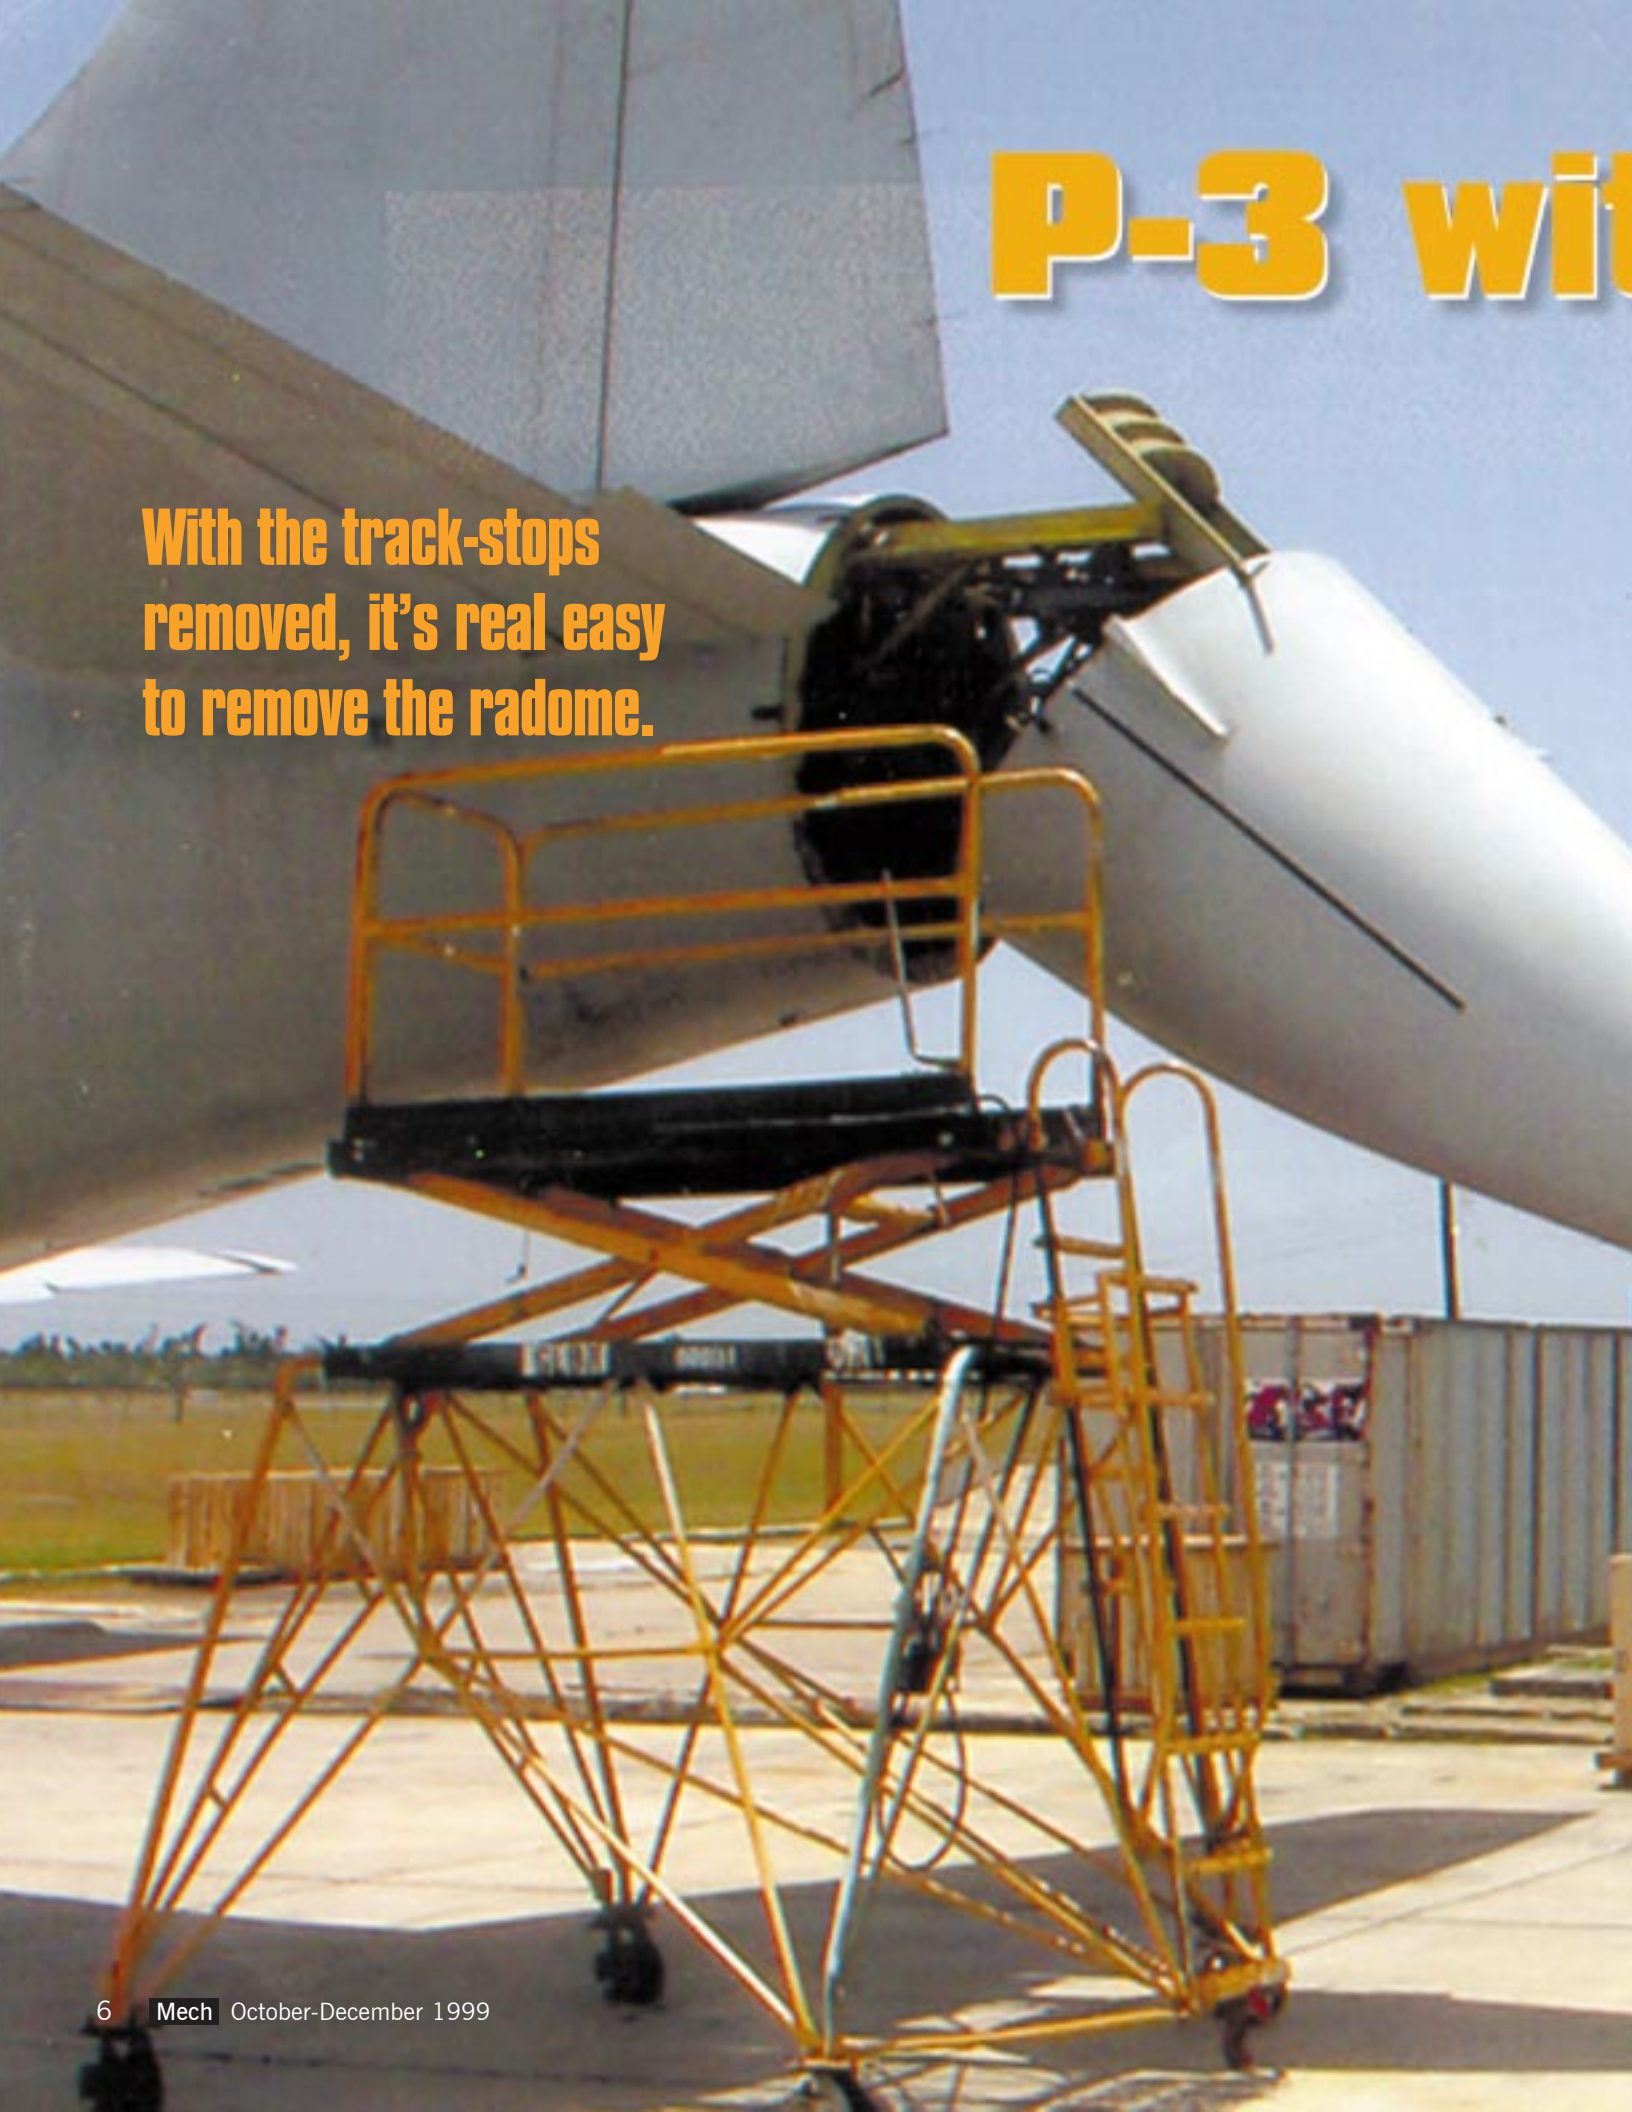
With the track-stops removed, it's real easy to remove the radome.

About 30 minutes later, the MO told maintenance control that repair plans for the P-3 had changed and to hold up preparations. Maintenance control radioed the airframe mechs and told them about the delay. At that point, airframes had already removed the aft radome's track-stops. The airframes supervisor directed the team to close and relatch the radome, but leave out the track-stops. He didn't reinstall the stops because he knew he'd have to remove them again later. The airframes crew returned to the shop without telling maintenance control the track-stops were not in place. The technicians didn't know that airframes had worked on the bird, so when the techs slid the radome open, it crashed to the deck.

The cause factors we identified during our investigation were failure to communicate and not following the book. The MIMs covering both removing the radome and the aft radar have warnings clearly identifying the danger of removing the track stops. We've relearned the importance of working by the book, communicating, and coordinating maintenance with MAFs. Not killing a shipmate is good news, but we can't take credit for it.

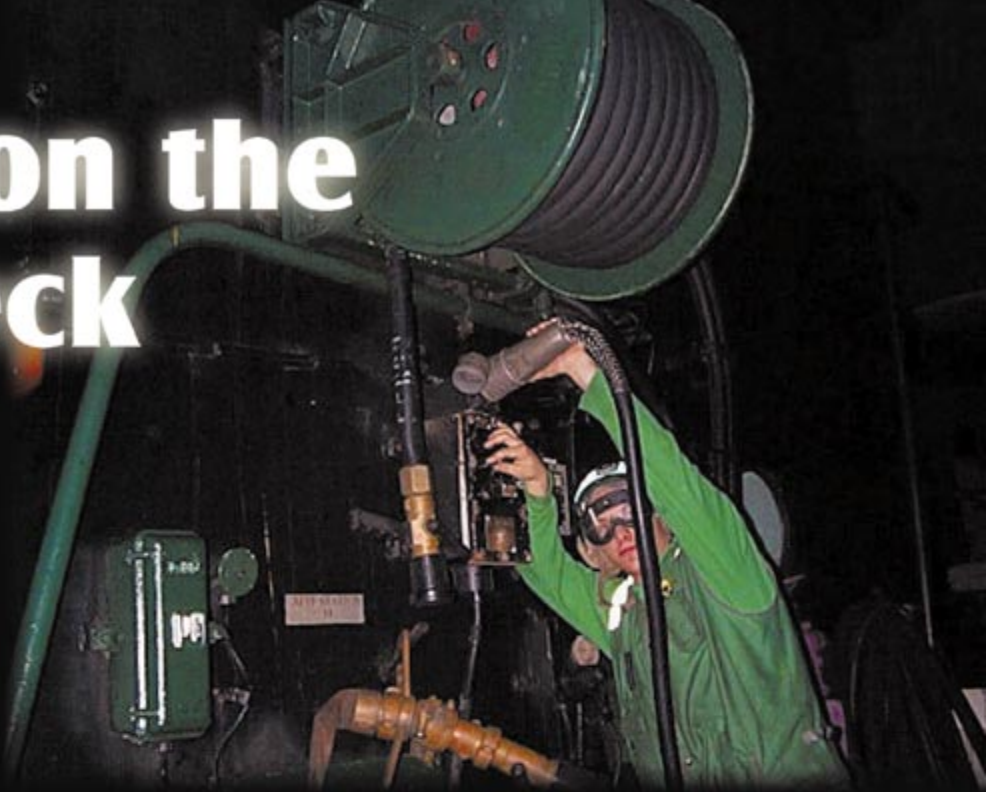
Later, I realized there were a few things that should have clued me in to problems with this particular ship-power outlet, despite assurance from FDC that E-Division had recently op-checked the box and its operation. First, the shoddy condition of the power box was obvious. Only one bolt secured the power outlet to the circuit-breaker box. Next, the cap on the power outlet was hard to remove because of built-up corrosion. Last, once I got the cap off, I could see the electrical contacts were also corroded.

The bright flash of an electrical explosion in a power box disoriented the author.

If I ever encounter a similar situation in the future, I'll tell my squadron's maintenance control and get in touch with the ship's electrical-safety people so they can fix the problem and prevent unexpected fireworks. Since the incident, E-division personnel have given a courtesy call to air-wing and squadron avionics personnel when they repair flight-deck-power outlets and power cords and are ready for an op-check. This procedure has allowed us to ensure these systems are, in fact, operational before use. We haven't had any more blinding incidents on the flight deck.

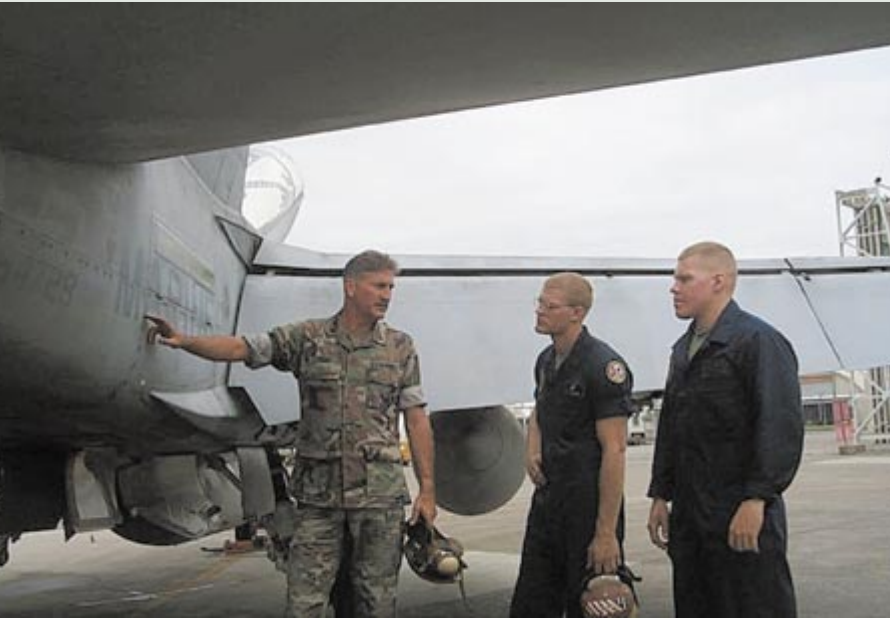
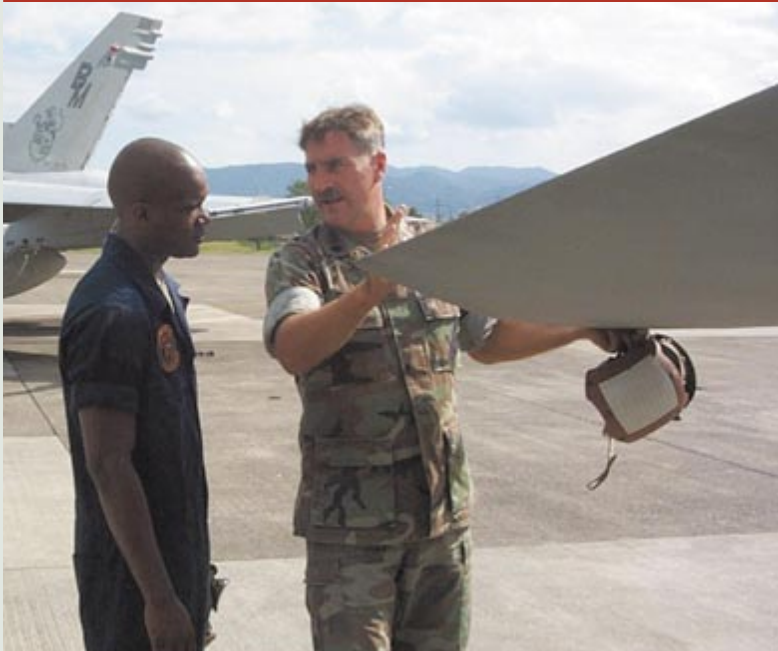
SSgt. Troup (top left) instructs plane captains Cpl. Cody Johnson and LCpl. Benjamin Packard on stabilator-positioning checks, and below, discusses the safety-wire problem with LCpl. Jeff Redd Jr. who found the same condition in a second Hornet.

**D**uring the final walk-around inspection of an FA-18D SSgt. Rodney Troup noticed something odd. From the rear of the bird, he could see a split of approximately 4 inches between the stabilators; in the cockpit, indications appeared normal to the pilot, even after precautionary built-in tests. After consulting with airframe troubleshooters and a QAR, the QAR declared the Hornet unsafe for flight.

Further inspection revealed that the safety-wire on a servo-cylinder, jam-nut had broken, allowing the nut and its tab-washer to back off the wrenching-lug to the extreme end of the rod. This allowed the servo-cylinder to travel beyond its correct distance and contact the rear bulk-head. Had the Hornet launched, further damage to this critical area could have resulted in a mishap.

A month after SSgt. Troup noted the split problem, LCpl. Jeff Redd Jr. was on a final-checks inspection and found the same discrepancy on another jet. This prompted the squadron to inspect each aircraft before any more flights. The troops found a third Hornet with the same problem. We sent a hazrep, and are still trying to determine how the safety wire on those servo-cylinder, jam-nuts broke. 🦅

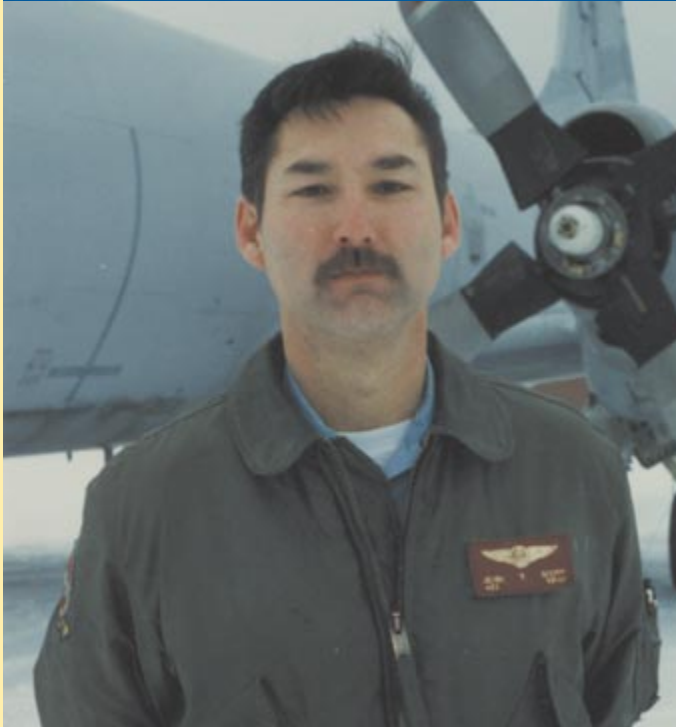
AE1 Jesse Scott  
VP-10

While preflighting an Orion, AE1 Scott (a NATOPS flight-engineer evaluator) checked the flight-control, cable-guide rollers in the main electrical load center because of a recent hazrep. While he was in that load center, he found a pool of water beneath the No. 2 and No. 3 generators' supervisory panels.

Maintenance control downed the P-3C, and a maintenance crew removed the water.

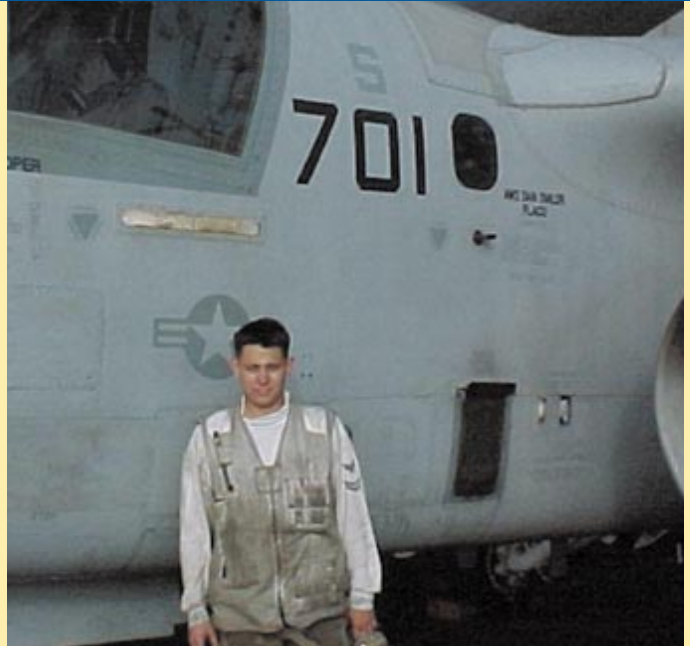
AT2 Paul Pasley  
VS-38

An S-3B aboard USS *Constellation* (CV 64) was in tension, the wipeout was complete, and both final checkers had given thumbs up to the catapult officer. Immediately prior to the cat shot, AT2 Pasley noticed a pink mist coming from the nose wheelwell and quickly suspended the launch.

There was a hairline crack in the launch-bar actuator, which soon grew large enough to completely drain the No. 1 hydraulic system. AT2 Pasley's fast action prevented an in-flight, flight-control failure.

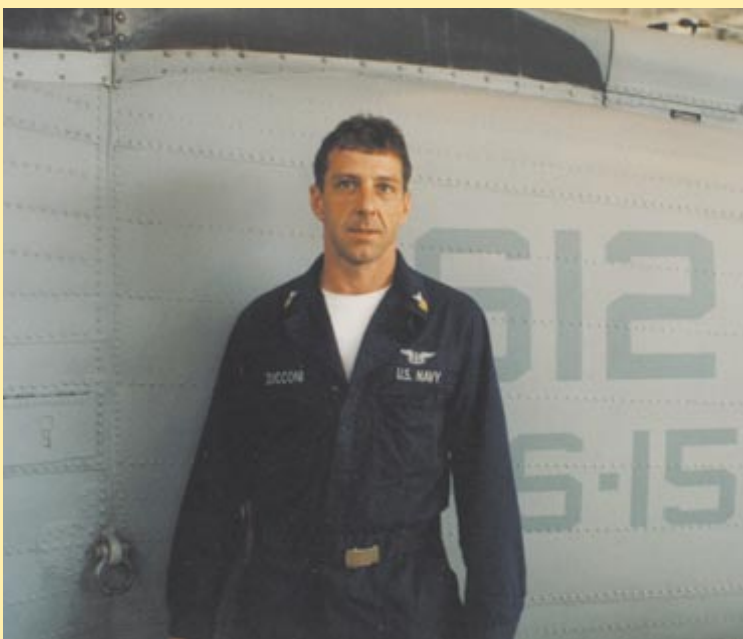
AD1(AW) Jeffrey Zucconi  
HS-15

AD1 Zucconi, a power-plants troubleshooter, was inspecting Red Lion 617, which had been scheduled to fly later in the day. While inspecting the area around the tail rotor, he discovered one of the pitch-control links' inboard bearings wasn't seated in the rod-end.

After reporting his find to maintenance control and writing a MAF, he removed the pitch-control link, and the rod-end bearing fell out. The bearing and rod-end were excessively worn. The aircraft had flown seven hours since this area had last been inspected.

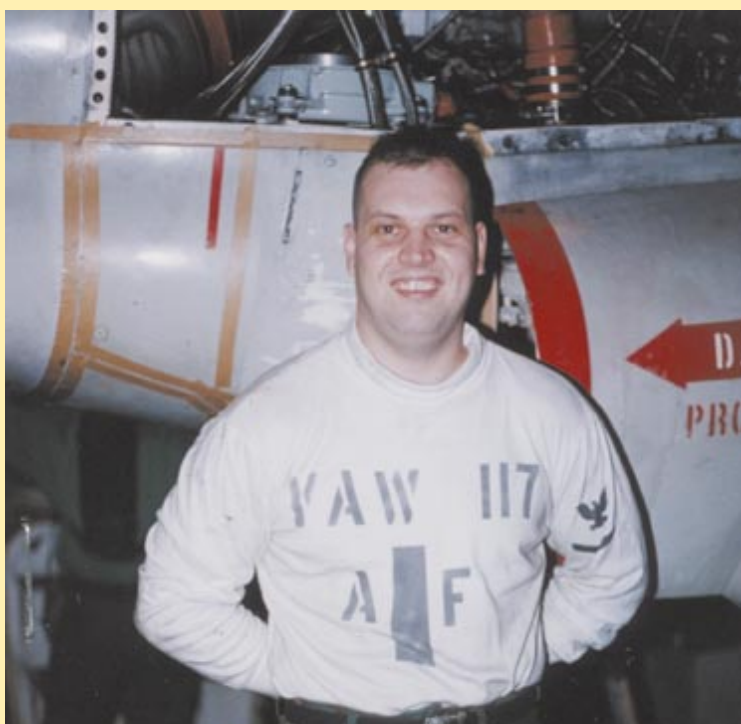
### AMS3 John Hallenbeck VAW-117

AMS3 Hallenbeck, an airframes troubleshooter, was preflighting Wallbanger 602 aboard USS *Carl Vinson* (CVN 70). During his inspection, he discovered the starboard-forward bracket for the MLG's timer check-valve was cracked. AMS3 Hallenbeck immediately told the FDC and a QA rep. Further inspection proved the cracked bracket was beyond limits and required depot-level repair.

A P&E team replaced the cracked bracket with assistance from the airframes shop. The aircraft was returned to full-mission capable in time to fly in Operation Southern Watch. AMS3 Hallenbeck's find prevented an emergency during a trap.

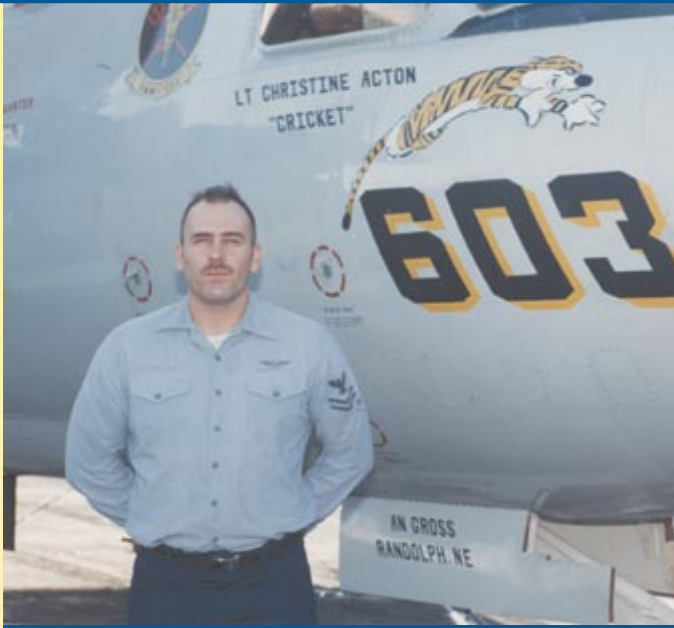
**AMS2(AW) Rodney Bradford**  
VAW-125

AMS2 Bradford was assigned a clean-bird inspection on Tigertail 600. Collateral duty inspectors (CDIs) must do a clean-bird inspection on aircraft that have been down or in the hangar a long time. The CDIs inspect for fastener security, FOD and panel integrity.

Checking areas outside his responsibility, AMS2 Bradford found a chafed wire bundle in the bulkhead between the forward equipment compartment and the combat information center. The exposed wires could have caused an airborne electrical fire.

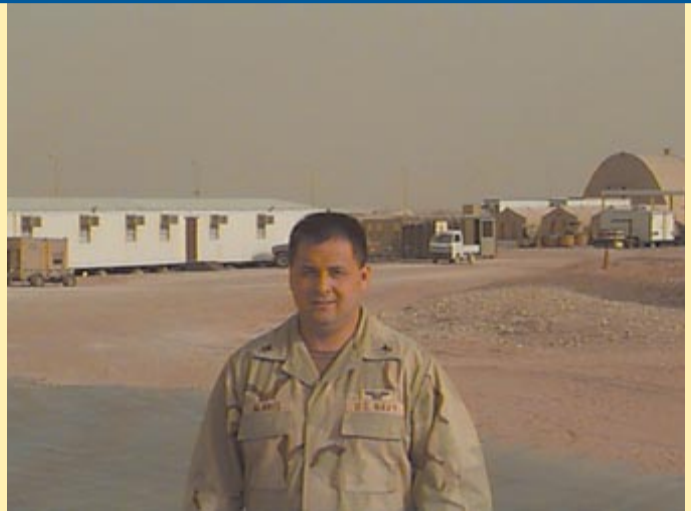
**AME1(W) Victor Alanis**  
VAQ-128

While serving as QAR for a close-panel inspection on Phoenix 670 after an AME inspection, AME1 Alanis was inspecting the flap-drive gearbox when he noticed a clump of grease on the gearbox cable. Looking more closely, he noticed that several strands of the cable were frayed.

Further investigation and consultation with airframe mechs revealed that the cable's condition was beyond acceptable limits. The aircraft was placed in a down status. Had this condition gone unnoticed, the cable might have failed and damaged the aircraft. AME1 Alanis' find prevented a possible in-flight emergency.
