**RI 9660**  
**REPORT OF INVESTIGATIONS/2003**

# **Evaluation of Systems to Monitor Blind Areas Behind Trucks Used in Road Construction and Maintenance: Phase 1**

**Todd M. Ruff**

February 2003

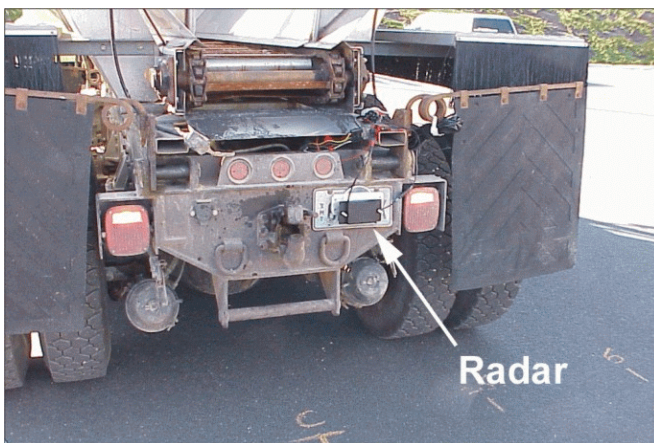
Figure 4.—Guardian Alert radar system on sanding truck for short-term test.

For the first set of tests, this radar system was mounted level on a sanding truck on the right side of the hitch plate at a height of 79 cm (31 in) (figure 4). The alarm display was mounted on the back of the truck so the state of the alarm could be easily recorded during tests. No false alarms occurred when the truck was moved in reverse in a clear area.

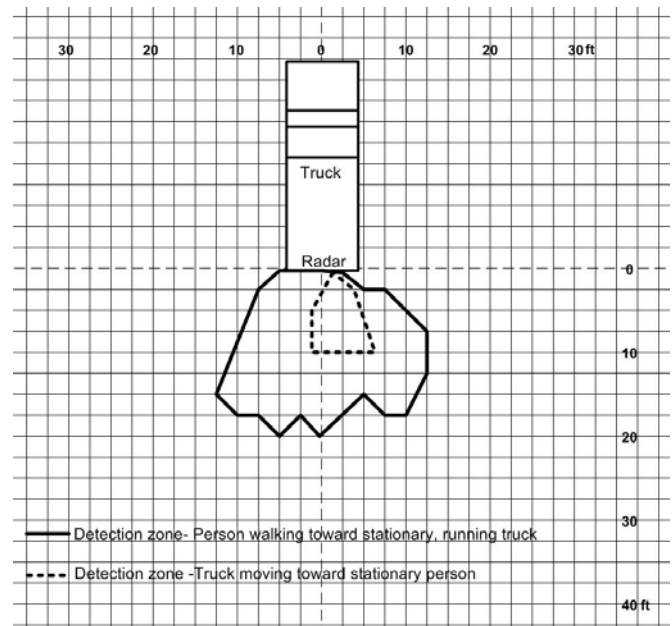
Figure 5.—Detection zones for person and Guardian Alert radar system.

To determine the detection zone of a person, the test subject walked toward the rear of the truck and recorded where reliable detection occurred. The detection zone for a person with a stationary truck is shown by the solid line in figure 5. The total

range of this radar was 6 m (20 ft) for detecting a person, and the width was adequate to detect a person near the tires.

Significant differences in the detection zone were seen when tests were conducted with the truck moving in reverse. The dashed line of figure 5 shows the detection zone for a person standing still and facing the radar while the truck moved slowly (3-5 km/hr [2-3 mile/hr]) in reverse. The range of the system decreased to approximately 3 m (10 ft), and the width no longer covered the width of the truck. An exact reason for this decrease in the detection zone was not found, but the manufacturer suggested the cause could be vibration or moving at a speed too slow for reliable detection (Guardian Alert, 2000). However, tests conducted by moving at the same reverse speed toward other objects, such as a building or vehicle, did not show the same decrease in detection. It is suspected that a combination of slow reverse speeds and the smaller radar cross section of a person contributed to the decrease in the detection zone.

Several different mounting locations were tried to determine if the detection zone could be improved for a moving truck. The radar unit was relocated to the center of the bumper area, just above the hitch, and no improvement was seen. The radar unit was then moved to a higher location in the center of the sand hopper at a height of 1.8 m (6 ft). Still no improvement in detecting a person was seen when the truck moved. The system was also tested on a dump truck with several different mounting configurations, and the same problems were seen.

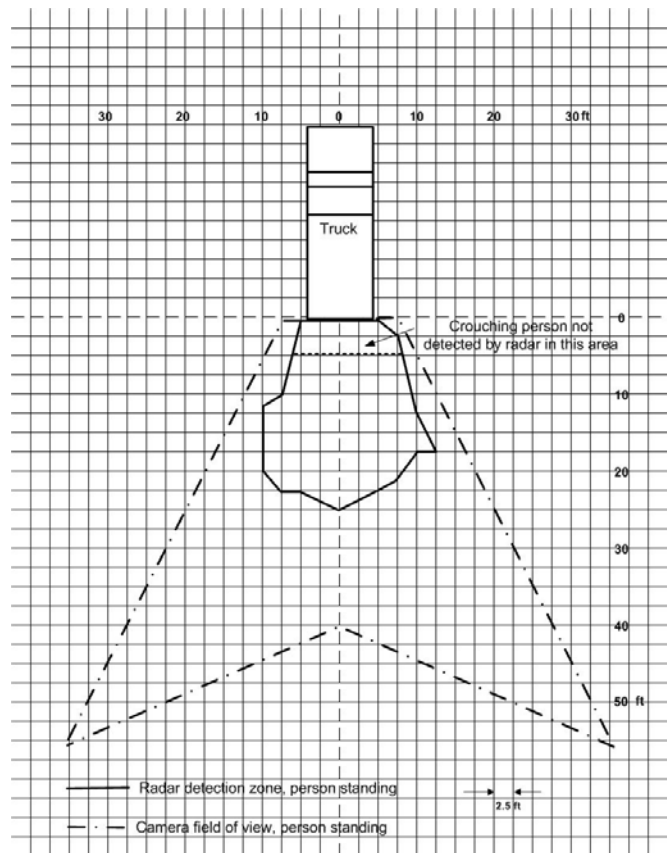
Figure 11.—Detection zone for Preview radar system and field of view for Clarion camera on a sanding truck.

After mounting the systems, the final radar detection zone and the FOV for the camera were recorded as shown in figure 11. The radar's detection zone for a person standing behind the truck (inner solid line) adequately covered the width of the truck and extended 7.6 m (25 ft) from the back. However, the system did not detect a person crouching or

kneeling immediately behind the truck. The downward tilt of the radar system was increased to improve detection of a crouching person, but the system began to sense the truck itself, which caused false alarms. The tilt angle was reset to 20°.

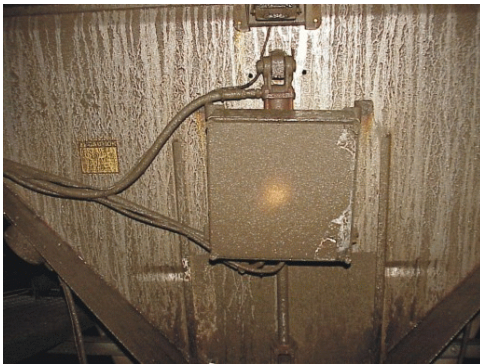
Figure 12.—Mud build-up on radar enclosure.

Driver comments stated that the system was useful at the beginning of the shift, when backing to the sand pile and driving around the maintenance yard. The radar accurately detected and displayed the distance to the sand pile, loading equipment, and other objects. However, problems with the radar system became evident after driving on the highway a few kilometers. On days when it was not snowing, mud and grime from the road covered the radar enclosure, as shown in figure 12. On days when it was snowing, snow mixed with sand built up on the enclosure (sometimes several centimeters thick). Snow or grime on the radar enclosure caused the system to generate a constant false alarm (all LED's were lit, indicating an object immediately in front of the radar unit).

Initially, it was believed that removing the additional enclosure for the radar system would solve the problem. The radar system manufacturer stated that snow or ice directly on the face of the radar unit (with no extra enclosure) should not cause an alarm. By adding the extra enclosure, we introduced an offset of about 2.5 cm (1 in) between the radar unit and the snow/mud. By removing the extra enclosure and mounting the radar as received from the manufacturer, the snow would build up directly on the radar unit and should be ignored.

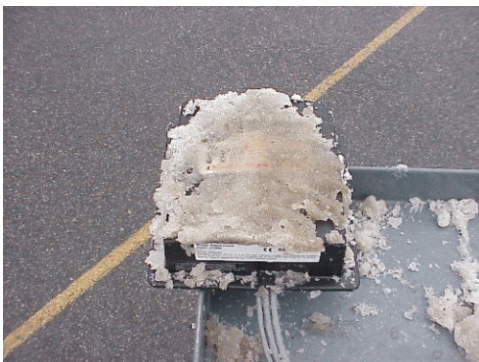
Figure 13.—Thin layer of snow on Preview radar, which caused an alarm.

Tests at NIOSH were conducted to see if the radar system would ignore snow. Figure 13 shows a simple test where a thin

layer of dirty snow was piled on top of the radar unit. This caused a false alarm, showing that remounting an unprotected radar system on the truck would not solve the problem. The manufacturer indicated that software changes could be made to ignore objects or snow build-up closer than 30 cm (1 ft) to the radar. This change has been made, but tests results are not available yet.

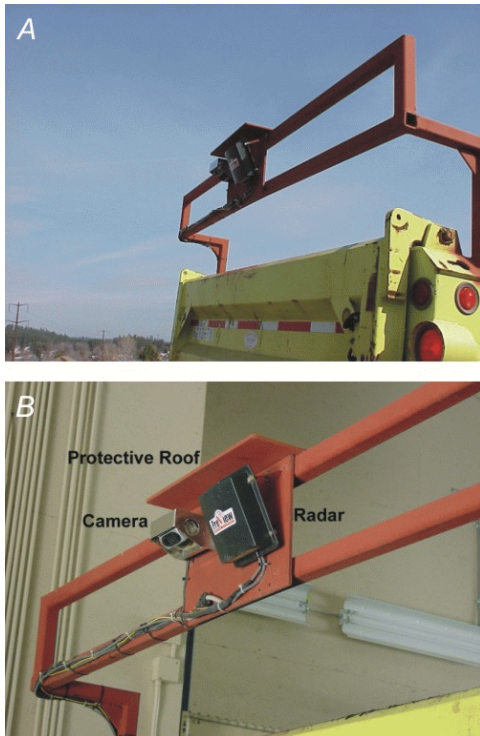
Figure 14.—A, Mounting bridge; B, radar and camera mounting.

NIOSH and WSDOT personnel designed the mounting bridge shown in figure 14. The size of material to be hauled, such as boulders, must be considered when determining the height of this bridge so that the bridge will not obstruct dumping. However, if the bridge is too high, it can be easily struck by a loader bucket or, as discussed later, it may not fit under some material loading bins.

- The mounting bridge was too high and would not pass under the asphalt loading bin in later tests. This truck could not be used for paving projects.

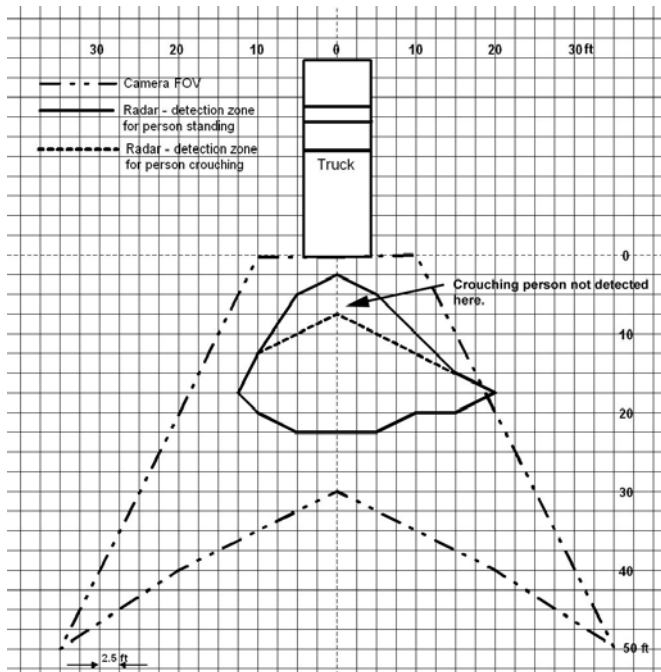
Figure 15.—Detection zone for Preview radar system and field of view for Clarion camera on dump truck.

After the system was mounted, the final radar detection zone and FOV for the camera were recorded as shown in figure 15. Because of the mounting height of the radar, a person was not detected immediately behind the truck. This was because a person could walk underneath the radar beam at close distances.

The mounting height also resulted in poor detection of a crouching person when close to the truck, as indicated by the dashed line inside the solid line of figure 15. A standing person was detected at distances between 0.76 and 6.9 m (2.5 and 22.5 ft) from the back of the truck, while a crouching person was detected at distances between 2.3 and 6.9 m (7.5 and 22.5 ft). The radar system was mounted several feet above the manufacturer's suggested mounting height, which caused the detection zone to be inadequate for this truck. Tests continued, however, because the addition of the camera system provided redundancy.

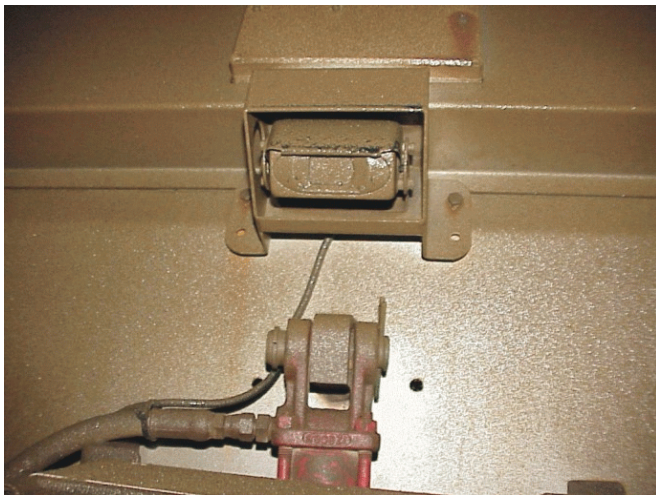
Figure 18.—Mud build-up on Clarion camera.

because (1) mud and snow build-up on the lens occurred quickly in forward gear (figure 18), obstructing the camera view, and (2) glare from headlights distracted the driver during night operations. After this change was made, the camera system operated reliably on warmer days. However, in snowy conditions, ice and snow quickly covered the camera when traveling forward. This caused the lens shield to become frozen in the closed position, making the camera unusable even in reverse. After a few days of operating under these conditions, the lens shield mechanism failed and was stuck in the closed position even after snow and ice were cleared from the camera. A heated camera enclosure or some other method to keep snow and ice from building up on the camera would be required before using this system on a sanding truck.

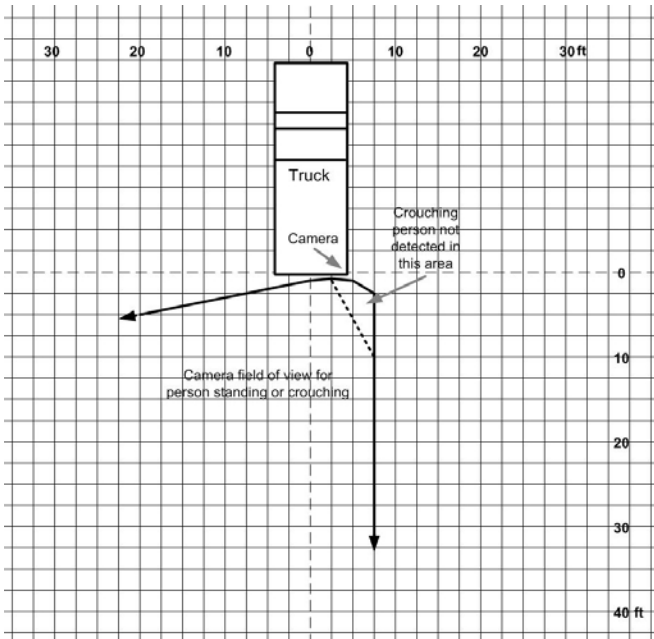
Figure 20.—Field of view for a person and Intec camera system.

extended from the back of the truck out to the horizon. The right side of the FOV was blocked by the camera enclosure. The area between the dotted line and the truck represents the area where a crouching person could not be seen in the video monitor because the person was beneath the camera’s FOV. Full coverage of a crouching person behind the truck could be achieved by tilting the camera further downward, but there is a tradeoff between close coverage and the distance that the FOV extends on the left side of the truck. Results of this initial test showed that the camera system could be useful, so long-term tests on a dump truck were conducted during the summer months.

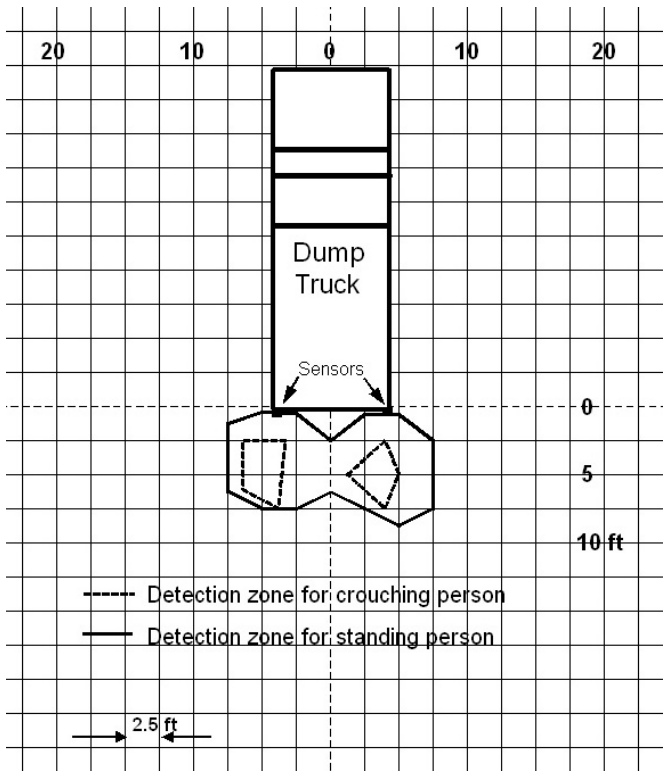
Figure 24.—Detection zone for person and Hindsight sensors mounted on dump box corners.

As suggested by the manufacturer, the two sensors were temporarily mounted on the lower corners of the dump truck's box (just below the tailgate hinge points) as shown in figure 23. The alarm was situated at the rear of the truck for easy viewing for these initial tests. Several problems were seen with this mounting configuration, including the potential for damage to the sensors when material flowed through the tailgate and the lack of continuous detection of a crouching person behind the truck, as shown by the dashed lines in figure 24.

An alternative mounting position for the sensors was tested (figure 25). This placed the sensors on the hitch plate and closer together, which resulted in a more continuous detection zone for a person, as seen in figure 26. The total range of the system was 2.4 m (8 ft), and detection covered most of the width of the truck except the corners of the dump box. The system did not generate false alarms in a clear area on asphalt, and the mud flaps were not detected. Despite the short detection range, long-term tests on a dump truck were conducted.
