The Explosion Hazard From Hydrogen Gas Generation Inside Sealed Frames

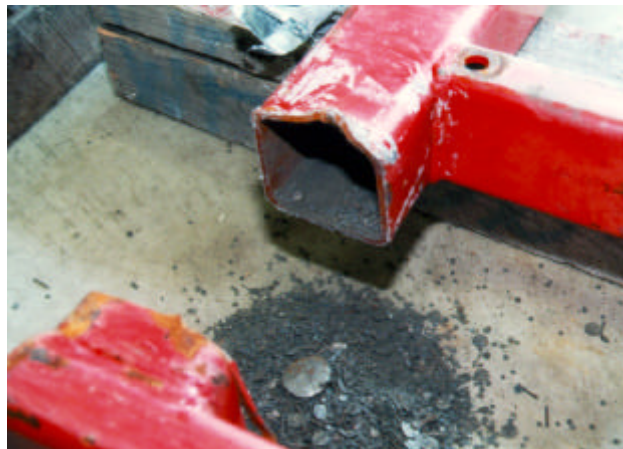
Inspection of the frame sections involved in the incidents showed discoloration, charring, or blistering of paint in the immediate vicinity of the holes. Probing the holes with a magnetized blade revealed a hard interior fill material and the presence of some metal punchings. This fill material was more extensively sampled from another section that had been cut through (figure 1). This revealed a wide range of metal punchings that was used as ballast in these steel frame sections, which had been welded shut after the filling operation. The punchings were found to consist of various forms of steel (carbon, galvanized, and stainless) and other metals, including titanium. Sealing the holes and sampling the gases present revealed the depletion of oxygen from the original air atmosphere and the presence of hydrogen. The hydrogen concentration was found to increase with time under sealed conditions. The pressure in the resealed sections also increased with time at a steady

Figure 1. Metal fill from exposed section of plow frame.
