REPAIR OF WHITE OAK GLUED-LAMINATED BEAMS

Lawrence A. Soltis, M. and Robert J. Ross, M.¹

PROCEEDINGS OF THE FIFTH ASCE MATERIALS
ENGINEERING CONGRESS

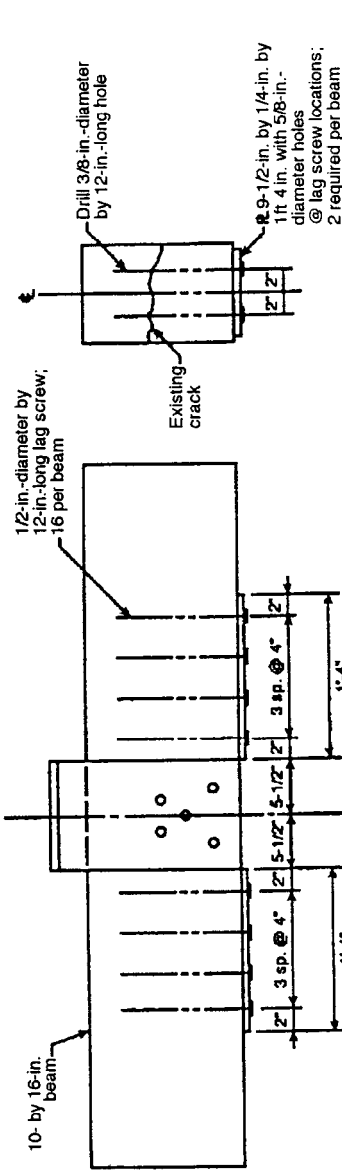
Repair method 3 used 13-mm- (1/2-in.-) diameter lag screws but otherwise had the same configuration as did method 1. Even though recommended-sized lead holes were used during fabrication, 3 of the 16 lag screws in one specimen sheared off. This configuration was chosen to find what beam capacity could be achieved with smaller lag screws.

Figure 4. Repair Method 3: Continuous steel plates and 16 1/2-in.-diameter lag screws (1 in. = 25.4 mm).

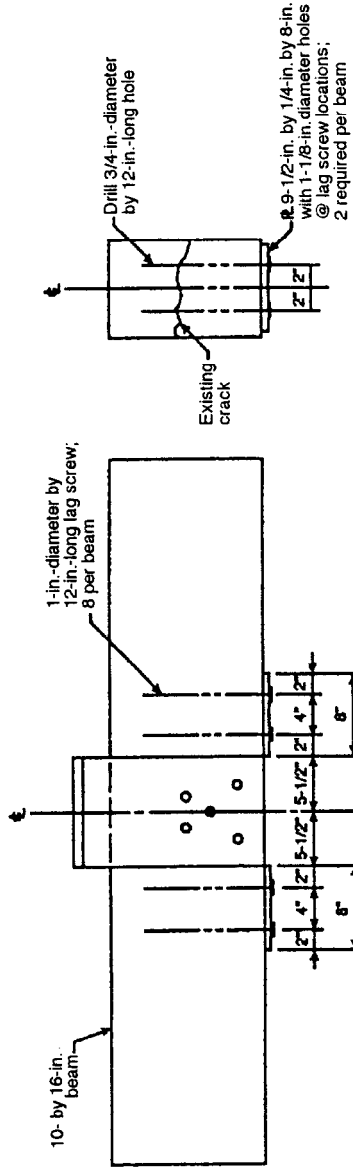
Repair method 4 consisted of eight 25-mm- (1-in.-) diameter by 305-mm- (12- in.-) long lag screws with two steel reinforcing plates 241 by 6 by 203 mm (9-1/2 by 1/4 by 8 in.). This configuration was part of the trial and error process related to the extent of the fracture. It consisted of half the number of lag screws compared with method 1.

Figure 5. Repair Method 4: Continuous steel plates and 8 1-in.-diameter lag screws (1 in. = 25.4 mm).
