ABATED ELECTRICAL TRANSFORMER HAZARDS

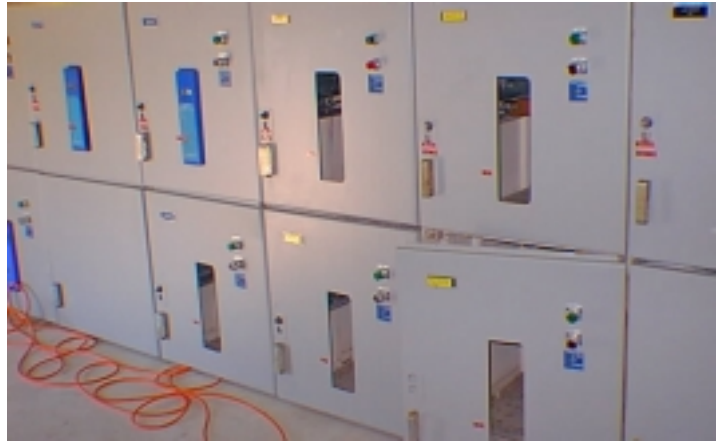
At Naval Station Newport, RI, Load Center One, the source of primary electrical distribution for the NAVSTA, was more than 40 years old and had transformers that did not have primary fusing. Primary fusing protects the service center from electrical current overages. The transformers overheated due to the absence of primary protection, had inoperable circuit breakers, and leaked dielectric compound. The resulting poor insulation capacity of the electrical wiring in the transformers coupled with the inability to manually trip the circuit breaker device (pictured below) due to faulty wiring put

Views of one of the aging transformers

The National Electrical Code (NEC) requires an accessible mechanical means for manually tripping circuit breaker devices that is independent of the control power. Using Operation and Maintenance (O&M) funds, NAVSTA Newport replaced the electrical equipment in Load Center One with new transformers that have primary protection, operable circuit breakers that can be tripped manually, and properly insulated electrical wiring.

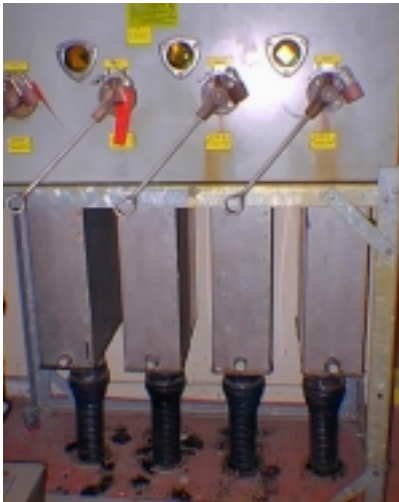
Circuit interrupter device (CID)
