# BRAVO ZULU

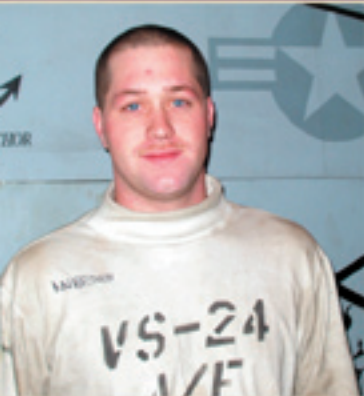
**AMAN Kenneth Brown**

While doing a final inspection on 701, which was on the catapult, Airman Brown noticed the elevator servo dumping hydraulic fluid from the rudder area. He immediately notified the flight-deck coordinator and suspended the launch. Later the same night, while doing a final check on 703, he noticed a hydraulic leak in the port wheelwell. He again notified the chain of command, and the aircraft was spun off the catapult for repair. His keen attention to detail prevented any damage to aircraft or injury to personnel.

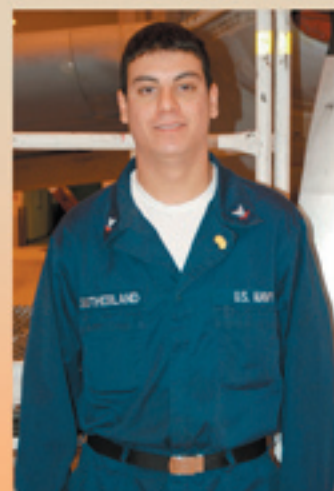
**AT2 Franklin Southerland**

Petty Officer Southerland was acting as a ground safety observer during an HF-radio "longwire" antenna change. After the cable was detached from the vertical stabilizer of a P-3C, the loose end was draped across and got caught on the aircraft boarding ladder. Knowing people were working inside the aircraft, Petty Officer Southerland stopped the maintenance action to remove the cable from the boarding ladder. As he approached, a co-worker prepared to exit the aircraft. He immediately shouted a warning, which the other Sailor heeded. Petty Officer Southerland then removed the antenna cable and continued the original job.

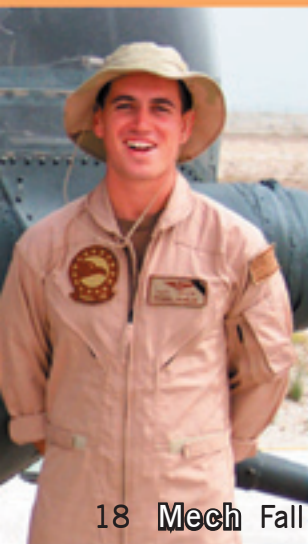
**AT3 Walter Shields**

Petty Officer Shields was manning a fire bottle on Hurricane 00, which just had returned from a VOD mission in the Arabian Gulf. The pilots were getting ready to shut down the engines when something caught AT3 Shield's attention. He noticed an excessive leak coming from the port engine area and immediately signaled the copilot to shut down the No. 1 engine. At that time, an aircrewman on longcord moved over and reported oil "pouring from the engine." The aircraft commander secured the engine and completed the shutdown checklist.

Maintainers determined oil was coming from the No. 1 nose gearbox and found the retaining-bolt assembly for the oil-filter housing had failed. This problem allowed the housing to come apart, resulting in a rapid loss of nose-gearbox oil. The loss of oil pressure and increase in oil temperature would have caused excessive and unnecessary wear, affecting the performance and service life of the gearbox.

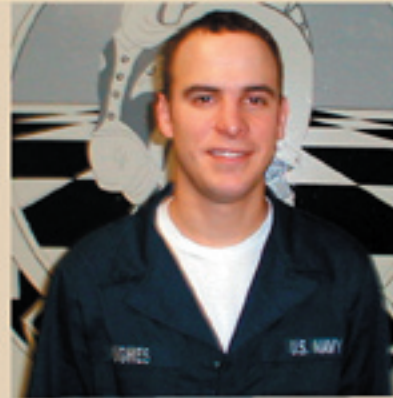
**AD2 Anthony Hughes**

While trying to secure the stabilator of Cutlass 477, Petty Officer Hughes watched a huge wave come over the back of the flight deck and knock a maintainer off his feet. He quickly grabbed the Sailor by his float coat and hung onto the aircraft as the wave swept his shipmate four feet off the deck. Petty Officer Hughes' superb situational awareness and quick reflexes prevented a maintainer from going overboard in the middle of the night.

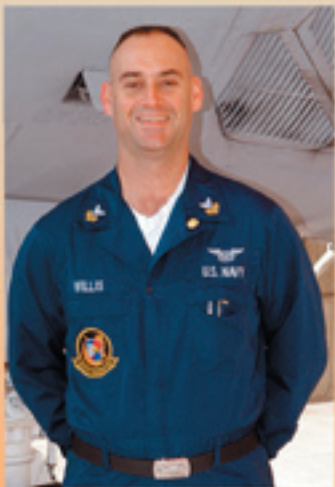
**AS1 Shawn Willis**

Petty Officer Willis found fuel leaking from an area around the bomb-bay doors. After a closer look, he discovered fuel was coming out a conduit from the No. 5 fuel tank and was leaking into the bomb bay. Had he not found this problem, the fuel would have pooled inside the bomb bay and could have ignited from a static-electric charge that always occurs while the aircraft is in flight. Although not part of his regular duties, his thorough inspection revealed a critical safety-of-flight issue.

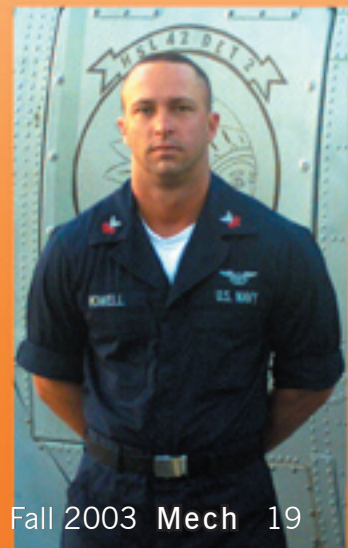
**AD1 Christopher Howell**

During a routine inspection on Proud Warrior 431, Petty Officer Howell found a cracked flex coupling on the high-speed shaft for the No. 1 engine. His keen attention to detail enabled him to find this small crack and to repair the shaft before major problems arose.
