BRAVO ZULU

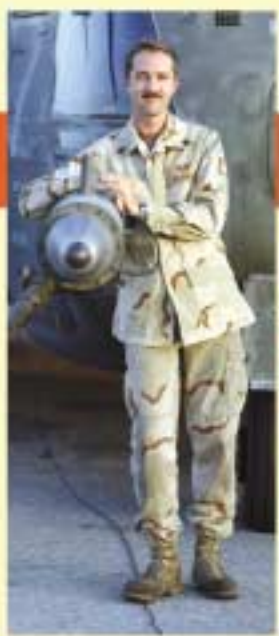
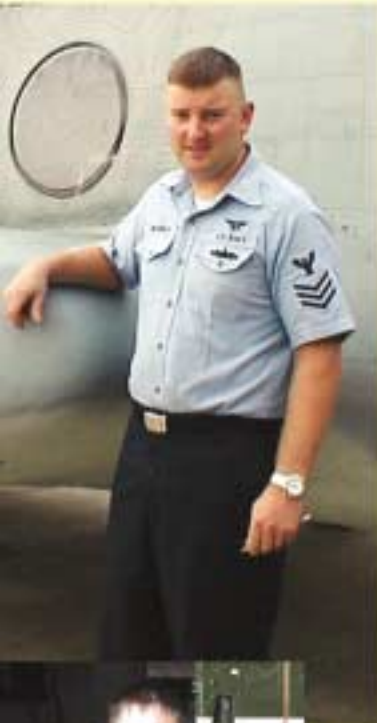
AE1 Randall Ackley

While deployed to Bahrain with HM-14 Det 1, Petty Officer Ackley made an incredible discovery. After many days of trouble shooting and changing components on an MH-53E rotor-brake system, he diligently started to open one panel after another, looking at individual aircraft wire bundles. His effort paid off when he found degraded Kapton wiring in a harness that holds several wires for the rotor-brake and blade-fold systems.

Petty Officer Ackley's find resolved the problems with the aircraft and also revealed a deeper discrepancy. After researching maintenance diagrams and schematics, he discovered a rotor brake could engage at high-rotor rpm when certain wires within the same bundle touched. His efforts led the command to release a hazard report to alert the fleet about this potential—one of many dangers related to Kapton wiring.

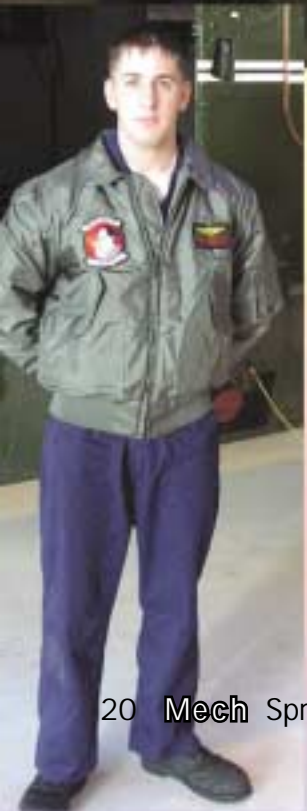
AM1 Richard Weatherly

While doing a pre-cruise aircraft material condition inspection on Bayraider 63, Petty Officer Weatherly discovered a problem. A rigid line between the utility hydraulic reservoir and the utility hydraulic pump had chafed against the airframe in the aft pylon area.

Given the severity of his find, the squadron submitted a hazrep and did a one-time inspection of all squadron aircraft. That search led to similar discrepancies on Bayraider 25.

In an unrelated incident, Petty Officer Weatherly inspected the forward rotor head on Bayraider 00 and found the horizontal hinge pin on the forward yellow blade had shifted within the rotor-hub assembly, damaging the hub.

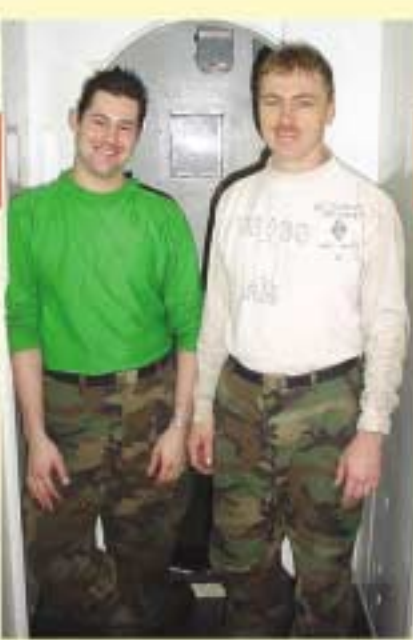
AT3 Timothy Anderson

While washing an aircraft at NAF Atsugi, Petty Officer Anderson discovered excessive play in a tail-rotor, drive-shaft viscous damper on Warlord 11—the Seventh Fleet's UH-3H. He immediately notified a QAR, who determined the viscous damper was out of limits—40 thousandths of an inch, to be exact. Petty Officer Anderson was not required to check this part during the wash job; however, he did while the drive-shaft cowling for the tail rotor was open.

One week later and immediately before a night launch, Petty Officer Anderson noticed a hydraulic leak on a dark deck. He told the pilots of the problem and summoned a QAR, who determined that the auxiliary, hydraulic, servo pump had failed. At the rate the pump was leaking, an in-flight emergency would have occurred within five minutes of takeoff. His keen attention to detail prevented a serious problem.

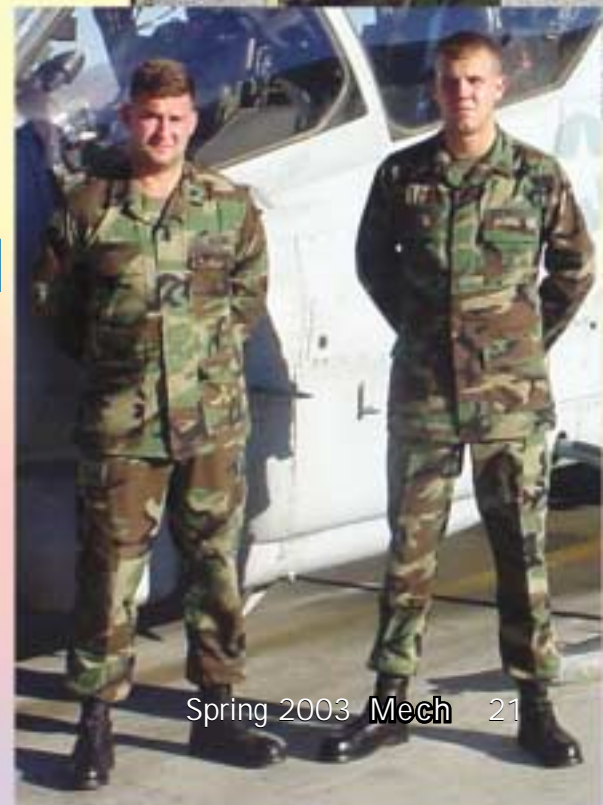
Sgt. Anthony Angell and LCpl. Wesley Trawick

These Marines removed an access panel to the turret-control amplifier and discovered a severely gouged and damaged forward, lateral, cyclic-control tube. In an effort to determine the nature of the problem, they partly reinstalled the panel and found a cannon plug had caused the damage. They then notified Quality Assurance.

A QAR and airframes rep determined a flaw existed in procedures for installing the forward, starboard, AAR-47 sensor. That part was installed as part of revision A to airframes change 230. The faulty step allowed the cannon plug to touch the gunner's cyclic-control tube, which caused a severe chafe and deep gouge. The command submitted an EI and HMR, detailing Sgt. Angell and LCpl. Trawick's find. Their effort prompted a fleetwide change to the installation procedures.
