# BRAVO ZULU

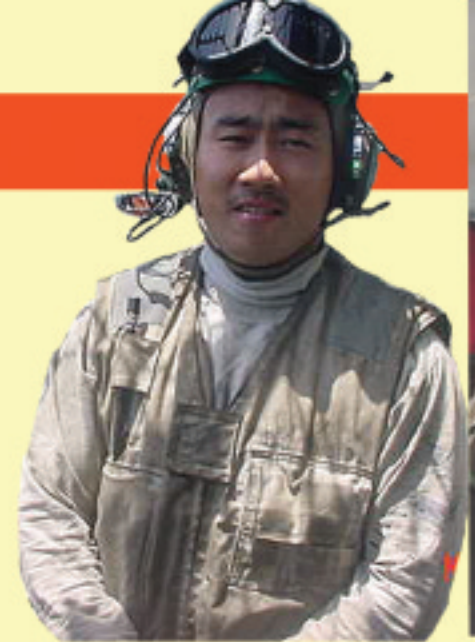
Petty Officer Yun noticed what looked like a misaligned flap louver on Stinger 501. A closer look showed the pin that secures the flap louver to the aircraft had come free. The louver was sitting in the track but was not attached to the aircraft.

He immediately notified the aircraft shooter, who then ordered the aircraft off the cat. Had this problem gone unnoticed, it easily could have resulted in FOD, TFOA or injury to flight-deck personnel.

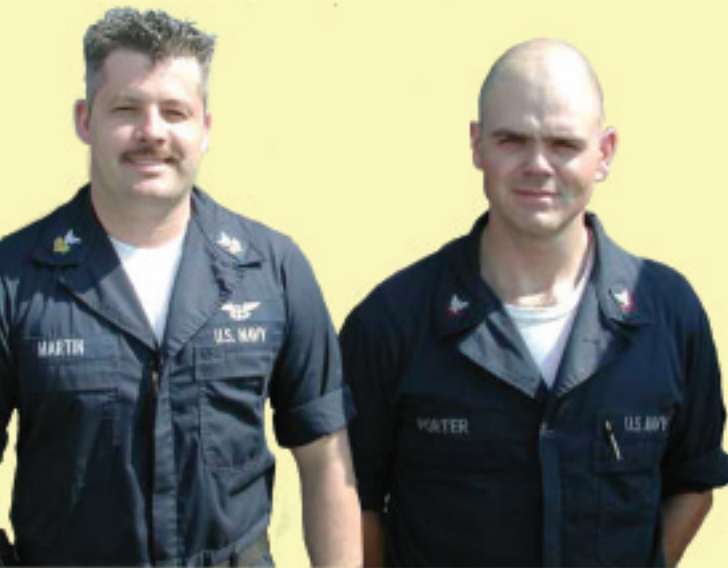
Petty Officers Martin and Porter were doing a daily inspection near the boarding ladder of Victory 105. During this inspection, AM3 Porter noticed light shining into the nose-wheelwell compartment from the area behind the boarding ladder. After a closer look, AM1 Martin and AM3 Porter found a 12-inch-long crack in the nose-wheelwell bulkhead.

This crack was a serious fault and led to a search of all aircraft. Similar cracks were found on two other aircraft. Petty Officers Martin and Porter prevented this discrepancy from leading to catastrophic damage.

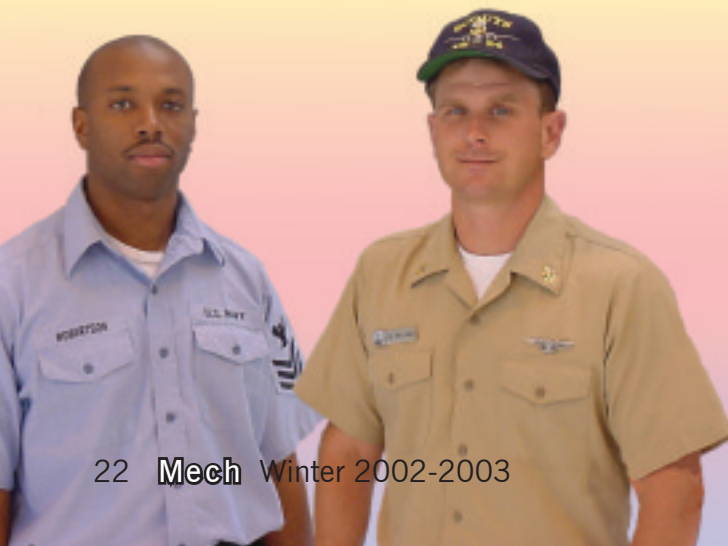
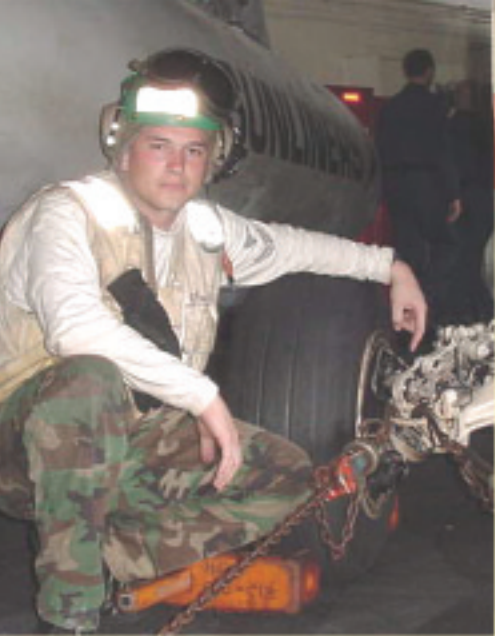
Chief Williams and Petty Officer Robertson inspected a newly replaced oil line. After a close look at the surrounding area, they discovered several loose, broken, or missing engine-casing clamps. Had they not discovered the defective clamps, the No. 1 generator would not have worked because the cannon plug was disconnected.

Chief Williams and Petty Officer Robertson also saw that the quick disconnect for the hydraulic filter on the No. 2 engine was not connected. They repaired that problem and began a routine preflight inspection on the aircraft.

Chief Williams and Petty Officer Robertson found two nuts partly backed away from the landing-gear linkage on Scout 706. They immediately notified a maintenance control chief, who downed the aircraft. These maintainers found three critical problems in one launch cycle.

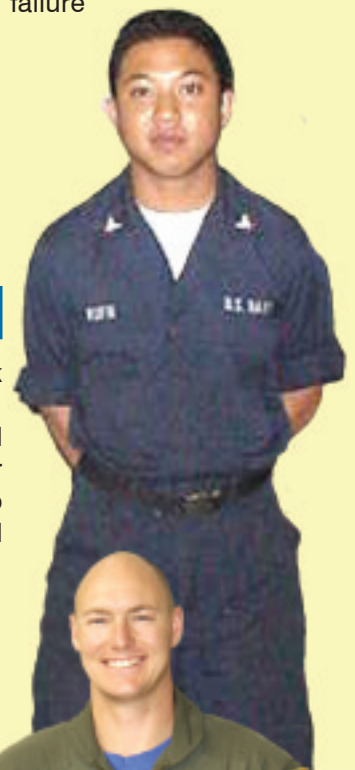
While troubleshooting Black Eagle 603, Petty Officer Rufin's alertness and quick reaction prevented a piece of support equipment from hitting a spinning propeller.

The E-2C's engines had started, and the ship was in a turn. Suddenly, the unsecured SE began to roll toward the prop. Petty Officer Rufin saw the potential for disaster and immediately grabbed the gear, slowing its movement until others were able to help. The SE stopped just three feet from the turning prop, and maintainers tied down the gear.

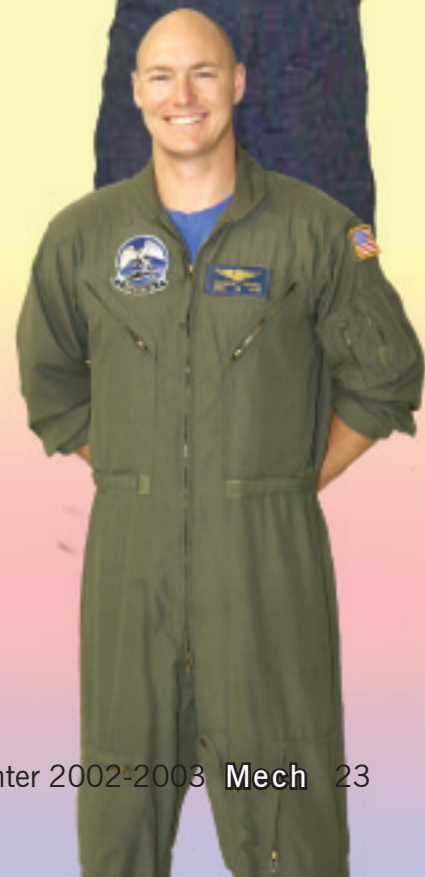
Petty Officer Nowell was doing a preflight inspection in a confined space between the center and fuselage fuel tanks on a squadron P-3C. He glanced up and spotted something out of the ordinary. Taking a closer look with a flashlight, he found the emergency-shutdown cable for the No. 2 engine nearly had severed.

The severely frayed cable could have snagged in a pulley or could have snapped, preventing the complete shutdown of that engine in an emergency. Petty Officer Nowell's thorough maintenance approach prevented a possible in-flight mishap on an aging aircraft.
