**IC 9311**

BUREAU OF MINES  
INFORMATION CIRCULAR/1992

## **In-Mine Evaluation of Smoke Detectors**

# IN-MINE EVALUATION OF SMOKE DETECTORS

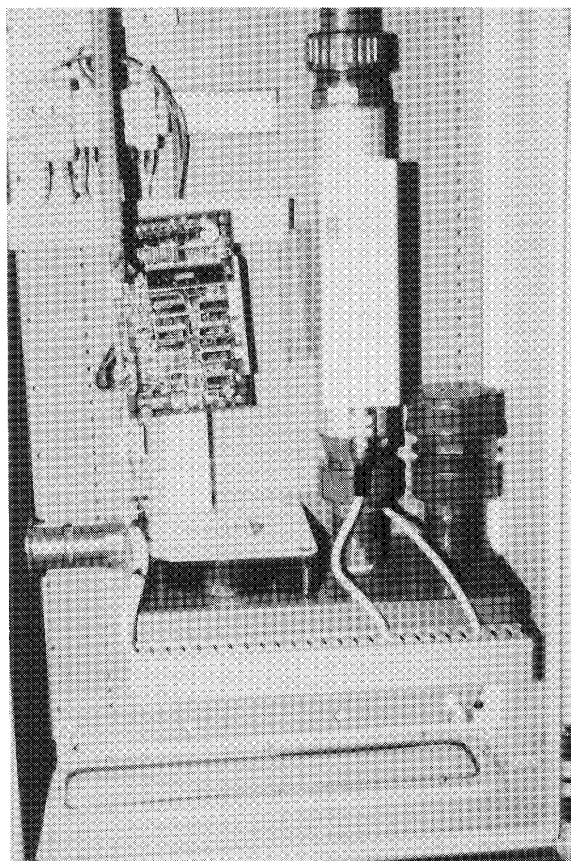
Figure 1.—HRD-2A smoke detector installed at Dilworth Mine.

The detector was installed February 7, 1990, on a main-line belt entry with an air velocity of 146 fpm. Power was obtained from a nearby CO sensor. The detector interfaced with the system via a 4- to 20-mA accessor provided by Conspec. The detector functioned properly until week 18, when the mine reported intermittent alarms lasting 10 to 20 min, but with no recurring pattern. The detector was removed, cleaned, and monitored continuously on a Conspec system at the Bureau with no alarms recorded. The mine had reported brief alarms from the detector while rock dusting. From July 30, 1990, to reinstallation in the mine on October 1, 1990, the detector was used for research purposes at the Bureau and functioned properly. The addition of a settling chamber on the sampling line, along with the insertion of honeycomb mesh at the end of the sampling tube, reduced but did not eliminate false alarms due to rock dusting. The detector remains in place to further research methods to reduce rock dust alarms.

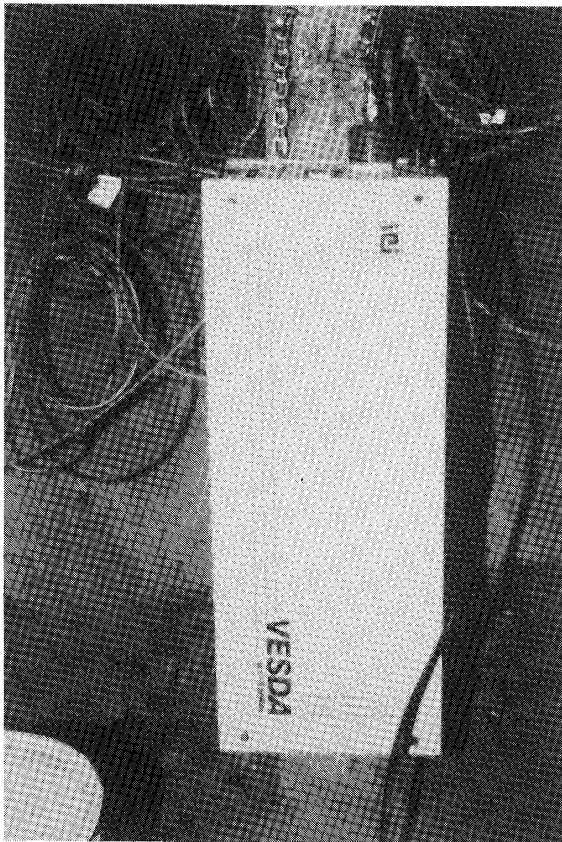
Figure 2.—VESDA smoke detector installed at McClure Mine.

Two detectors were installed on February 13, 1990, along a main-line belt. Air velocity at this location was 690 fpm at the time of installation, and increased to 1,000 fpm during the test period. Both detectors interfaced directly to the monitoring system, although the VESDA detector required mine power to operate a dc power supply.

During 47 weeks of operation the HRD-2A detector alarmed 488 times and the VESDA detector alarmed 4 times. Diesel contaminants accounted for 486 alarms on the HRD-2A detector and 2 on the VESDA detector. Rock dusting caused two concurrent alarms on both smoke detectors.

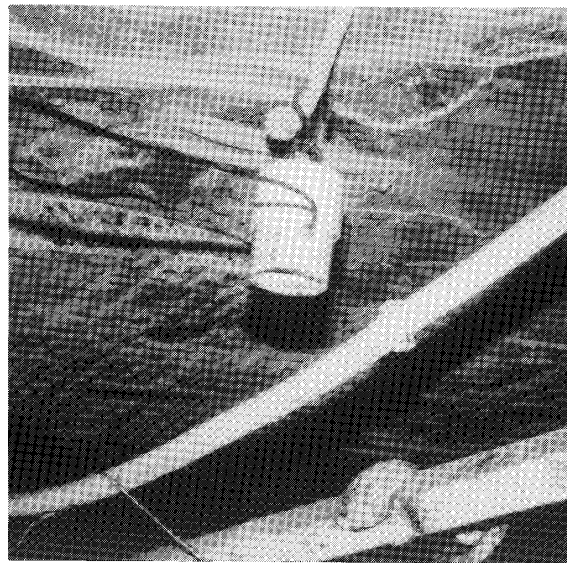
Figure 3.—End-of-line sampling port used at all test sites.

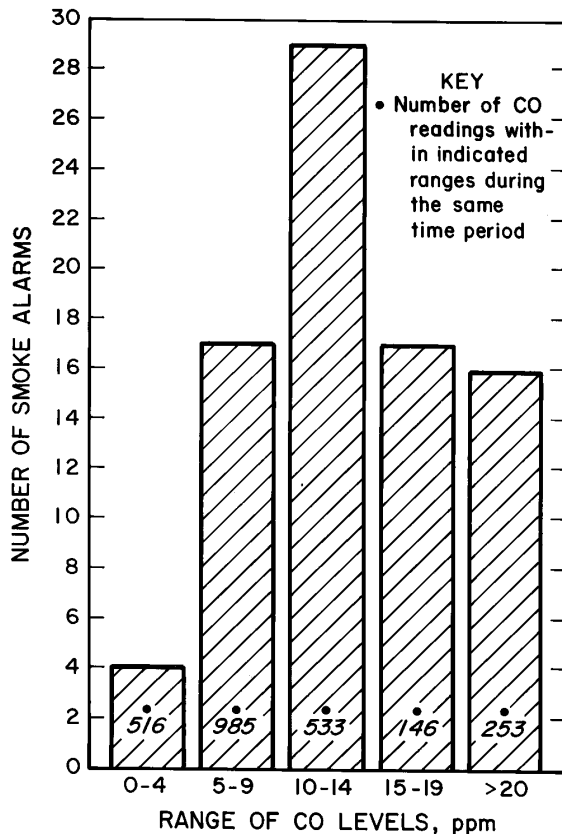
Figure 5.—Smoke detector nuisance alarms versus CO levels for 42-day period at Shoshone Mine.

The detector was installed April 5, 1990, in a two-entry section in the belt entry return air. Eighty-three alarms occurred during the period of April 28, 1990, through June 9, 1990 (42 days); all were attributed to diesel emissions. During the same period, a companion CO sensor had 516 readings of 0 to 4 ppm, 985 readings of 5 to 9 ppm, 533 readings of 10 to 14 ppm, 146 readings of 15 to 19 ppm, and 253 readings in excess of 20 ppm.

These smoke detector alarms and CO levels due to diesel exhaust allow for a direct comparison of the nuisance alarm frequency for the two types of detectors. For the smoke detector, this alarm frequency is about two per day. For CO at the 10-ppm level, the alarm frequency is 22 per day. For CO at the 15-ppm level, the alarm frequency is 10 per day. At the 20-ppm CO level, the alarm frequency is still six per day, or three times greater than the alarm frequency for the smoke detector.

In general, the smoke alarms correlated with significant increases in the CO levels. With the exception of two alarms on May 2, 1990, and May 4, 1990, the average CO reading at the time of the smoke alarm ranged from a low of 3 ppm to a high of 34 ppm, with the average level being 17 ppm. On June 9, 1990, the sampling tube was moved into intake air and the alarms ceased. On July 27, 1990, the operator decided to remove the detector from the mine, could not be convinced to relocate it in the mine, and returned it to the Bureau.

Even though the nuisance alarms are not eliminated, their frequency is reduced significantly. It is possible that by decreasing the smoke detector sensitivity by a small amount, these alarms could be reduced even further.
