ABATED LIFE SAFETY HAZARD IN FLIGHT SUIT STORAGE

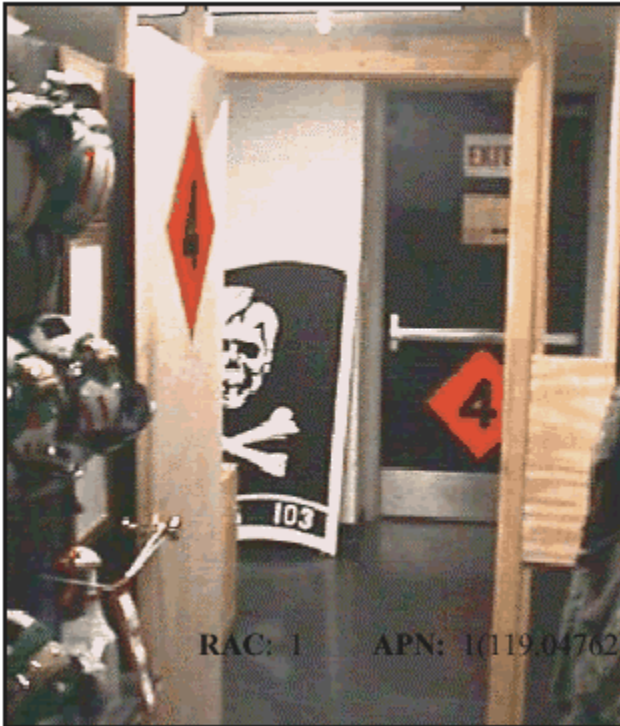
Flight suit storage room exit without emergency egress hardware or NEPA-approved exit signage.

Over 200 workers at Naval Air Station (NAS), Oceana, Virginia had been exposed to a potential life safety hazard due to the absence of proper emergency exits from the building in which their workshops were located. The building did not have emergency egress (panic) hardware on any of its exits. In addition, the doors did not open outward in the direction of travel for ease of exit during an emergency, and exit doors were not fire-rated. The exits also did not meet National Fire Protection Association (NFPA) requirements for *Exit* signs.

To correct the problem, the Chief of Naval Operations' Hazard Abatement Program funded a new flight suit storage facility. The new building was fitted with fire-rated doors that open in the direction of travel. Exit doors are also equipped with panic hardware and proper NFPA-approved exit signs.
