2.0 BACKGROUND

2.1.1 General setting: The study site is located near Inez (Martin County), Kentucky. The approximate coordinates are N 37° 44' 30" latitude and W 82° 32' 18" longitude. The pertinent rock units comprise the Breathitt Group of the Princess Formation and include the Coalburg and Stockton coal seams, which were mined in the area. The Coalburg coal seam dips locally to the south at the minesite near the impoundment.

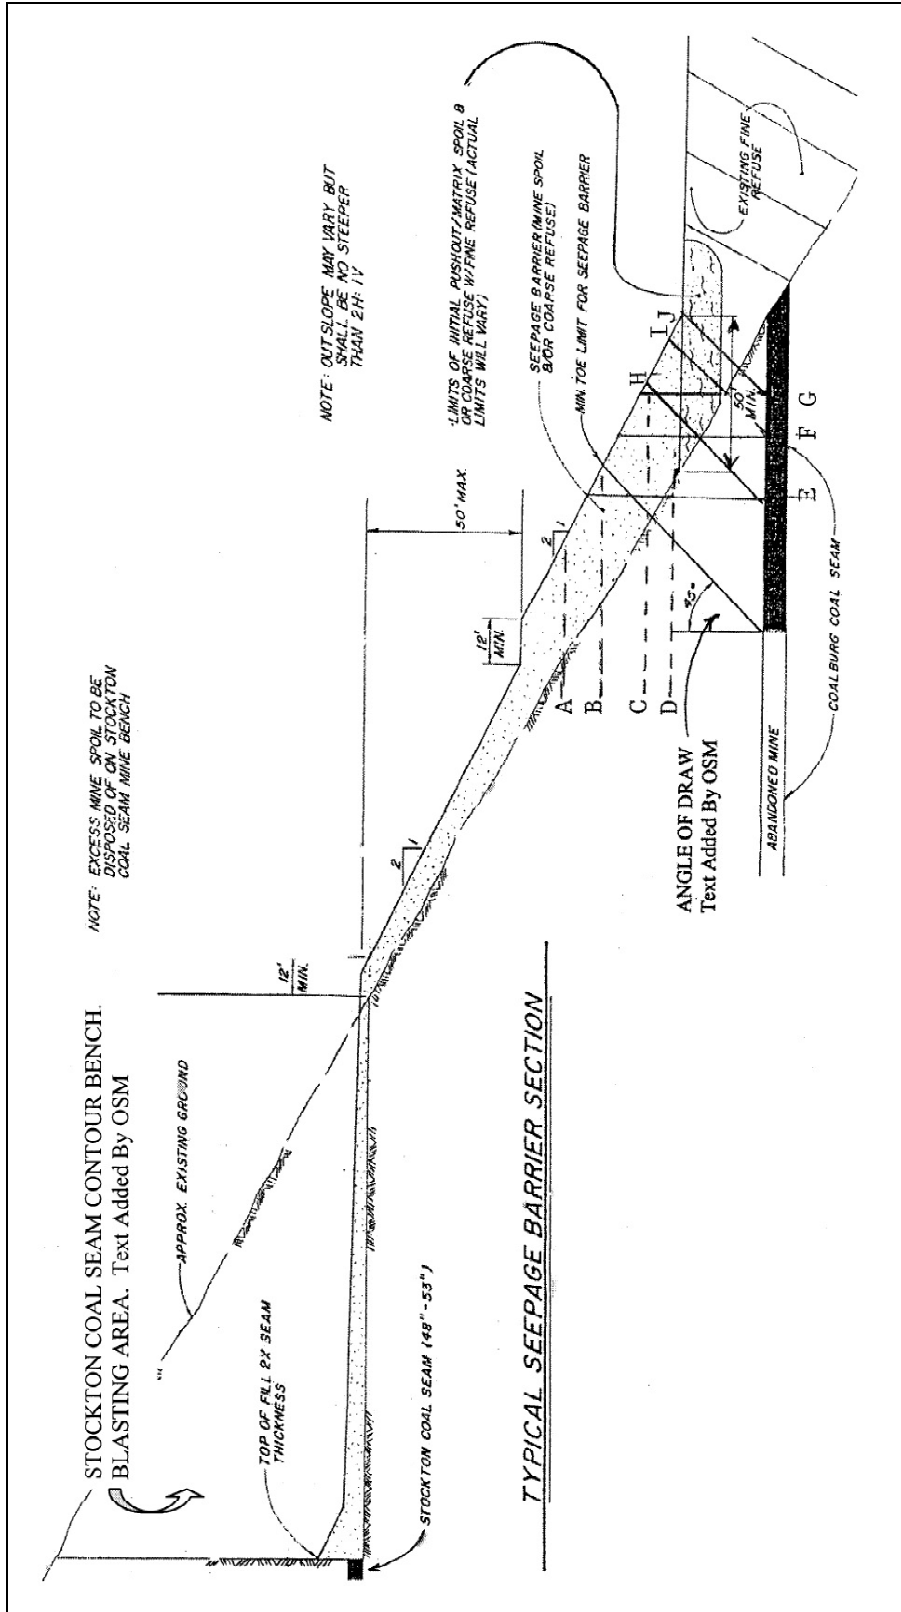
Figure 5. Cross-Section of Designed Seepage Barrier. Source: Sealing Plan, Details Sheet. Information added by OSM: 1) Mine roof caving height based on five times the mining height—line A for 12-foot mining height, line B for 10-foot mining height, line C for 7.5-foot mining height, and line D for 6-foot mining height; 2) Outcrop barrier width—vertical line E for 70-foot width, vertical line F for 50-foot width, and vertical line G for 35-foot width; 3) Lateral extent of subsidence based on a 45-degree angle of draw per MCCC —slanted line H based on a 70-foot wide outcrop barrier, slanted line I based on a 50-foot wide outcrop barrier, and slanted line J based on a 35-foot wide outcrop barrier.

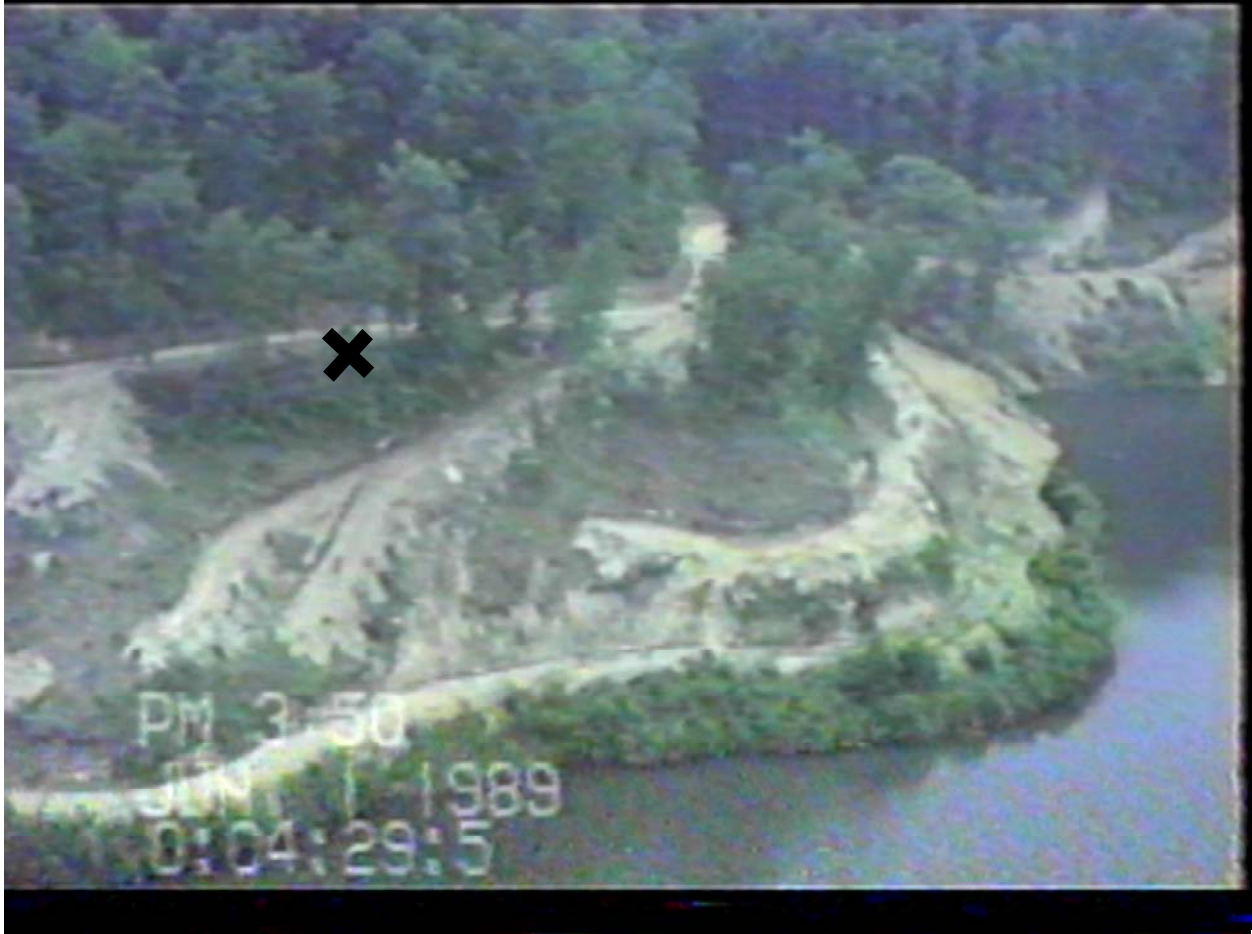
2.1.5 Surface features around the impoundment: At various times, clearing and grubbing, construction of roads and drainage ditches, and other activities have been performed around the impoundment. The size and stability of an outcrop barrier can be affected by cut and/or fill activities on the surface. OSM noted evidence of such surface modifications at the locations of the 1994 and 2000 breakthroughs. According to a map attached to the sealing plan, there was a road or diversion ditch about 20 feet below the Coalburg coal seam cropline near the 1994 breakthrough (Figure 3 [Page 17]). The map is based on 1985 aerial photography. It is not clear whether the road was excavated into the hillside or constructed on fill material obtained from clearing and grubbing operations. A June 1, 1989, aerial video shows another road a few feet above the top of the projected Coalburg coal seam and a road higher up the hillside (Figure 3 and Photo 7 [Pages 17 and 22]). These roads appear to have been excavated into the hillside.

Photo 7. Surface Conditions at 1994 Breakthrough - June 1, 1989. Source: DSMRE aerial video. The X marks the approximate location of the 1994 breakthrough. Pool elevation 958 feet msl. Mine roof elevation 964 feet msl.

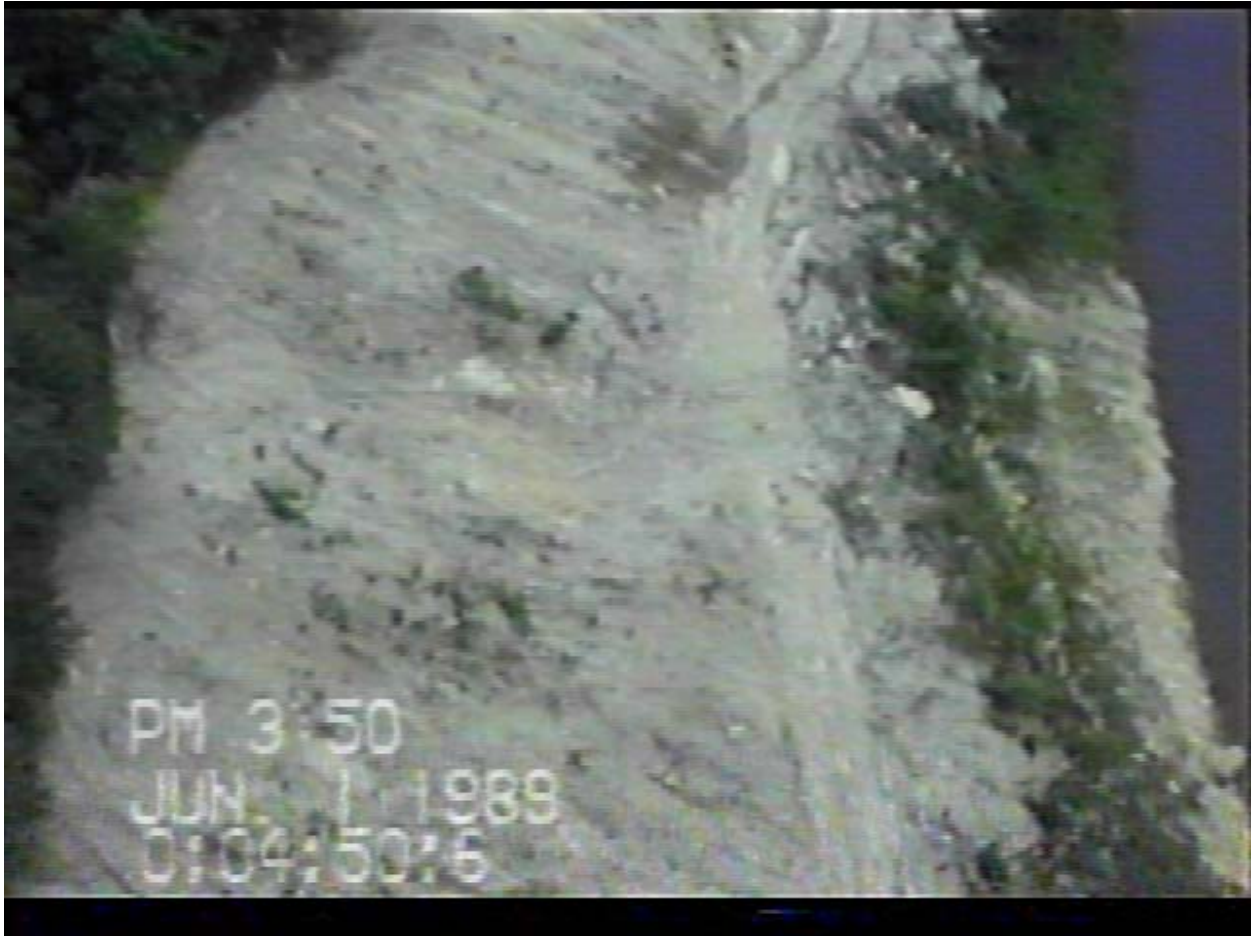
The map also shows either a road or a diversion ditch about 13 feet below the Coalburg coal seam cropline near the 2000 breakthrough point. A June 1, 1989, aerial video shows another road approximately ten feet above the coal seam (Figure 4 and Photo 8 [Pages 18 and 23]). The permit maps and aerial photographs do not provide sufficient clarity to allow a determination whether this road was excavated into the hillside or constructed on fill material.

Photo 8. Surface Conditions at 2000 Breakthrough – June 1, 1989. Source: DSMRE aerial video. Pool elevation 958 feet msl. Mine roof elevation 973 feet msl.
