OFFICE OF SURFACE MINING
REPORT ON OCTOBER 2000
BREAKTHROUGH AT THE BIG BRANCH SLURRY IMPOUNDMENT

Martin County Coal Corporation
Big Branch Slurry Impoundment
Martin County, Kentucky

March 2002

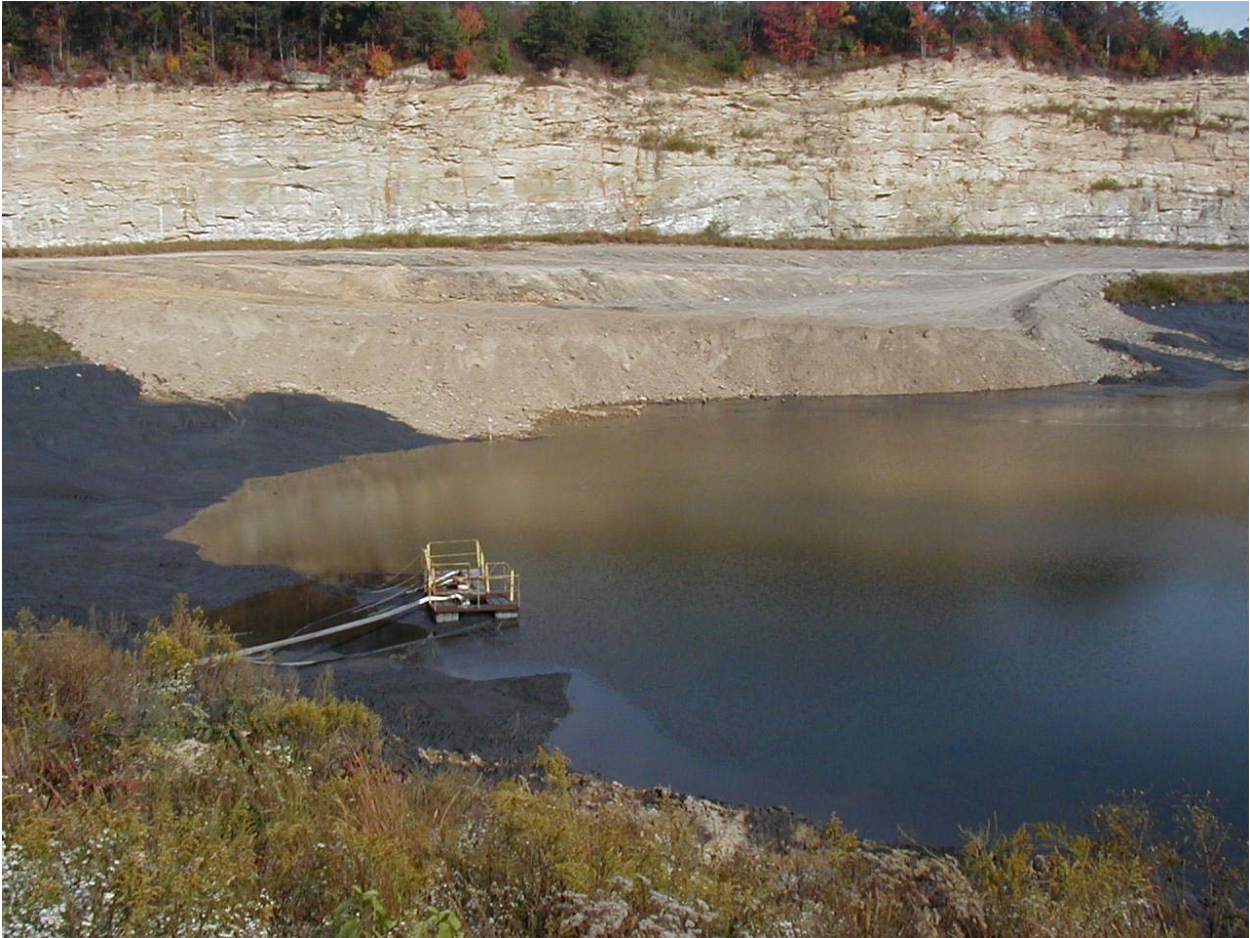
Photo 2. 2000 Breakthrough Area - October 16, 2000. Source: OSM. Pool elevation about 1,060 feet msl prior to breakthrough and 1,046 feet msl after breakthrough. Mine roof elevation 973 feet msl.

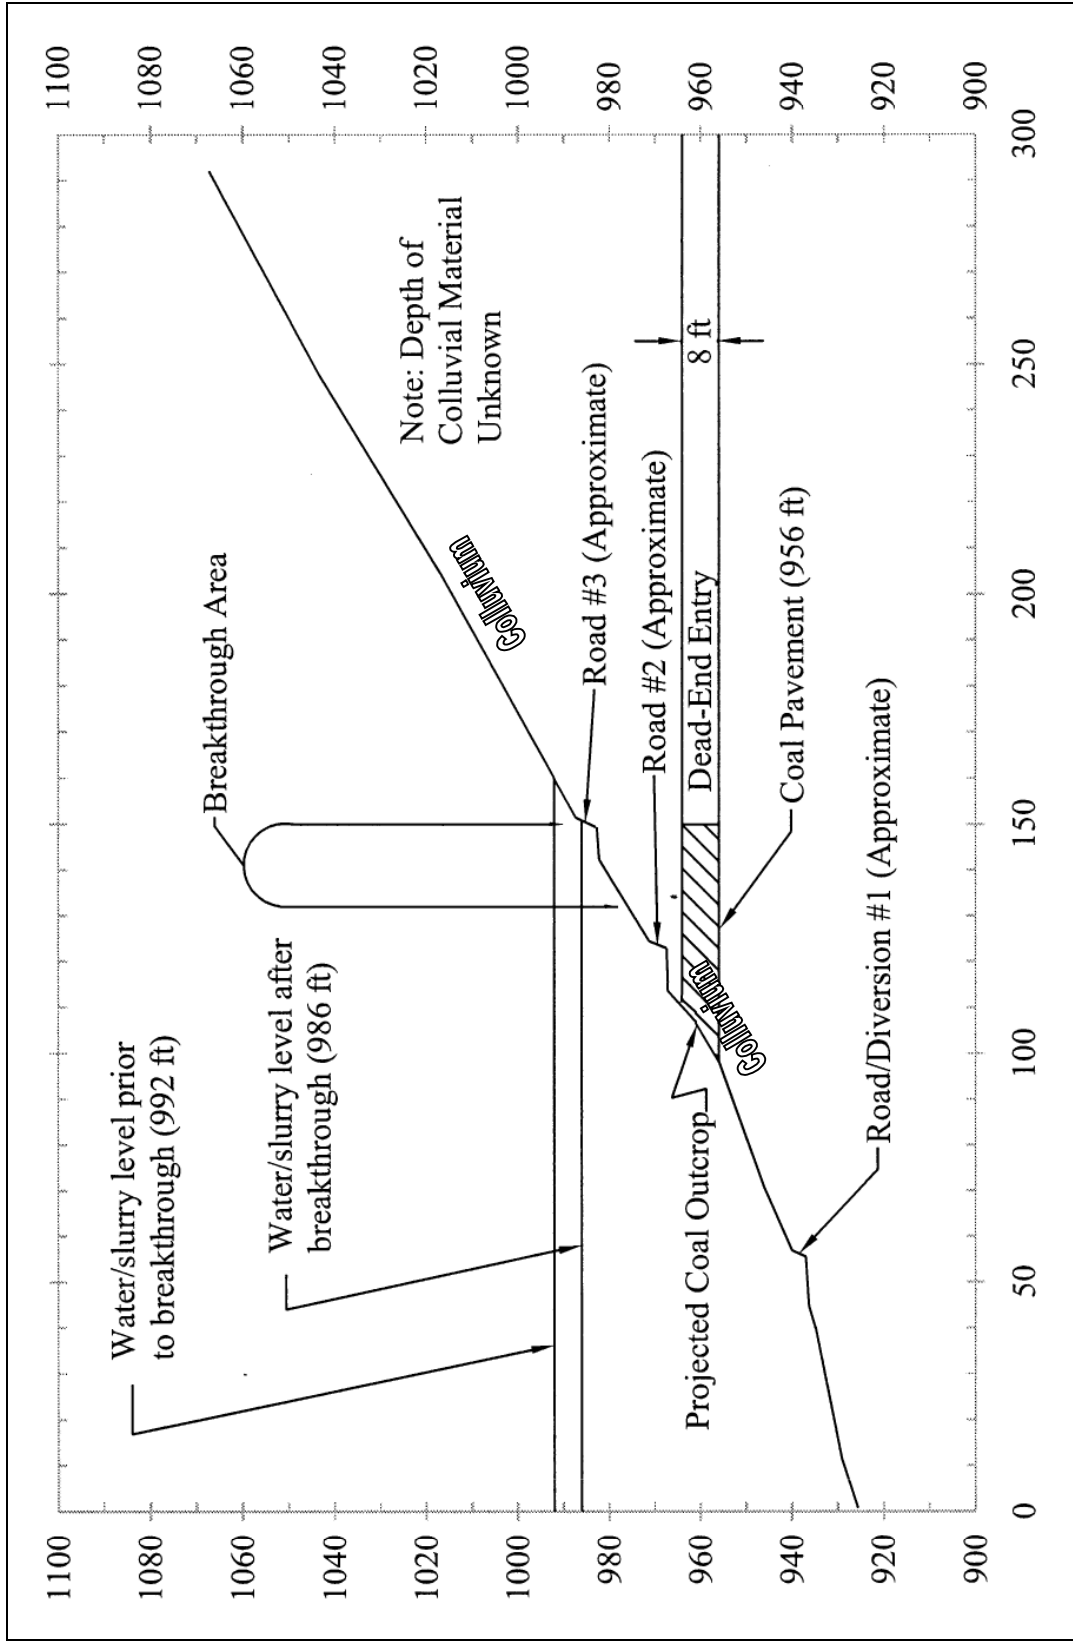
Figure 3. Cross-Section A-A' at May 1994 Breakthrough. Drawn by OSM.

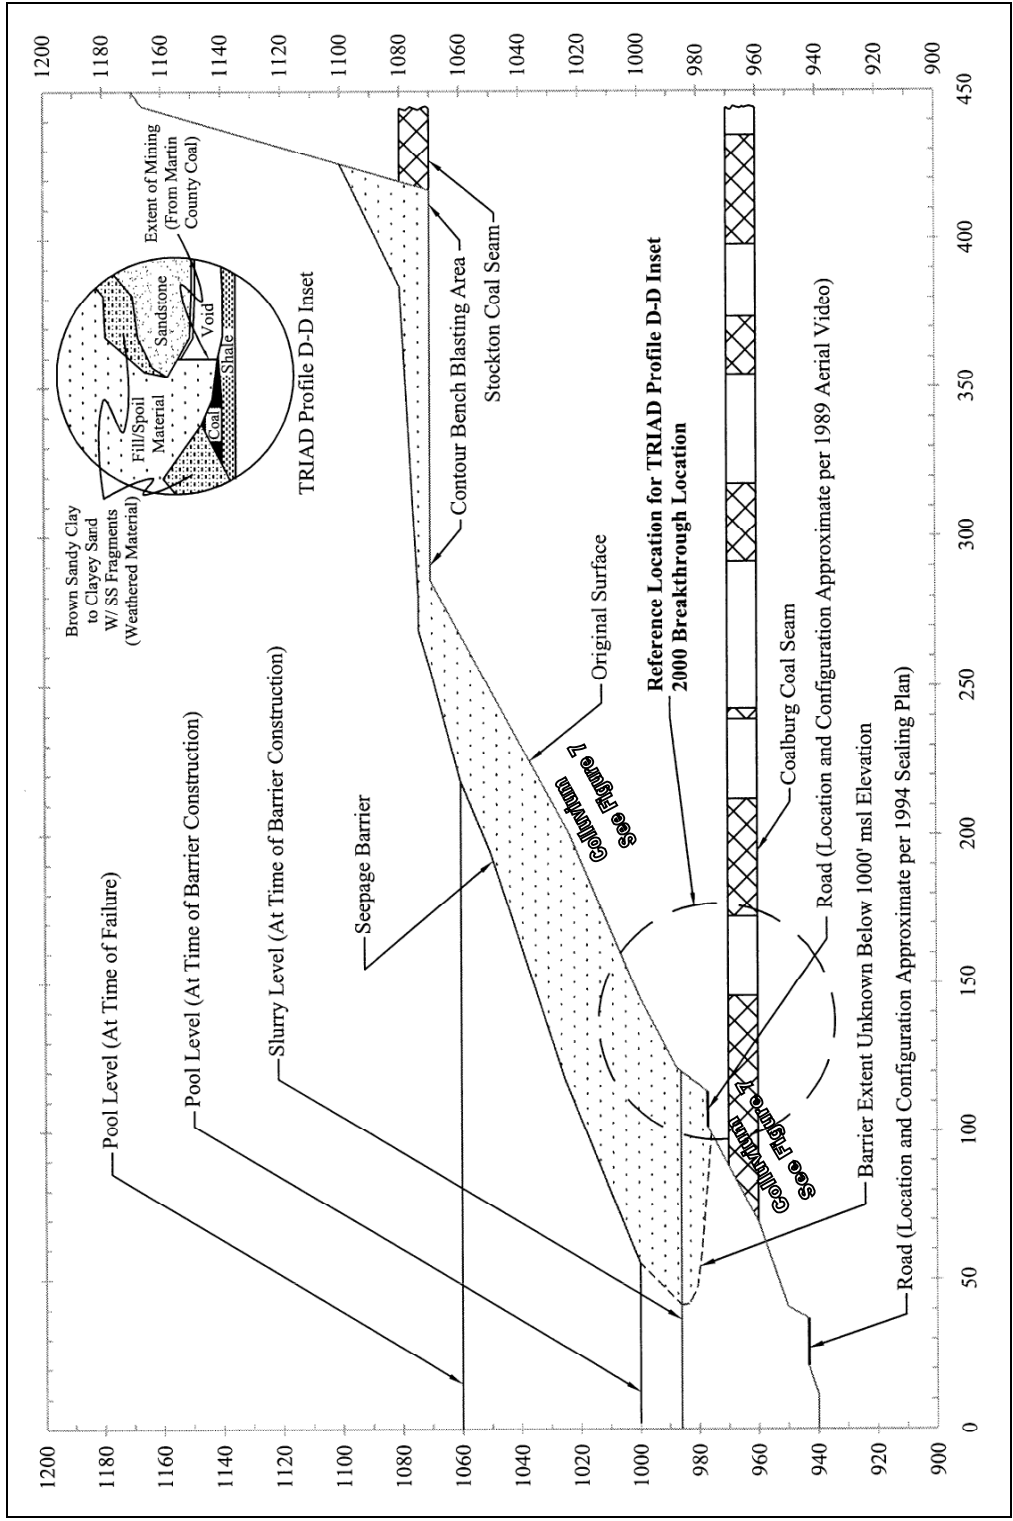
Figure 4. Cross-Section B-B' of Seepage Barrier Constructed at 2000 Breakthrough. Drawn by OSM with Triad Profile D-D inserted.

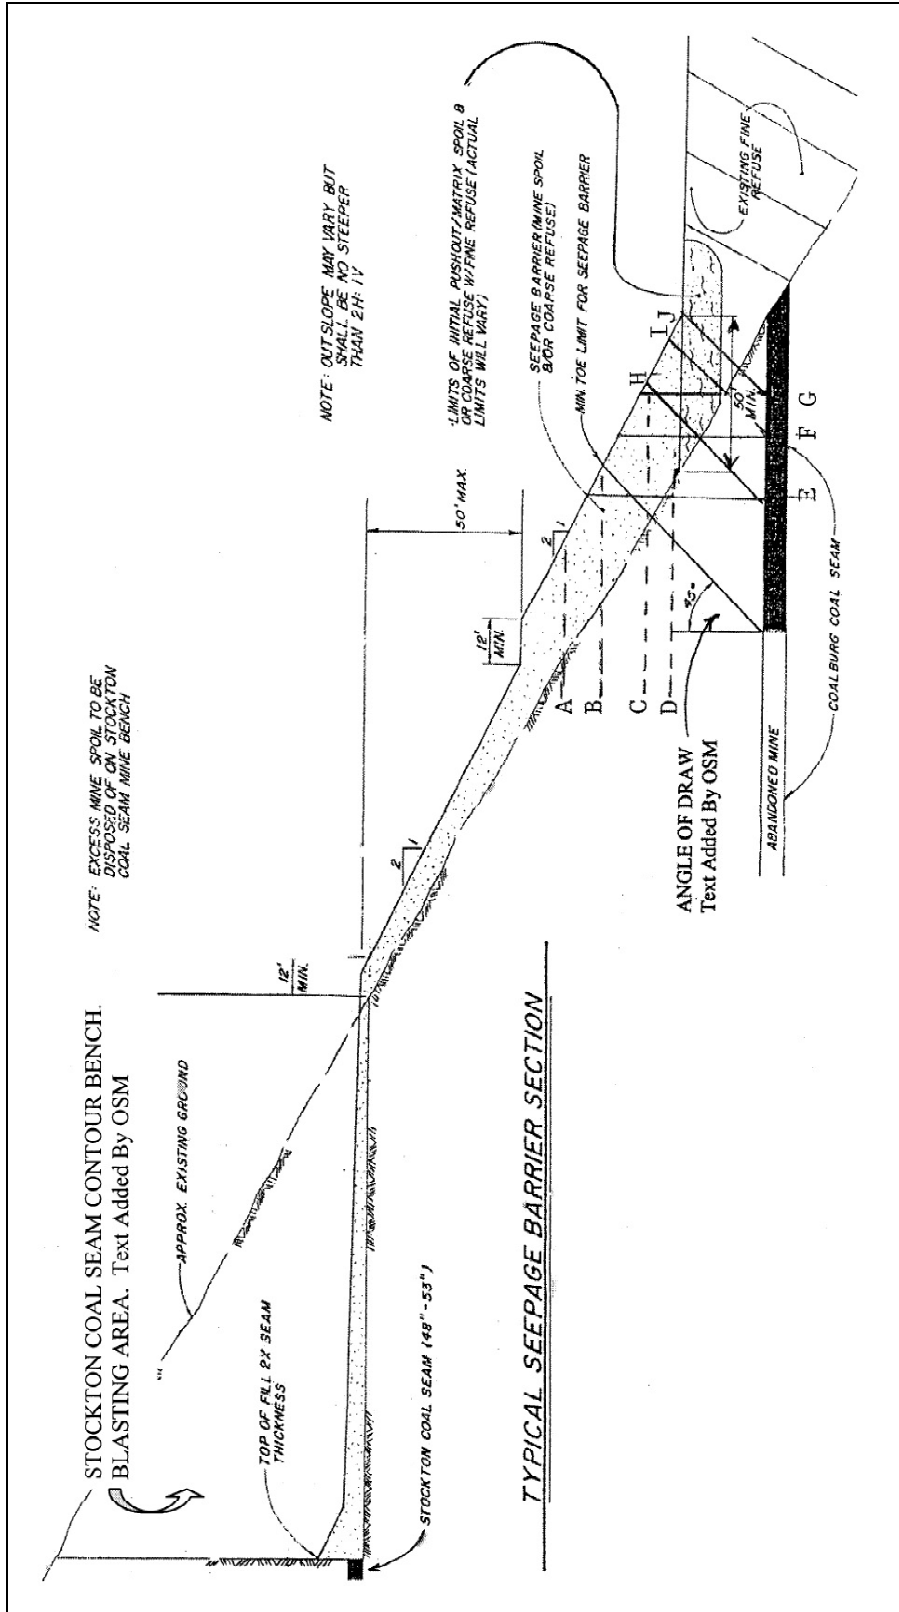
Figure 5. Cross-Section of Designed Seepage Barrier. Source: Sealing Plan, Details Sheet. Information added by OSM: 1) Mine roof caving height based on five times the mining height--line A for 12-foot mining height, line B for 10-foot mining height, line C for 7.5-foot mining height, and line D for 6-foot mining height; 2) Outcrop barrier width—vertical line E for 70-foot width, vertical line F for 50-foot width, and vertical line G for 35-foot width; 3) Lateral extent of subsidence based on a 45-degree angle of draw per MCCC —slanted line H based on a 70-foot wide outcrop barrier, slanted line I based on a 50-foot wide outcrop barrier, and slanted line J based on a 35-foot wide outcrop barrier.

The sealing plan stated that seepage from the impoundment would be limited to 10^{-7} centimeters per second (cm/sec) if the “fine refuse is deposited in the impoundment” and “the pool level is maintained as low as possible.” This seepage rate equates to 0.00028 feet per day or 3,528 days per foot. The permit, however, does not contain test results or a quantitative analysis to support the 10^{-7} cm/sec permeability rate. Further, the sealing plan does not specify the thickness of the slurry coating necessary to achieve that permeability. The permit also stated that the permeability of the spoil material used to construct the seepage barrier would vary and could not be estimated.

Research conducted by the Bureau of Mines found flow rates through spoil derived from massive gray sandstone ranged from 1.2×10^{-3} to 4.9×10^{-3} cm/sec (3.37 to 13.82 feet per day or 0.3 to 0.07 days per foot) (Hawkins and Aljoe, 1991). The Triad investigation independently confirmed high permeability of the seepage barrier material, which was largely sandstone-derived spoil.

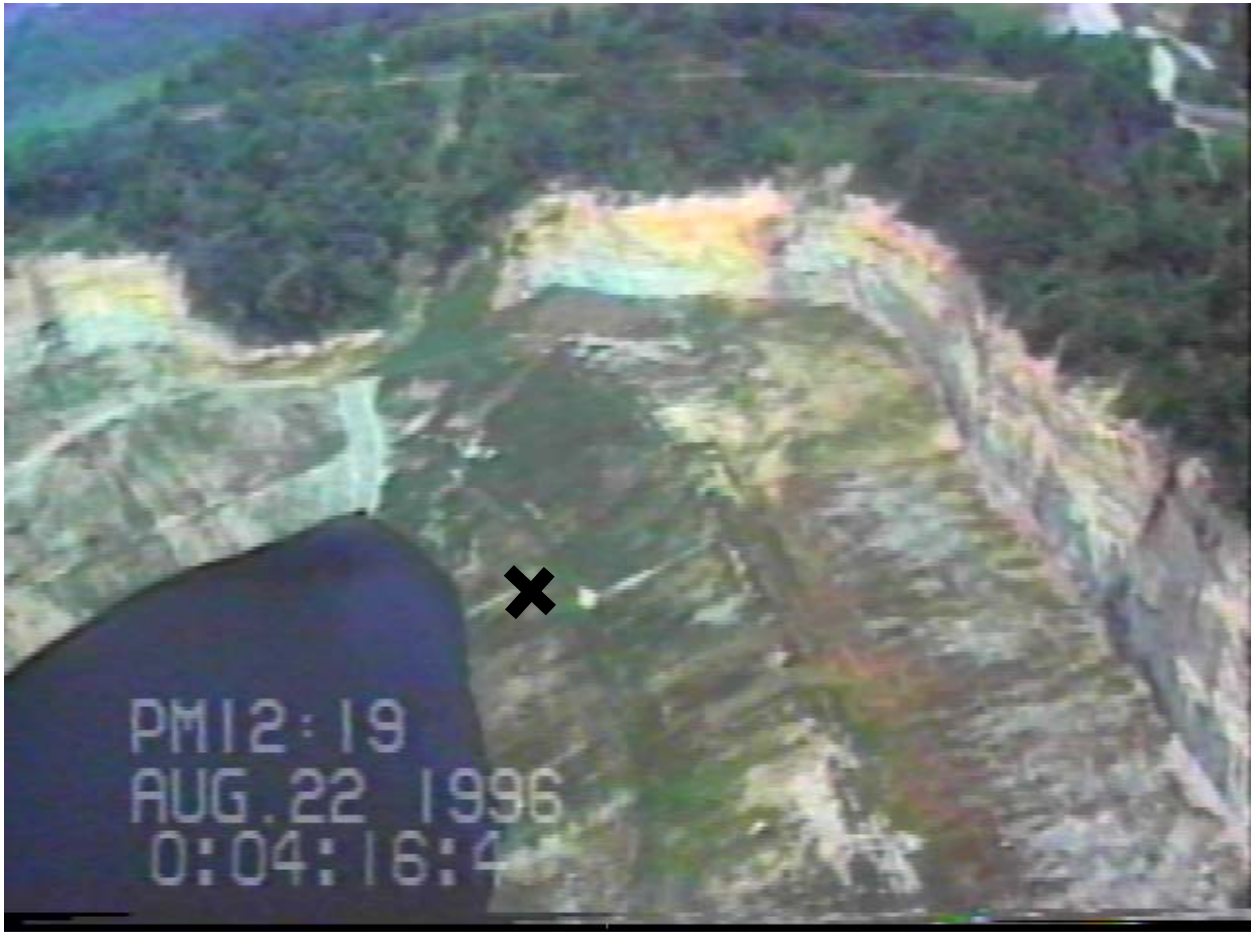
Photo 6. Seepage Barrier by 2000 Breakthrough (After Construction) - August 22, 1996. Source: DSMRE aerial video. The X marks the approximate location of the 2000 breakthrough. Pool elevation 1,018 feet msl. Mine roof elevation 973 feet msl. Contour bench elevation 1,075 feet msl.

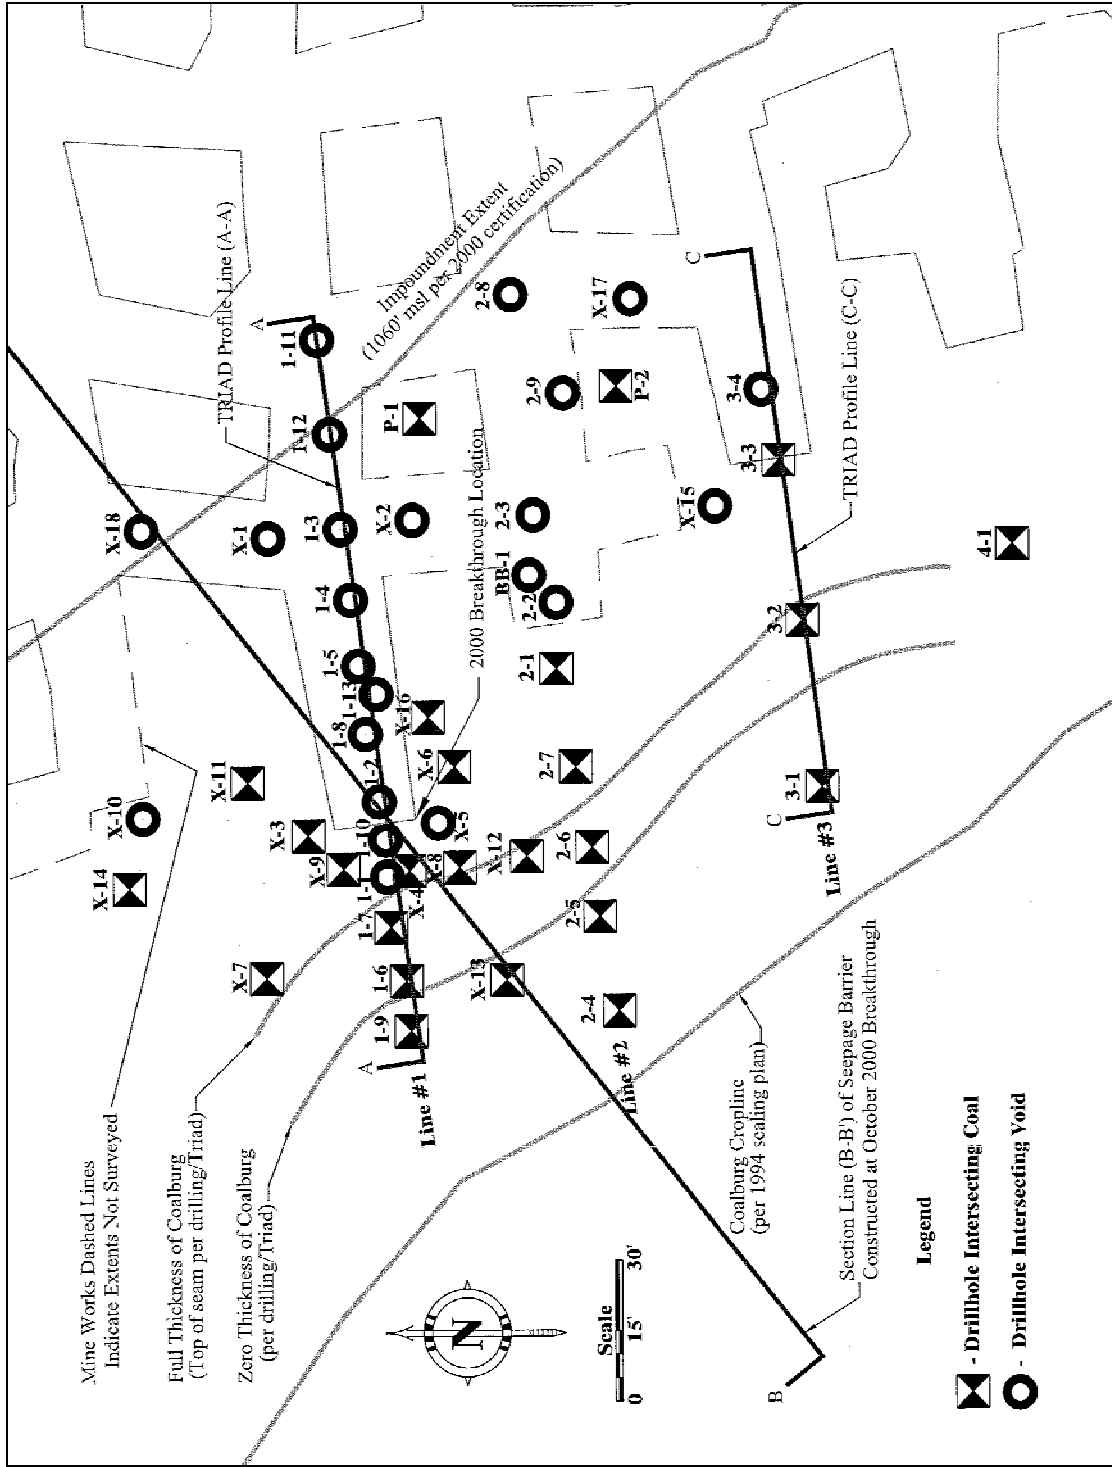
Figure 6. Drill Hole Location Map. Drawn by OSM using Triad drilling data. Note: The Triad drill logs did not indicate that voids were encountered by holes X-4 and X-8; however, these holes, along with X-5, are located in the breakthrough erosion channel.

The drilling, holes 1-1 and 1-10, identified a void beyond the mapped mine entry (mine limit) at the 2000 breakthrough. These drill holes were located along the centerline of the entry. This is in contrast to drill hole X-9, which did not identify a void near the left side of the entry. It is not known whether the “missing” coal was mined or eroded during the breakthrough. However, coal remaining at the base of the holes (1-1, X-4, X-5, X-8) suggests that the coal was eroded and not mined. Except for holes 3-4 and X-15, the Triad drilling indicates that MCCC mined the total thickness of coal.

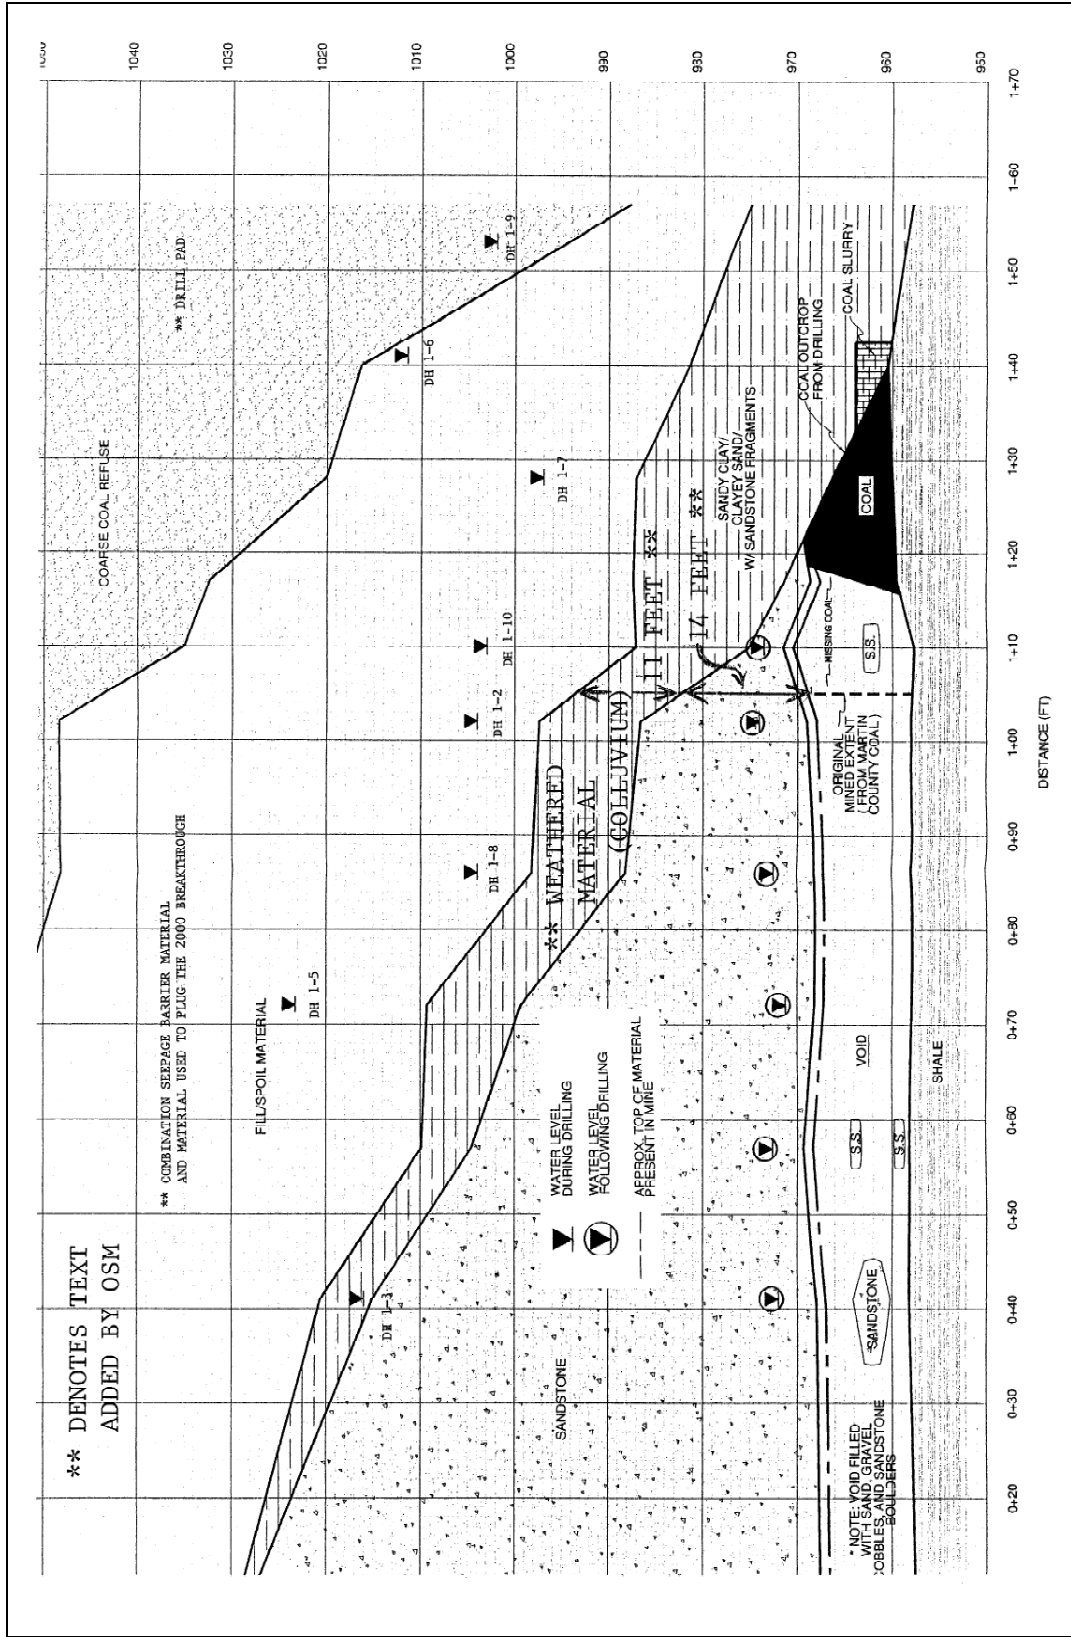
At the end of the 10- to 12-foot section of “missing coal” (Figure 7 [Page 55]), the overburden is composed of only about four feet of weathered sandstone and 15 feet of colluvium. This is in contrast to the sealing plan that indicates that the overburden was solid rock (Section 3.3.2.5). Further, the sealing plan’s cross-section and maps indicate that the horizontal distance between the mine limit at the 2000 breakthrough and the surface was 50 feet at the top of the coal seam and 70 feet at the bottom of the coal seam. However, the drilling near the breakthrough indicates that the Coalburg coal seam extended less than half the distance from the mine limit to the surface. The full thickness of the Coalburg coal seam exists for only about 15 feet beyond the mine limit as mapped and then it thins to zero feet thick at about 33 feet from the end of the mine (Figure 6 [Page 53]). The Triad drill logs did not identify coal in the remaining portion of the 70-foot wide outcrop barrier. This coal is presumed to be in a weathered condition, and it may have been transported downslope due to hillside creep.

Figure 7. Triad Profile A-A. From Triad Report, Cross-Section at Line #1, Figure 6.

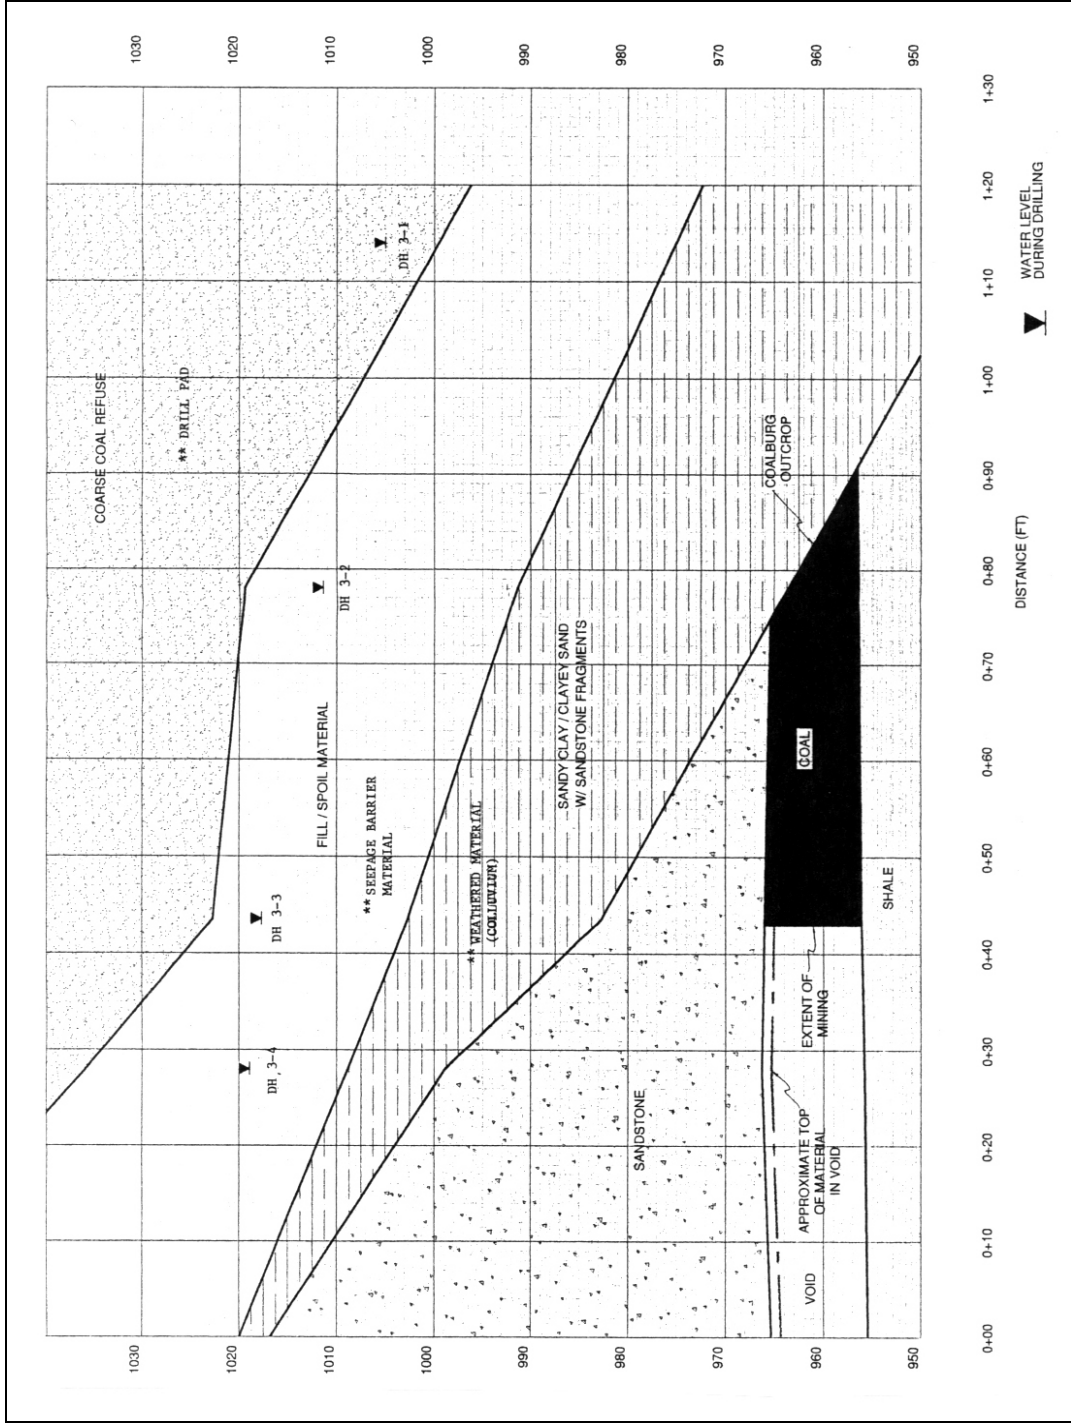
**Figure 8. Triad Profile C-C. From Triad Report. Cross-Section at Line #3, Figure 6.
 ** Denotes Text Added by OSM.**

- Mine and surface map accuracy (3.5.1.2). The Triad drilling generally confirmed the accuracy of the underground mine location and configuration at the 2000 breakthrough. The drilling identified 10 to 12 feet of missing coal beyond the end of the breakthrough entry. It is not known whether the “missing” coal was mined or eroded during the breakthrough. However, OSM’s review, based on an examination of the drill logs, indicates that coal was eroded during the breakthrough.

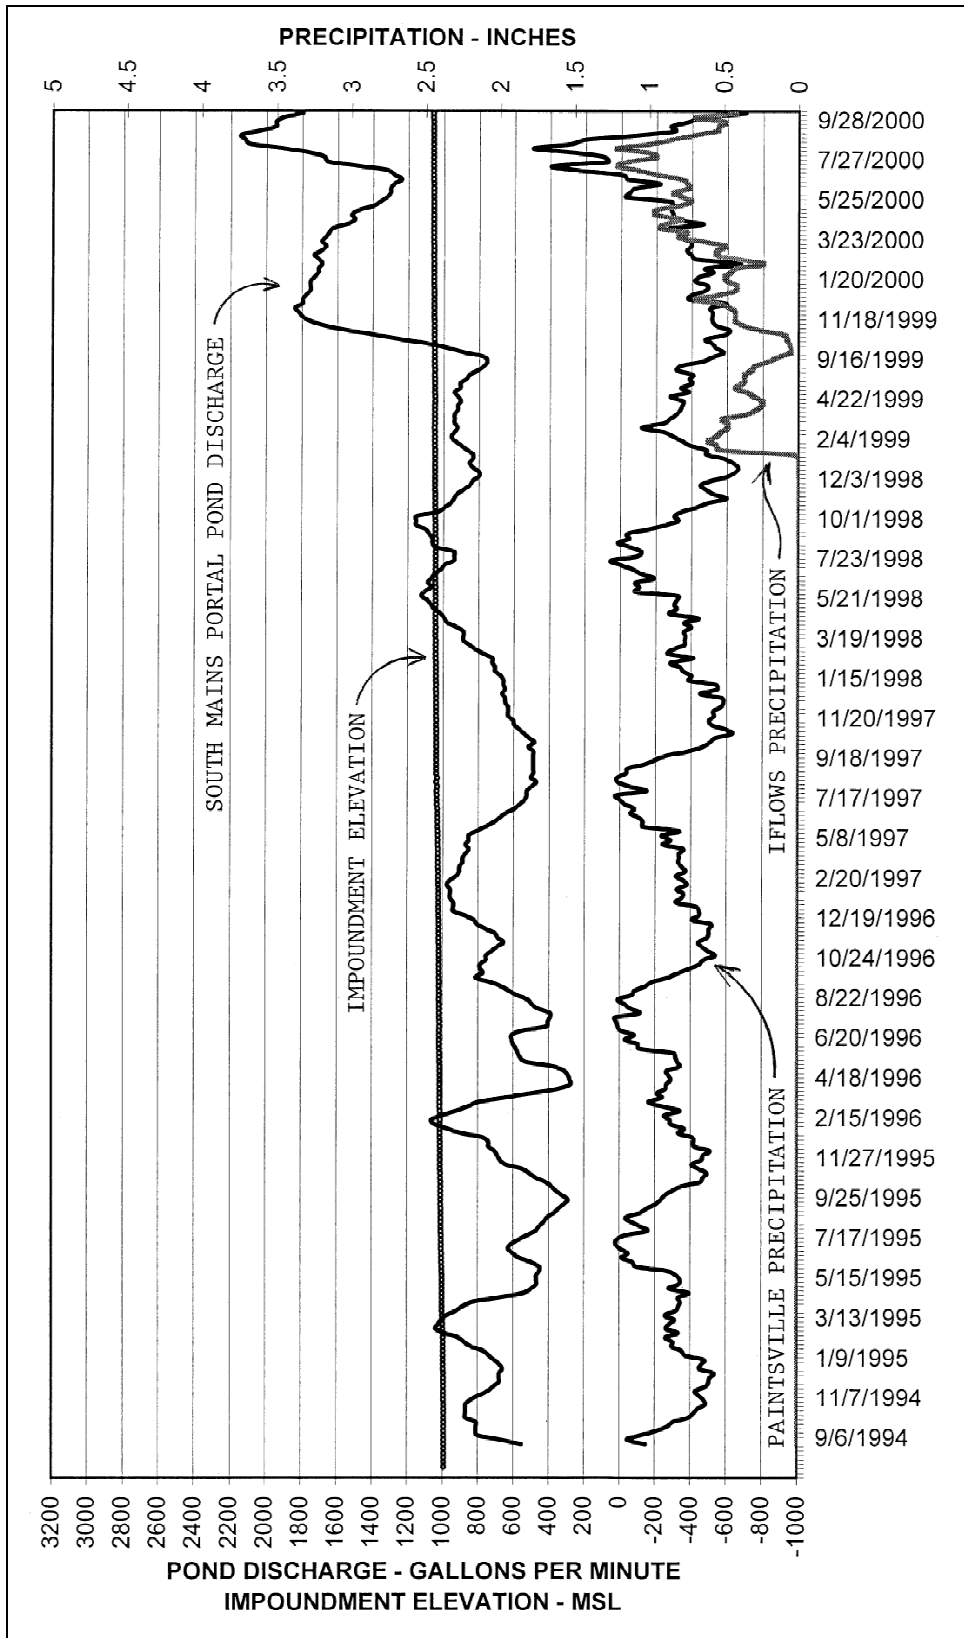
Because the IFLOWS data was not available for precipitation prior to 1999, OSM used the Paintsville, Kentucky, NWS data to obtain a long-term trend. Figure 9 (Page 62) shows that while the Paintsville and IFLOWS rates differ, they both have similar trends.

Figure 9. Impondment Elevation, South Mains Portal Pond Discharge, and Precipitation. Impondment elevation obtained from MCCC. Pond discharge calculated by OSM—for details see Appendix 10, Section 4. Precipitation obtained from National Weather Service, Paintsville, Kentucky and IFLOWS station number 3194. See Appendix 10, Figure 4 for data points. The discharge and precipitation lines are “trendlines” based on an eight point moving average.

- There was no clear, consistent trend between discharge rates and precipitation for the six ponds as contended by MCCC.
- There was not a relationship between precipitation and impoundment pool elevation.
