SUBJECT: ELECTRICAL SAFETY PERFORMANCE CHALLENGES AND GOALS

**Fiscal Year 2004
Electrical Safety Performance
September 30, 2004**

Fernald Closure Project
2004 Electrical Safety Incident Review
September 20, 2004

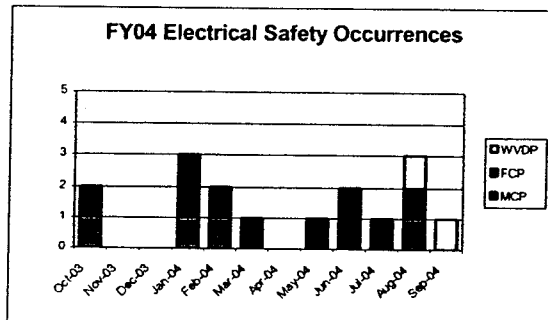
Attached are review reports for the Fernald Closure Project, Miamisburg Closure Project, and West Valley Demonstration Project. These reviews examined the performance data for each site, analyzed underlying causes to electrical safety issues, and developed action plans to improve performance. The chronological data for OH overall, shows two clusters of events, one in the January to March timeframe and another in the June through September timeframe.

Of the six (6) events in the January to March timeframe, three (3) were related to vehicle contact with lines or poles. Aggressive management attention was brought to this issue and has reduced these types of events with only one occurrence since March and none in the last three months. The two West Valley events in the last two months have

prompted that site to start an aggressive electrical safety campaign in order to head off any future occurrences. The details of the campaign are contained in their report (attached), which appears to be comprehensive. OH will continue to monitor their progress.

OH will continue to track and trend electrical safety related events on a monthly basis to identify changing trends and look for lessons learned to ensure performance improvement.
