# UNITED STATES COAST GUARD

INVESTIGATION INTO THE CIRCUMSTANCES  
SURROUNDING THE SINKING OF THE  
UNINSPECTED FISHING VESSEL

## ARCTIC ROSE

OFFICIAL NUMBER 931446, IN THE BERING SEA ON  
APRIL 2, 2001, WITH ONE PERSON DECEASED AND  
FOURTEEN PERSONS MISSING AND PRESUMED DEAD

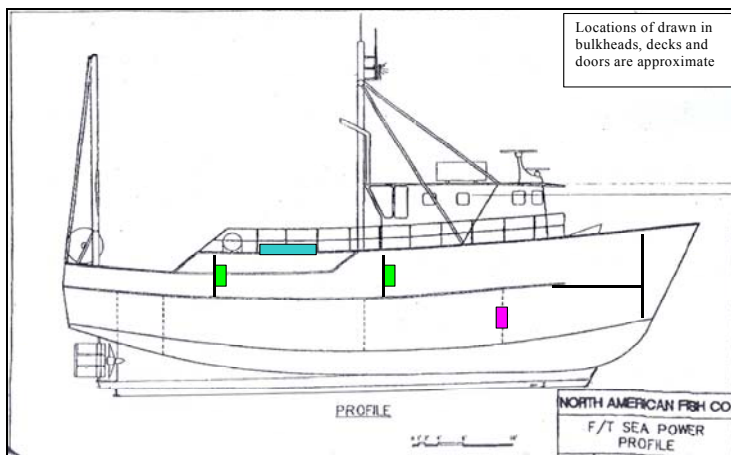
Figure 11  
Drawing showing  
locations of the  
weathertight or watertight  
doors and hatches

h. Watertight/Weathertight Doors and Hatches. There was a six-dog weathertight door located on the starboard side that opened out to the trawl deck, and a slide hatch located on the aft bulkhead of the processing space. The sliding weathertight chute on the aft bulkhead

facilitated the movement of the catch from the dump box to the processing space. The overhead of the processing space had a weathertight hatch used to offload product. The processing space had six sideshell openings. A small manhole with a raised coaming was located in the top of the deck hatch, which was fitted with a non-watertight or weathertight plywood cover. A weathertight door provided access from the processing space to the mudroom. Access to the engineroom was via a flush deck trunk. A hatch cover was not fitted over the engineroom trunk. There was a watertight door between the engineroom and auxiliary machinery space and a non-watertight hatch between the engineer's stateroom and the auxiliary machinery space. The Jensen Marine Consultants (JMC) issued stability booklet required this watertight door to remain shut at all times except when used for passage. This same book required all openings for scrap and fish chutes in the processing space bulkhead to be kept closed at all times except when used while processing fish.

Action: We concur with the intent of this recommendation. We believe that the fitting of watertight and weathertight doors, required to be closed by a vessel's stability booklet, with alarms and status indicators would improve fishing vessel safety by making masters and crews more aware of the status of their vessel's watertight integrity and alerting them to possible threats of flooding. However, we believe that the development and implementation of a voluntary compliance program rather than attempting to publish regulatory requirements is more appropriate and more likely to be completed faster and with better success. We will consult with the Commercial Fishing Industry Vessel Safety Advisory Committee and work with the industry on the development of appropriate voluntary standards and seek to include the results in an update to Navigation and Vessel Inspection Circular 5-86, *Voluntary Standards for U.S. Uninspected Commercial Fishing Vessels*.

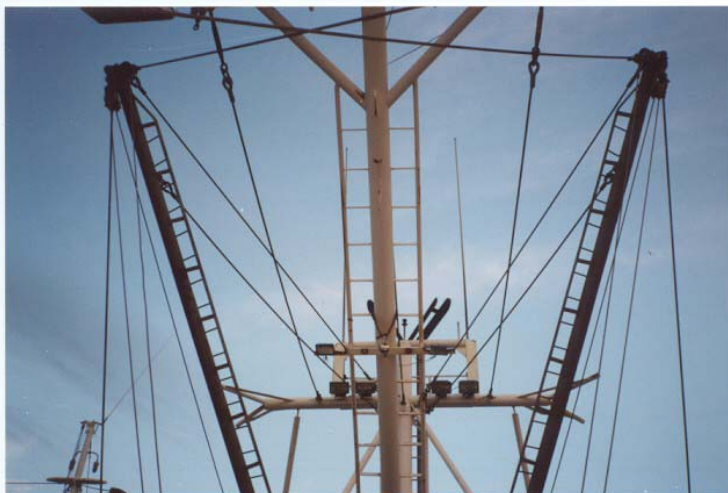
Figure 16  
Photo of “Stability  
Vanes (1995)

The existing stability vanes (see Figure 16), were removed.

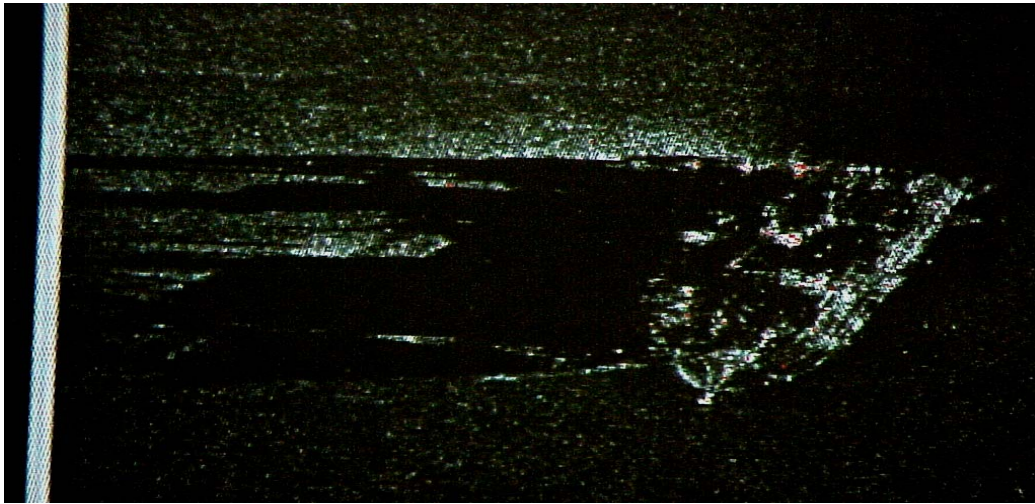
Figure 27  
Picture from side scanning sonar of ARCTIC ROSE (2001)

water. Shortly thereafter, the Board received its first look at the vessel, which was sitting upright on the sea floor in 73 1/3 fathoms, or 428 feet, of water in the location 58° 56.22 minutes North latitude and 175° 53.10 minutes West longitude. The location is approximately 200 miles northwest of St. Paul Island, Alaska. The ROV was maneuvered slowly up the port side of the hull and revealed the name – ARCTIC ROSE. The ROV
