MARINE CASUALTY REPORT

ALEUTIAN ENTERPRISE

Flooding, capsizing, and sinking in the Bering Sea on March 22, 1990, with nine persons missing and presumed dead

U.S. COAST GUARD
MARINE BOARD OF INVESTIGATION REPORT

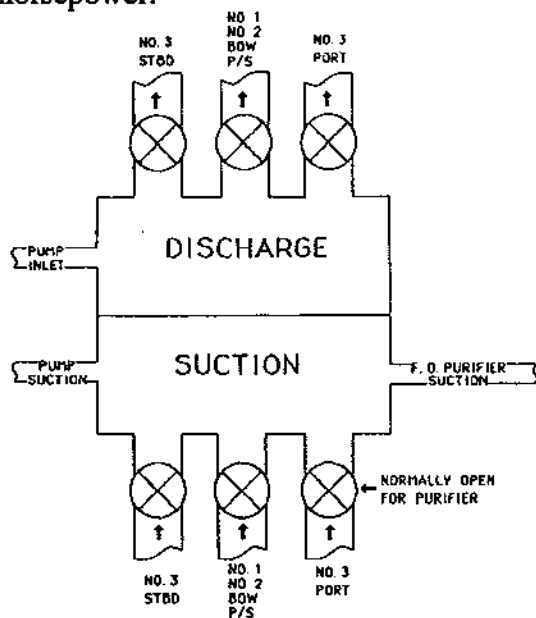
Figure 5

k. Fuel Oil Manifold Figure (5) is a sketch of the fuel oil transfer manifold as described by the assistant engineer. Transferring fuel from No. 3 port to No. 3 starboard fuel oil tanks required opening the No. 3 starboard discharge valve since the No. 3 port suction valve was normally open. The assistant engineer testified that this was a simple task.

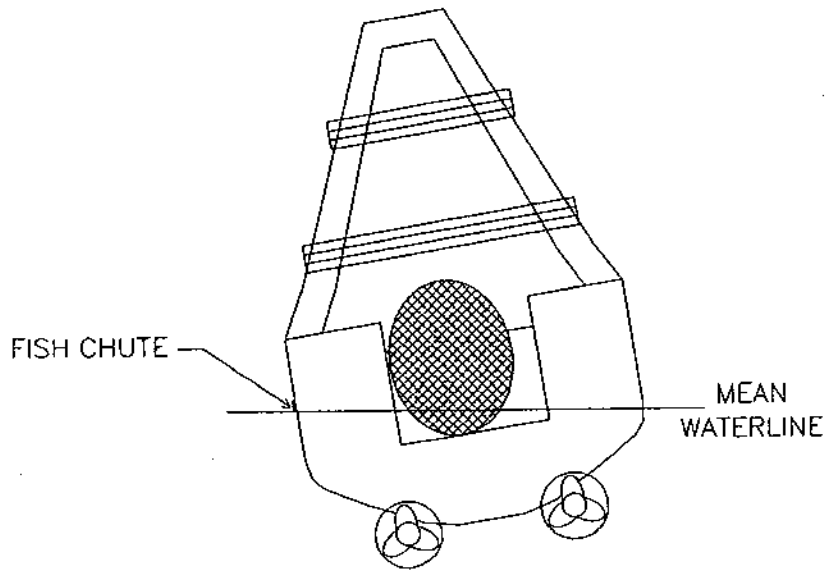
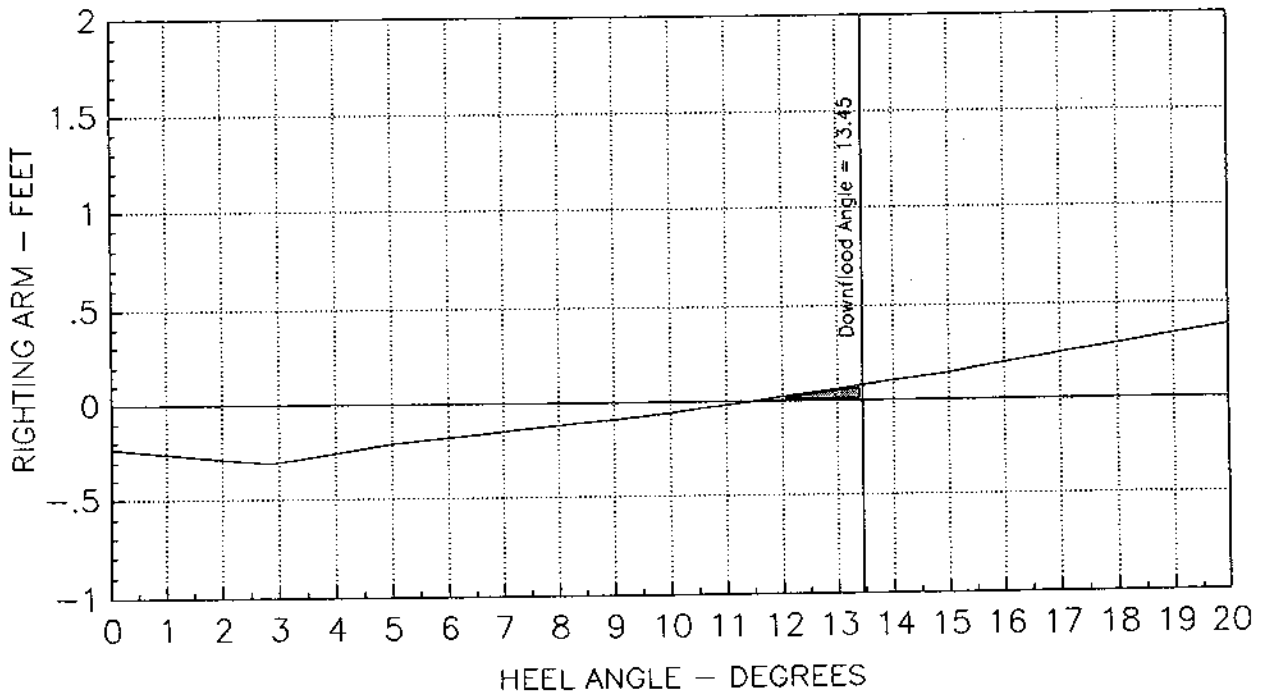
Figure (18)

EQUILIBRIUM LIST ANGLE FOR LOAD CONDITION 5 M 2

RESIDUAL RIGHTING ENERGY
