MARINE CASUALTY REPORT

SS AMERICAN EAGLE, O.N. 278327

EXPLOSION IN THE GULF OF MEXICO

**Marine Board of Investigation Report
and
Commandant's Action**

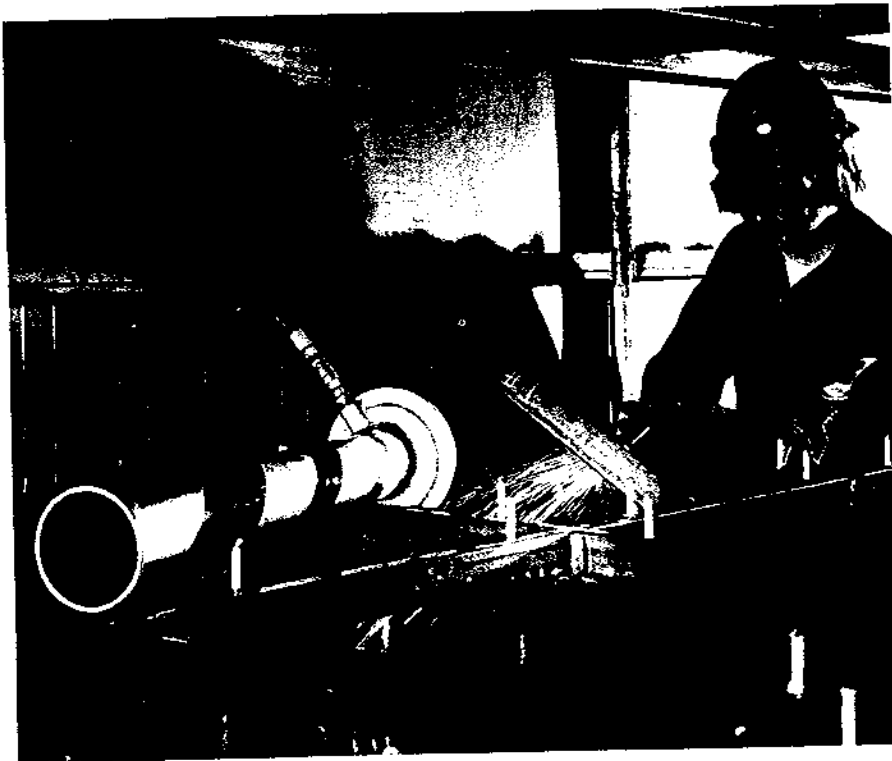
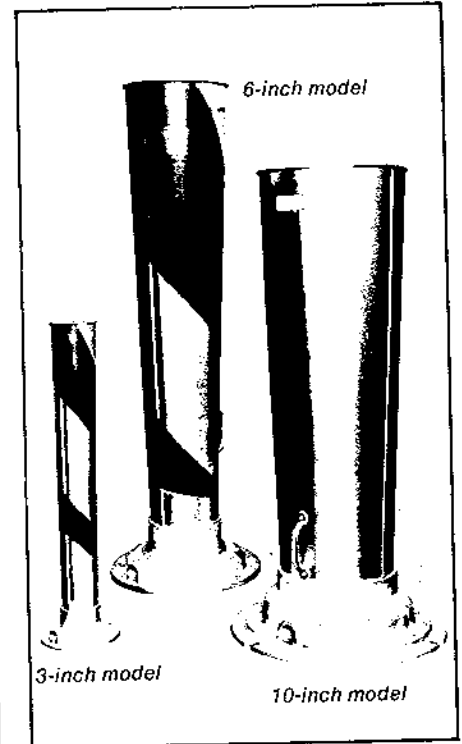
Lamb Air-Mover™ Ventilator

Comment: This conclusion is concurred with. The air mover should have been properly grounded in accordance with the manufacturer's instruction in the warning label. However, proper grounding of the air mover would not have eliminated the risk of electrostatic discharge from the plastic sleeve or the vapor cloud.

Action: This recommendation is concurred with. Although normal placement of metal equipment on a deck cleared of high resistance materials such as gaskets will normally provide an adequate leakage path to eliminate an electrostatic discharge, this recommendation will be forwarded to MSA and other manufacturers of portable venturi air mover ventilators for their consideration. Ultimately, the equipment operator is responsible for ensuring that all safety precautions including grounding of the equipment are observed.
