# MARINE CASUALTY REPORT

M/V ANGELINA LAURO (ITALIAN);  
FIRE ON BOARD WHILE DOCKED IN  
CHARLOTTE AMALIE HARBOR, ST.  
THOMAS, USVI, ON 30 MARCH 1979  
WITH NO LOSS OF LIFE

U.S. COAST GUARD  
MARINE BOARD OF INVESTIGATION REPORT

REPORT NO USCG 16732/01282

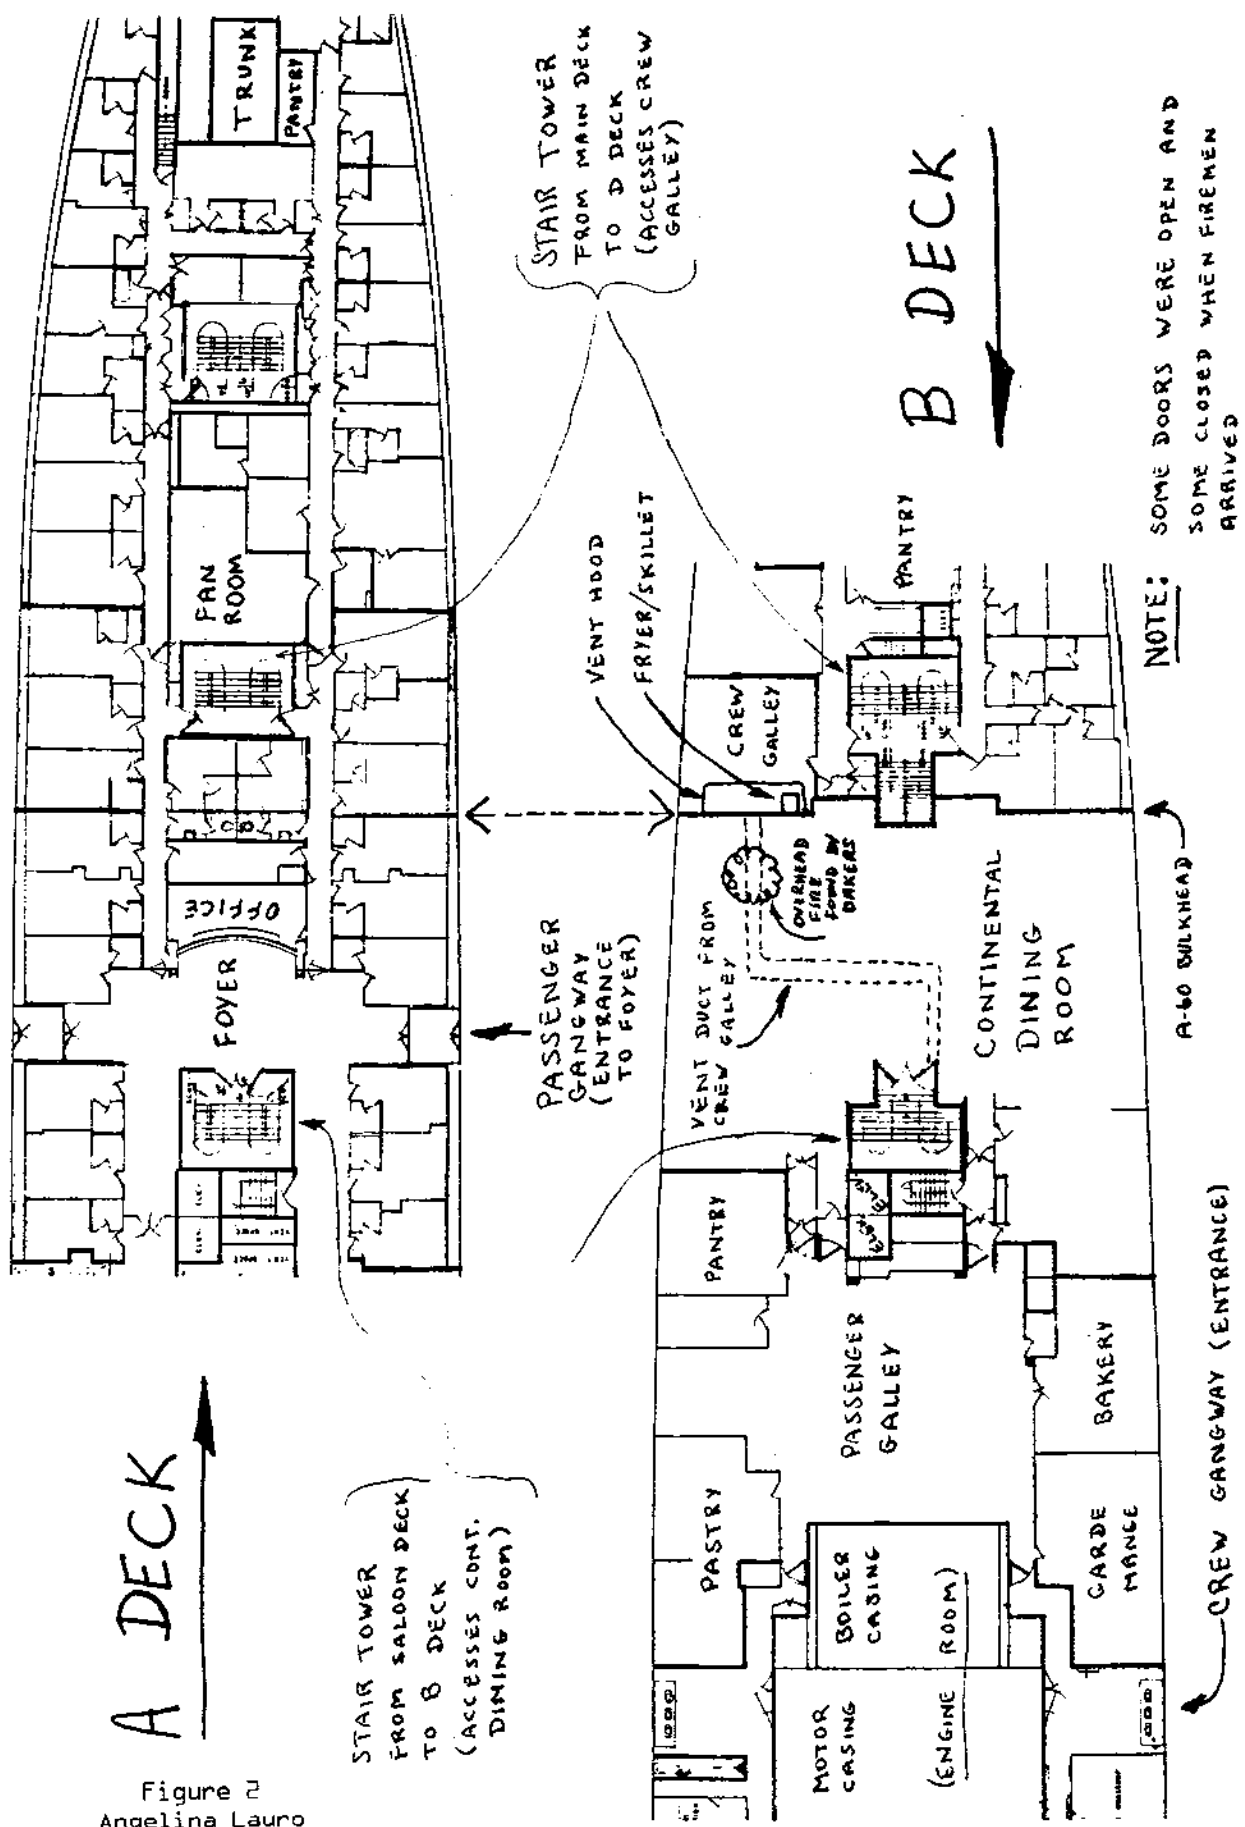
Figure 2  
 Angelina Lauro  
 Partial  
 A & B Deck Plan

OVERHEAD  
 FIRE  
 CAUSED BY  
 BAKERS

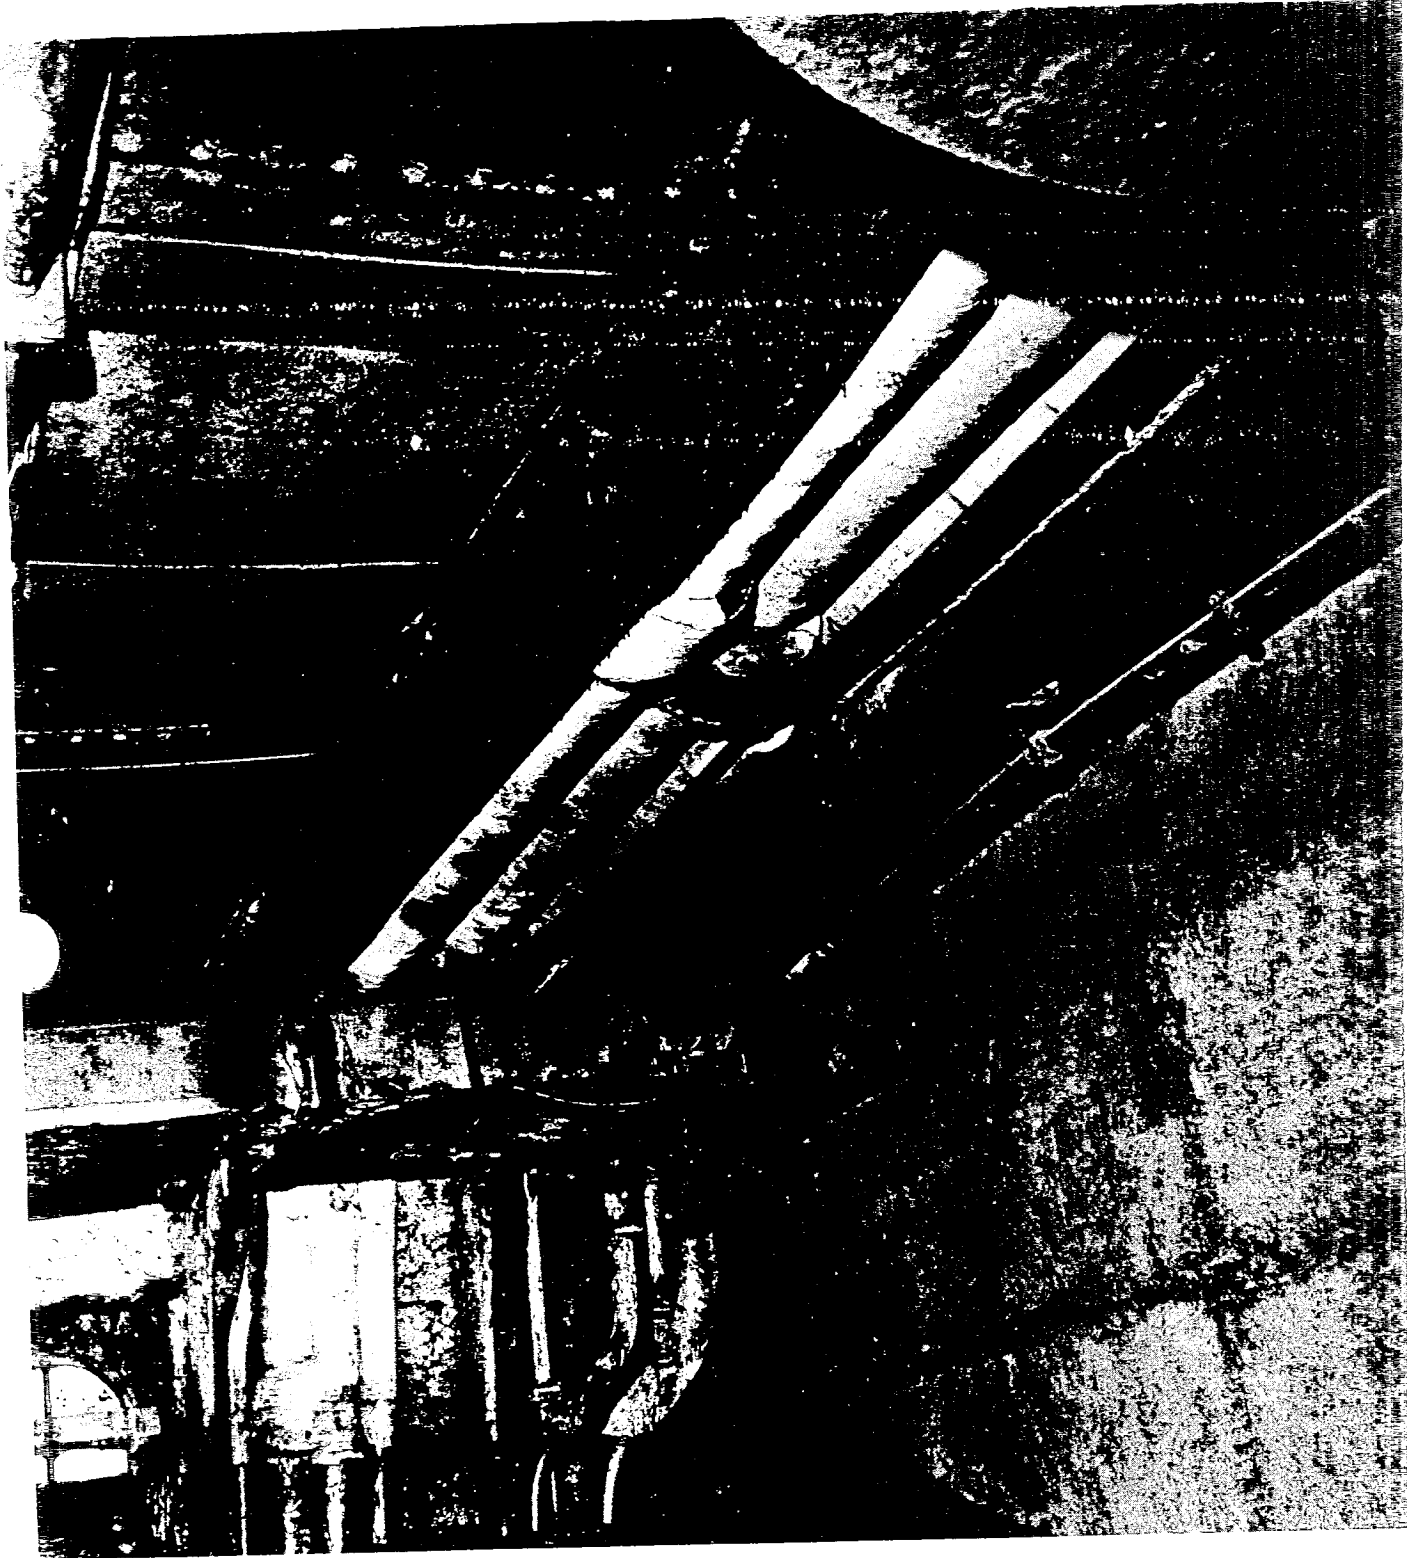
Figure 9  
Continental Dining Room  
View of the Crew Galley  
Exhaust Vent

35. Above the galley range and fryer/skillet was a steel exhaust hood which collected vapors from these appliances. Exhaust was extracted from the hood through a rectangular exhaust duct wrapped with fiberglass, 750mm x 200 mm in size. The exhaust duct passed horizontally through the main vertical zone at frame 166 and was routed through the Continental Dining Room aft to frame 151 where it turned 90 degrees and ran athwartship to the starboard corridor adjacent to the staintower on the centerline of the after end of the dining room. Here it turned 90 degrees and ran aft to frame 142 where it entered the staintower and was then routed vertically to the vessels forward stack. On the Stack Deck, the duct ran aft to frame 125 and terminated inside the after funnel. It was fitted with an electrically driven exhaust fan and a manually operated, blade type damper at this termination. Two automatic fire dampers were fitted in the hood exhaust duct, one

inside the galley and one inside the Continental Dining Room adjacent to the main vertical zone bulkhead. Both dampers were identical. They were constructed of 5mm thick steel. The blade was held in the open position by a fusible link designed to melt at 72 degrees centigrade and could be manually operated. The portion of the duct in the Continental Dining Room was covered with fiberglass. The ducts along with air conditioning ducts, sprinkler system piping and electrical wiring were hidden from view by a false ceiling composed of fiber panels supported by wood battings.

38. A post fire examination of the hood exhaust duct revealed that the damper on the galley side of the hood exhaust duct did not close, although the fusible link had melted. The damper on the dining room side had closed; however, it was severely warped. The inside of the duct had a heavy residue of burned grease, however; Chief Crew Cook CAPRICANO claimed that the vent was frequently cleaned and had been so as a matter of routine for as long as he was on the vessel. The hood was equipped with screens intended to catch and condense the grease vapors from cooking. Several witnesses said they were regularly changed, and CAPRICANO stated that this was a matter taken care of by the engineering department. The vent screens were changed on the 28th of March and normally changed once a week and examined by the ships engineers and by inspectors during Coast Guard examination. Also present in the hood was a steam smothering line. The line was traced where it comes out of the hood at the port side of the ship, down to the decklevel, and then forward to the port corner of the galley, thence vertically where there was a manual valve at ceiling level for activation. This system was not used to fight the fire.

Action: This recommendation is concurred with. Although such procedures have previously been unwritten, galley exhaust ducts have long been identified as potentially unsafe areas aboard vessels, requiring the specific attention of both the Coast Guard inspector and the crew of the vessel. A soon to be published amendment to Volume II of the Marine Safety Manual (CG-495) sets forth detailed examination procedures regarding galley exhaust ducts. These procedures are required to be followed during the biennial and mid-period inspection of U. S. vessels and during SOLAS verification examinations of foreign flag vessels. They include the removal of sufficient inspection plates to insure that the duct wall is clean and free of grease and that an operational test of the fire damper is carried out.
