**INVESTIGATION INTO THE CIRCUMSTANCES
SURROUNDING THE LOSS OF PROPULSION
ON THE BULK CARRIER**

BRIGHT FIELD

**AND ALLISION WITH THE RIVERWALK
SHOPPING COMPLEX ON DECEMBER 14, 1996,
NEW ORLEANS, LOUISIANA, WITH MULTIPLE
INJURIES AND NO LOSS OF LIFE**

**COMMANDANT'S ACTION
ON
THE MARINE BOARD OF INVESTIGATION**

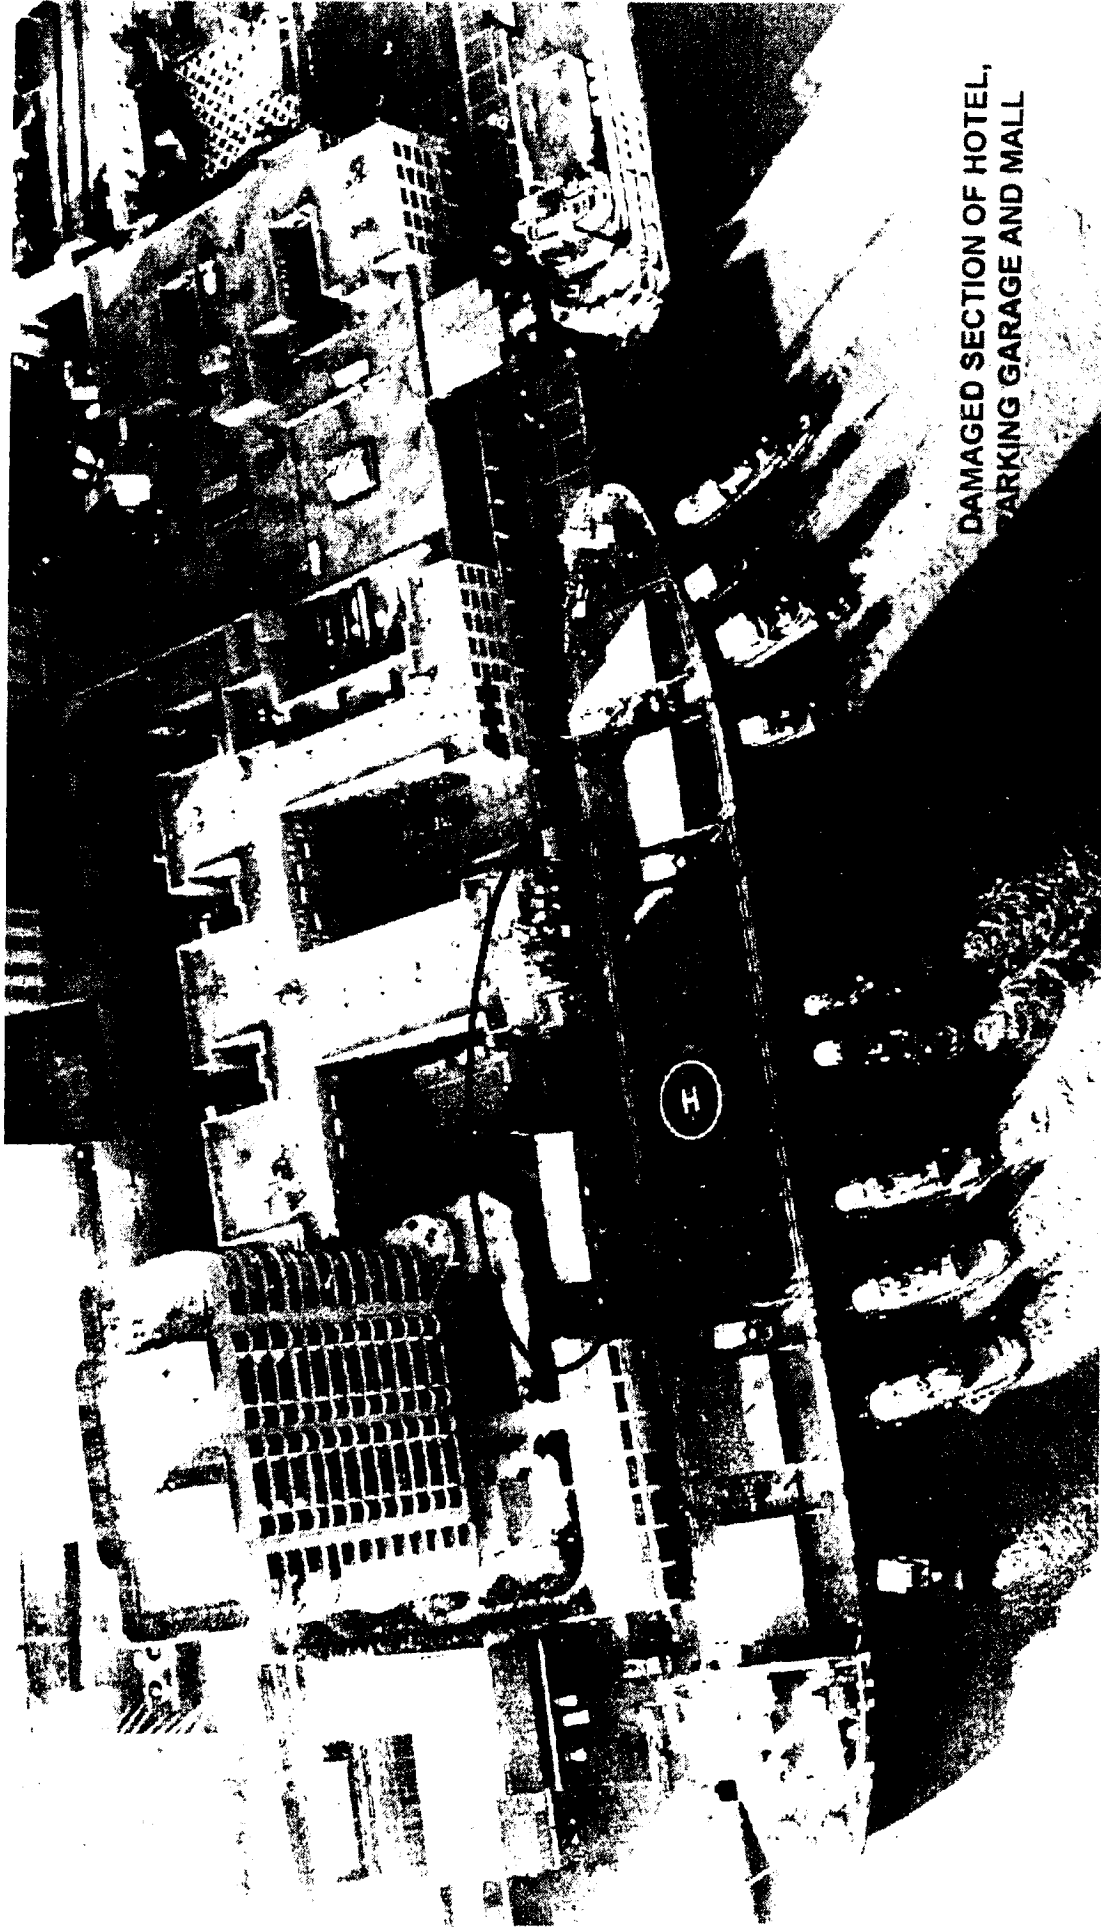
FIGURE 1
(Photograph courtesy of the Times-Picayune)

The allision caused significant damage to the Riverwalk structure, collapsing about 350 feet (122 meters) of the open pier and damaging part of the adjacent condominium and garage. Several riverside rooms in the Hilton Hotel, as well as several of the shops in the mall, were damaged. Because of concern that additional sections of the damaged structures might collapse if the vessel was moved, tugs continued to assist in holding the BRIGHT FIELD in position for three weeks until emergency bracing and repairs were made to the damaged structures. Structural damage to the pier, hotel, and condominium is estimated at \$ 10 million. Non-structural damage to shops in the mall is estimated at \$ 5 million. See Figure 1 for the most inclusive view of the damage.

BRIGHT FIELD AT REST AND PIER DAMAGE

DAMAGED SECTION OF HOTEL,
PARKING GARAGE AND MALL
