**USCGC BLACKTHORN, SS CAPRICORN;  
COLLISION IN TAMPA BAY  
ON 28 JANUARY 1980 WITH LOSS OF LIFE**

**U.S. COAST GUARD  
MARINE BOARD OF INVESTIGATION REPORT**

**REPORT NO. USCG 16732/01279**

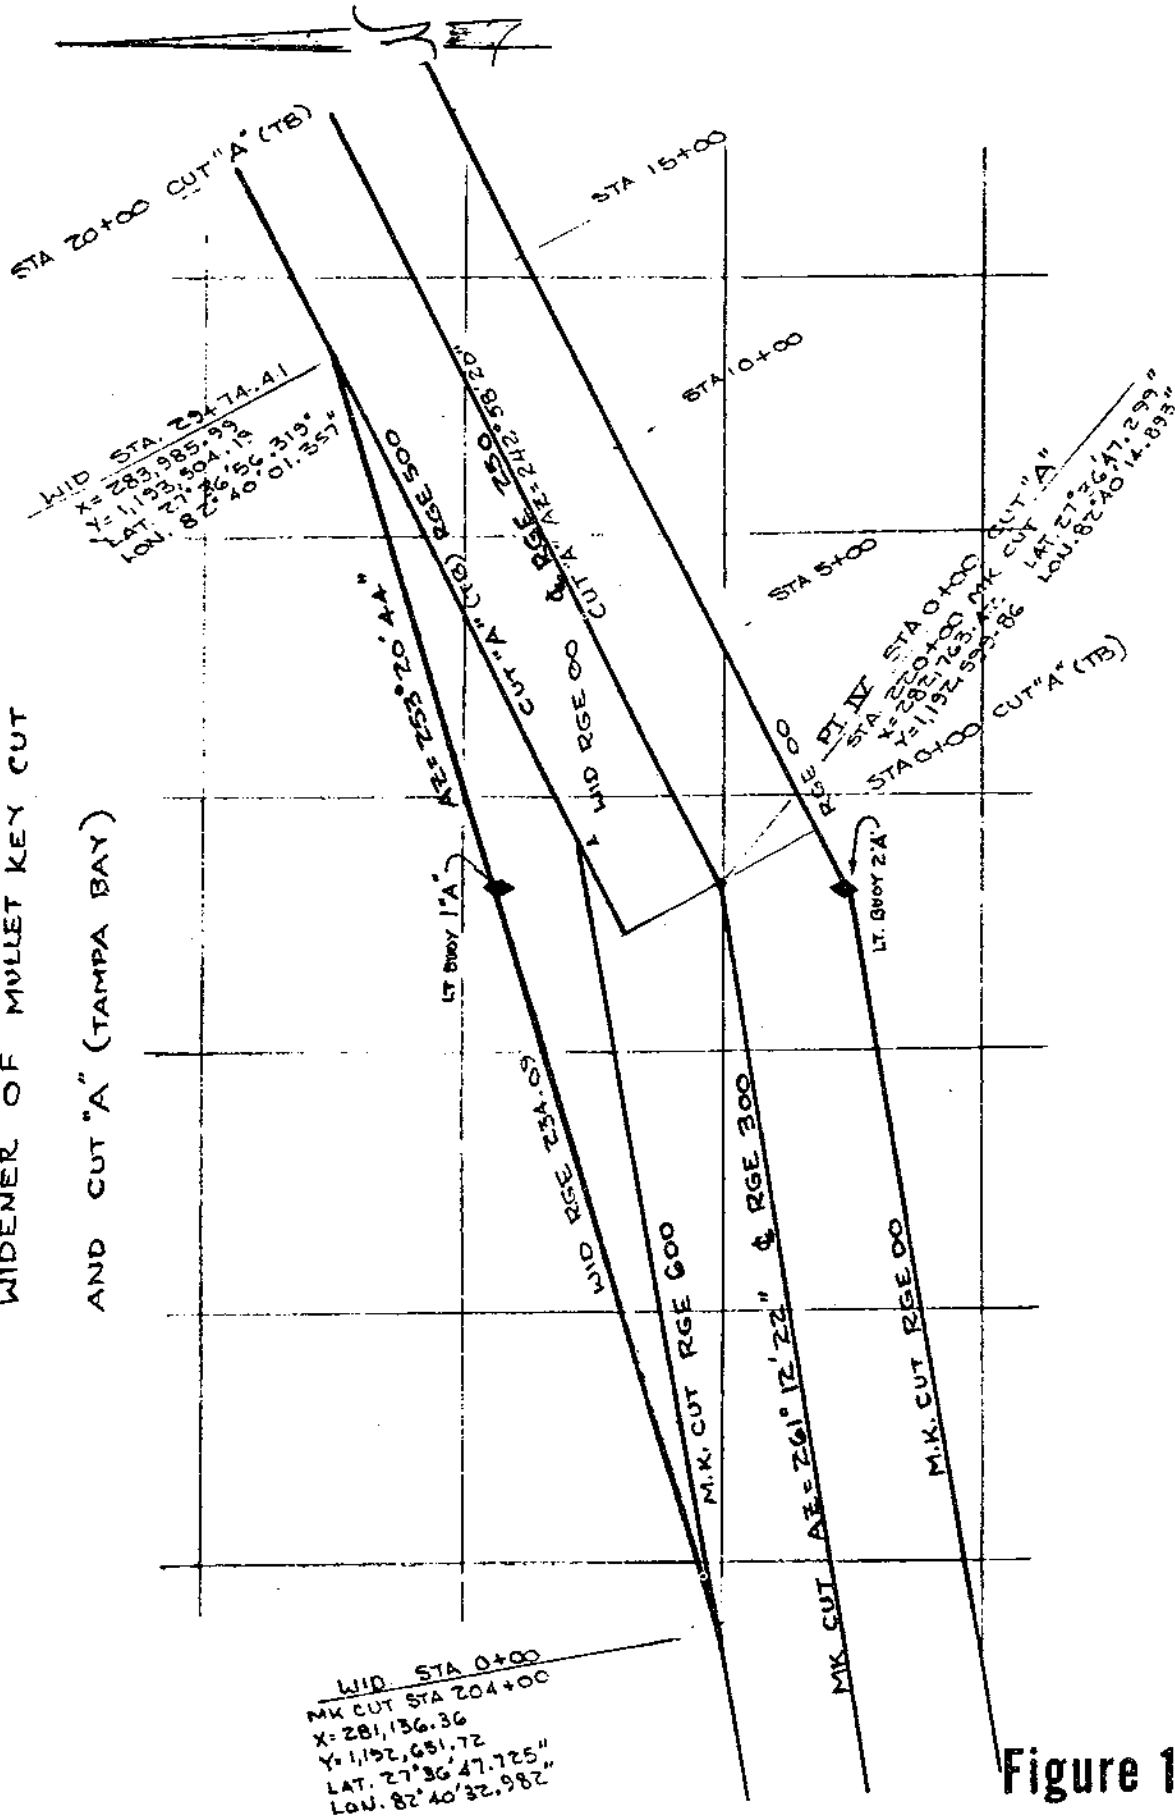
Figure 1

e. The limitations of the junction of Mullet Key and Cut "A" Channels are such that pilots feel that two large ships should not meet in the junction. Harry E. Knight, the pilot aboard CAPRICORN, testified that inbound loaded ships normally commence the turn into Cut "A" Channel by ranging the north side red lights under the Skyway Bridge with the Cut "A" Range Rear Light (LLNR 1049). A plot of this results in the ship crossing through the junction north of the range line intersections and near the center point between Cut "A" Channel Lighted Bell Buoy "1A" and Lighted Buoy "2A". However, Pilot Knight insisted throughout his testimony that the normal turn for such vessels was executed south of Mullet Key Channel range line close to Buoy "2A".

WIDENER OF MULLET KEY CUT  
AND CUT "A" (TAMPA BAY)

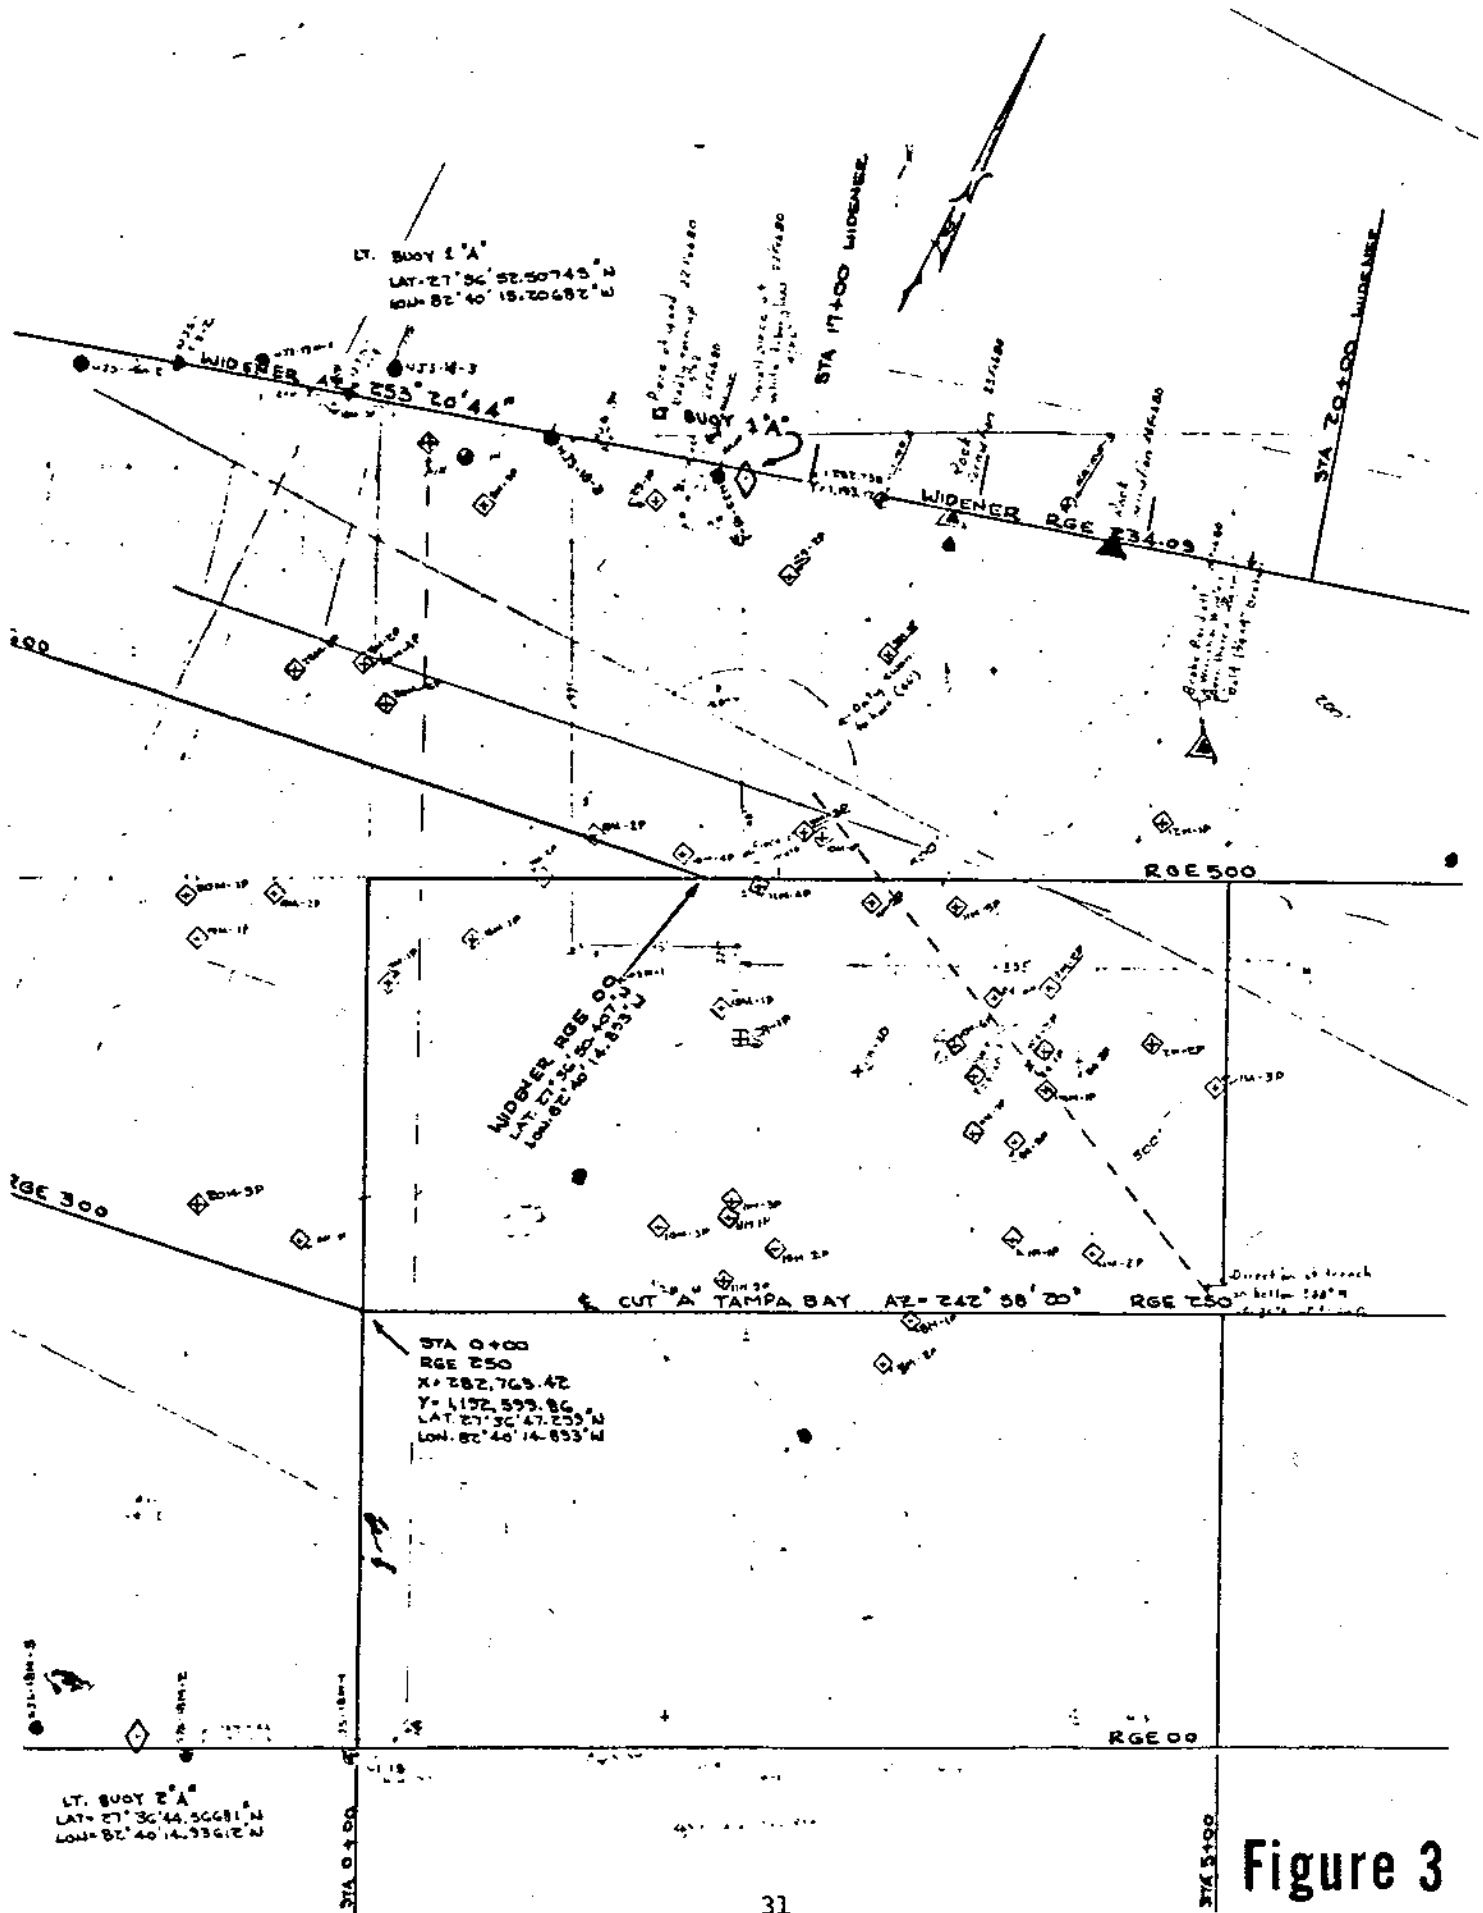
Figure 3

11M-1P(a)	049°T - 73	yds	TORN & TWISTED METAL PLATE
11M-1P(b)	049°T - 73	yds	TORN & TWISTED METAL PLATE
11M-2P	059°T - 70	yds	METAL PLATE
11M-3P	047°T - 74.3	yds	PIECE OF METAL (BROKEN I OR T BEAM, GREY PAINT ON ONE SIDE)
BOLSTER	067°T - 527	yds	LARGE HORN SHAPED PIECE 1½" STEEL PLATE
PLATING	067°T - 527	yds	11' x 3' STEEL, WEIGHING APPROXIMATELY 1100 lb
BLACKTHORN	064°T - 875	yds	SHIP
FORWARD HATCH COVER	064°T - 870	yds	7' x 7' STEEL
CAPRICORN's ANCHOR	063°T - 542	yds	13,500 lb STOCKLESS
