**MARINE CASUALTY REPORT**

**M/V CHESTER A. POLING;  
SINKING IN THE ATLANTIC OCEAN  
ON 10 JANUARY 1977 WITH LOSS OF LIFE**

**U.S. COAST GUARD  
MARINE BOARD OF INVESTIGATION REPORT**

**REPORT NO. USCG 16732/73448**

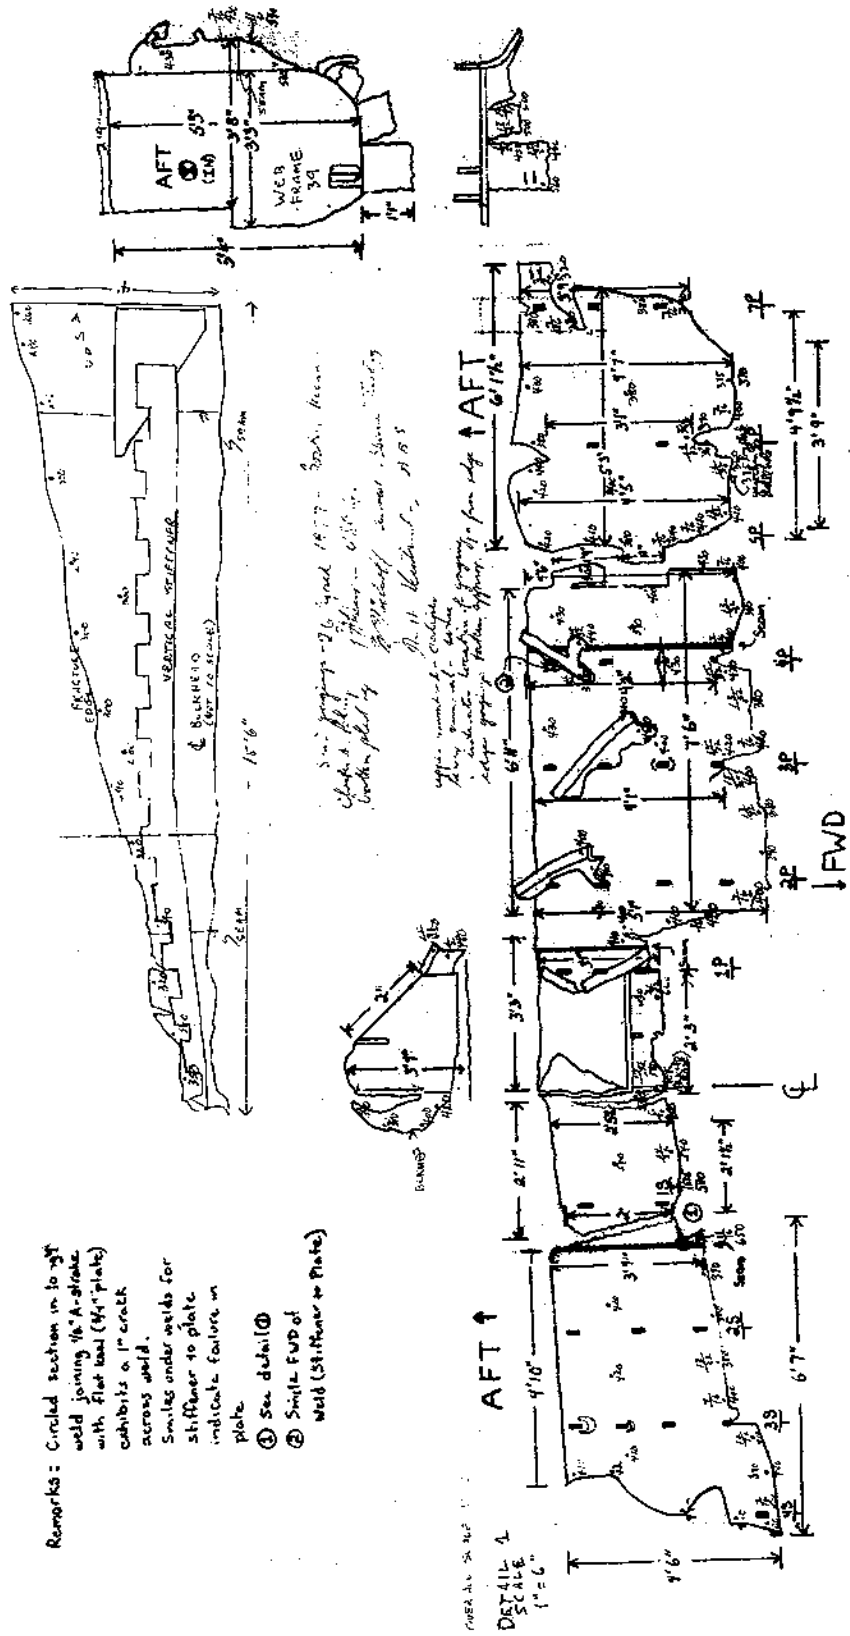
Figure 3

33. Figure (3) contains the actual thickness of recovered steel as measured by the Arnold Greene Testing Labs, Inc. and witnessed by American Bureau of Shipping and Coast Guard representatives on 26 April 1977 at Coast Guard Support Center, Boston, Massachusetts. These final readings were analyzed from two aspects; (a) transverse gagings along the fracture edge were averaged separately, and (b) then combined with the remainder of the plate to obtain a total average plate thickness. The average plate thicknesses are as follows:

The lowest individual gagings were found along the fracture edge with .360 to .390 not uncommon. Averaging gagings across the plates closest to the break yielded the following results:

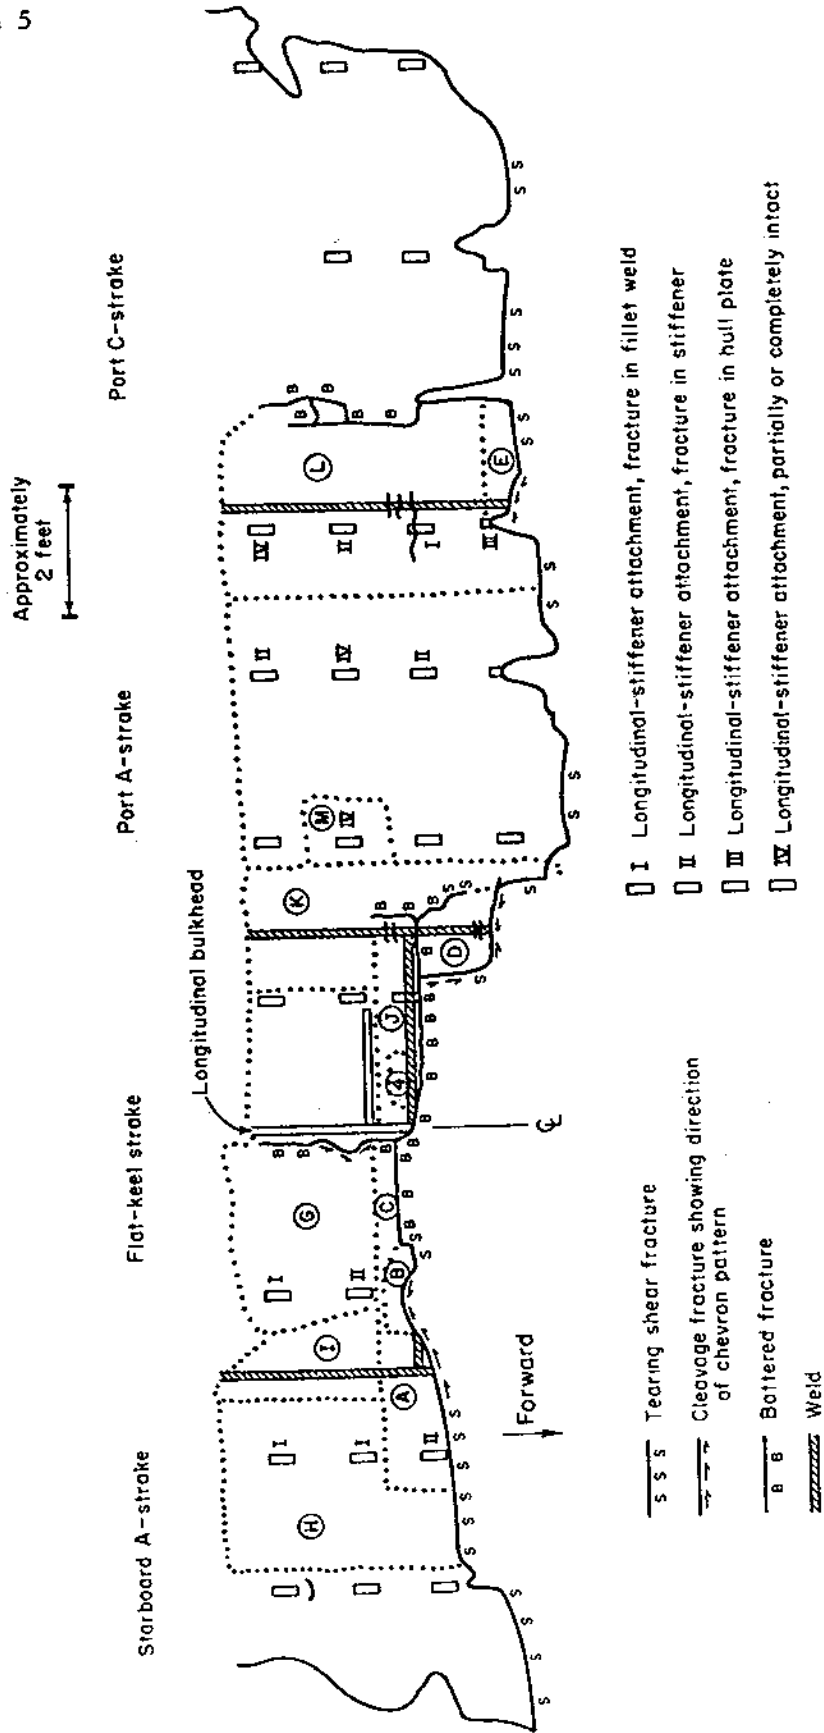
Figure 5

(d) Fractures—A map of the portion of the fracture studied is shown in figure (5). The circled letters designate the pieces that were sent to Battelle. The pieces of the bottom plate were bent with the concave side of the bend generally being upward, especially along the fracture. The centerline bulkhead also was bent, and a vertical stiffener on the bulkhead had been bent backward approximately 90 degrees. Four of the longitudinal stiffeners remained attached to the plate at positions several feet from the fracture, but they had been torn from the plate near the fracture. The stiffeners also were severely bent as though they had been pushed toward the stern. Fractures in the attached stiffeners occurred in one of three places: in the fillet weld, in the stiffener, or in the plate. The locations of some of the individual fractures are indicated by Roman numerals in figure 5. Most of the fracture in the flat keel plate was badly battered, giving the appearance that it had been pounded by the mating fracture surface prior to the ultimate failure. This implies that the two halves of the hull maintained their alignment for some time after some plating and stiffeners failed. The flat keel plate fracture surface was probably a brittle mode failure. Most of the fractures in both A-strakes and the port C-strake were tearing shear fractures. The surfaces were smooth and at approximately 45 degrees to the top and bottom surfaces. Battelle's metallographic examination revealed that the deformation associated with the tearing shear fractures was all downward, indicating that the forward half of the ship was moving downward with respect to the aft half as the bottom hull plate tore apart. A tearing shear fracture, as opposed to a tensile or propagating shear fracture, generally is the final event in a fracture process and is not associated with fracture initiation.

(e) Secondary Cracks—Many secondary cracks were observed in the top surface of the longitudinal seam welds and the plate within a couple of feet of the fracture. Secondary cracks were also observed in the bottom surface of the flat keel within an inch of the fracture. Some of the cracks were opened fairly wide, suggesting that the plate had previously been bent upward and the cracks probably formed when the plate was bent back downward.

FIGURE 5. MAP OF FRACTURE IN THE BOTTOM HULL PLATE OF THE CHESTER A. POLING  
The top (inside) surface of the plate is shown.
